## SKAGIT COUNTY DEPARTMENT OF PUBLIC WORKS

### 2013 ANNUAL BRIDGE REPORT

**SUBMITTED FEBRUARY 2014**

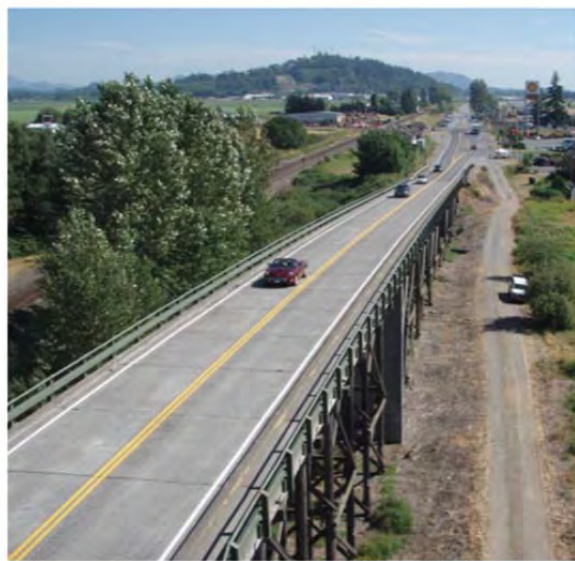
**Old Highway 99 BNSF Railroad Overpass**

In 2012, a load rating was performed on the Burlington Northern Santa Fe (BNSF) Overpass due to deteriorating pile caps. The load rating indicated that in its current state, the bridge should be load rated at 8 tons. But due to the importance of this route for freight and goods and the nearby quarries, Skagit County crews installed temporary shoring at the deteriorating pile cap locations. This allowed the overpass to remain open to handle legal loads; no overweight loads are permitted at this time.

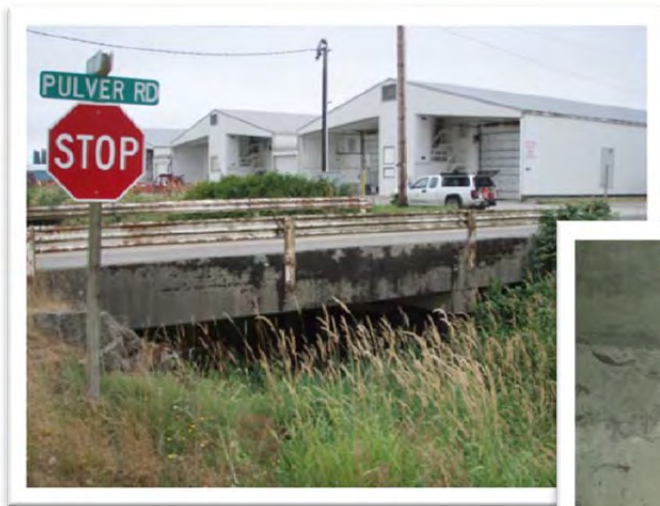
*Pulver Road at Joe Leary Slough*

The Pulver Road @ Joe Leary Slough Bridge #40031 remains on the County's watch list. It has incurred some damage due to what is believed to be an overloaded vehicle crossing the bridge. Staff is working with our on call Bridge Consultant, Shearer Design, to have a load rating completed on this bridge. The engineering plans are inadequate, but the bridge design is similar to other county bridges built at that time. Based on these factors and past performance we should be able to perform a reliable load rating on the bridge. Skagit County has increased the inspection frequency to a 12 month cycle to keep on top of any further deterioration that may arise. When the load rating is completed, it is anticipated the bridge inspection cycle will be increased to the standard two year cycle.

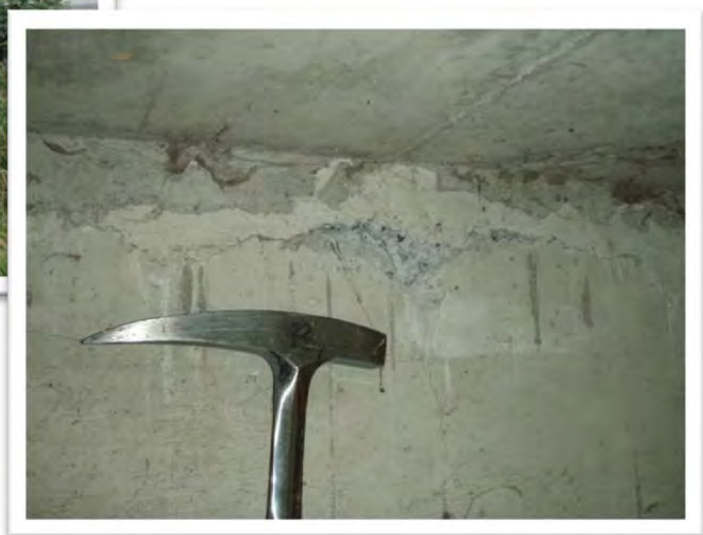
*Example of longitudinal cracking in girder on Pulver*

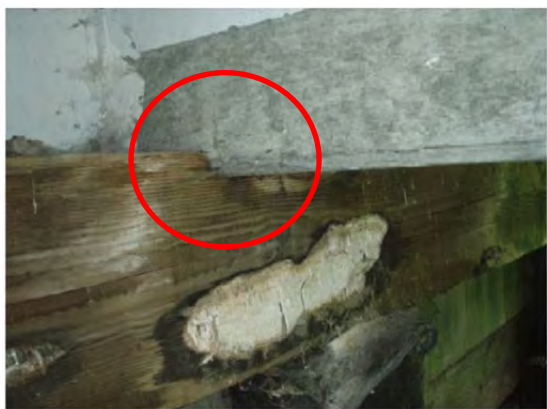
The South Lake Campbell Road Bridge recently had two timber pier caps replaced by the Skagit County Road Crew. And the Old Highway 99 BNSF Railroad Overpass received epoxy injections on two pier caps to prevent any further crushing that was occurring.

***Crushing of the pier cap***

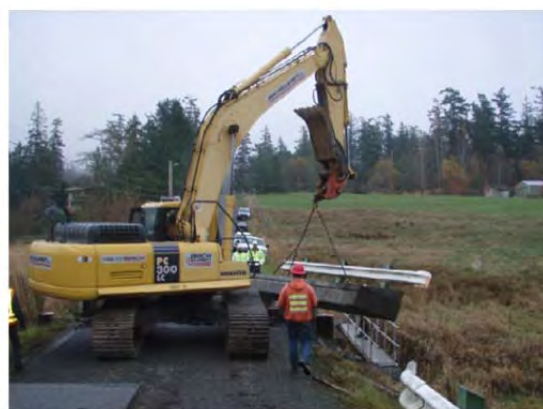
***Removal of bridge girders***

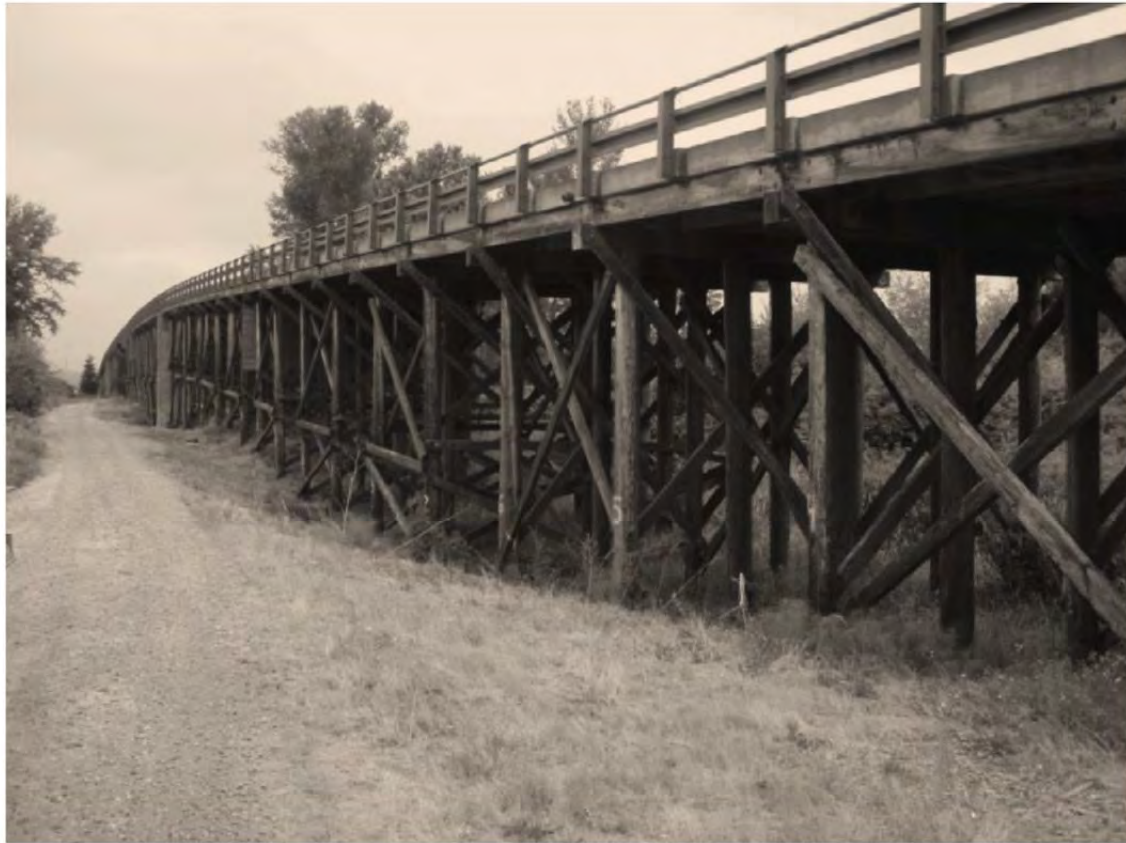
***Old Highway 99 BNSF Railroad Overpass***

It was discovered during the inspection of the BNSF Railroad Overpass this summer that some crushing has been occurring on the pier caps that support the main span of the BNSF Railroad Overpass. With the aid and direction of our contracted bridge engineer, David Shearer, a high strength epoxy application was injected into the pier caps to strengthen the timber, prevent further rotting, and stop any further crushing from occurring.

Skagit County was awarded BRAC funding in the amount of \$10-million to help fund the replacement of the BNSF Railroad Overpass. Skagit County has contracted with Berger Abam to design the new overpass and is working with BNSF on design parameters.
