TITLE NOTIFICATION

Non-compliant under-slab plumbing drain piping

Parcel Address: 13099 Thillberg Road

Permit Number: BP17-0495

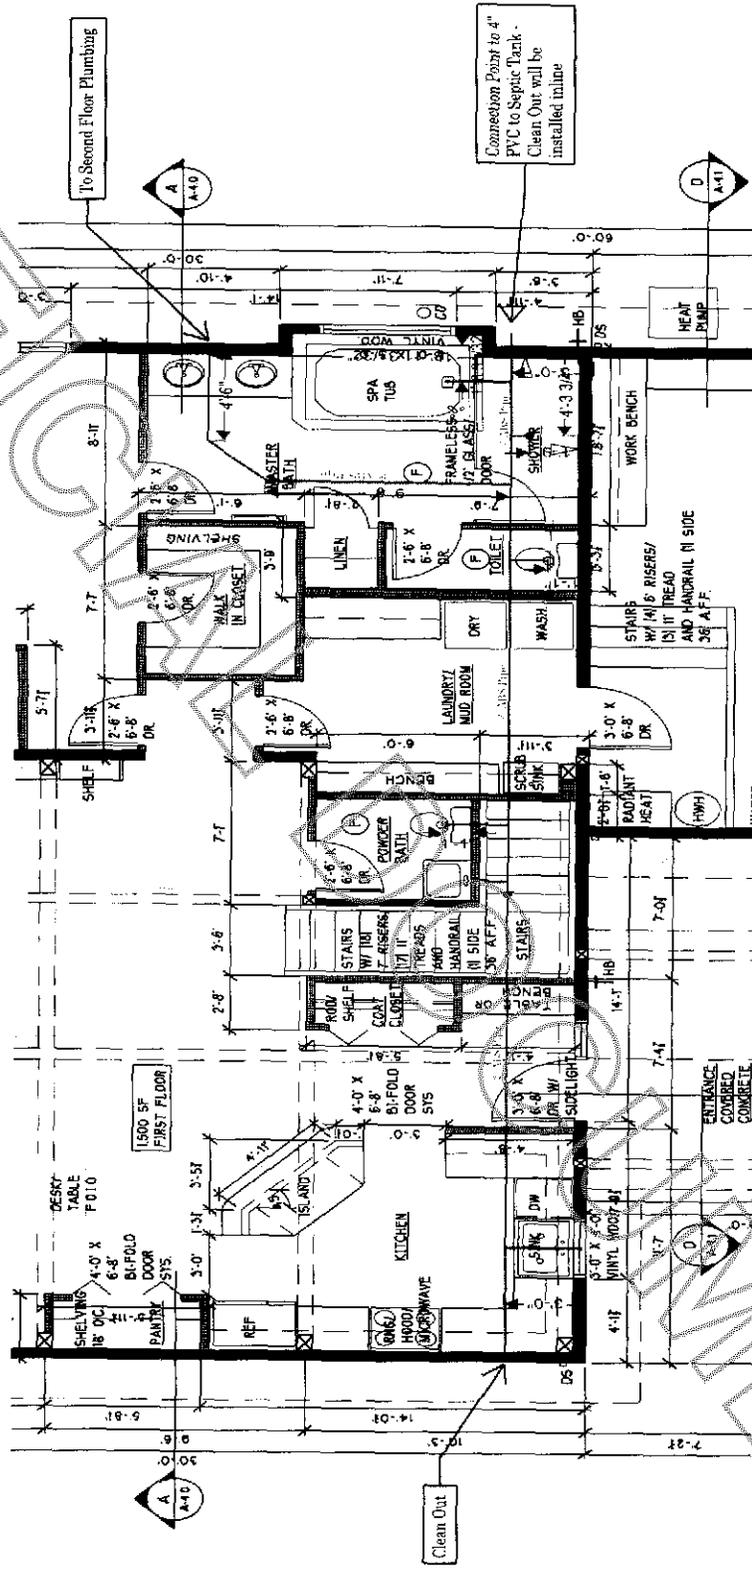
Sligar Residence - As-Built Plumbing under Floor Slab
 13099 Thillberg Road
 Mt. Vernon, WA 98273

Notice: The under-slab plumbing above was installed and covered without first obtaining inspection approval from Skagit County. Non-compliant sanitary tee fittings were installed for the horizontal connections. The slope and bedding could not be verified. These deficiencies increase the likelihood of the plumbing drains developing a blockage.

All underground piping is ABS Schedule 40 Pipe and Fittings. The 3" ABS Main Line was installed from the exterior cleanout to one foot east of the powder bath sink tee. A 3" x 2" reducer was installed and 2" ABS pipe continued to the end cleanout at the east wall. This 2" section of pipe will serve only the kitchen sink. The main sewer run is located 3' south of the north foundation wall sloping from the east to the west at a 2% slope. All stubs off of the main are sloped at 2% to the main. The 3" Tee Main sewer run to the second floor is laid at a 2% slope back to the Main Line. This pipe run has two 45 degree sweeping elbows to head to the west wall and a 90 degree sweeping elbow to turn up the wall. All toilet runs are 3" ABS. The pipe to the bath tub is 3" ABS with a trap. The pipe to the shower is 2" ABS with a trap. The Tees off of the Main Line to all services are Sweeping Sanitary Tees. A preliminary water test was performed prior to pouring the concrete foundation. The system held water with no leaks for two
