ANACORTES SCHOOL DISTRICT NO. 103

2014 State Study and Survey

*Anacortes School District No. 103
Skagit County, Washington*

December 2014

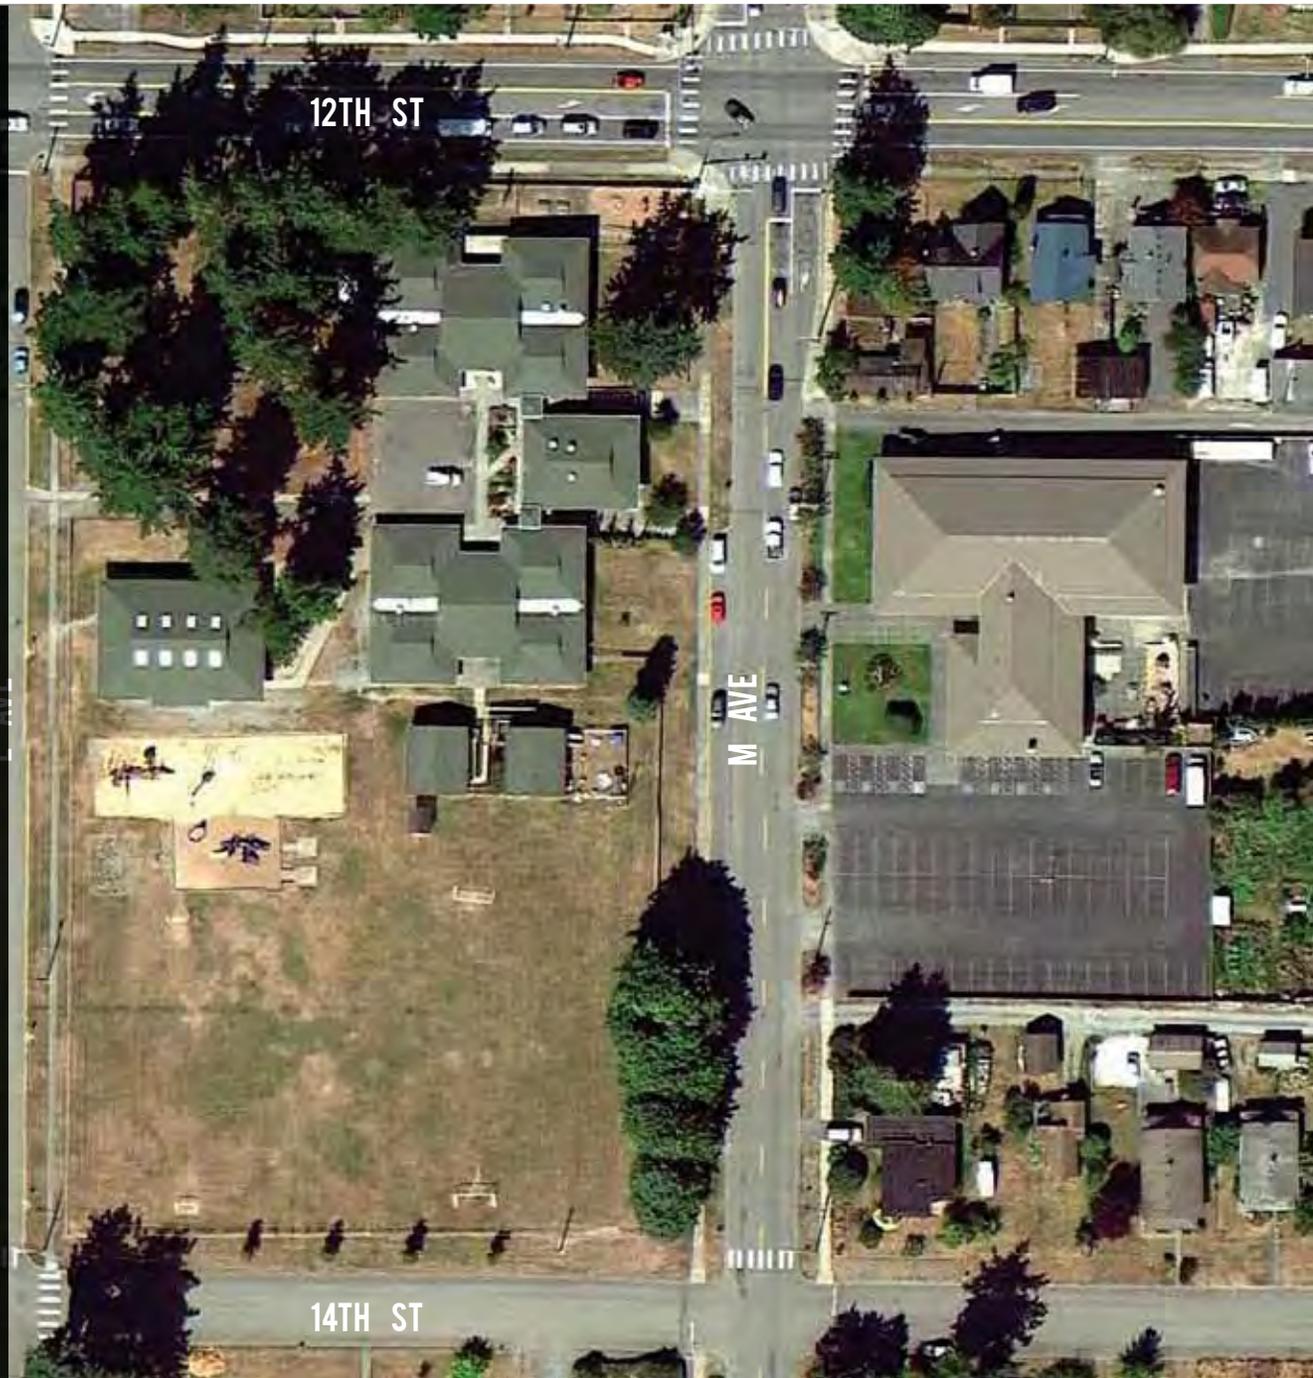
1. Site does not accommodate on-site parking or vehicular circulation.
2. Remote location of bus loading and unloading requires extra staff effort to supervise this activity for safety reasons.
3. Limited area for student drop-off and pick-up.
4. Lack of a convenient designated crosswalk from church parking lot is a safety issue.
5. Exterior lighting is minimal and needs supplementing for safe nighttime use.
6. Site does not comply with current fire and emergency vehicle access code requirements.
7. Site does not contain water quality treatment or detention.
8. Asphalt paving at center courtyard is in poor condition and retains standing water.

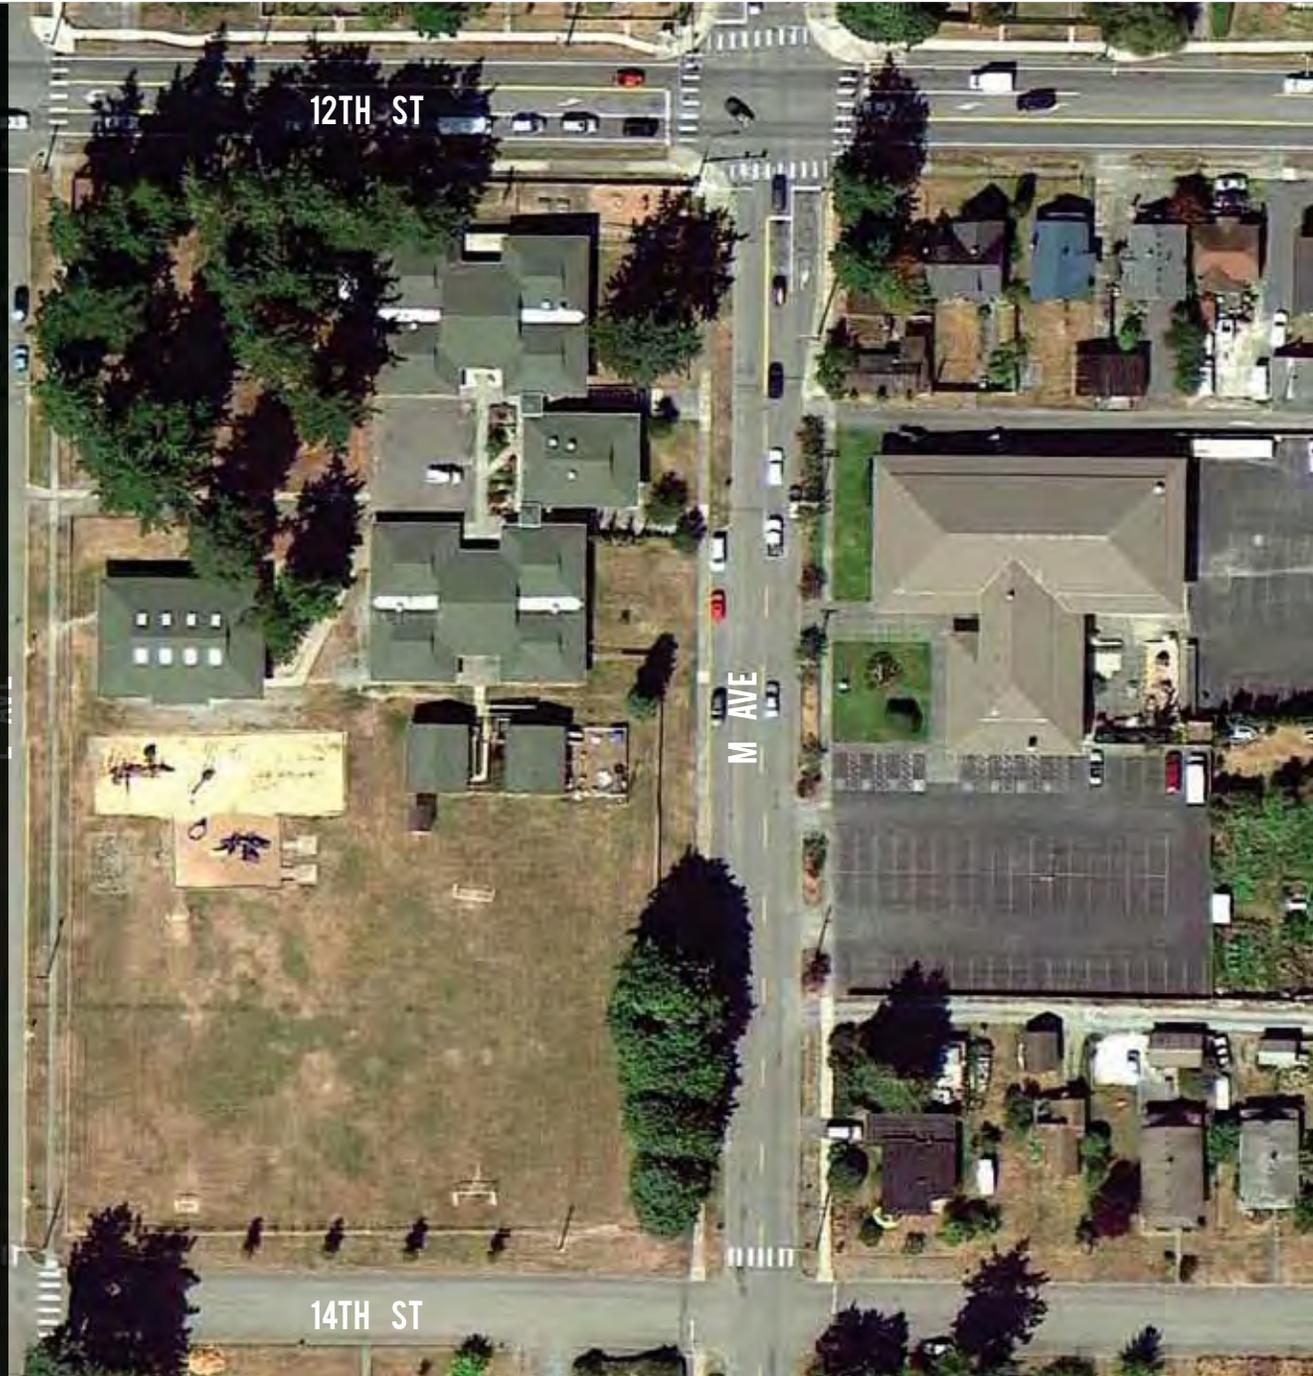
SUMMARY OF FINDINGS CONT.

- 9. School is constructed of “residential quality”. Maintenance efforts should be planned to continue at an increasing rate.
- 10. Exterior wood siding shows obvious signs of rot.
- 11. Elevator access is not provided to lower floor of general office building.
- 12. The school is not fire-sprinklered.

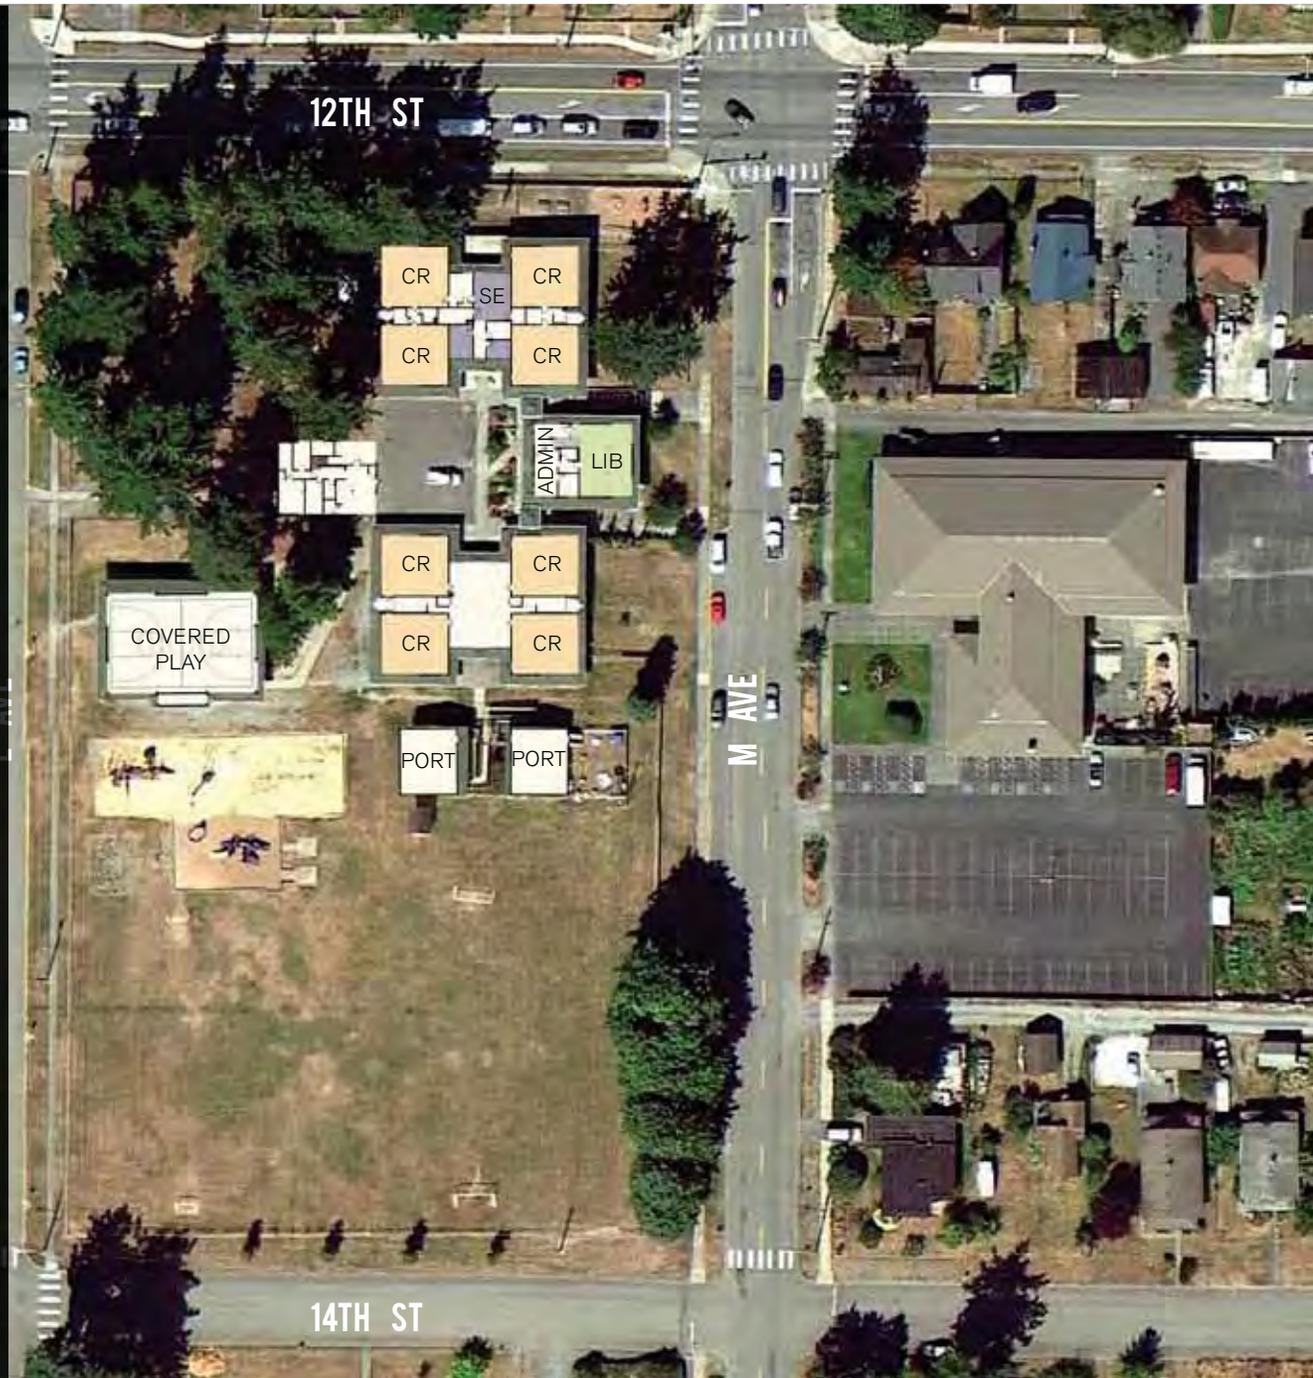
SUMMARY OF FINDINGS

1. Interior emergency exit lights and signs are currently powered by standard battery powered units which have no indication of dead batteries.
2. Classroom casework is worn and past its serviceable life.
3. Restroom finishes are old and exhibit obvious signs of patching required by maintenance issues.
4. No room for expansion of lunch program.
5. Many windows are original single-pane construction.
6. Upgrade to the DDC head end, panels, devices, actuators, and sensors is needed.
7. Intercom system should be upgraded with a new IP head end.
8. Fire alarm panel and devices should be upgraded.
9. Power panels have limited space for future expansion.

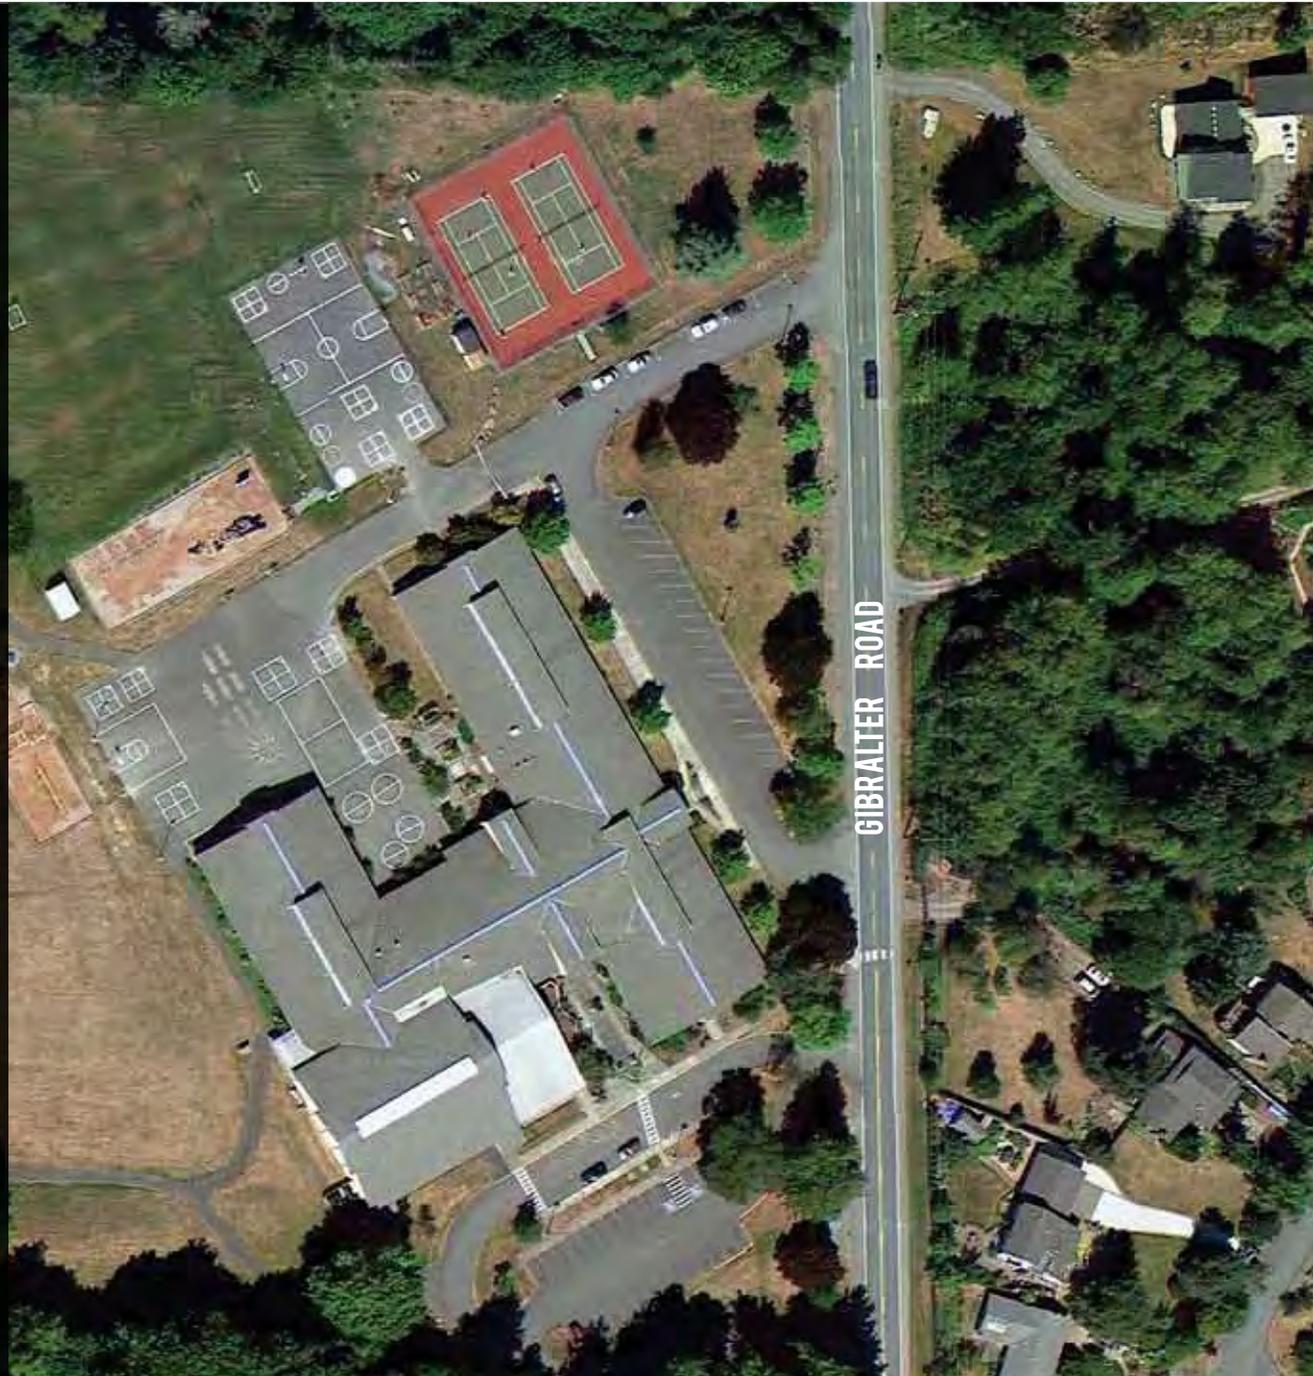
1. The volume of vehicular pick-up traffic causes backups and congestion along Gibraltar Road causing traffic delays and conflicts for busses exiting the site.

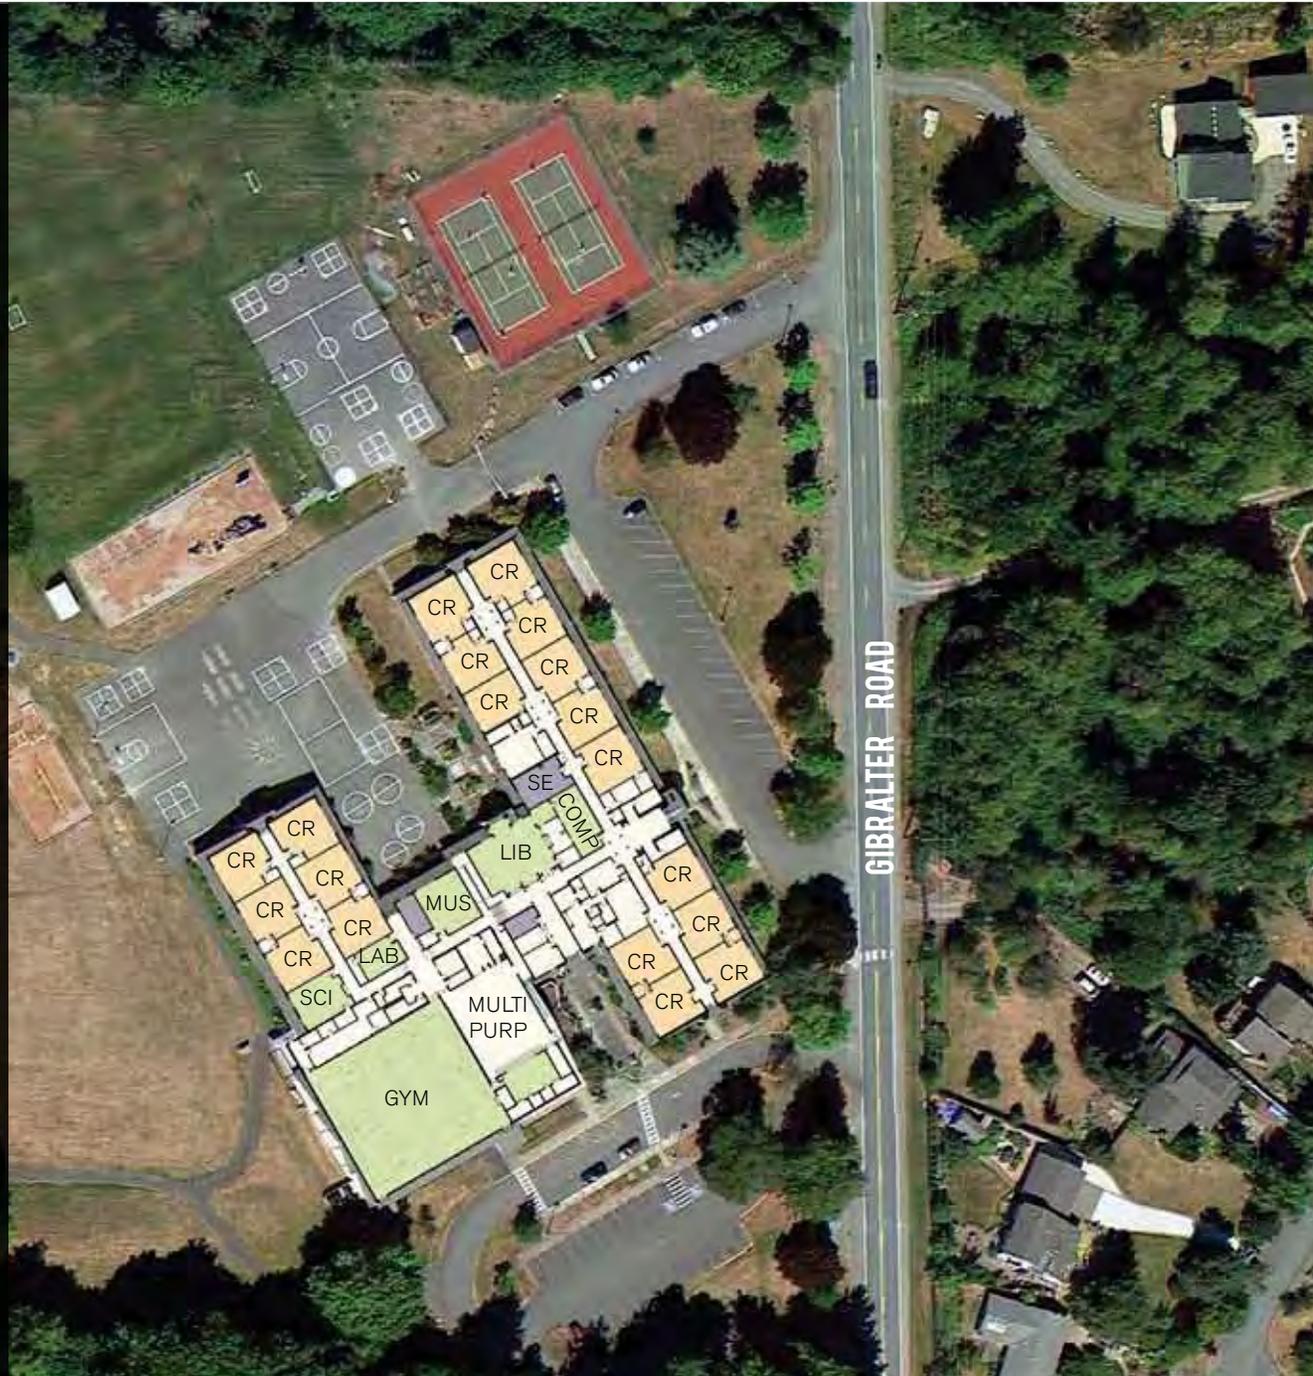
SUMMARY OF FINDINGS

1. Water heater is 20 years old; the burner has been rebuilt, the tank has not yet leaked, but is beyond anticipated service life.
2. Upgrade to the DDC head end, panels, devices, actuators, and sensors is needed.
3. Intercom system should be upgraded with a new IP head end.
4. Fire alarm panel and devices should be upgraded.

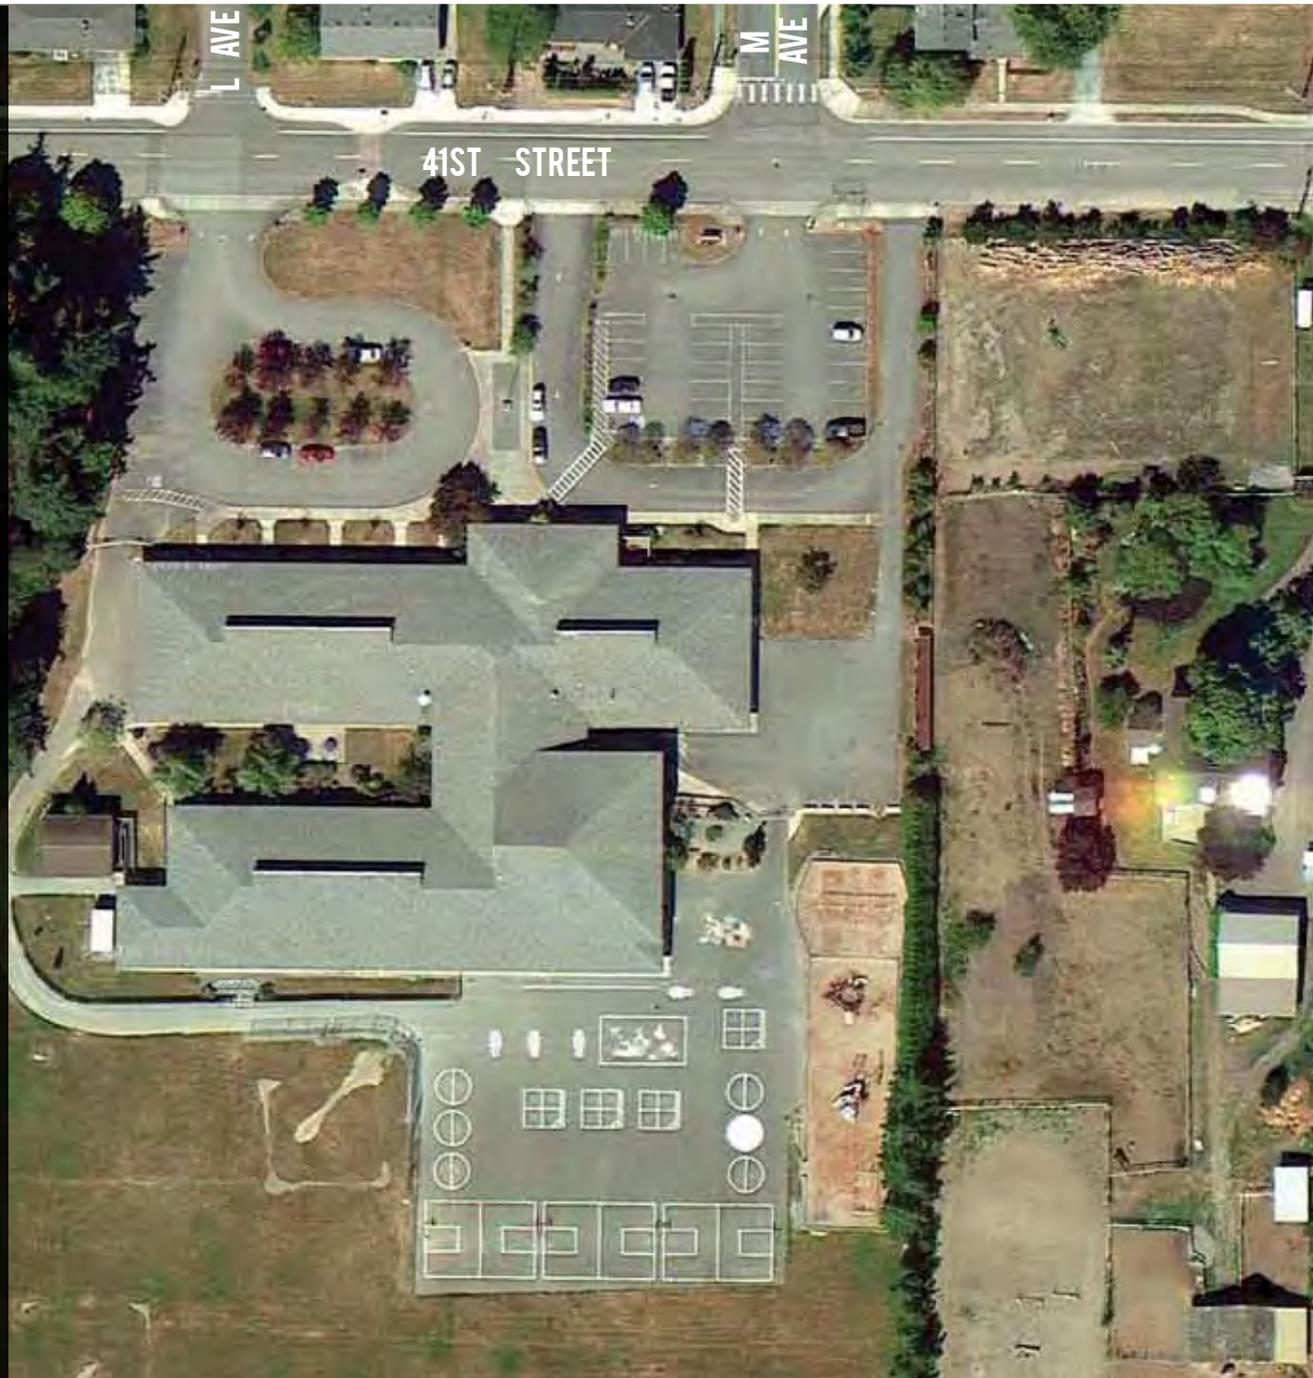
1. On-site traffic circulation is tight and congested creating a safety issue.
2. Site does not contain sufficient vehicular parking (33 spaces).
3. The parking lots do not have lighting - the campus is dark until you get close to the building.
4. Site does not provide storm water quality treatment for exterior pollution generating surfaces.
5. Grass playfields behind the building do not drain well which restricts use.
6. Domestic water piping between water meter and the building is PVC and continues to fail (leak) at the joints.
7. The asphalt shingles are 22 years old and nearing the end of their serviceable life.

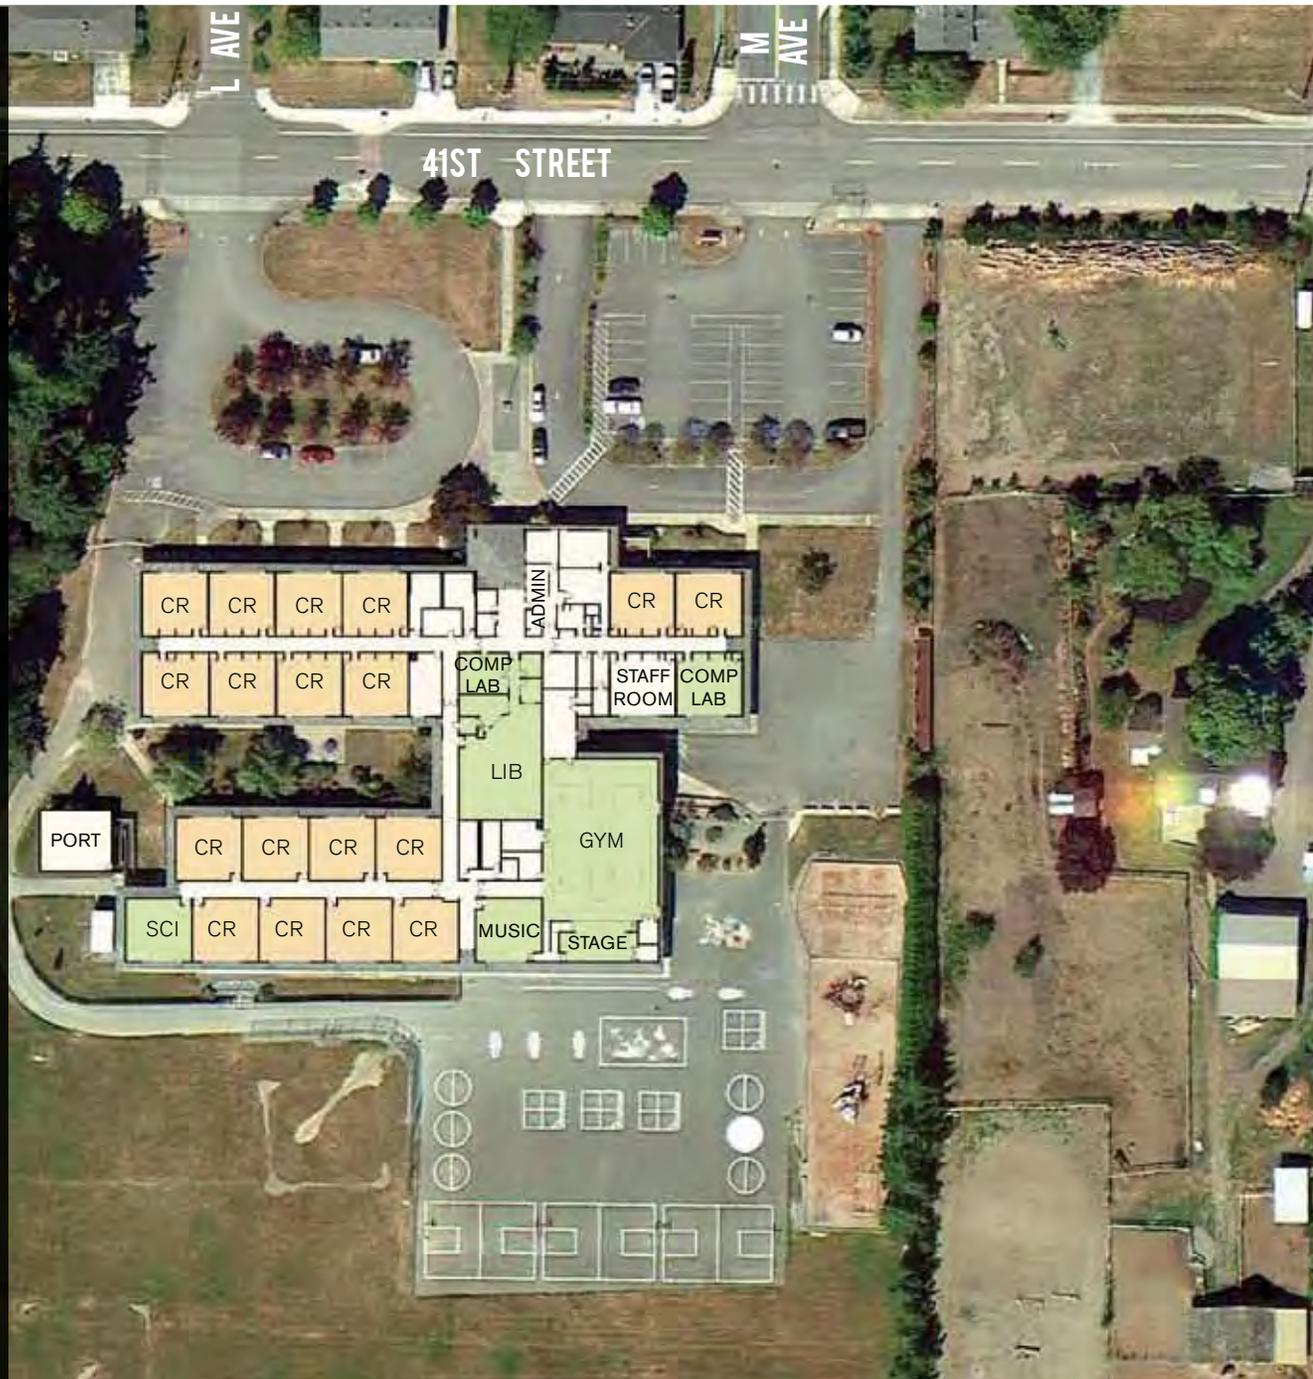
SUMMARY OF FINDINGS

1. Interior arrangement of the general office does not provide clear visual control of the exterior parking lots and student loading and unloading areas.
2. Exterior classroom doors provide a safety and security issue
3. 1955 building still contains galvanized domestic water piping which can affect drinking water quality.
4. North classroom wing (1955 portion) does not provide proper clearances for handicap accessibility into the classrooms from the corridor.
5. Two staff toilet rooms and the nurse's toilet room do not comply with ADA accessibility requirements.
6. Toilet rooms in the east classroom wing do not comply with ADA accessibility requirements or health code requirements.
7. In many instances the door hardware does not comply with ADA accessibility code.

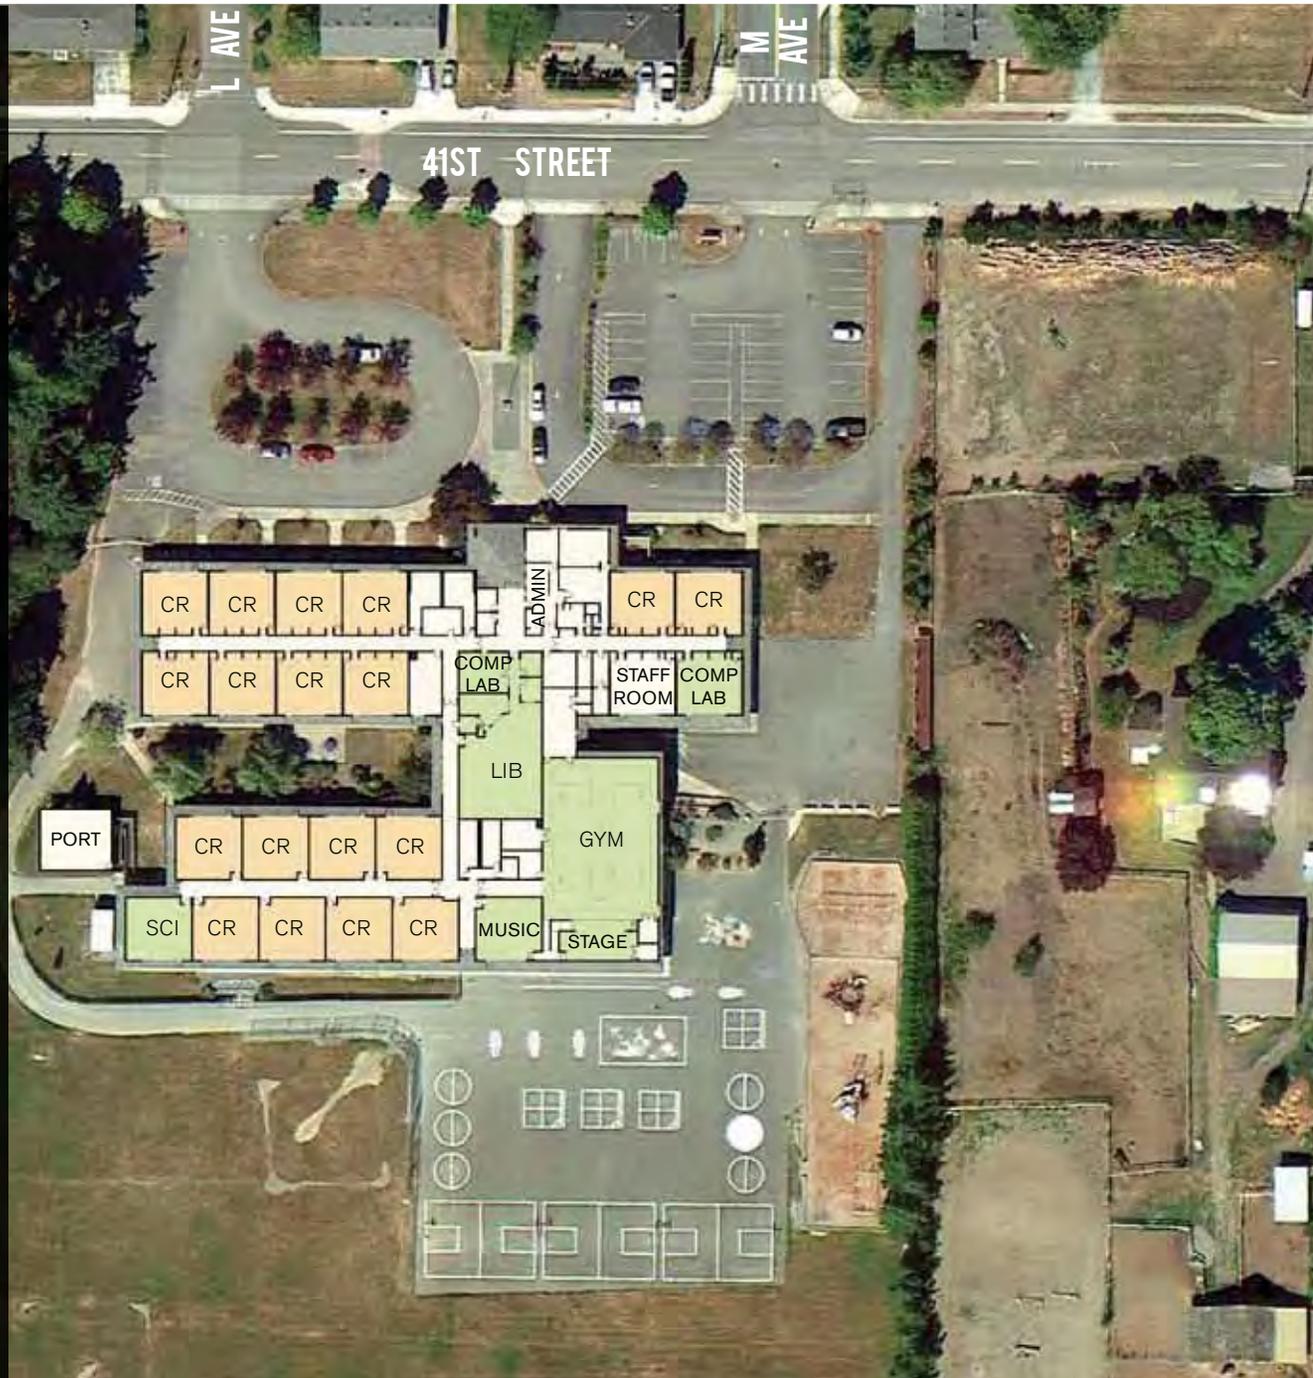
SUMMARY OF FINDINGS CONT.

8. Classroom casework in the 1955 portion of the building is past its serviceable life.
9. Stage equipment consisting of lighting, sound, and A/V is outdated and in need of replacement.
10. Multi-purpose room has poor acoustics, limited storage for tables, chairs and PE equipment.
11. Staff room is located in a repurposed classroom and does not provide a professional atmosphere for the staff.
12. The multi-purpose room is used for both PE and as a cafeteria which limits the functionality of providing proper PE instruction during the lunch periods.
13. Kindergarten classes are being held in standard size classrooms.
14. This school lacks flexible and adaptable instructional space to accommodate current teaching models. There are no flexible shared learning spaces for small group activities or personalized learning.

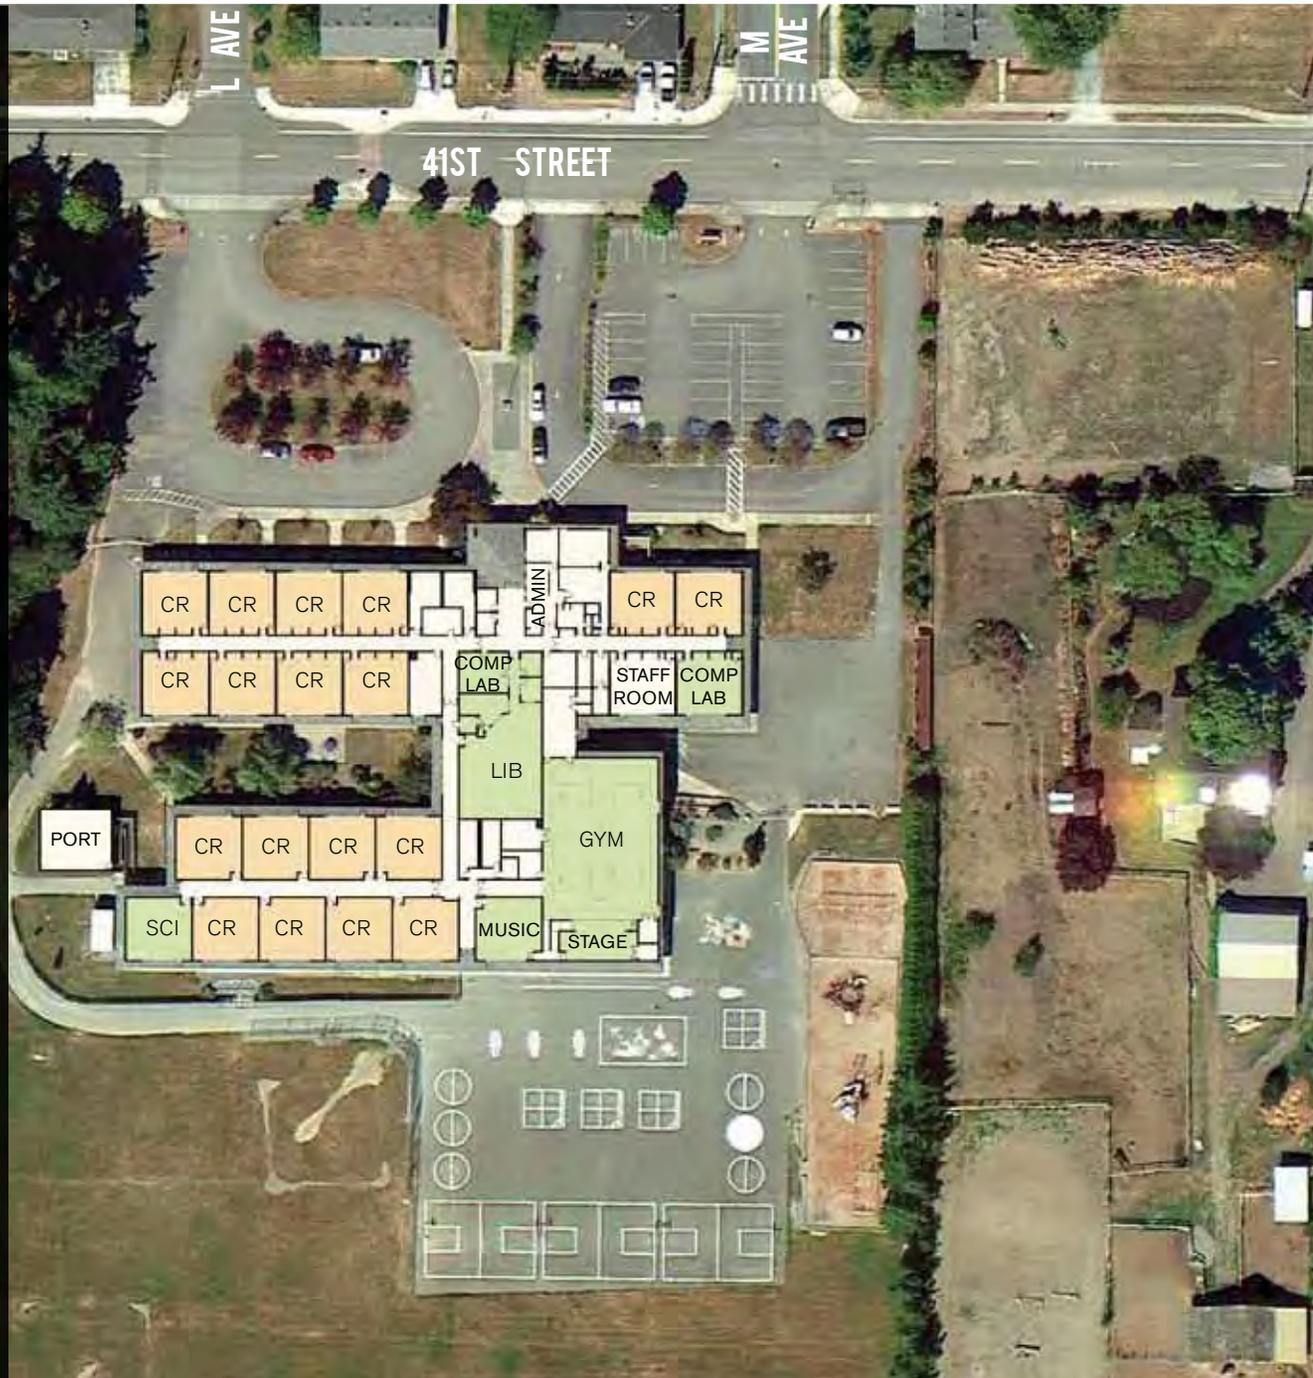
SUMMARY OF FINDINGS CONT.

- 15. Corridors in the 1955 wing are narrow and contain painted concrete masonry units (CMU) walls providing a hard and sterile feel.
- 16. Classrooms have minimal power outlets.
- 17. Electrical panels in the 1955 portion of building have limited space for added load.
- 18. Interior emergency exit lights and signs are currently powered by standard battery powered units which have no indication of dead batteries.
- 19. The building intercom system is in need of replacement.
- 20. Fire alarm panel and devices should be replaced.

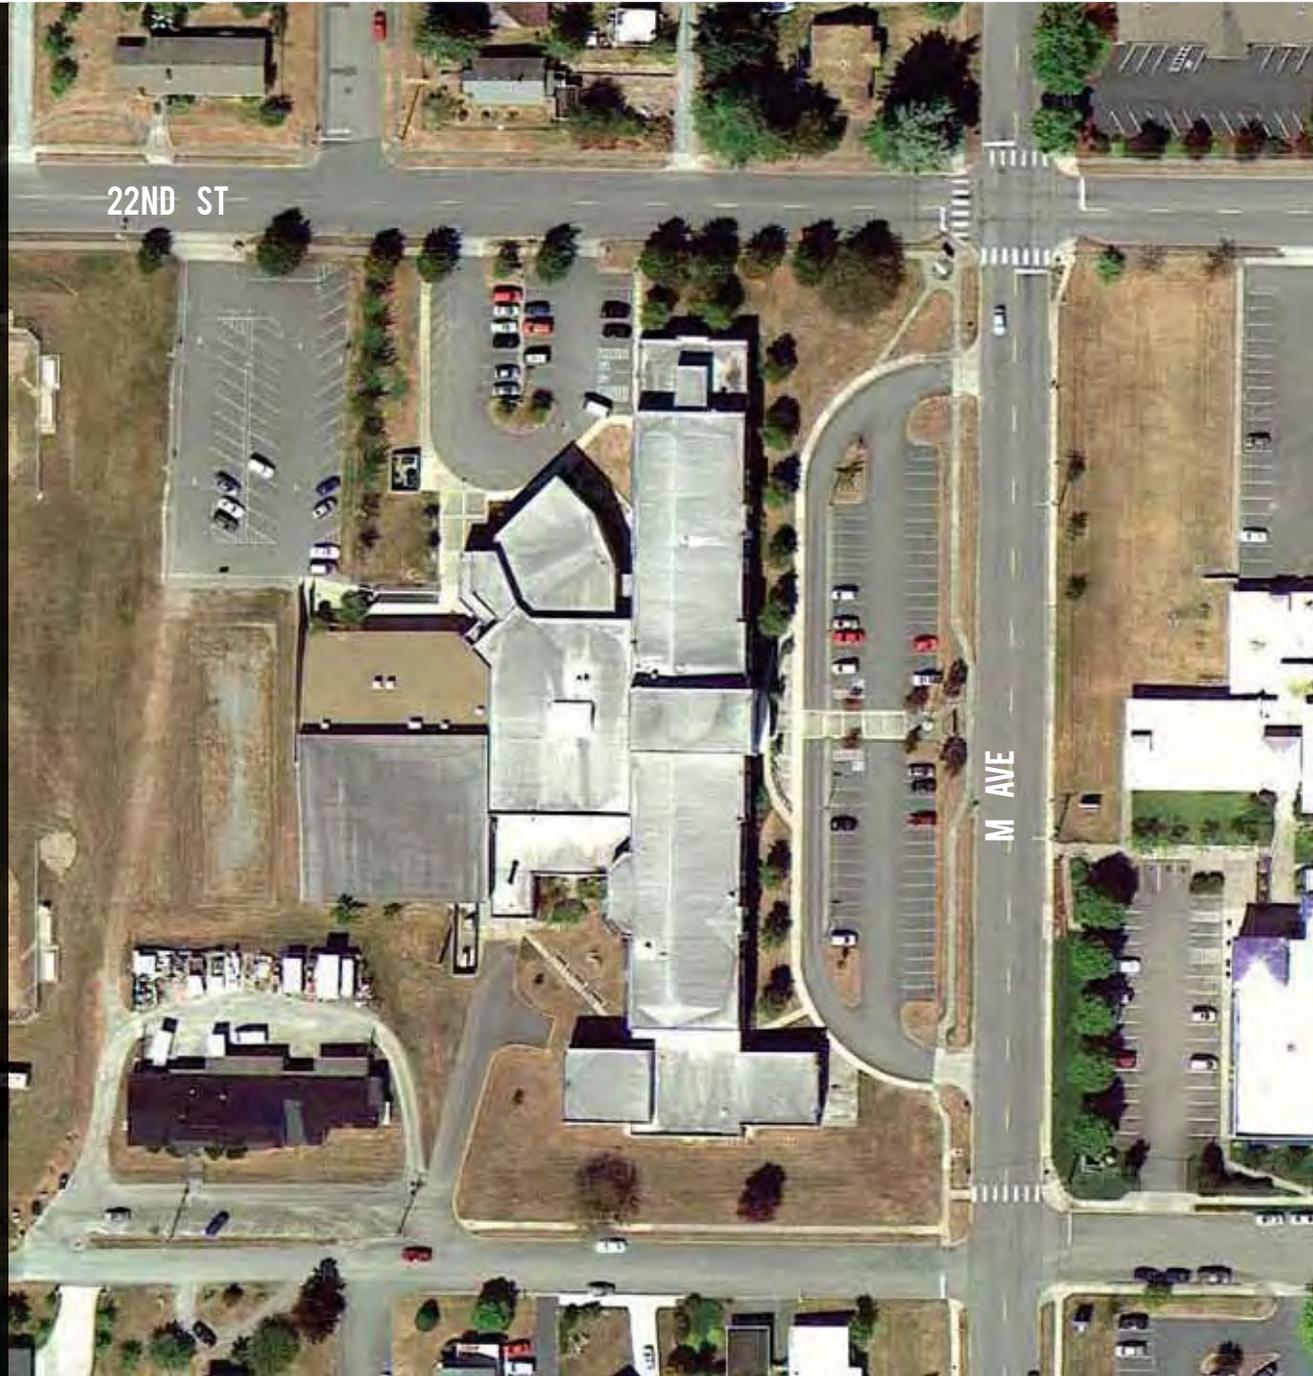
1. Exterior sill flashing does not have proper slope to allow drainage away from the window. This is causing water to leak into the building at a number of locations.
2. Roofing should be carefully monitored over the next 5 - 8 years as it will reach the end of its expected serviceable life in 8-10 years.

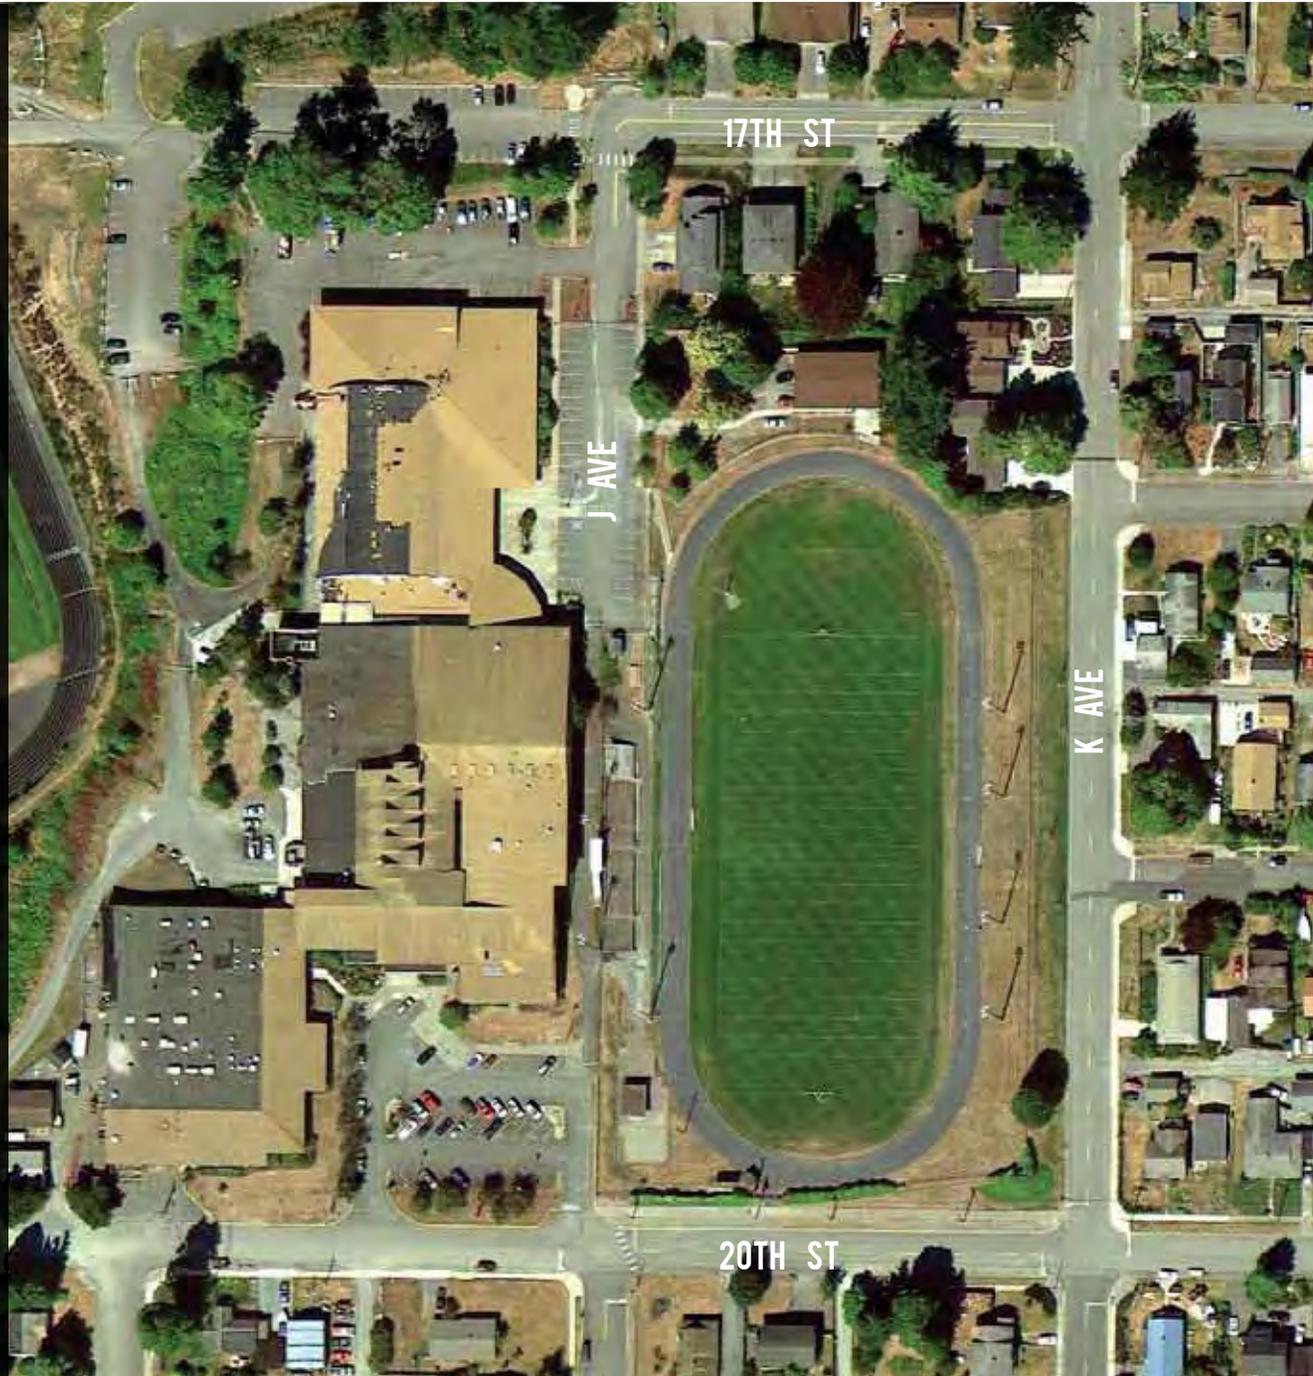
1. Bus loading/unloading occurs on 20th Street requiring students to walk across parking lot to main entrance of High School.
2. Main parking lot is undersized for normal school operations as well as event use (43 spaces).
3. Parent drop-off/pick-up occurs in the drive aisles of the front parking lot.
4. Student parking is remote, difficult to supervise, and requires back door entrance.
5. Total on-site parking is not sufficient for either normal school operations or large community events.
6. The High School site does not comply with current fire and emergency access requirements.
7. Utility company has informed the District that the main power feed to the building (which runs under the vocational technology wing) is in bad condition and if it fails again, they will not be able to pull a new feed into the existing conduit.
