ANACORTES SCHOOL DISTRICT NO. 103

2014 State Study and Survey

*Anacortes School District No. 103
Skagit County, Washington*

December 2014

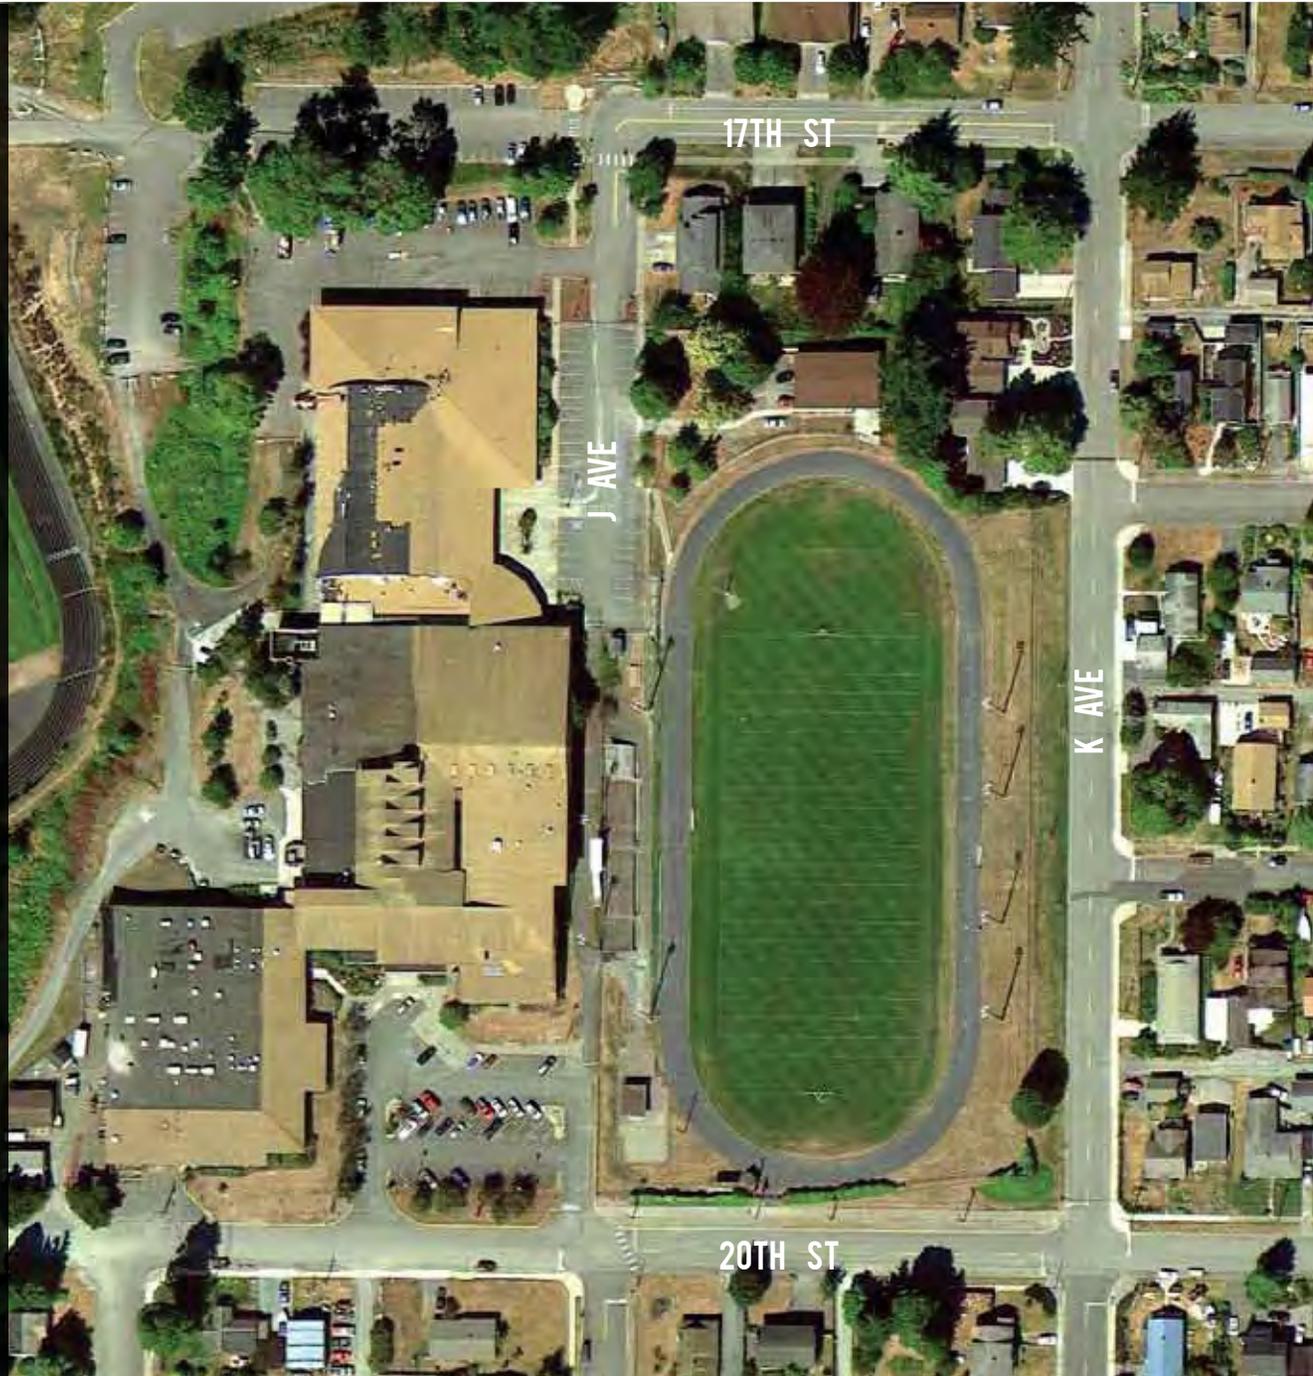
SUMMARY OF FINDINGS CONT.

8. There is concern over the capacity of the structural roof system over the vocational technology wing.
9. Vocational technology wing roofing is in very poor condition and in need of replacement.
10. Low-slope roofing over the cafeteria and music rooms is in very poor condition and in need of replacement.
11. Expansion of Memorial Field is restricted due to the limited surrounding undeveloped area.
12. Press box at Memorial Field is in poor condition.
13. Use of natural grass playfields is limited during wet months.
14. There is no ADA accessibility to Rice Field.
15. There are no bleachers at Rice Field.

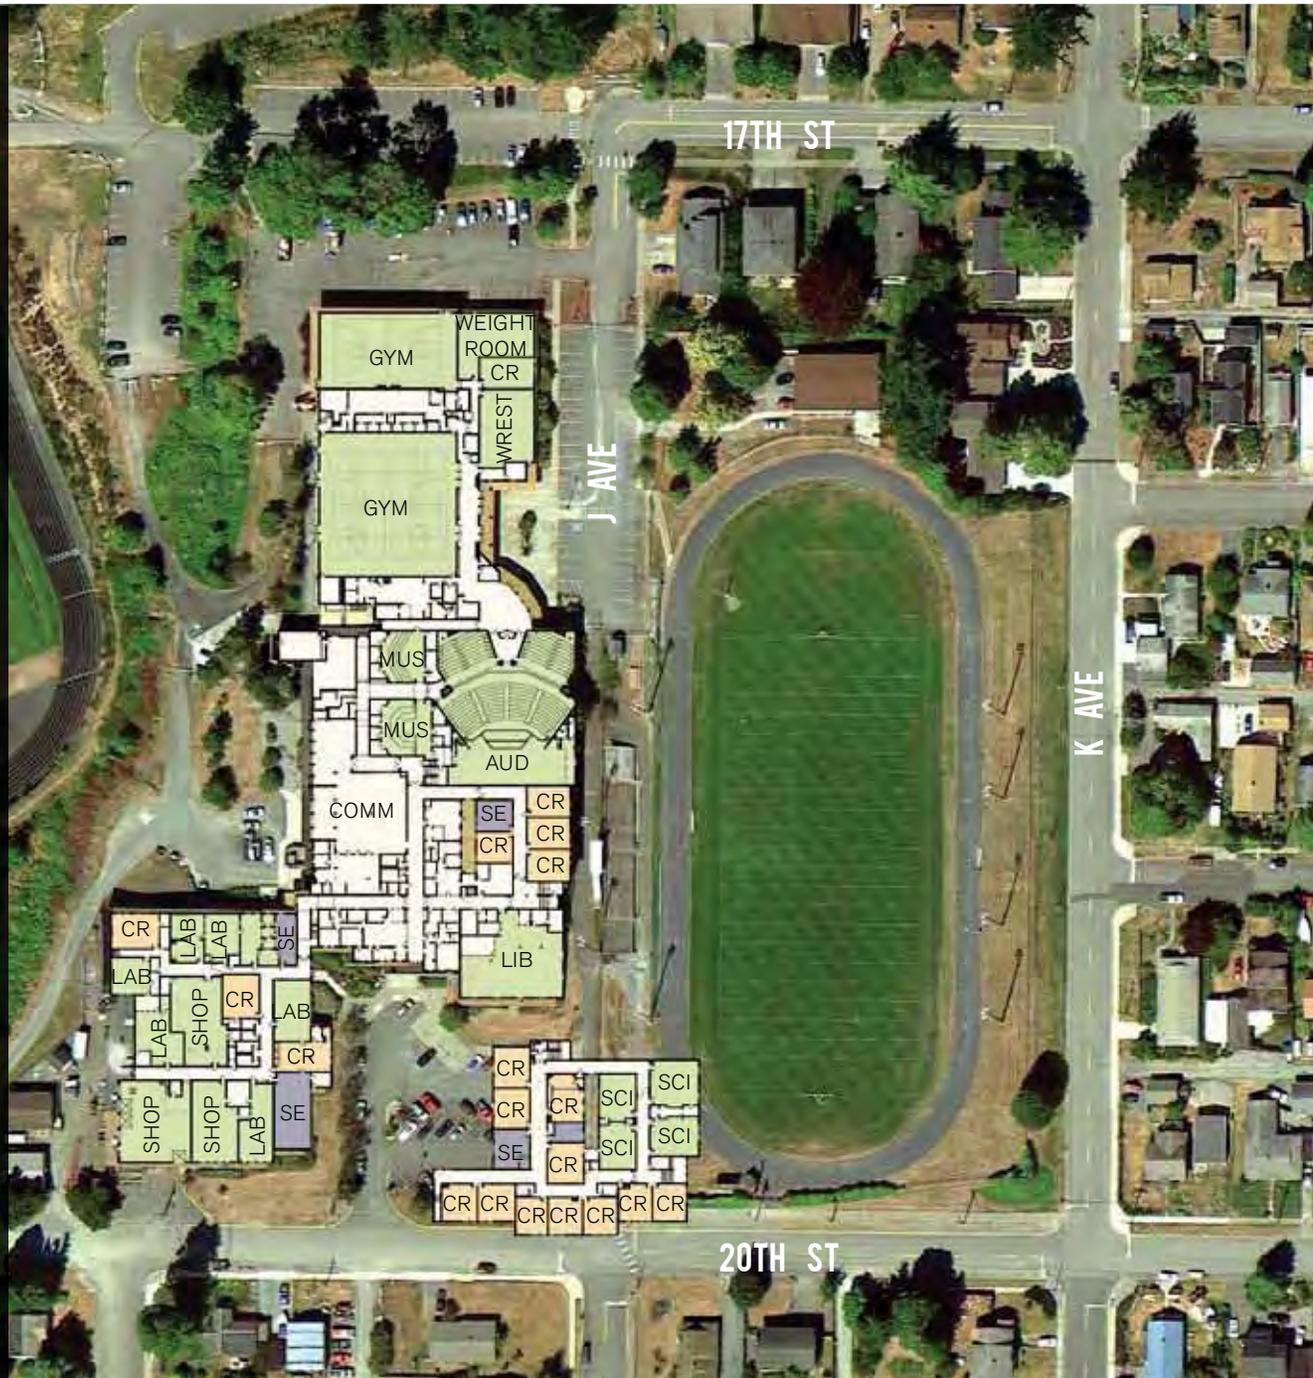
SUMMARY OF FINDINGS

1. There is visible settlement of the concrete slabs-on-grade throughout the school.
2. Many of the CMU walls have vertical cracks. Daylight is visible through some of the cracks.
3. There are significant cracks in the second floor of the classroom area due to building settlement.
4. Some of the wood joists supporting the roof panel of the outdoor walkway between the auditorium and the main gym appear to have significant rot near the ends.
5. General classrooms are small and inadequately supported for educational needs of the curriculum.
6. Building offers very limited opportunities for flexibility or adaptability to accommodate alternative education delivery models.
7. There are very few flexible shared learning spaces for small group activities or personalized learning.

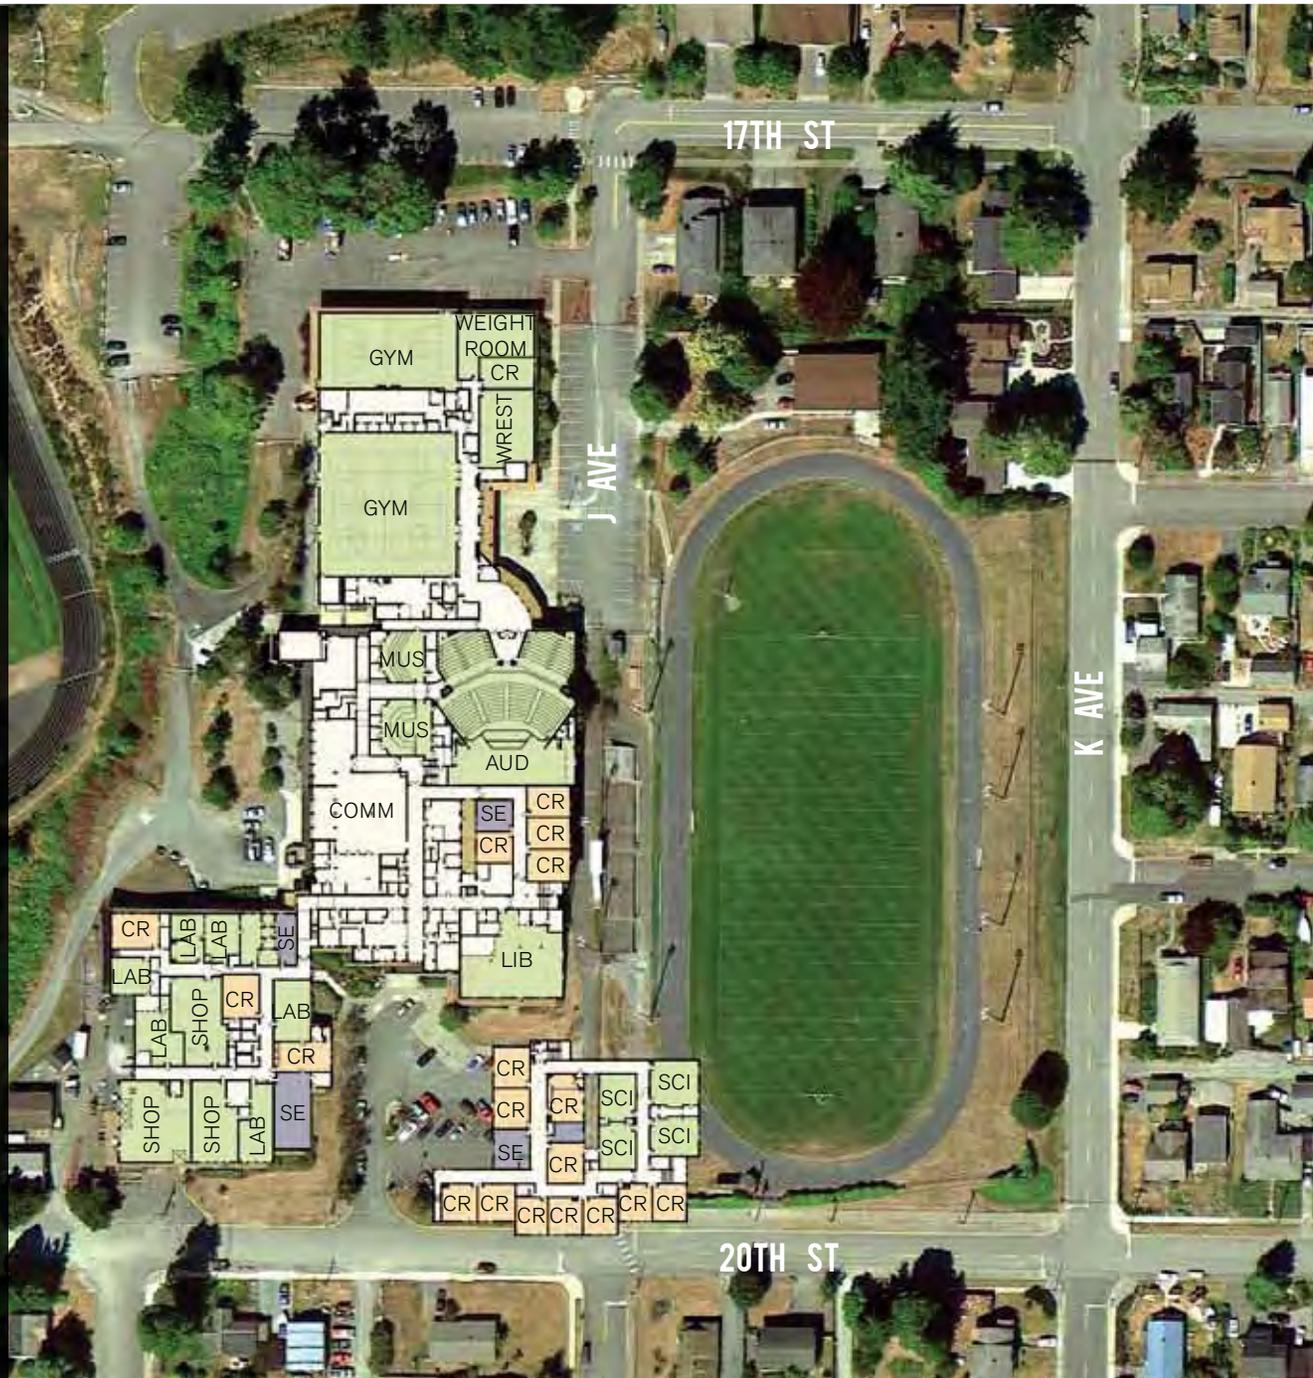
SUMMARY OF FINDINGS CONT.

- 8. Cafeteria is small and crowded during lunch. It also portrays a very institutional feel.
- 9. In general, the facility does not take advantage of outdoor learning environment opportunities.
- 10. Most classrooms lack appropriate natural lighting.
- 11. The gymnasium, auxiliary gym, choral, band and multiple classrooms in the center of the building have no access to natural daylight or views.
- 12. Majority of the administration areas do not have a direct line of site to the outdoors.
- 13. Casework and finishes throughout the school are worn and showing their age.
- 14. Carpet and ceiling tiles are stained and worn throughout the building.
- 15. Finishes and equipment throughout the auditorium are past their useful life.
- 16. Locker rooms still have original 1955 floor and wall finishes.

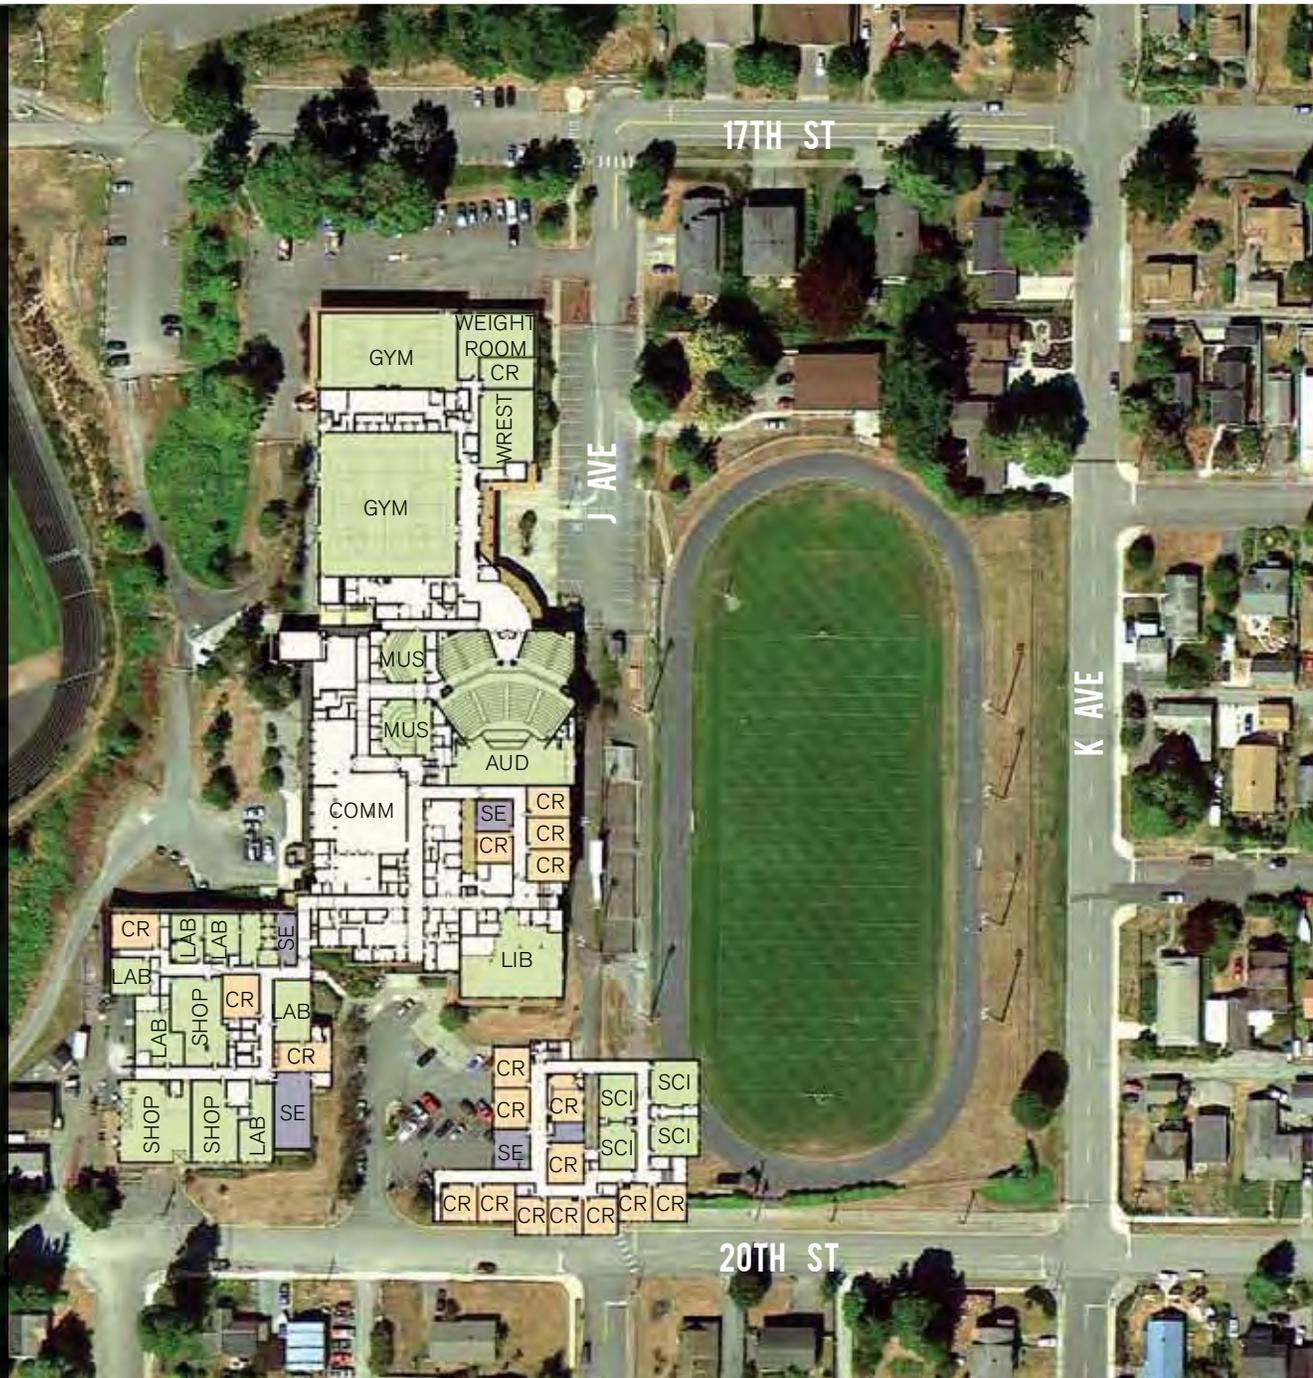
SUMMARY OF FINDINGS CONT.

- 17. The power drive system on the gymnasium wood bleachers requires constant maintenance.
- 18. Wood shop dust collector system is not code compliant.
- 19. Woodworking equipment does not have safety interlocks.
- 20. Plumbing fixtures are old and replacement parts are not easily available.
- 21. The heating, ventilation and air conditioning system for the auditorium has not been operational for several years.
- 22. Return air duct system for the auditorium is underground and fills with water during rainy periods of the year.
- 23. Gymnasium heating and ventilation system is not functioning well. The system is over 20 years old.
- 24. The vocational technology wing heating and ventilation systems are not functioning reliably.

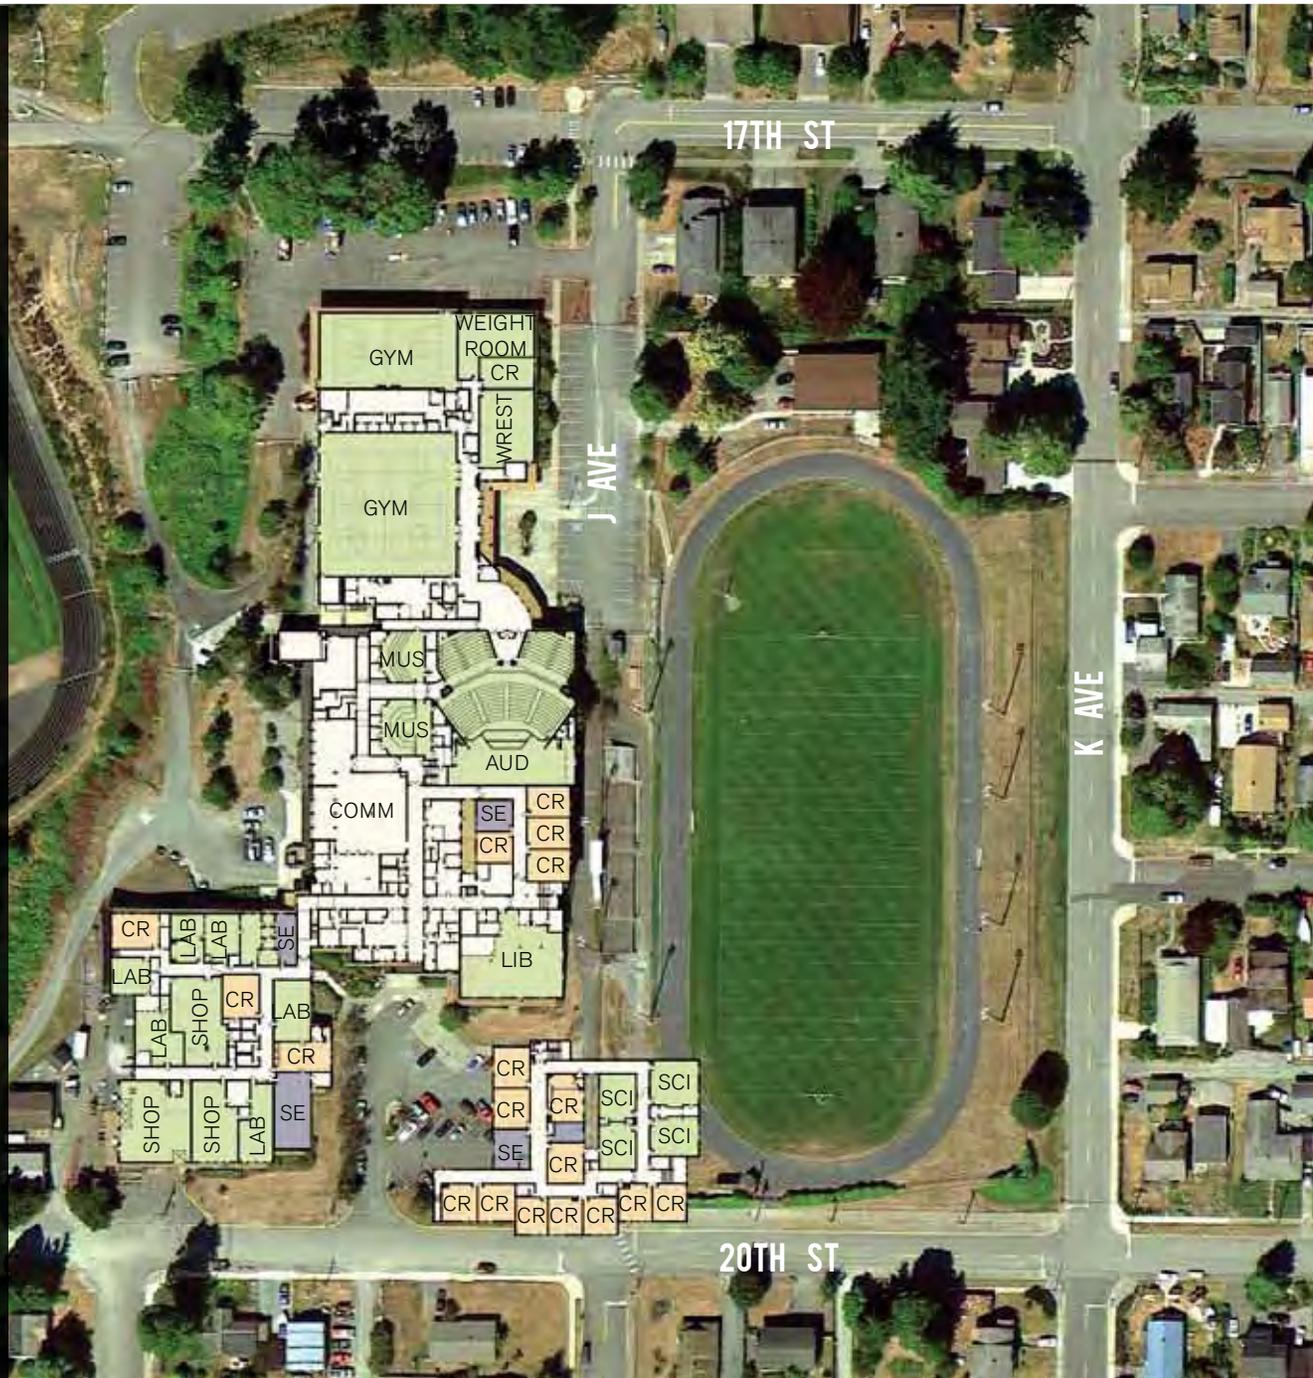
SUMMARY OF FINDINGS CONT.

- 25. Digital control system has surpassed its serviceable life.
- 26. The main campus electrical switchboard is nearing the end of its useful life.
- 27. Older electrical panels in the vocational technology wing do not have enough capacity to serve current loads.
- 28. Auditorium dimmer board has multiple failed dimmers.
- 29. Auditorium lights are controlled by the original 1955 lighting control board which has surpassed its serviceable life.
- 30. Performance light fixtures in the auditorium are out of date and nearing the end of their useful life.
- 31. Intercom system should be upgraded with a new IP head end.
- 32. Fire alarm panel and devices should be upgraded.
- 33. Existing steam generating boilers are 45 and 25 years old.
