Geologic Hazard Site Assessment

Lake Erie Pit 1 Expansion

Project # PS2220529-0

August 11, 2022

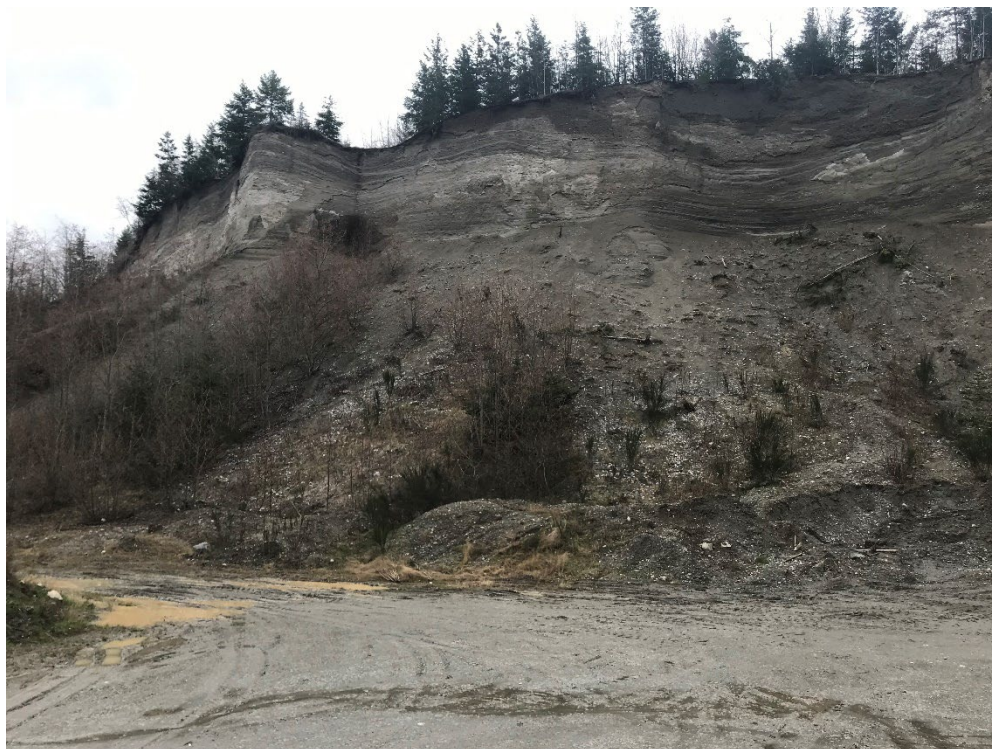
There were no ongoing operations occurring at Pit 1 and there was no evidence of recent mining (grass and shrubs were encroaching onto the access roads). First, Wood visited the most recent mining area of Pit 1, accessed from Rosario Road on the north near Marine Drive. The excavated sidewalls of Pit 1 were near-vertical for the upper 30 feet, and sloughed soil formed steep slopes of about 1.3H:1V down to the level base of Pit 1 (see photographs 1 through 3 in Appendix A).

Photograph 1. Lake Erie Pit looking east

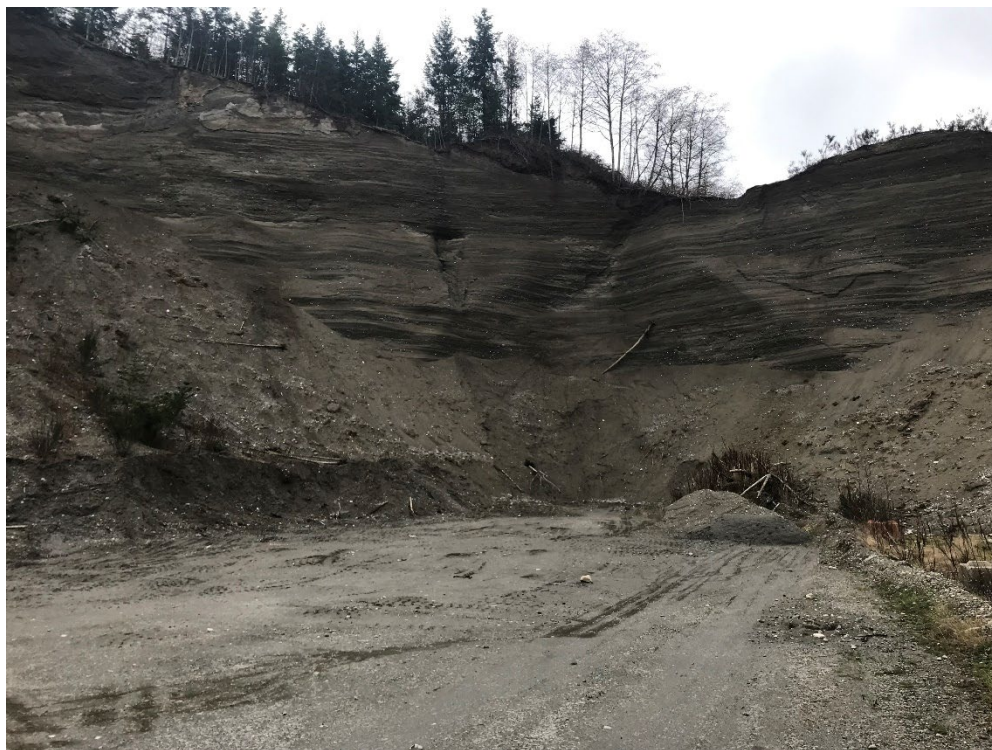
Photograph 2. Lake Erie Pit looking south

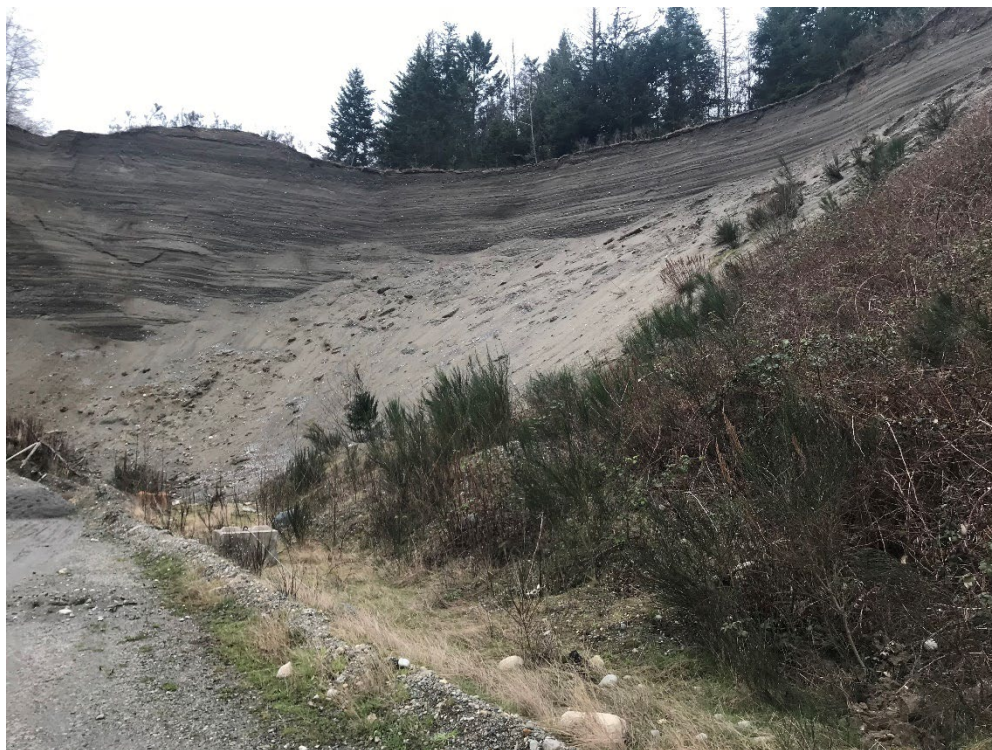
Photograph 3. Lake Erie Pit looking southwest

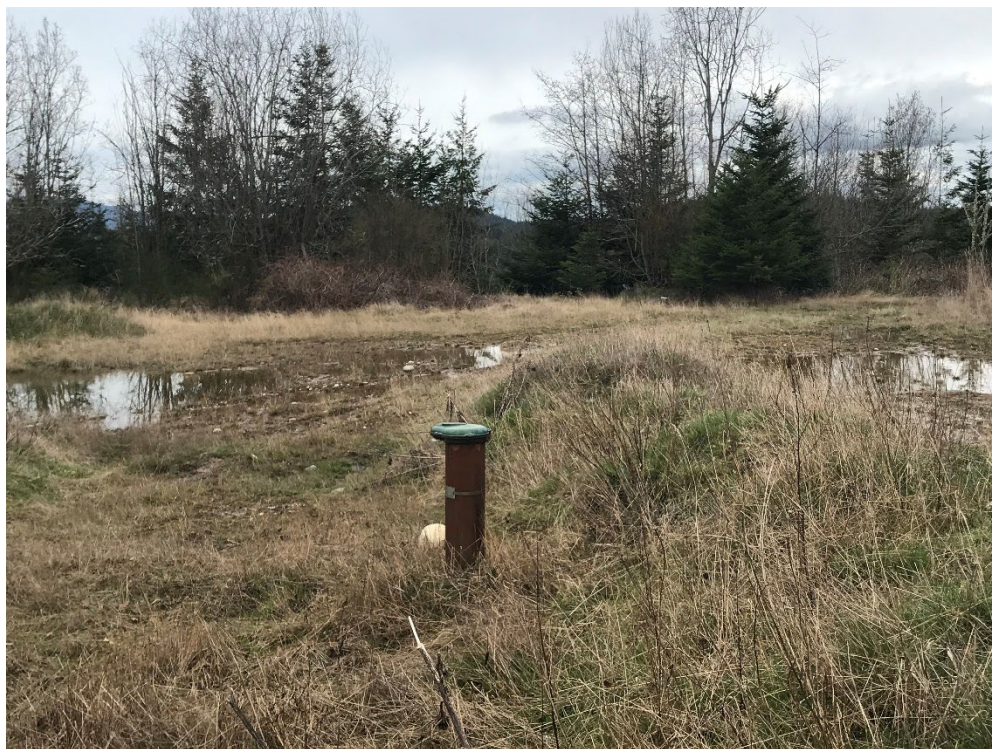
Photograph 4. New well looking east
