May 21, 2020

Re: **Geologic Hazard Assessment**
Proposed surface mine expansion
Skagit County Parcel P44865

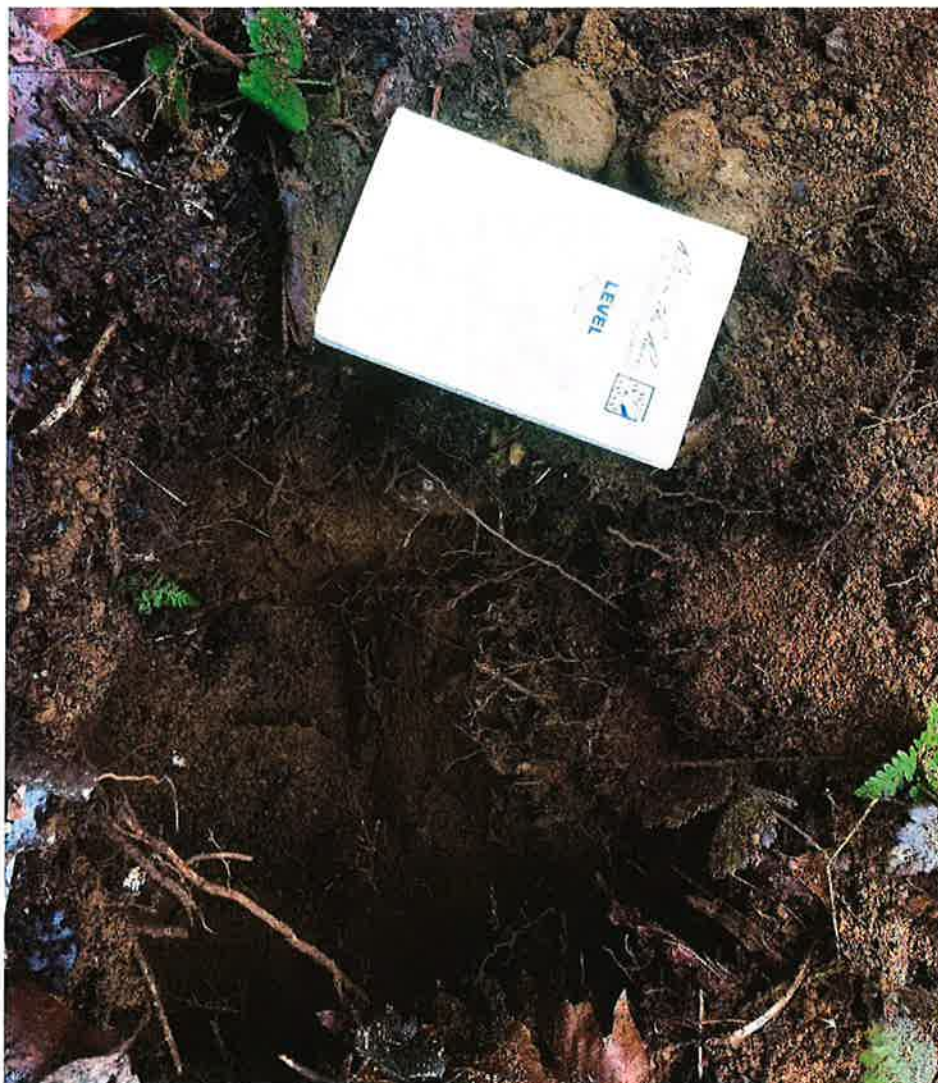
Our observations are generally consistent with the above-described mapping. Observations at the existing gravel mine, review of well logs in the vicinity and hand-dug test pits on top of and along the gentle to moderate slopes of the subject property revealed medium dense sand and gravel with rounded pebbles and cobbles consistent with Vashon recessional outwash (Figure 2).

Figure 2. Photograph of recessional outwash in shallow test pit on subject property.

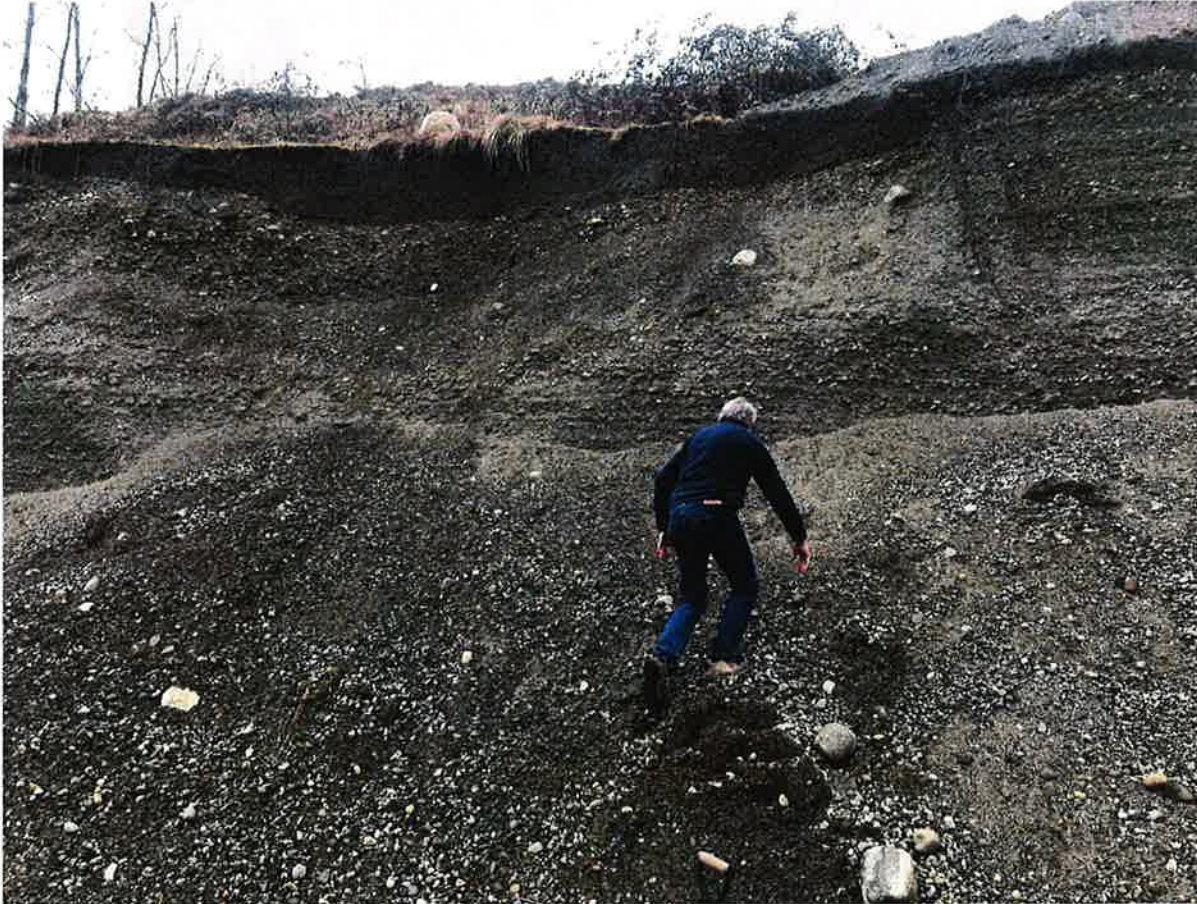
Observations from the adjacent parcel to the north, which consists of an operational sand and gravel mine, are also generally consistent with mapped geology. Mine exposures revealed well-stratified sand and gravel deposits in excess of 75 to 100 feet thick (Figure 3). The sand and gravel deposits in the mine were generally medium dense to dense and able to maintain near-

vertical faces. Rip-up clasts of Vashon till up to 5 feet long were observed locally and are consistent with these deposits being recessional outwash.

Figure 3. Photograph of outwash in existing gravel mine on adjacent property to the north.

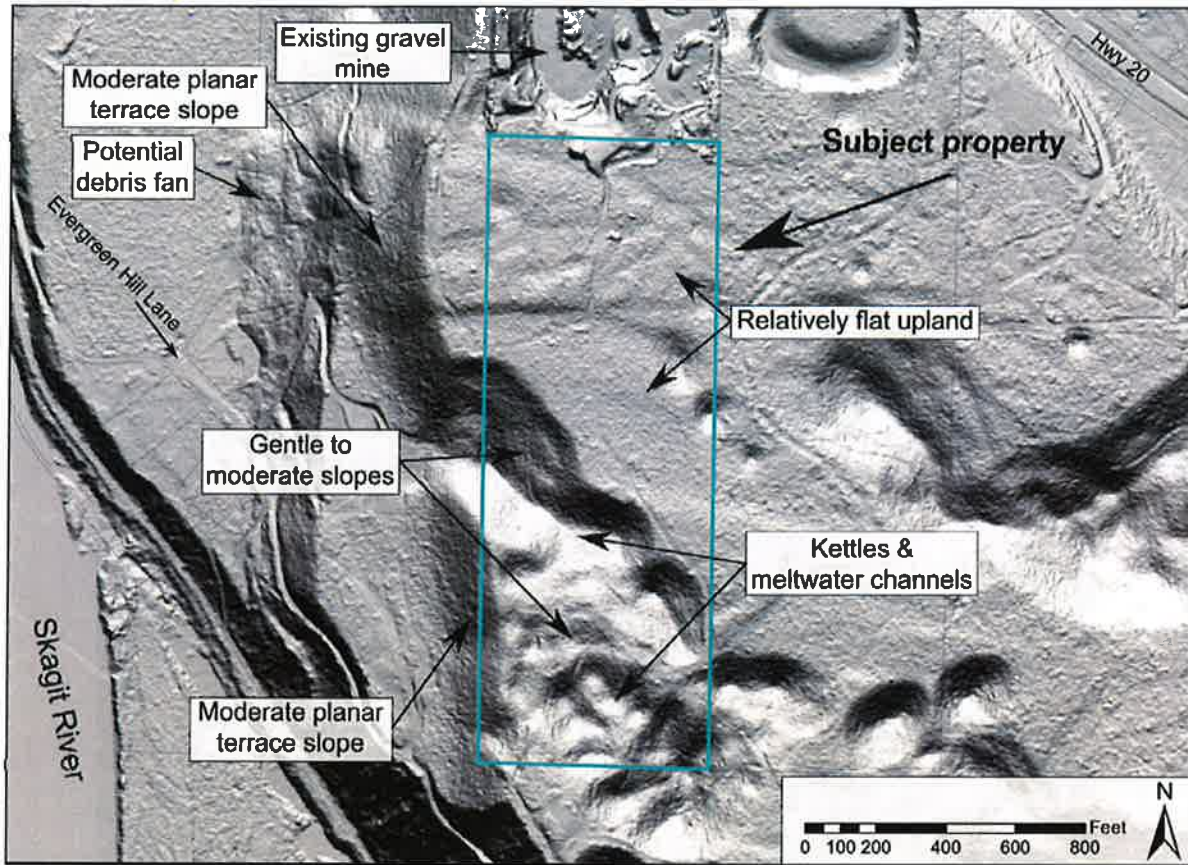
Pertinent features on the property and vicinity are indicated on the lidar bare earth image of the area (Figure 4). The subject property is located on a late-Pleistocene terrace in the Skagit River valley. We interpret this terrace to be remnant of the valley floor that formed at the late stages of the last glacial period.

Figure 4. Annotated lidar hillshade image of the subject property and vicinity.

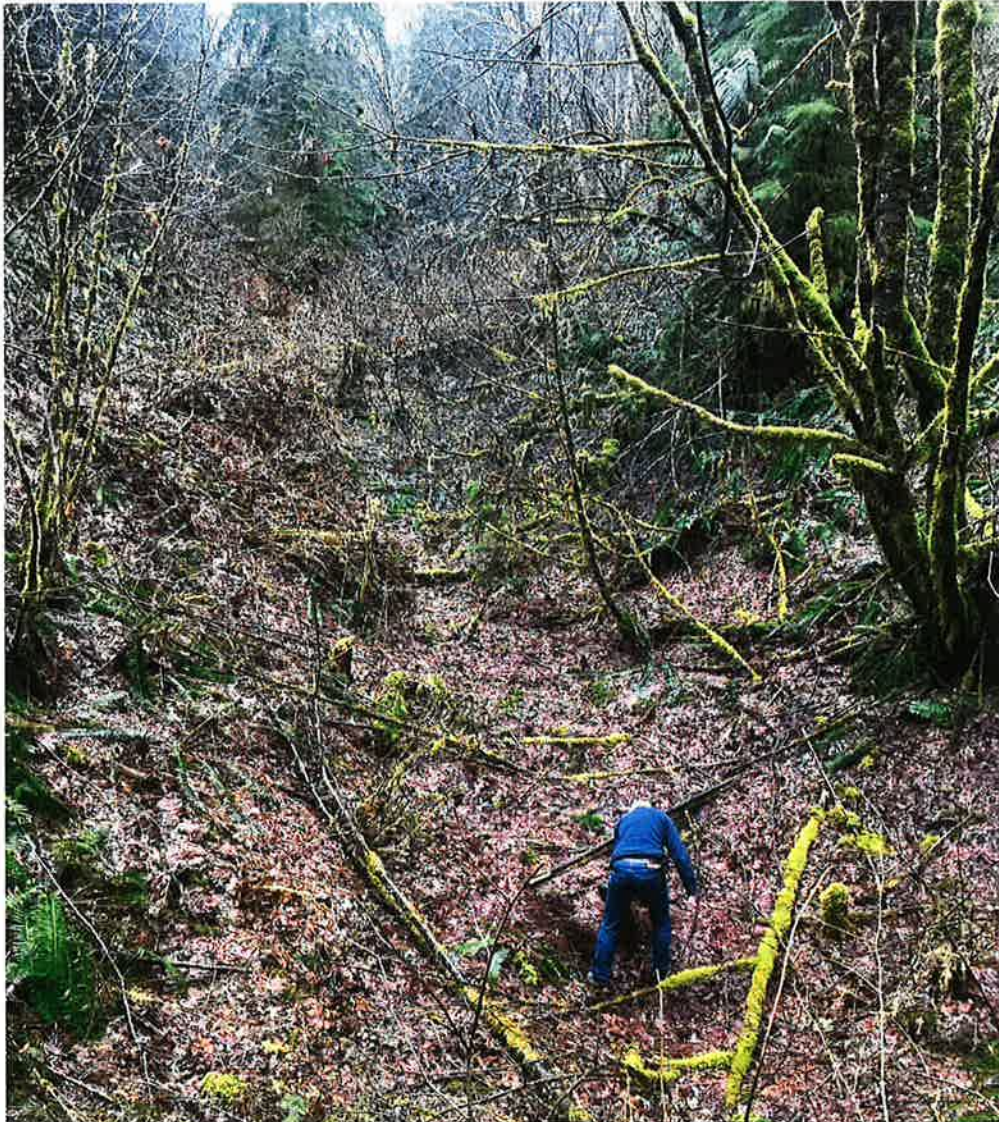
The southern portion of the subject property consists of more irregular topography defined by depressions in the terrace formed by kettles. Slopes that descend to the base of the kettle features are typically moderate, measuring 10 to 20 degrees, increasing locally to 25 degrees for short sections of slope (Figure 5 and 6). Slopes are generally planar with no evidence of slope instability and slopes generally contain mature trees that stand vertically. One of the kettle slopes contains a sequence of several 3- to 4-foot wide benches. However, no fresh scarps, active raveling, or significantly bowed trees that would indicate slope instability are present. No surface water or evidence of intermittent surface water accumulation was observed in the kettles and soils are well drained throughout the property.

Figure 5. Photograph of the steeper slopes on the southern portion of the property that drop into a kettle.

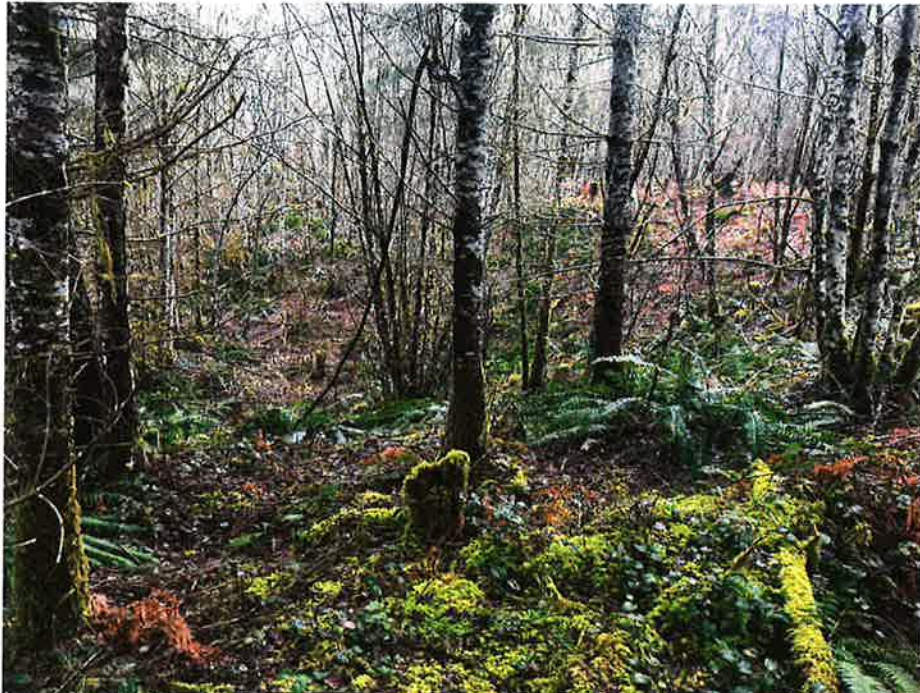
Figure 6. Photograph of some of the gentler, undulating topography on the southern portion of the subject property.

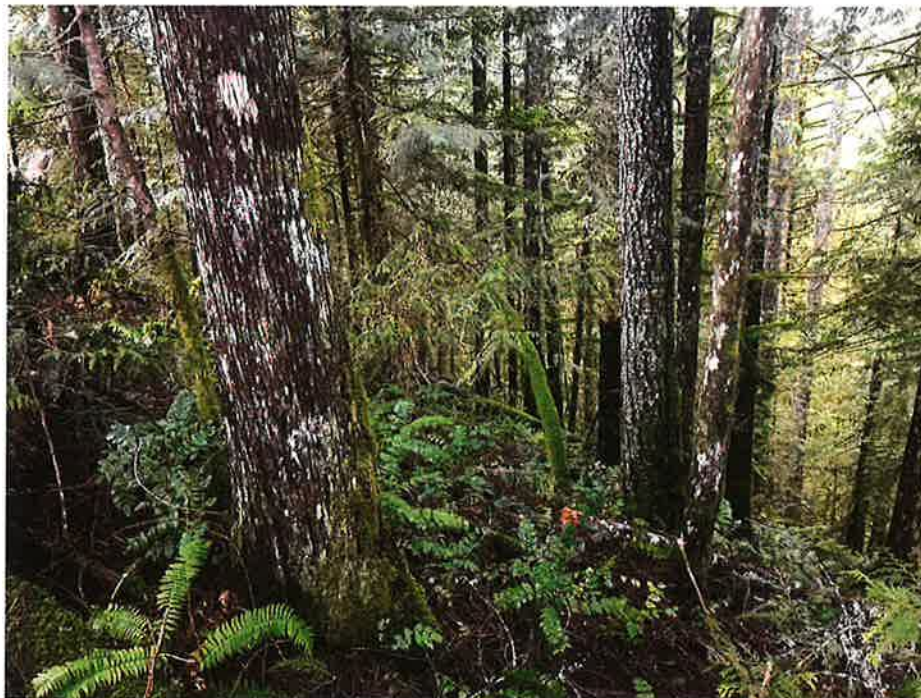
The western edge of the southern portion of the property is located on top of a moderate planar west-facing slope that measures approximately 25 to 30 degrees (Figure 7). This slope slopes down to another remnant terrace. No evidence of instability is evident on this slope and no existing or incipient fractures are present near the slope crest.

Figure 7. Photograph of the moderate west-facing slope that drops from the southwestern edge of the subject property to a lower terrace below.

We recommend that no soil or vegetation debris be placed on or within the 10 feet of the top edge of the slope to the west of the subject property. Such debris piles can eventually build up and form a wet unstable mass that will slide down the slope, damaging the slope and increasing the likelihood of a future slope failure.
