# SKAGIT COUNTY DEPARTMENT OF PUBLIC WORKS

## 2016 ANNUAL BRIDGE REPORT

**SUBMITTED: APRIL 2017**

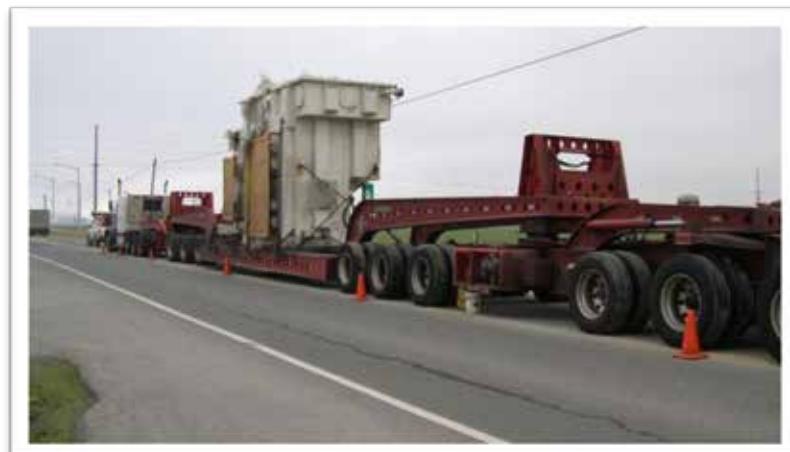
*An unpermitted overweight load that was ticketed after crossing the North Fork Bridge*

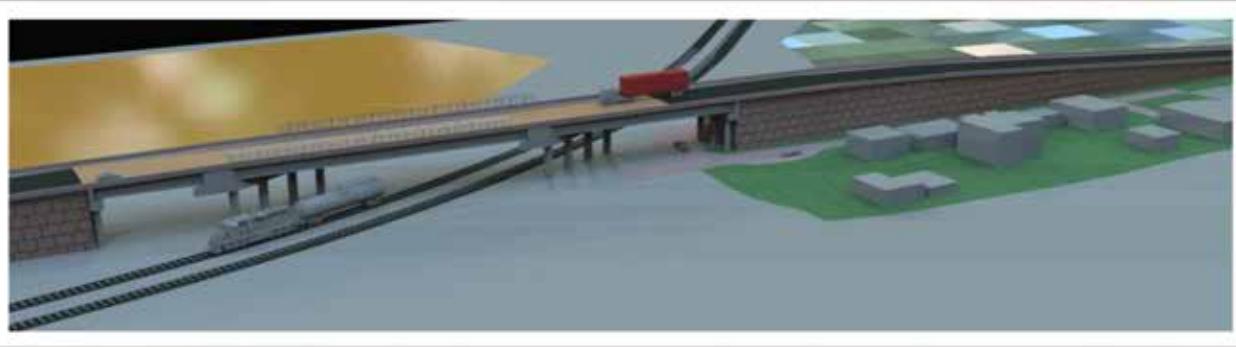
- Burlington Northern Overpass #40111
  - Structurally deficient, timber structure is deteriorating.
  - Functionally obsolete, does not meet the geometry standard of the road system.
  - Skagit County completed design and hired Cascade Bridge to construct the new 3-span concrete bridge with MSE walls.
  - Demolition of the old bridge is scheduled to begin late March.

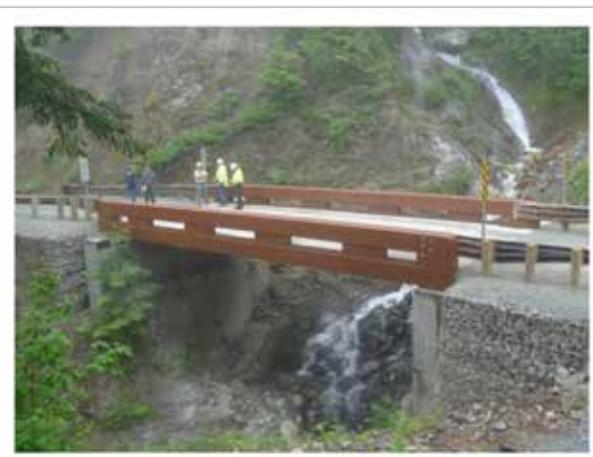
- The Hard Crk. Bridge #40076 Project
  - Completed last year and opened for use in May '16.
  - The bridge was removed down to its abutments and then reconstructed with new girders and rails.
  - The new bridge deck is not as wide as the previous. This was done to increase the distance between the bridge and the hillside and reduce the likelihood of damage from rockslides.
  - Because of the low traffic volumes and good site distance, going from two lanes to one will not adversely impact level of service or road safety.

*Hard Creek Bridge Rehabilitation - Completed*

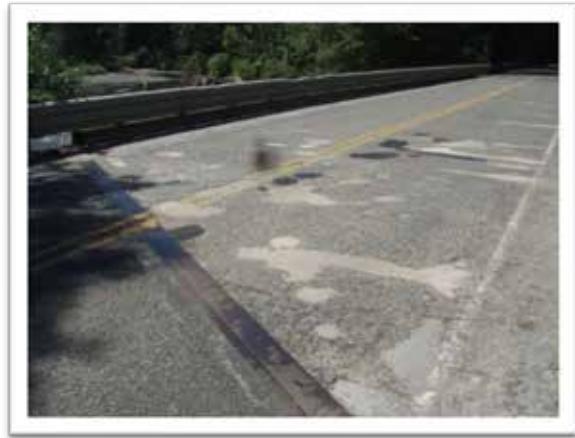
- Work is scheduled to begin in summer of 2018.
- Lower Finney Creek Bridge on South Skagit Highway #40089
  - The bridge deck is deteriorating due to age and wear resulting in spalling and exposed rebar

*Deck patching on South Skagit Highway's Finney Creek Bridge*

- BRAC awarded Skagit County \$342,000 in Federal funding to resurface the deck and level the approaches.
  - Work is scheduled to begin this summer of 2017.

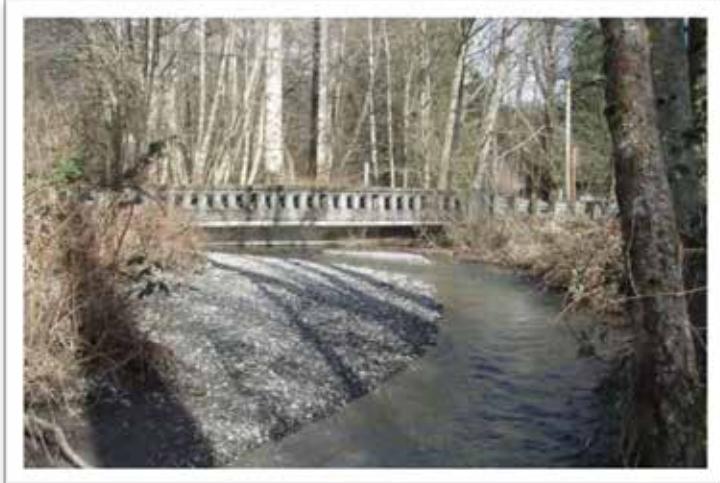
*Lyman Hamilton Highway at Childs Creek*

County staff is pursuing both immediate and long-term solutions to sediment aggradation at the Lyman Hamilton Highway Bridge over Childs Creek. The County removed 50 cubic yards of sediment removal during the 2014, 2015, and 2016 allowable work windows but this did little in the way of increasing conveyance. For the 2017 allowable work window, the County has submitted permits for a larger in-stream sediment removal to increase conveyance and reduce flood risk to properties impacted by backwatering. The goal of the 2017 project is to return the channel's bed elevation to a level similar to when the bridge was first constructed in 1947. For the longer term solution, the County acquired 3.43 acres of land adjacent to Childs Creek that could serve as a future sediment management site. The structures on that property are targeted for demolition in 2017.
