# SKAGIT COUNTY DEPARTMENT OF PUBLIC WORKS

## 2017 ANNUAL BRIDGE REPORT

**SUBMITTED MARCH 2018**

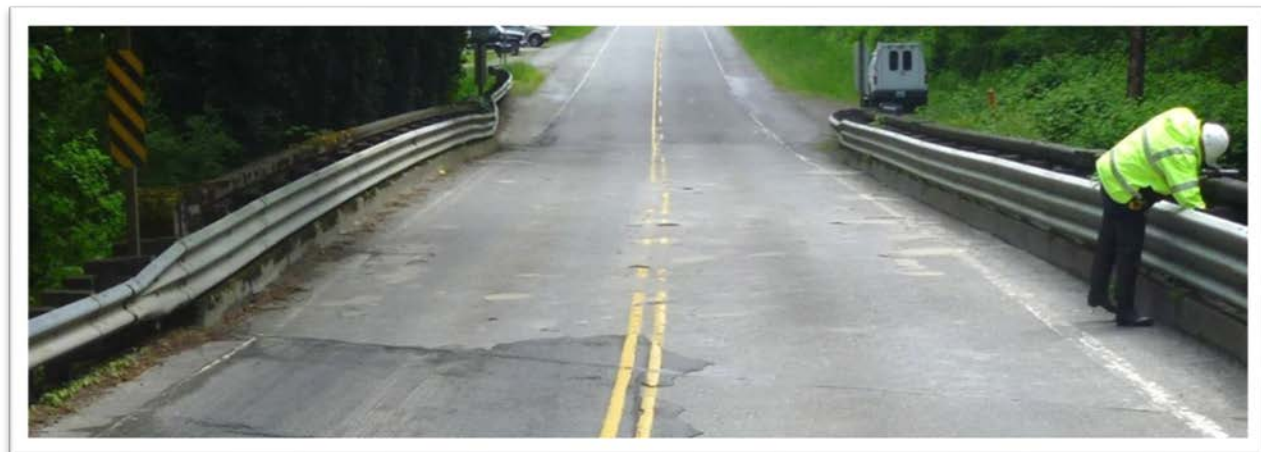
***Friday Creek Bridge on Old Highway 99 N, deck covered in concrete patch repairs.***

- Friday Creek Bridge on Old Hwy 99 #40115
  - The bridge deck is deteriorating due to age and wear resulting in spalling and exposed rebar
  - BRAC awarded Skagit County \$360,000 in Federal funding to resurface the deck and level the approaches

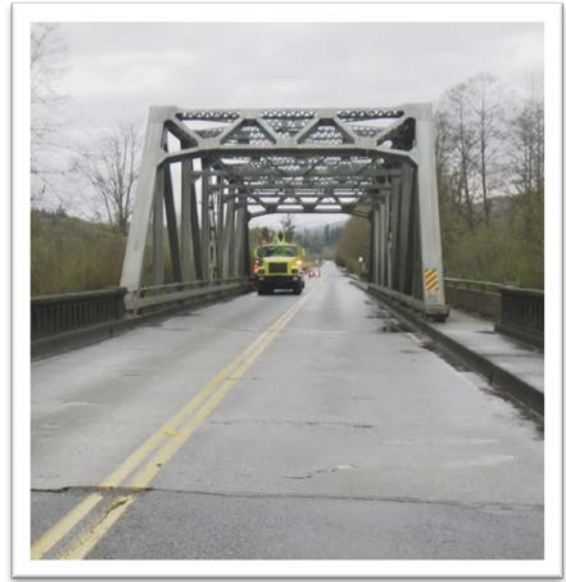
- Samish River Bridge on Old Hwy 99 #40114
  - Due to frozen rocker bearings, the bridge deck experiences compression stress which results in failing joint headers, cracks and spalling with exposed rebar in the concrete deck

*Samish River Bridge deck during inspection*

- BRAC awarded Skagit County \$824,000 in Federal funding to replace the bearings, expansion joints, and resurface the deck/driving surface
  - Work is scheduled to begin in summer of 2019

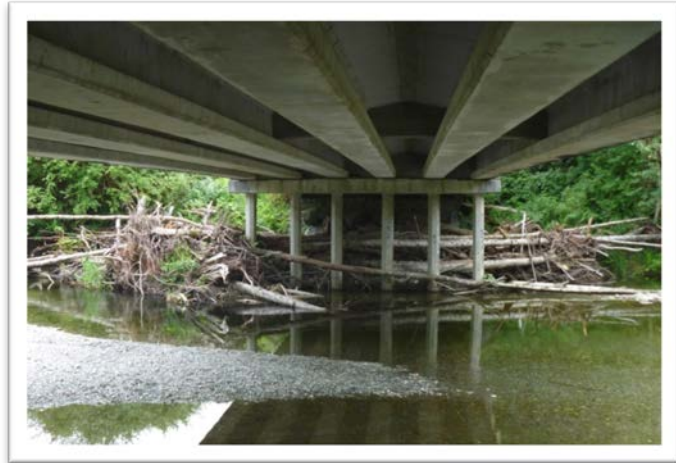
*Debris under S. Skagit Hwy at Day Creek*

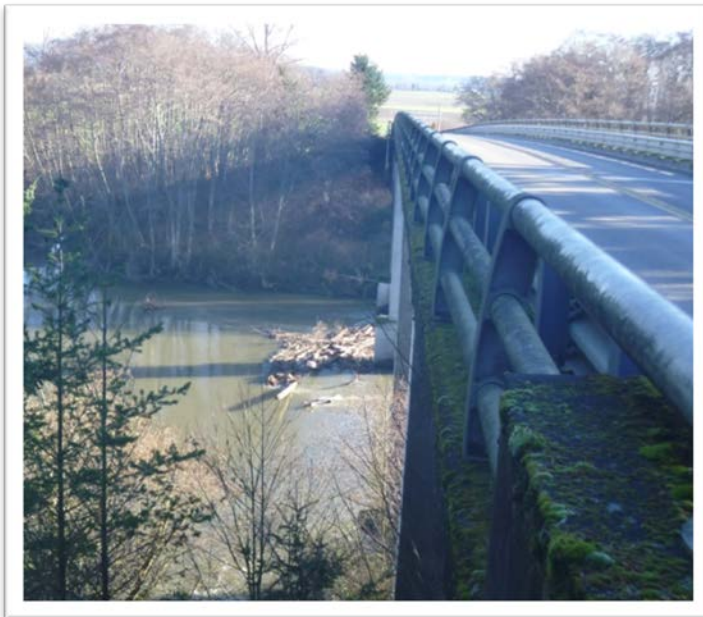
*Debris on the North Fork Bridge*

For the second time in two years, debris has collected on the North Fork Bridge. The first blockage was cleared by a contractor out of Portland but the second time the WSDOT maintenance crew was available. They came up in December with a couple boats and removed the blockage between Pier 4 and Pier 5. These piers have already undergone scour repairs in 2005 so it's very important that we clear these blockages before problems occur. Because WSDOT's crew was able to respond quickly, the blockage was still relatively small and easier to clear. With the increased frequency of these blockages, we'll be monitoring the North Fork Bridge closely next fall.

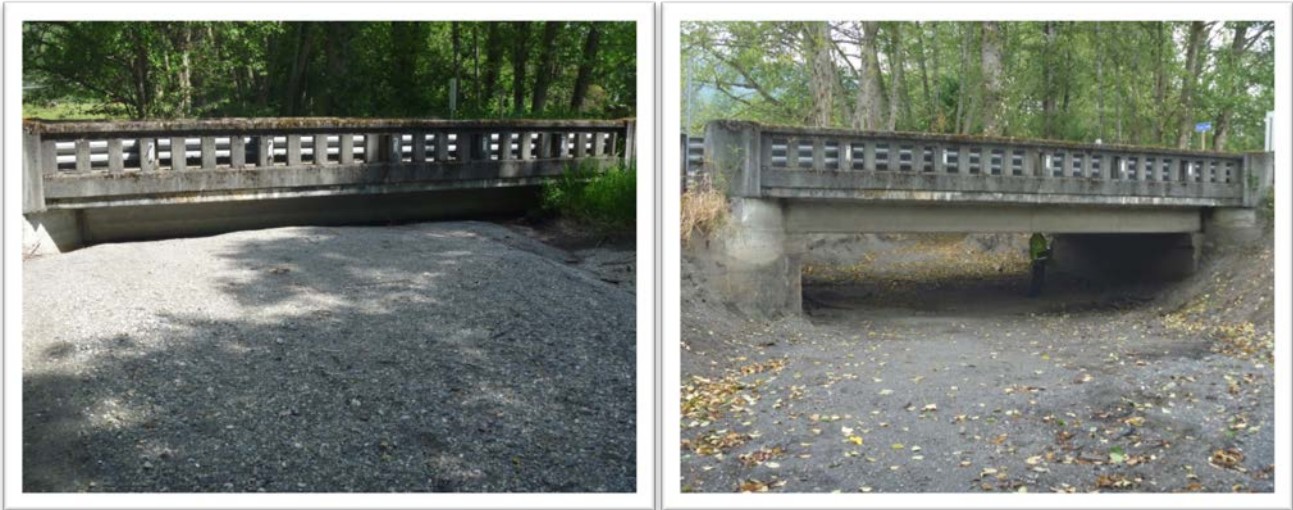
County staff is pursuing both immediate and long-term solutions to sediment aggradation at the Lyman Hamilton Highway Bridge over Childs Creek. During the 2017 allowable work window, the County completed an in-stream sediment removal project to increase conveyance and reduce flood risk. For the longer term solution, the County acquired 3.43 acres of land adjacent to Childs Creek that could serve as a future sediment management site. The residential structures on that property were demolished in 2017

***Before and after of Lyman Hamilton Highway at Childs Creek***
