# SKAGIT COUNTY DEPARTMENT OF PUBLIC WORKS

## 2019 ANNUAL BRIDGE REPORT

## 2019 BRIDGE REPORT

**Submitted: March 2020**

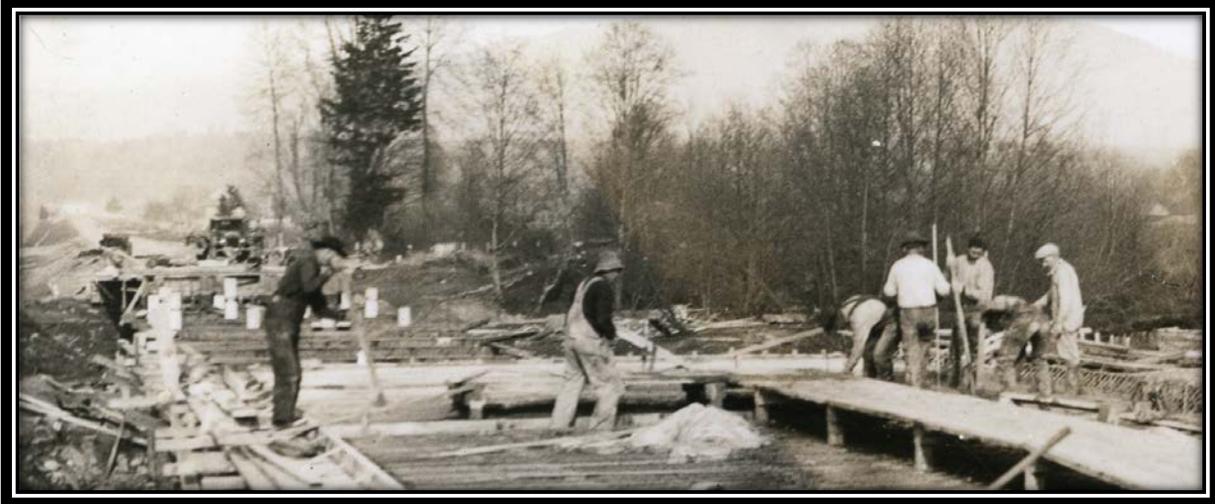
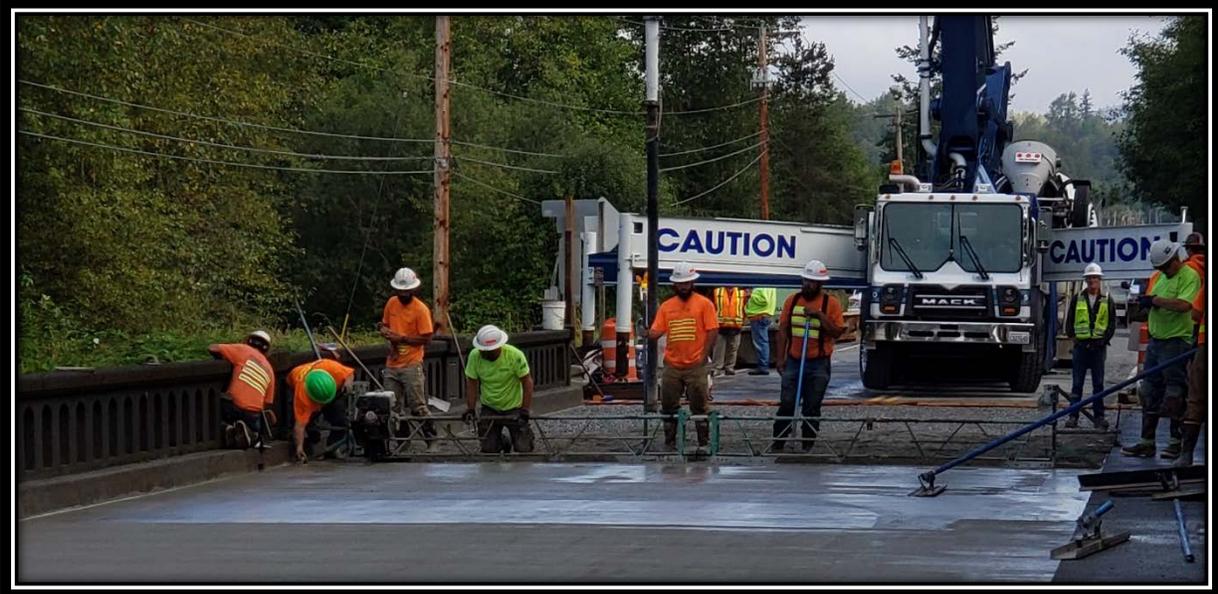
*Samish River Bridge: Top - 1934 Deck Construction / Bottom - 2019 Deck Rehabilitation*

- **Samish River Bridge:** deck rehabilitated, rocker bearings reset, fatigue cracks repaired, and concrete railings patched.

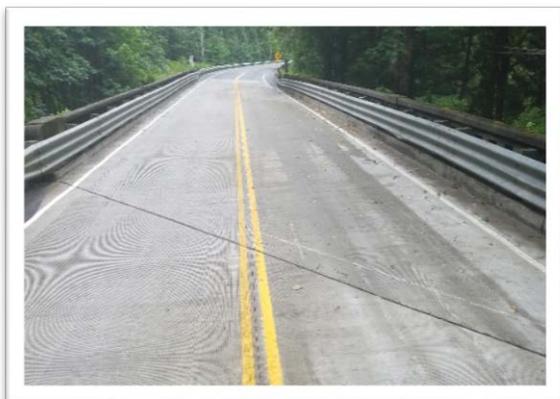
***Friday Creek Bridge Deck Rehabilitation***

- **Friday Creek Bridge:** deck rehabilitated, approach slabs rebuilt, and voided slab superstructure was drained of seepage in the voids.

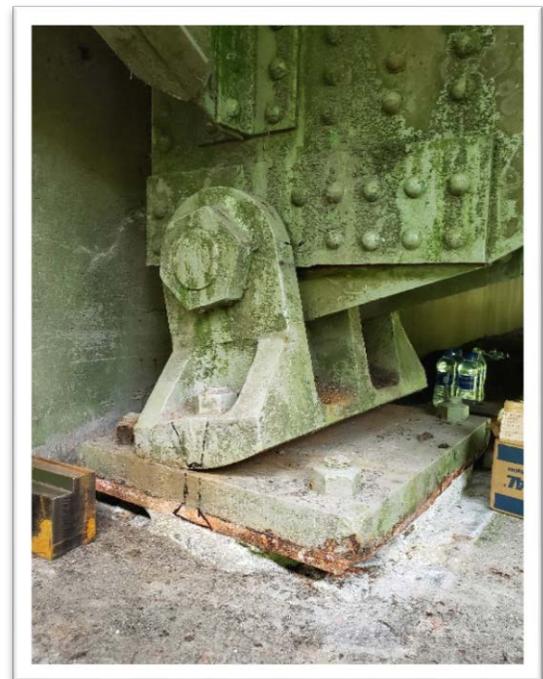
***Samish R. Bridge frozen rocker bearing***

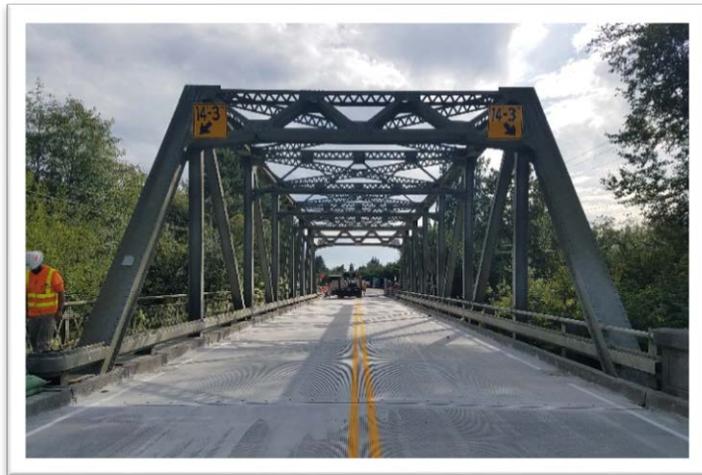
Steel Truss Bridges all have sway bracing across the top which creates a vertical limitation to vehicles traveling over the bridge. Below is a list of bridges that have this limitation with a vertical measurement which helps when reviewing the route of an oversized load application. Skagit County crews have also posted the height restriction on two of the bridges that are near or below legal height (See Table 3).

*Samish River Bridge - Vertical Clearance Signage*

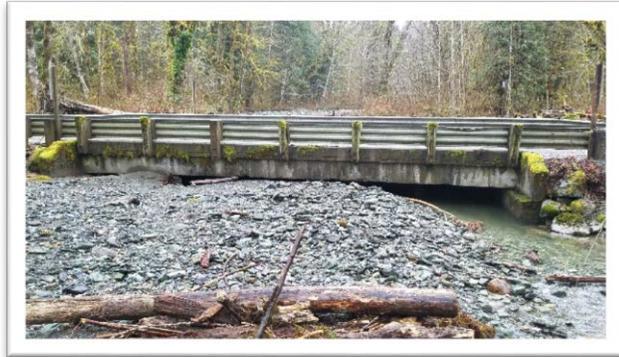
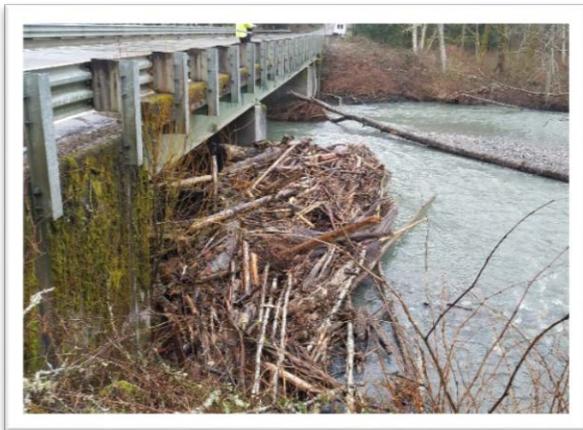
#### **Debris**

This bridge continues to be a maintenance headache, continually being blocked by earthen material and woody debris. Recent rain events have caused Mill Creek to meander east and now the majority of the flow is crossing South Skagit Hwy through a nearby cross culvert. The County's Environmental Services is working on a plan to remove a large amount of the material and get Mill Creek back in its main channel.

Debris is an ongoing battle. Currently there are large rafts on the North Fork Bridge #40037, South Skagit Hwy at Day Creek #40081 (*left*), and a small collection is beginning on the South Fork Bridge #40008. We have already secured programmatic HPA's a couple years ago for clearing debris off certain bridges. County crews will begin clearing Day Creek as soon as possible, and we're working with the WSDOT maintenance crew to assist on the other two Skagit River bridges.
