SKAGIT COUNTY DEPARTMENT OF PUBLIC WORKS

2020 ANNUAL BRIDGE REPORT

2020 BRIDGE REPORT

Submitted: March 2021

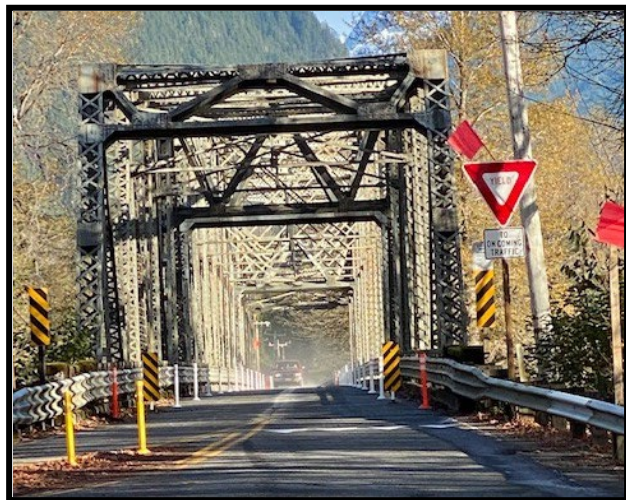
Marblemount Bridge – Skagit River

- The Skagit River Marblemount Bridge was re-load rated and concluded that the bridge needs to be restricted to a maximum 23 Ton load for all truck types. This would prevent any type of logging or tractor/trailer type truck from crossing and result in a 20 Mile detour. The County was able to avoid load restricting the bridge by making it a one-lane, two-way bridge.

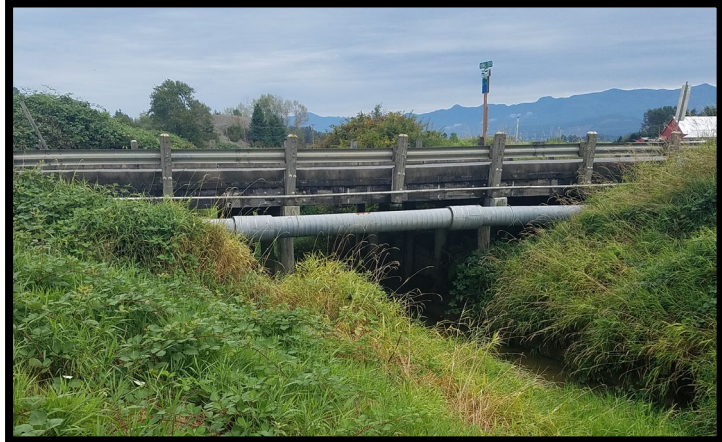
Thomas Creek Bridge – Old Hwy 99 N.

This bridge is considered structurally deficient and has a sufficiency rating of 37.16, making it eligible for replacement funding. The inspection frequency has been increased to every 12 months to better monitor the deterioration and maintain motorist safety along this heavily traveled corridor. We will be applying for replacement funds in the **2021 Local Bridge Program Call for Projects**.

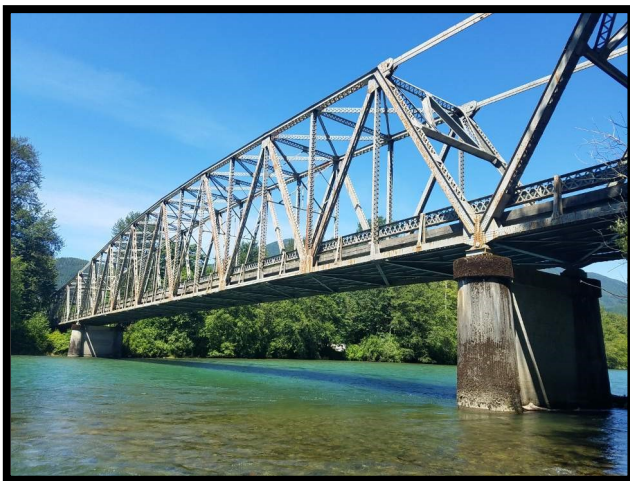
Marblemount Bridge – Skagit River

The sufficiency rating dropped from 39.93 to 32.38 after a new load rating was performed, acknowledging minor deterioration in the superstructure and limitations in the gusset plates. The load rating recommends load restrictions for all legal truck types for the bridge. However, load restrictions were avoided by modifying the lane configurations and making it a one-lane two-way bridge. By making it one lane, this allows us to channelize heavy loads into the middle of the bridge, distributing the load more evenly.

The replacement of this structure may not be economically feasible so a more suitable path forward could include a series of repairs and replacing the gusset plates to strengthen the superstructure and return the bridge to two-lane operation. We will continue looking at ways of strengthening the bridge and propose a solution in time for the **2023 Local Bridge Program Call for Projects**.

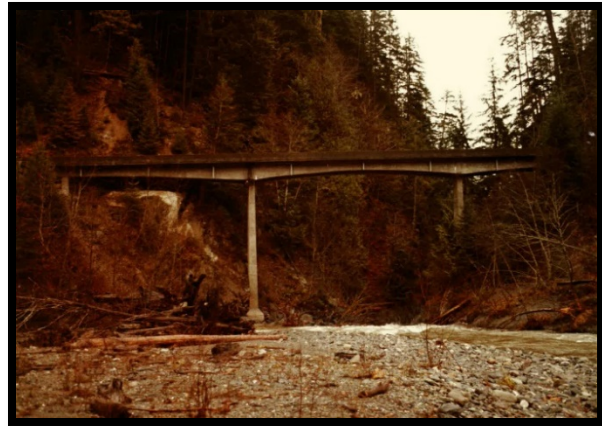
Upper Finney Creek Bridge – Finney Creek

In 2012, we repaired a damaged girder but the bridge still does not have the load carrying capability to handle today's logging industry vehicles. Skagit County has been awarded \$3 Million in grant funds from the Federal Local Bridge Program to perform a seismic retrofit, making the bridge more resistant to earthquake damage, while also increasing its overall strength and load capacity. **The project is currently in design phase and will move into construction late 2021/early 2022.**

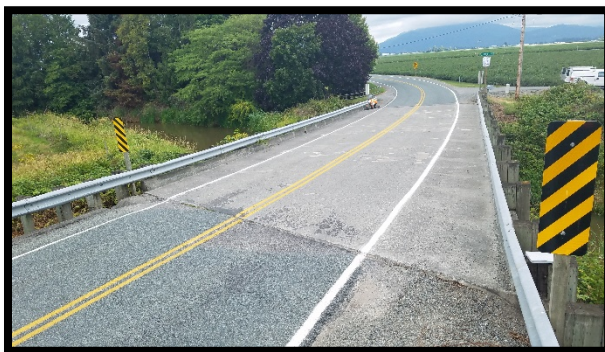
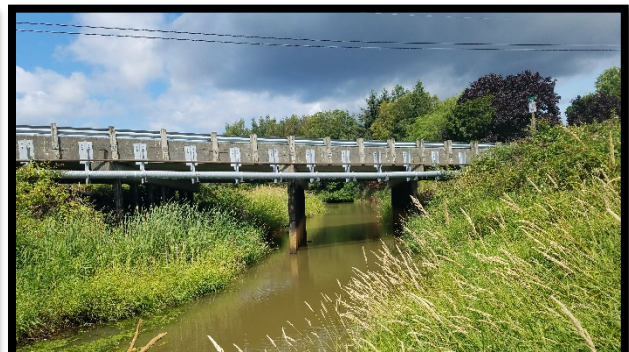
Bay View-Edison Bridge at Joe Leary Slough

The substructure and superstructure of this bridge is in very good condition (SR 84.90) but the deck is in very bad condition, currently coded a 4 (Poor). This coding of 4 makes the bridge structurally deficient and qualifies for deck repair funding through the Local Bridge Program. We will be applying for funding in the **2021 Call for Projects**.

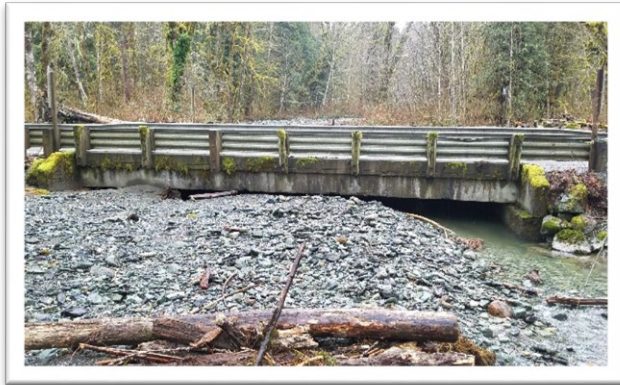
Mill Creek Bridge – South Skagit Highway

This bridge continues to be a maintenance problem, continually being blocked by earthen material and woody debris. Recent rain events have caused Mill Creek to meander east and now the majority of the flow is crossing South Skagit Hwy through a nearby cross culvert. The County's Environmental Services was able to remove some material and repair the bank to get a majority of Mill Creek back in its main channel.

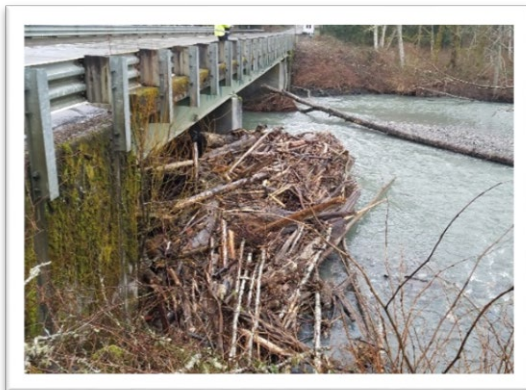
Old Day Creek Bridge – South Skagit Highway

Debris is an ongoing issue for many of our bridges. To improve crew efficiency and response time, we secured programmatic HPA's a few years ago for clearing debris off problem bridges. Our crews were able to remove the debris at South Skagit Hwy at Day Creek #40081 (*left*) this last summer.

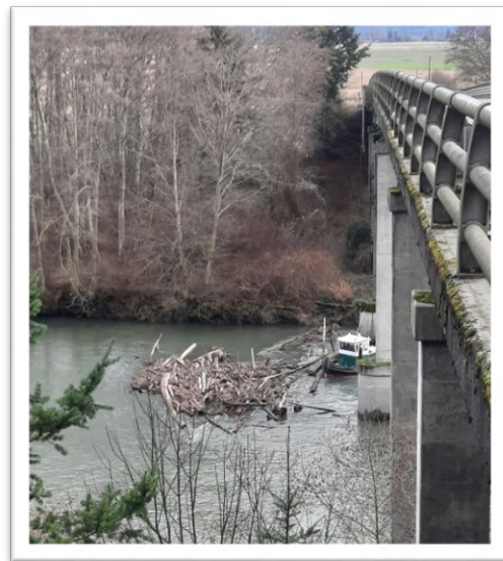
North Fork Bridge – Best Road

A large raft accumulated at the North Fork Bridge #40037 (*right*), which we were able to clear with the help of Carlson Construction and their mighty little tug boat. In the past, we've utilized the WSDOT Bridge Maintenance crew for debris removal but due to COVID, they were unable to fit it in their schedule.
