## SKAGIT COUNTY DEPARTMENT OF PUBLIC WORKS

# 2021 ANNUAL BRIDGE REPORT

2021 BRIDGE REPORT

Submitted: March 2022

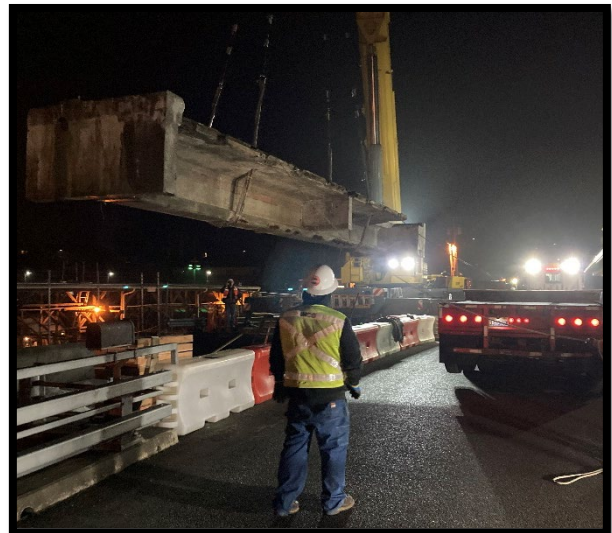
- The Anacortes Ferry Dock Girder Replacement project is underway involving the removal of 3 girders with significant section loss, caused from steel inside the girder getting rusty, expanding, and breaking/spalling the concrete around it. With the new girders installed, the sufficiency rating will greatly increase and remove the structure from the “Structurally Deficient” list (Table 1).

***Removal of deteriorating girders, Anacortes Ferry***

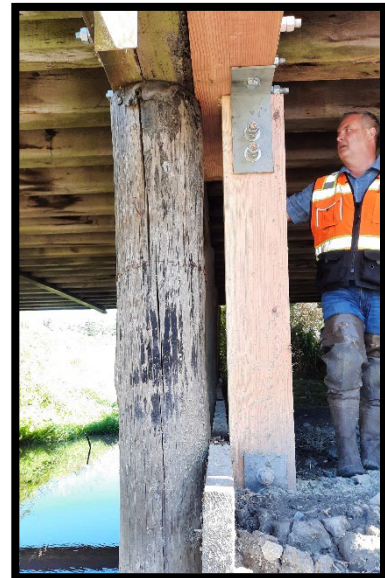
- Temporary shoring was installed on the Old Hwy 99 at Thomas Creek Bridge after discovering a deteriorating timber pile. The shoring prevents the need to load restrict the bridge.

*Old 99 at Thomas Cr, temp shoring*

- Bridge Engineering consultant, TranTech, prepared the design; permits and construction accomplished by County staff.
  - Application submitted to Federal Local Bridge Program for replacement funds but did not receive award. However, we will continue to seek replacement funding for this bridge in the coming year.

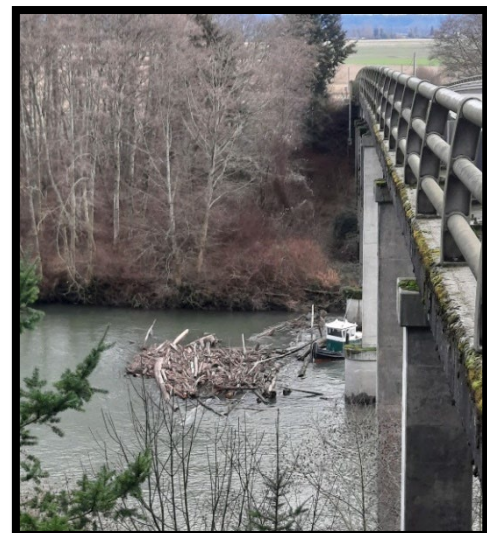
- North Fork Bridge debris was cleared by Carlson Construction using a small tugboat. The raft of woody debris blocked entire span between piers #4 & #5, approximately 1/3 of the main channel. County has an on-call contract with Carlson Const for whenever debris begins to pile up on our lower Skagit River bridges.

*North Fork Bridge, debris removal*

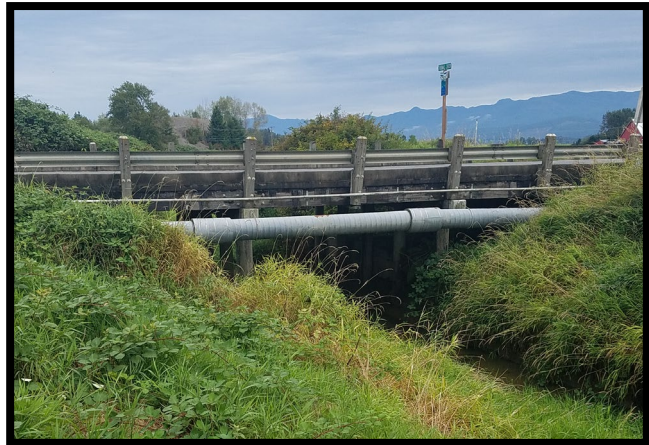
*Thomas Creek Bridge – Old Hwy 99 N.*

This bridge is considered structurally deficient and has a sufficiency rating of 9.6, making it eligible for replacement funding. The bridge has a deteriorating pile that has been red tagged and normally would require a weight restriction or closure of the bridge. But County forces were able to quickly permit and construct temporary shoring to reduce pressure on the pile. We will be applying for replacement funds in the **2022 Local Bridge Program Call for Projects**.

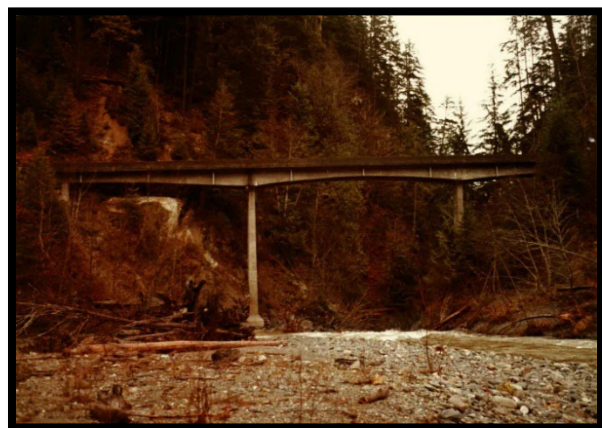
*Upper Finney Creek Bridge*

The Upper Finney Creek Bridge was damaged in 2012 due to a suspected overweight load crossing the bridge. A shear crack was found in one of the two girders at the mid-span of the bridge. The bridge girder was repaired and re-opened to traffic but remains restricted to loads of no greater than 60,000 LBS or 30 tons (see page 14 for additional information).

In 2012, we repaired a damaged girder, but the bridge still does not have the load carrying capability to handle today's logging industry vehicles. Skagit County has been awarded \$3 Million in grant funds from the Federal Local Bridge Program to perform a seismic retrofit, making the bridge more resistant to earthquake damage, while also increasing its overall strength and load capacity. **The design phase is near completion and will move into construction this summer.**

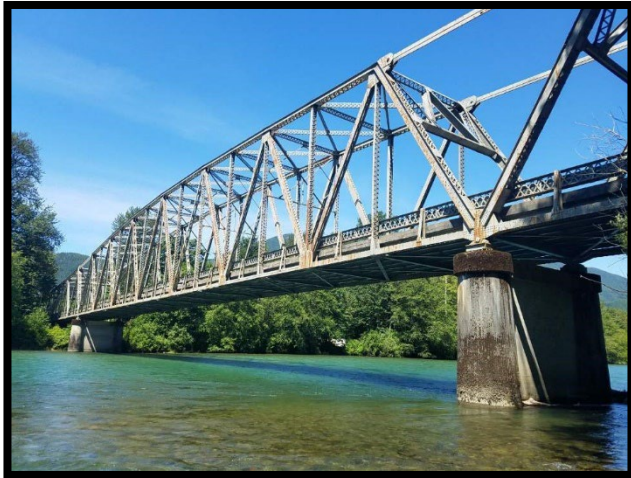
*Marblemount Bridge – Skagit River*

The sufficiency rating dropped from 39.93 to 32.38 after a new load rating was performed, considering some minor deterioration in the superstructure and limitations in the gusset plates. The load rating recommends load restrictions for all legal truck types for the bridge. However,

load restrictions were avoided by modifying the lane configurations and making it a one-lane two-way bridge. By making it one lane, this allows us to channelize heavy loads into the middle of the bridge, distributing the load more evenly.

The replacement of this structure may not be economically feasible so a more suitable path forward could include a series of repairs and replacing the gusset plates to strengthen the superstructure and return the bridge to two-lane operation. We will continue looking at ways of strengthening the bridge and propose a solution for future grant funding opportunities.

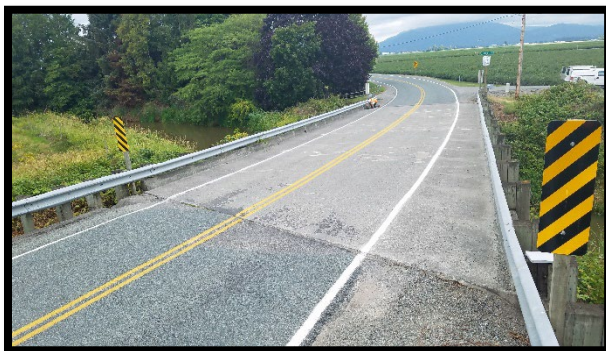
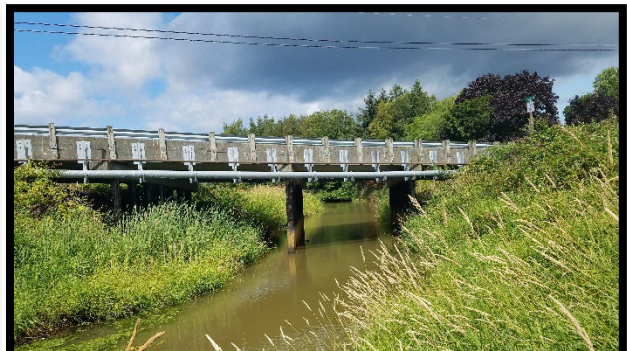
*Bay View-Edison at Joe Leary Slough Bridge*

The substructure and superstructure of this bridge is in very good condition (SR 84.90) but the deck is experiencing advanced deterioration and in need of repair, currently coded a 4 (Poor). This coding of 4 makes the bridge structurally deficient and has been awarded \$487,400 through the Federal Local Bridge Program to repair the deck, as well as the approach road fill retaining wall and existing drainage system.

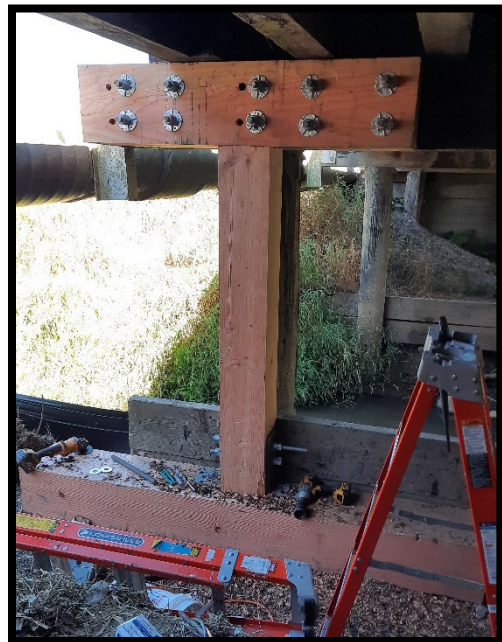
With design help from our bridge engineering consultant, TranTech, county staff permitted and constructed temporary shoring around one of the structures' deteriorating piles. This shoring is fastened to the timber cap and helps distribute the load to the ground carried by the pile. The shoring allows us to avoid having to load restrict the bridge, or possibly a lane closure. This temporary shoring technique keeps the sufficiency rating low for grant opportunities but maintains the structure's load carrying capacity.

*Old 99 at Thomas Creek – temp shoring*

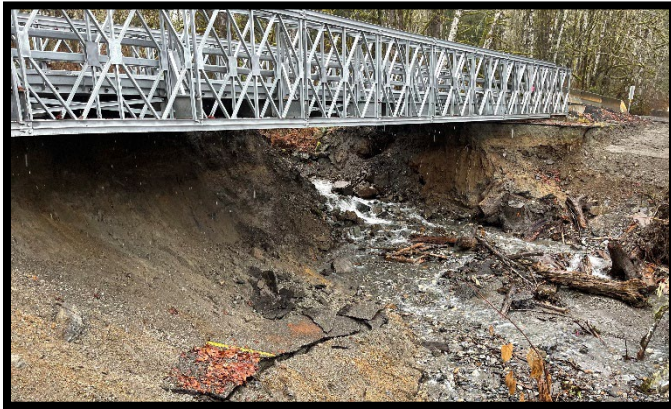
*Concrete-Sauk Valley at North Osterman*

The temporary bridge was installed to keep the road open while the North Osterman Creek culvert continued to fail due to massive head cutting from the unpredictable migration of the

Sauk River. When 100% failure was imminent, County crews sprang into action to add two more 10' sections to the bridge, increasing the overall span length to 130'. With the extra span length to help account for additional head cutting and lateral scour of the creek, Special Operations crew were able to safely remove the remaining concrete culvert sections. The temporary structure will remain until the permanent crossing is designed and ready for construction.

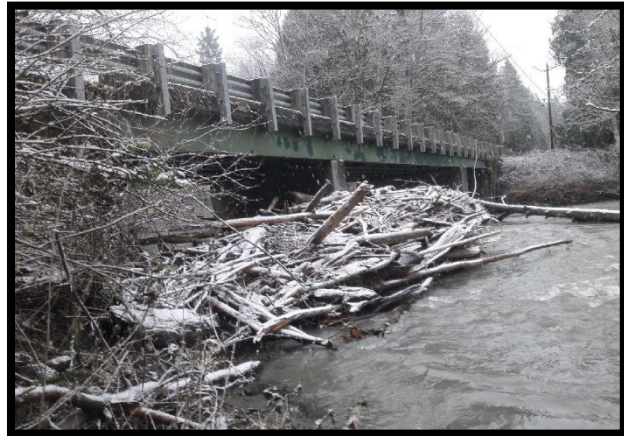
*South Skagit Highway at Finney Creek*

Debris is an ongoing issue for many of our bridges. To improve crew efficiency and response time, Environmental Services secured programmatic HPA's for clearing debris from problem bridges. Our crews were able to remove the debris from South Skagit Hwy at Finney Creek #40089 during the November '21 flood event (*right*).
