## SKAGIT COUNTY DEPARTMENT OF PUBLIC WORKS

# 2025 ANNUAL BRIDGE REPORT

**SUBMITTED MARCH 2026**

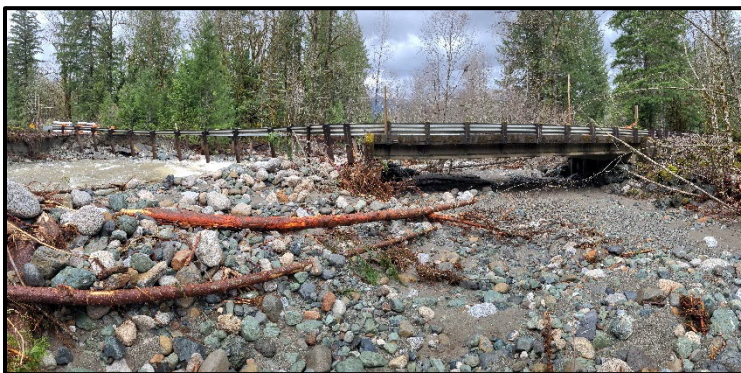
- Due to a massive debris blockage during the December 2025 extreme weather event, Jordan Creek migrated to the west and destroyed a portion of Rockport Cascade Road.

The bridge is structurally sound, but it did suffer an extensive amount of scouring around its pile foundation. The road will remain closed for an indeterminate amount of time until a new crossing is constructed over the current Jordan Creek location.

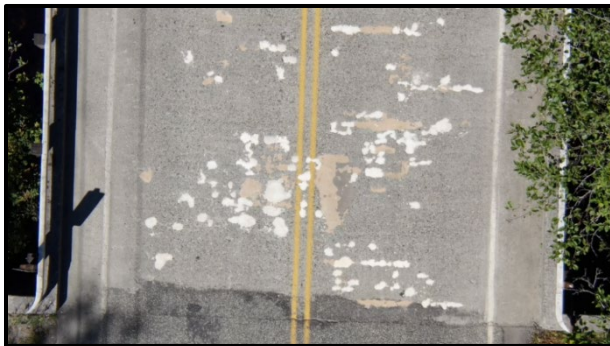
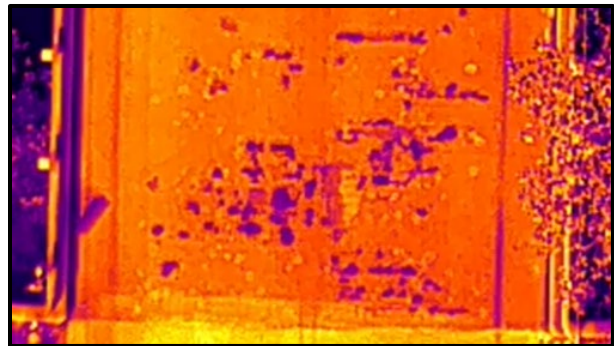
Thermal imaging of a portion of Lake Cavanaugh Road at Pilchuck Creek Bridge:

The patched spalls and delamination areas heat and cool at different rates than the concrete in good condition. The existing patches of spalled delamination (top photo) show up in the thermal imaging (bottom photo) as dark purple spots. The lighter yellow spots indicate delamination in the concrete that will eventually spall and need additional patching.

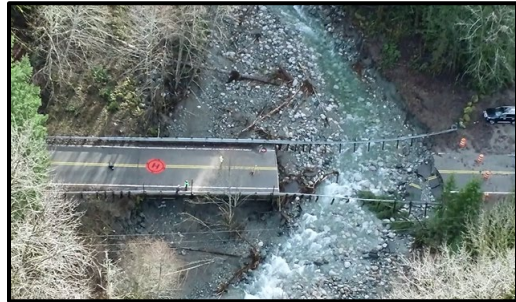
#### **Rockport Cascade Rd at Jordan Creek #40095**

During the extreme weather event that occurred in December of 2025, Jordan Creek migrated to the west and destroyed the approach roadway leading up to the bridge and suffered an extensive amount of scouring around its pile foundation. The bridge remains structurally sound but will require grant funding support to design and construct a long term solution that will span the new channel width of Jordan Creek.

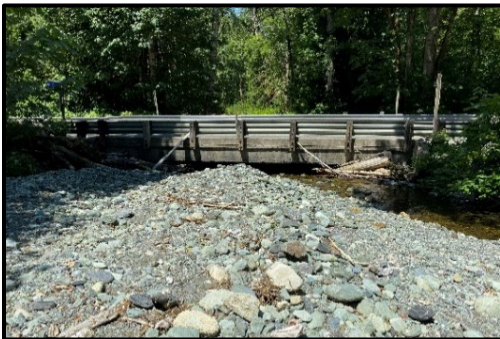
Mill Creek channel upstream of bridge.

Environmental processes have rendered the Mill Creek crossing inadequate for its intended purpose. Mill Creek, located in an alluvial fan, has filled in with large aggregate and decreased the structures' available conveyance, causing the creek to overtop the roadway during the most minor rainfall events. Currently, the channel diverts flow to the east of the bridge and joins with Savage Creek, reducing salmonid habitat. The County was not awarded funding in the 2025 Call for Projects but plan to try again in the next call, expected in March of 2027.

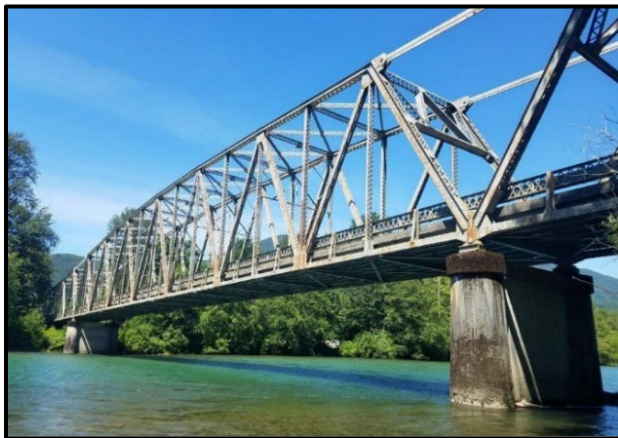
Marblemount Bridge – Skagit River

The structure would be posted for load restrictions based upon its current rating, however, considering the low average daily traffic, Public Works elected to reduce the bridge to one-lane with signal controlled two-way traffic operation. With a one-lane configuration, legal trucks are allowed to cross one-at-a-time to avoid a 20-mile detour.

Rehabilitation of the structure will include cleaning and painting, replacement of damaged and/or deteriorating members of the truss and upgrading key members to increase the load carrying capacity of the truss system.

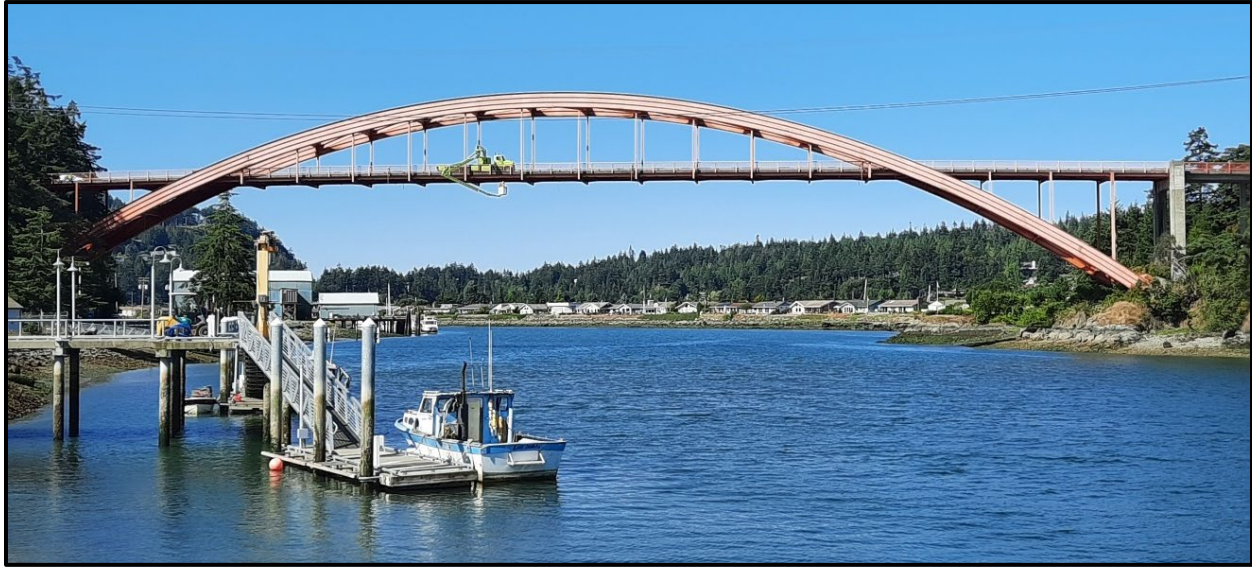
The Rainbow Bridge (below) is rated in Fair condition and does not meet the eligibility requirements for rehabilitation funding, despite the paint/protective coating being considerably faded. However, the bridge has multiple minor repair needs so preventative maintenance funding could be an option to pursue, bundled with a cleaning and painting effort. County staff will continue to look for ways to fund these items.

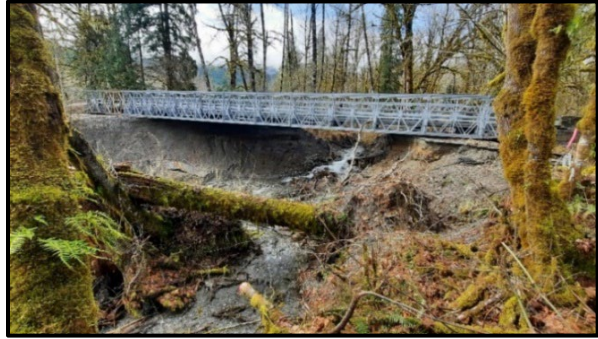
The temporary bridge was installed to maintain regionwide access when the culvert at North Osterman Creek failed due to storms and massive head cutting from the unpredictable geomorphology of the nearby Sauk River. Due to the bridge's lack of substructure, it is considered scour critical and has a Scour Plan of Action in place directing County staff to monitor site conditions during rainfall events. Recently, County Forces successfully permitted and installed Super Sacks, filled with river rock, along the banks of Osterman Creek to prevent further channel migration towards the ends of the bridge. The temporary structure will remain until the permanent crossing is designed and ready for construction. This crossing was submitted for FEMA funding and recently received more than \$770,000 in FEMA funding to begin design of a new bridge. Once the design is complete, the County will submit the estimated construction cost to FEMA to secure additional funding.

Temporary Bridge over North Osterman Creek, looking upstream.

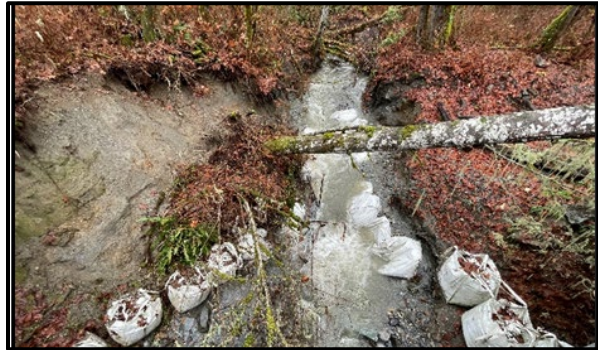
Super-sacks filled with river rock are placed to armor bank and slow down channel migration. Photo taken from bridge looking upstream.

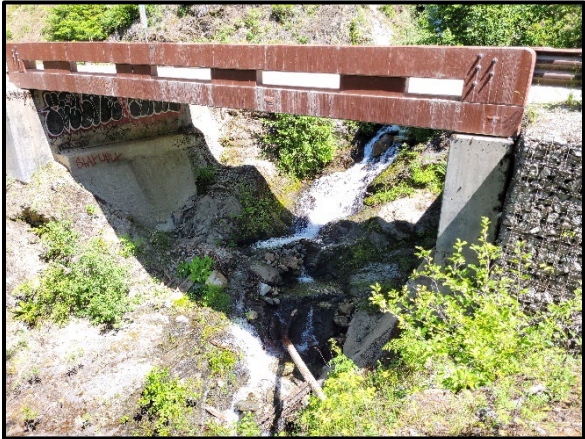
Cascade River Road at Hard Creek Bridge, looking north, upstream.

Hard Creek Bridge on Cascade River Road experienced some scour along the eastern bank that is undermining the road base retaining wall. A temporary patch was installed by County crews in November to prevent further erosion. A permanent solution will be constructed in summer of 2026.

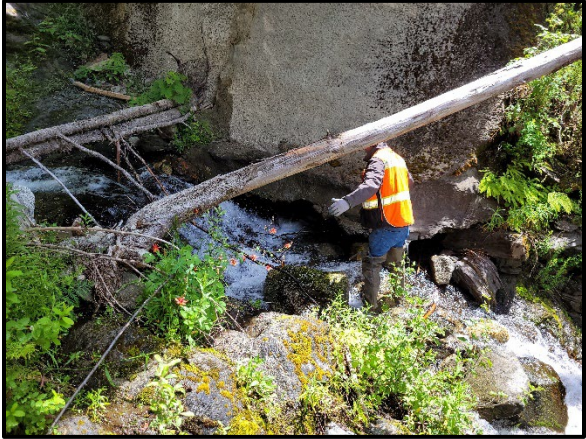
Scoured channel bank undermining retaining wall along east bank.
