M/V Guemes CY2019 Lifecycle Valuation and Propulsion Study

Produced By:

Match 31, 2020

M/V Guemes 2019 Valuation Survey and UT Inspection Plan

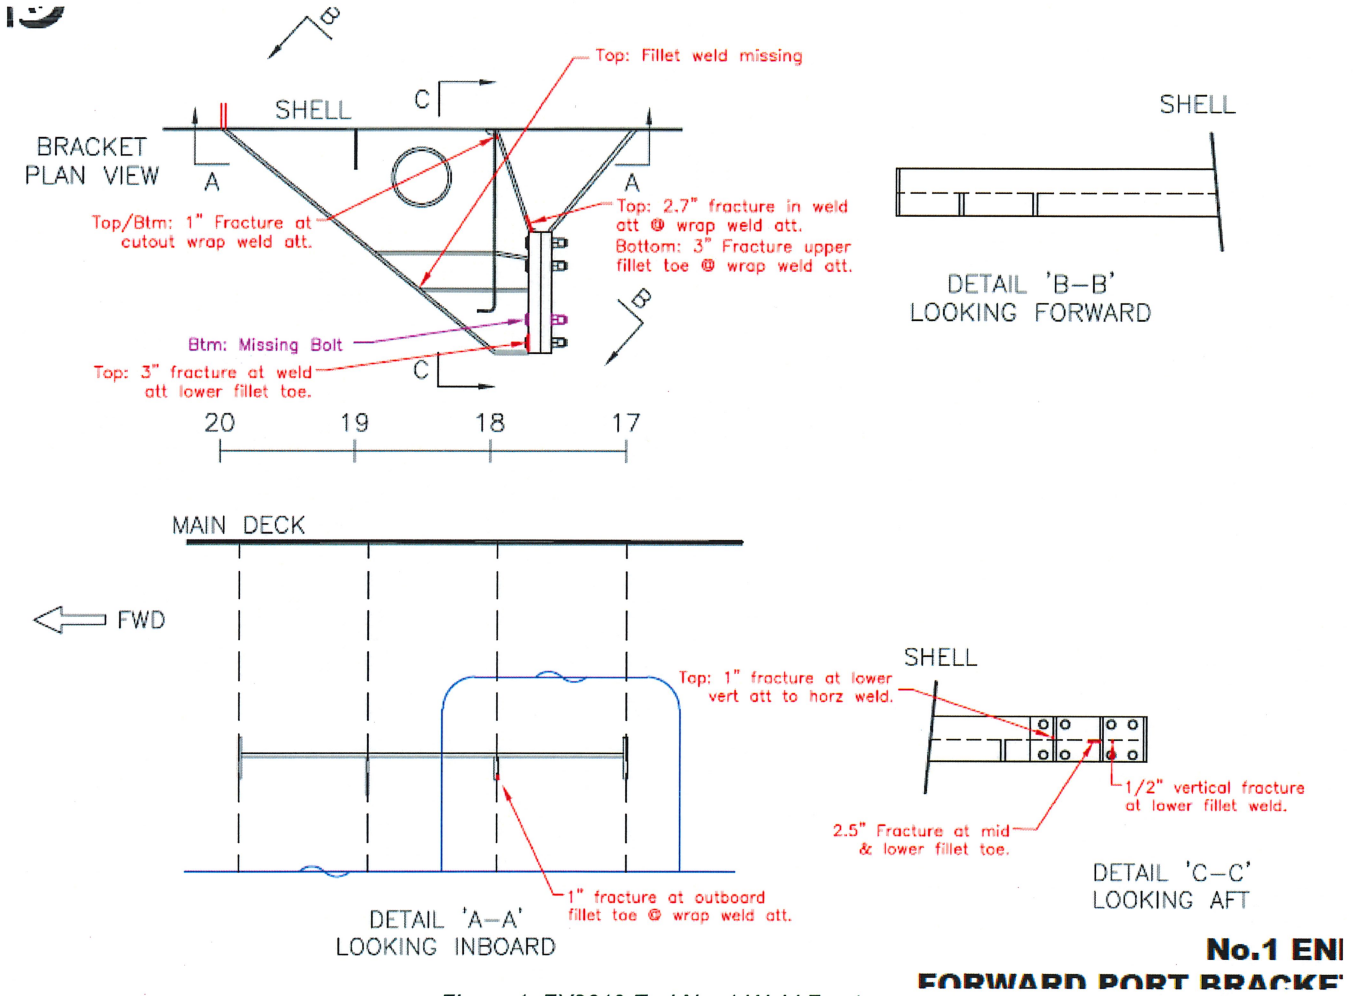
Figure 1: FY2019 End No. 1 Weld Fractures

propellers' thrust. It was also determined that the cracking between the 2017 and 2019 dry dockings was likely caused by poor weld preparations and procedures during the 2017 emergent repairs. These welds were repaired using a heavily controlled preparation, inspection, and documentation process. A detailed monthly inspection plan and required submittal to the Coast Guard was initiated. Since then, there have been no further concerns as of the writing of this report.

connects from the above structure. Upon notification of these cracks, the USCG inspector dictated that a detailed evaluation of the root cause of these recurrent cracks be conducted in order to maintain the vessel's COI. A plan was formulated and provided to the inspector and temporary repairs authorized while the analysis was being conducted. The cracked welds were repaired by being ground out, the base metal magnetic particle tested for cracking, the structure welded, then the welds magnetic particle tested and inspected.

Based on the results from the 2019 UT inspection, the results from the thruster bracket analysis, and the satisfactory monthly inspections on the brackets, immediate further analysis or abnormal maintenance procedures are not warranted. The hull and its primary members shall be inspected and maintained at their normal intervals as required to maintain the vessel's certificate of inspection (COI). As recommended in the thruster bracket analysis memo, the brackets should be monitored closely. If further cracking or missing bolts are found, then the brackets should be re-designed and replaced in whole. During the next dry docking, the welds should be ultrasonically tested.

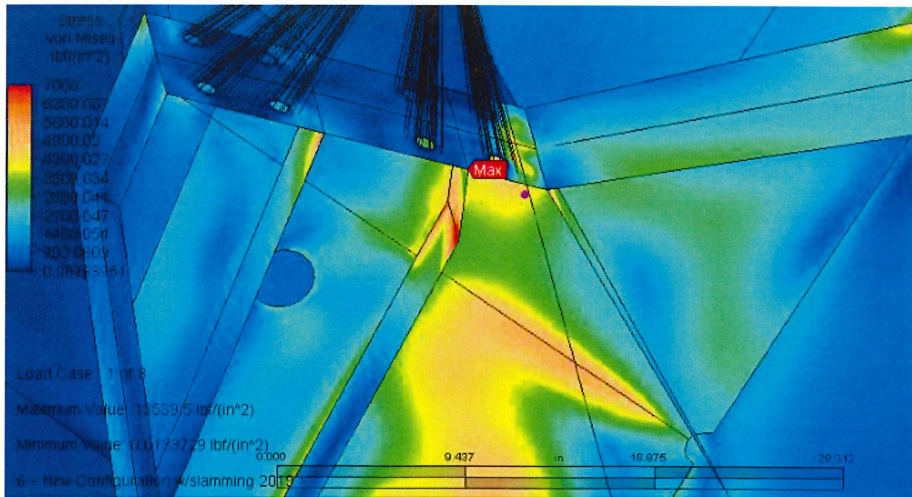
Figure 5: End No. 1 with 13,500 pound Thrust

Another goal of determining the actual thrust being produced by the propeller was to input it into the FEA model [A] and determine the affect of the higher static thrust loading on the principle stresses of the brackets. The thrust input into the FEA model (13,600 pounds) is an increase of about 43% from the previously used value of 9,400 pounds. The increase did not cause any of the structure to fail due to yielding. However, the magnitudes of stress ranges increased significantly, indicating a decrease in fatigue life. The stress range at the location of the highest measured stress (End No. 1, location 3) from NCE's testing was also investigated. The stress range output by the FEA model aligns closely with their measured values. This information will serve to validate the thrust to be used if the thruster brackets are re-designed in the future. Figure 5 and Figure 6 show results of the higher thrust value input into the FEA model. Location 3 is labeled.

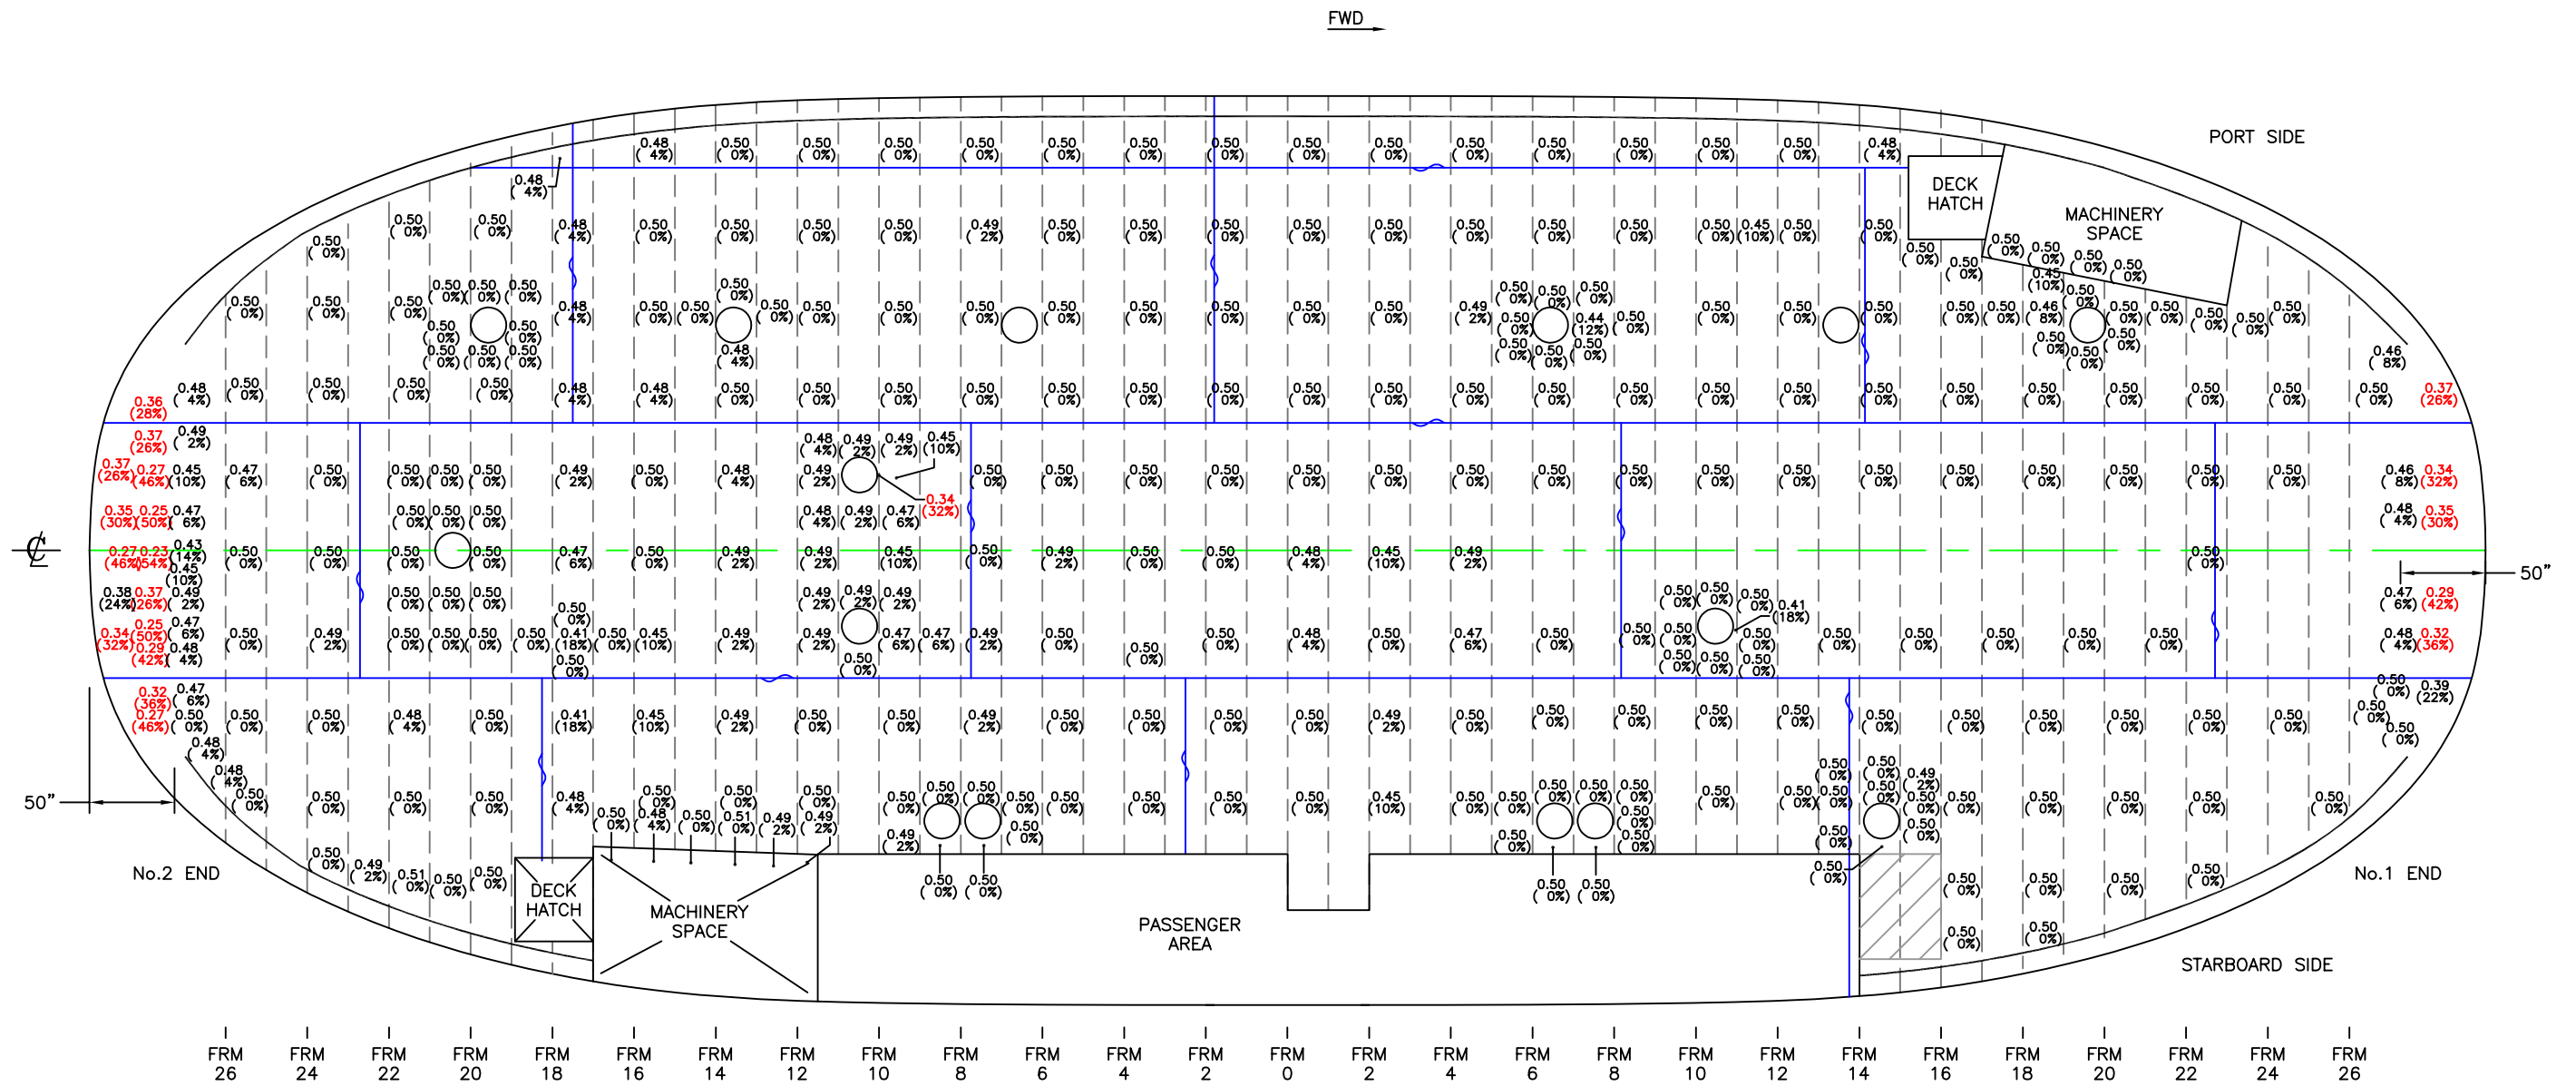
PROJECT: M/V GUEMES		DESCRIPTION: MAIN DECK PLATING	
DRAWN BY: G. GRAHAM		JOB # S3603	
DWG # MnDk		DATE: MARCH 2019

NOTE:
 MAIN DECK PLATING .50"
 RED = EXCESSIVE WASTAGE (25% AND GREATER).
 ▨ = RAMP.

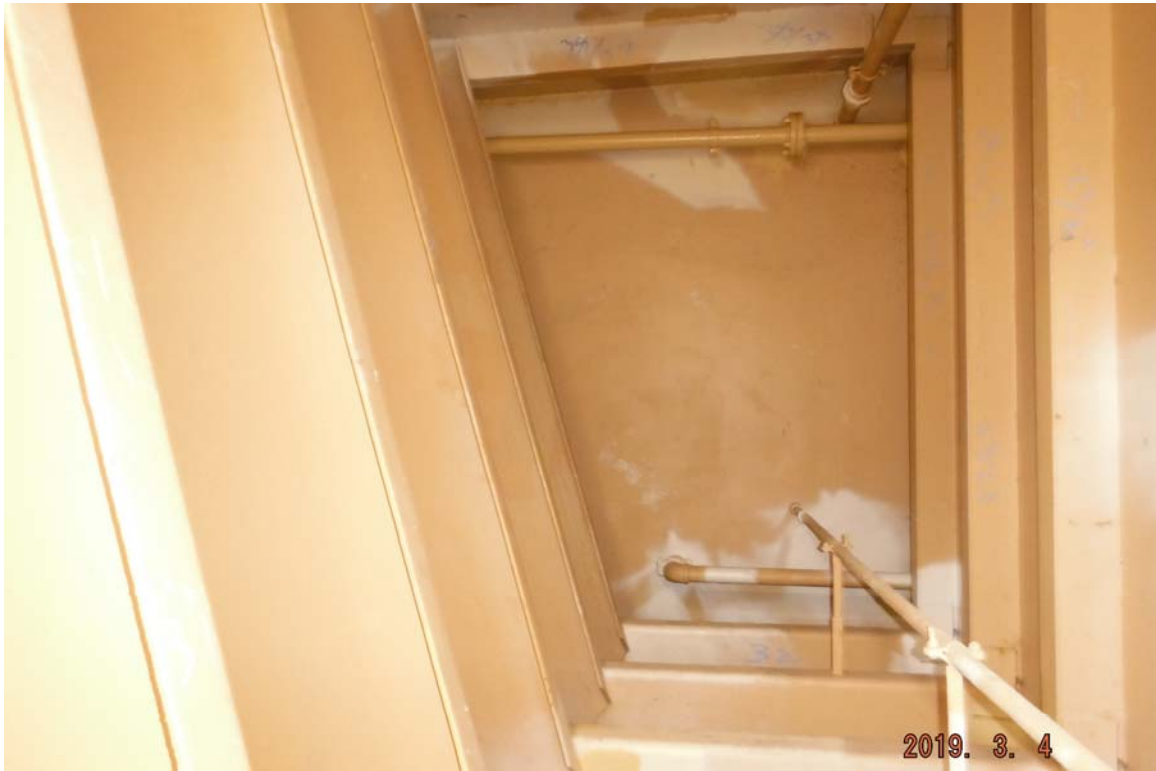
Photo No. 6
Interior void, representative sample of internal coatings

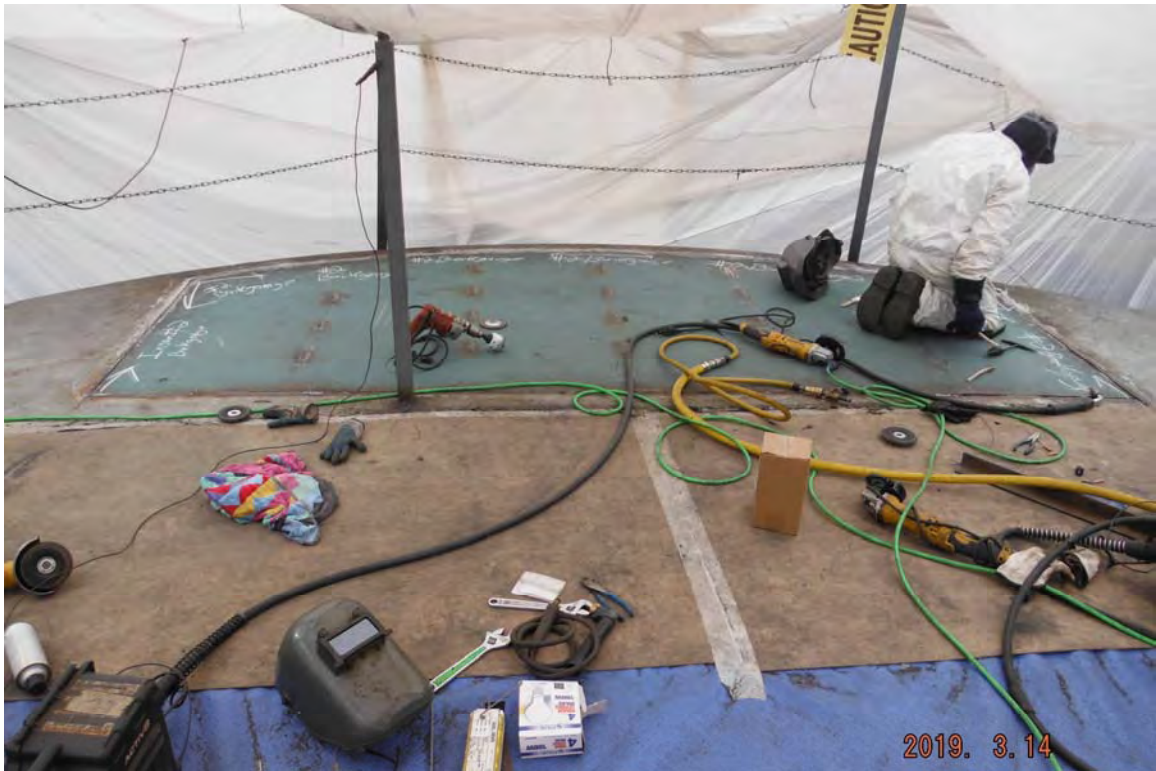
Photo No. 11
Main deck apron showing new insert
