# COAL CREEK ALTERNATIVES FEASIBILITY STUDY

December 21, 2010

Prepared for Skagit County Public Works

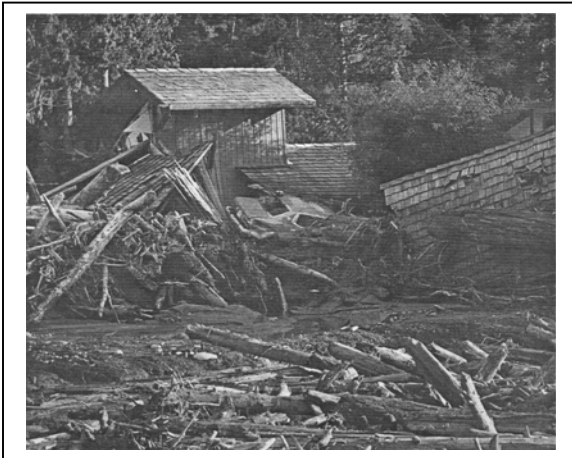
Diagram 1: Smith Creek, Whatcom County Washington following a debris flow in 1983.

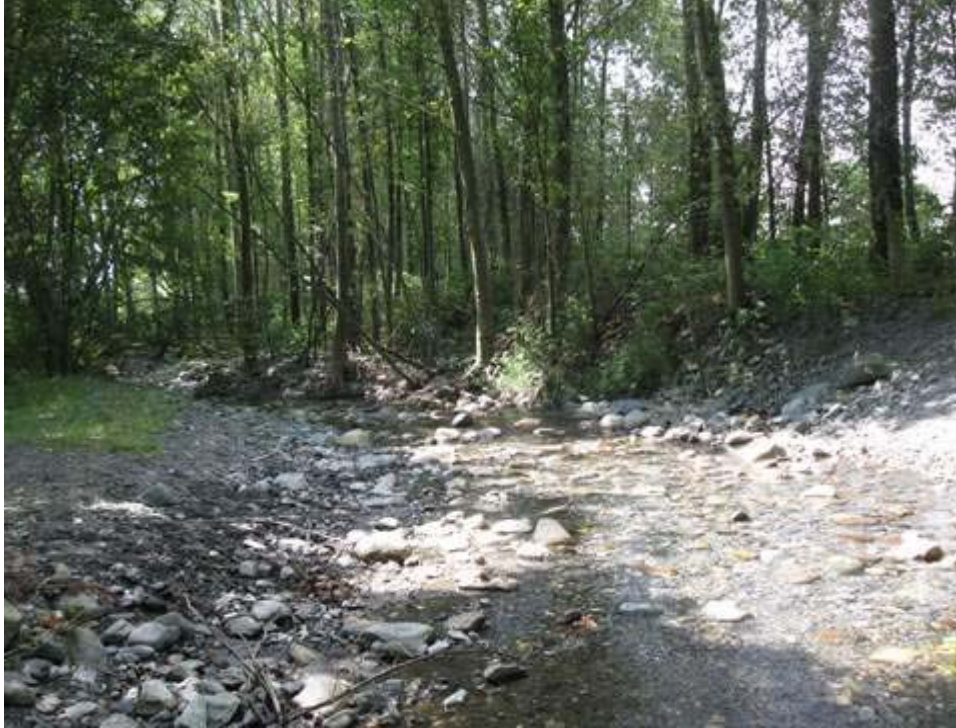
*Picture 3. Coal Creek upstream of Minkler showing channelized and straightened stream.*

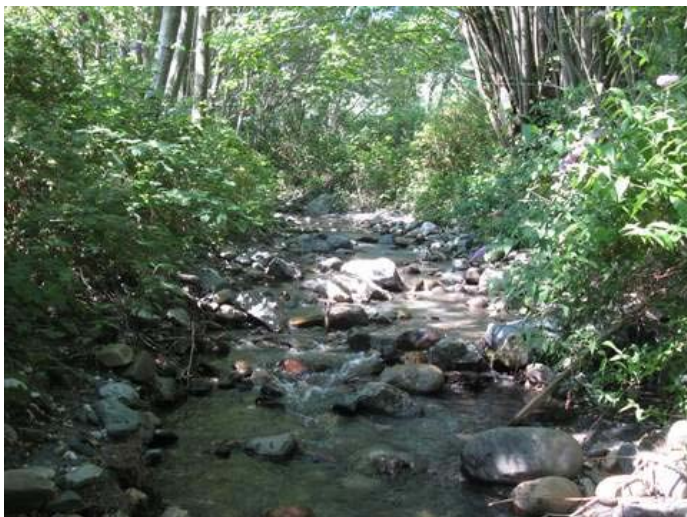
*Picture 4. Descent to Coal Creek via Sierra Pacific road access. Steep, densely vegetated bank with erosion, small landslides, and evidence of past logging on steep banks.*

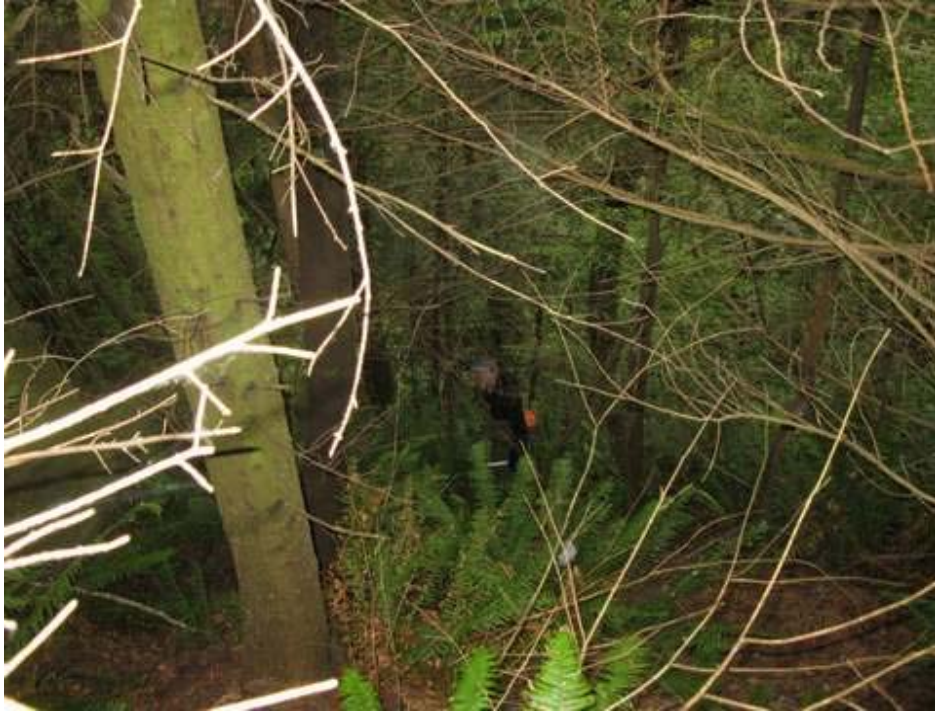
Picture 5. Large eroded bank on left-bank near entry point from road, on Mr. Lindzy's property. Active erosion and sediment recruitment including several recently fallen trees with green leaves. Bank is approximately 30 feet high and 100 feet long, with undercutting of mature trees at the top of the bank.

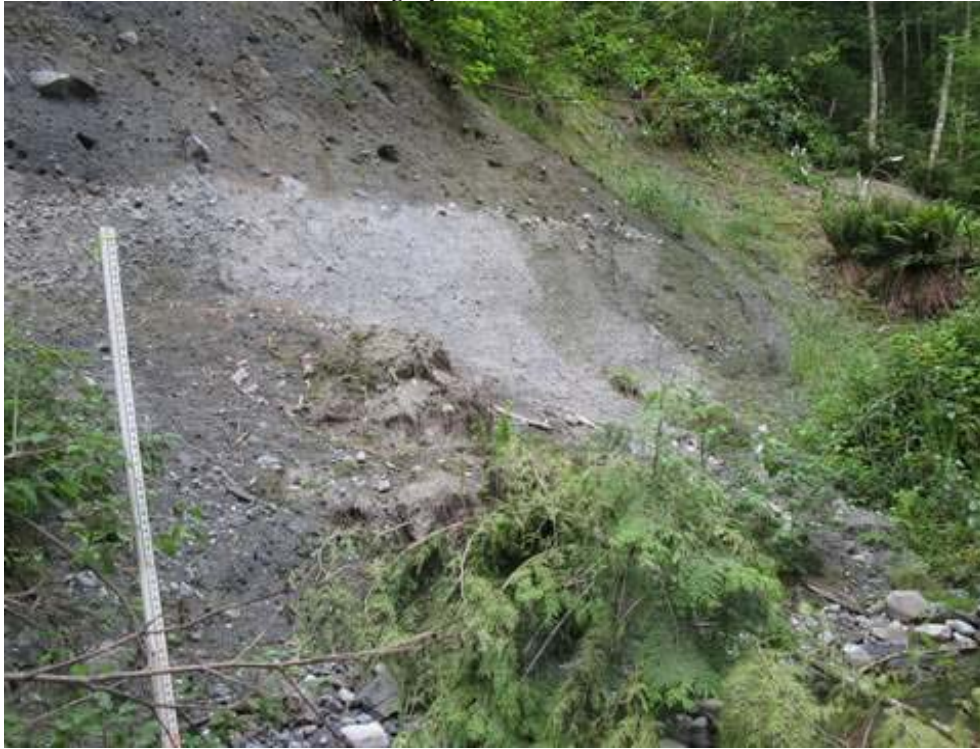
*Picture 7. Eroded bank looking downstream.*

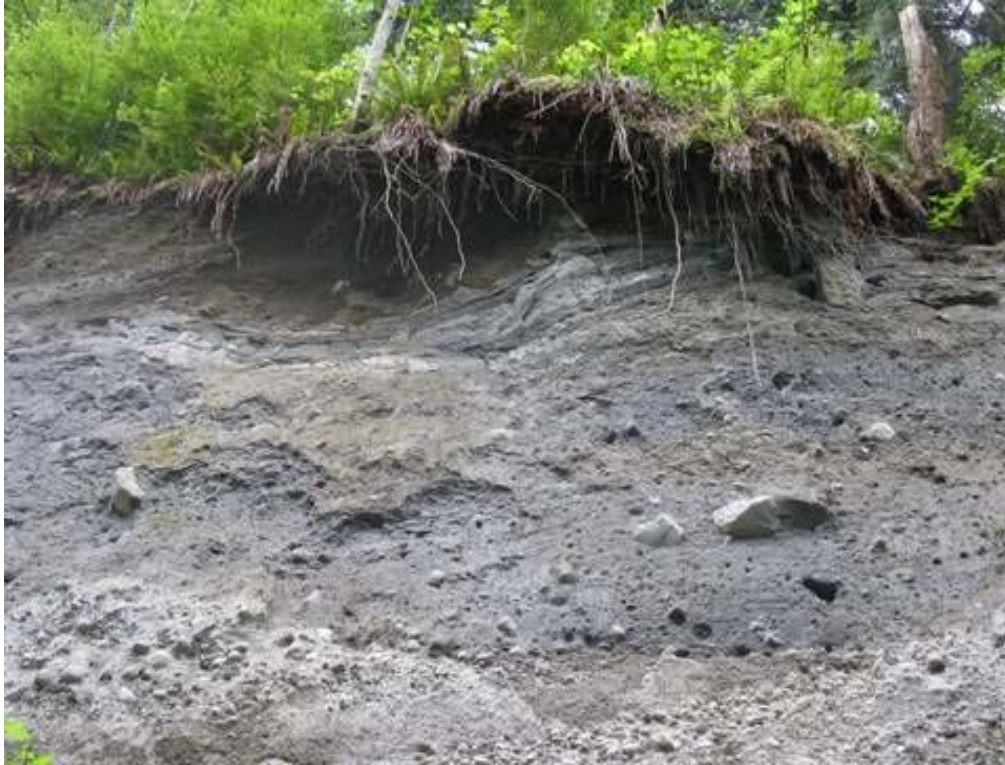
*Picture 10. Left-bank erosion upstream from large eroded bank.*

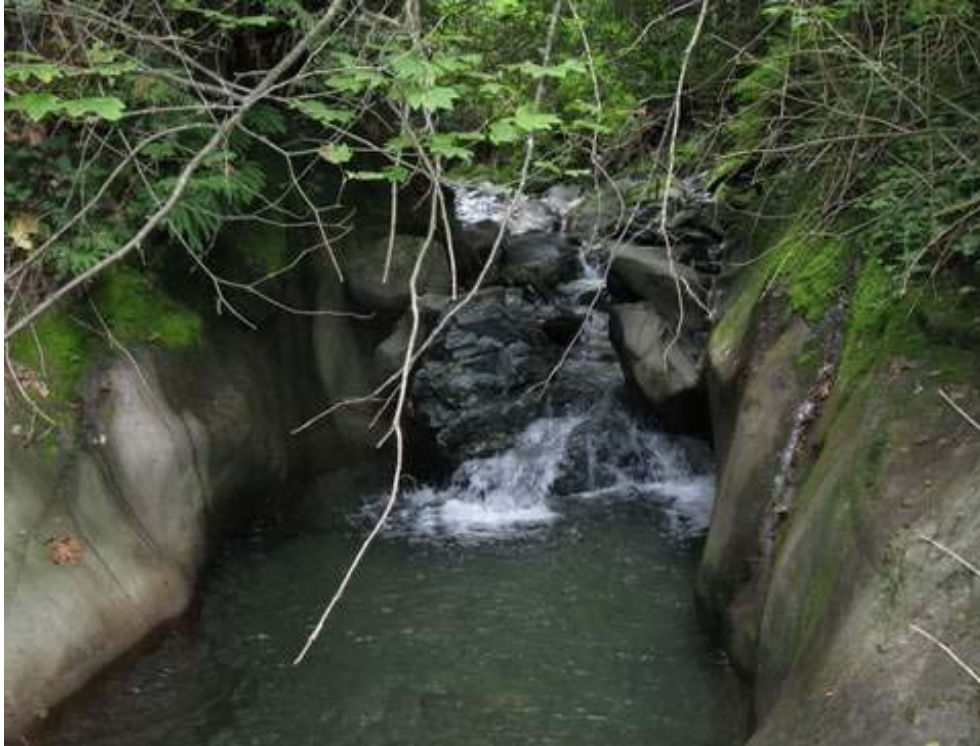
*Picture 19. Fish barrier at terminus of habitat survey. Narrow falls approximately 6 m tall. Falls and barrier may be formed by build-up of sediment associated with LWD logjam in narrows just upstream and at top of falls. Much LWD and largest logs in Coal Creek immediately downstream of falls. Largest logs show signs that they were human-felled rather than naturally fallen trees. Middle image shows build-up of sediment at immediate top of falls. Right image shows gravel sediment on right bank suggesting that sediment build-up was historically higher than current levels.*

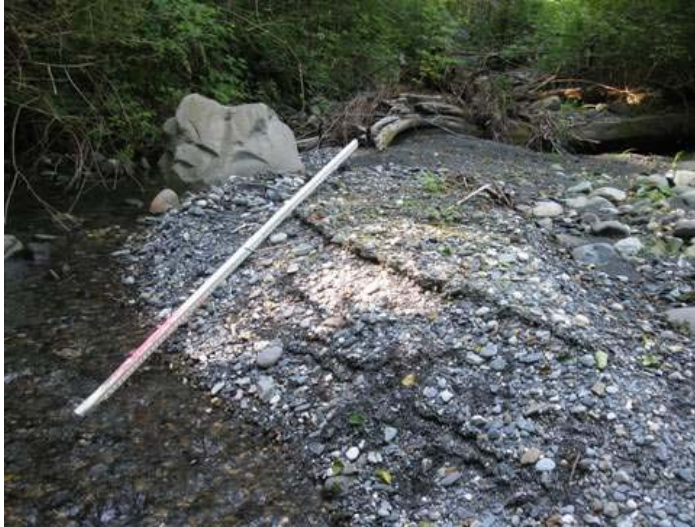
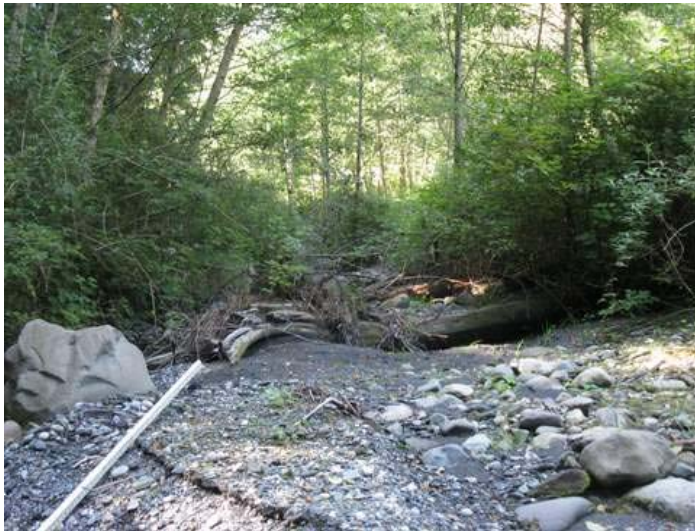
*Picture 20. Instream sediment pile (cobbles, gravels, sands) in center across to left-bank approximately 0.5 meters high at deepest point. Sediment pile is immediately upstream of Mr. Lindzy's home (visible from stream).*

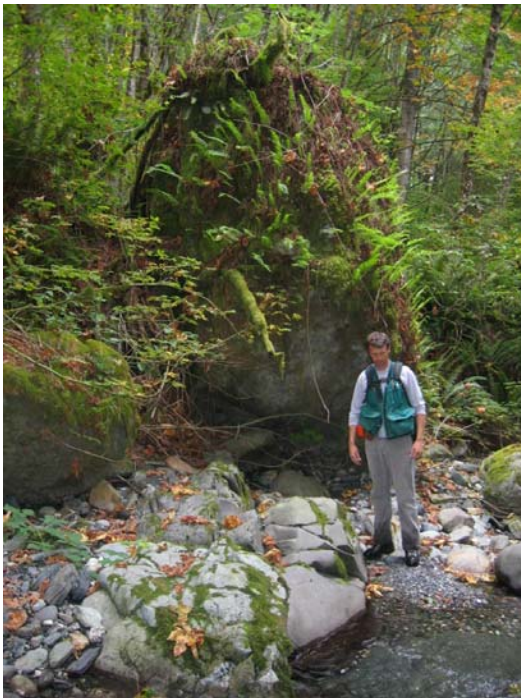
**Photo D2: A large sandstone boulder sitting on top of alluvium (inversely graded) demonstrates evidence of debris flows moving through the Chuckanut Formation canyon and entering the alluvial fan area (upstream of logging road bridge and SR 20).**

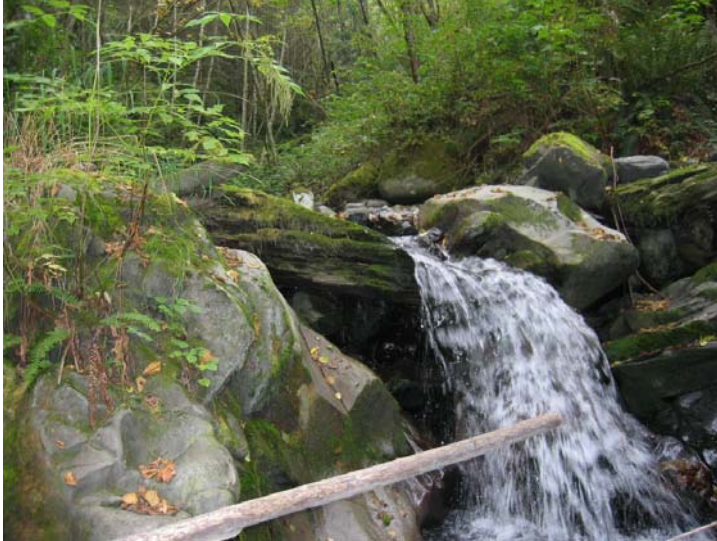
**Photo D3: Sediment wedge created by wood.**

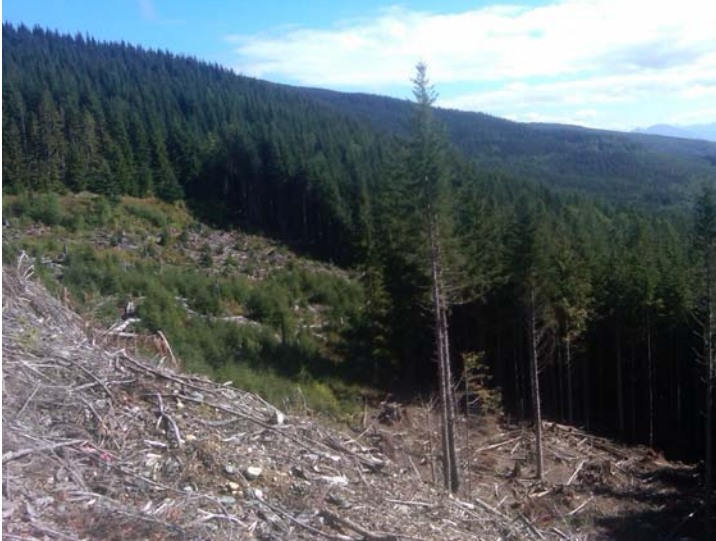
062 Photo D6	West Slide Complex (younger slide) – Head scarp and offset of continental glacial sediment and glacial morphology texture. Some bedrock exposed in scarp. A convex slope profile.
063 Photo D8	East Slide Complex (older slide) – Head scarp. Less defined offset of slide mass. Significant bedrock exposed in scarp. A zone of numerous perennial initiation points located at slope break below scarp. A concave slope profile.

**Photo D6:** West Slide complex head scarp

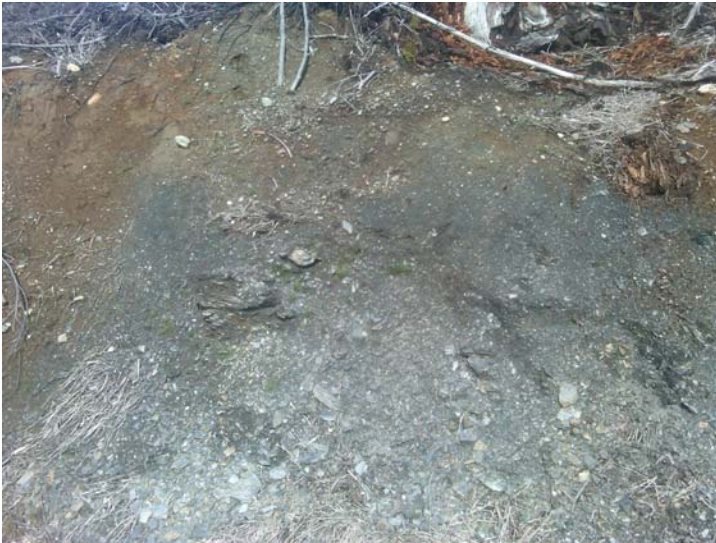
**Photo D7:** Darrington Phyllite geology – highly fractured and foliated metasedimentary rocks. Much of the stability issues within the Coal Creek watershed are related to the occurrence of this geologic unit.

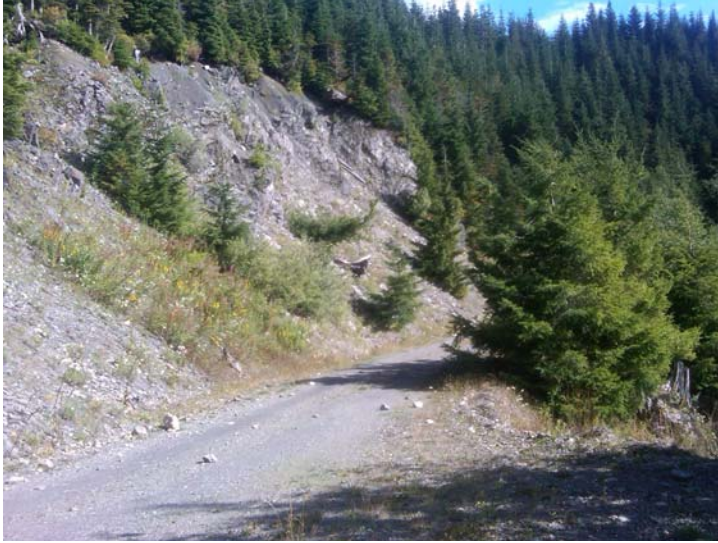
**Photo D8:** The headscarp of the East Slide complex

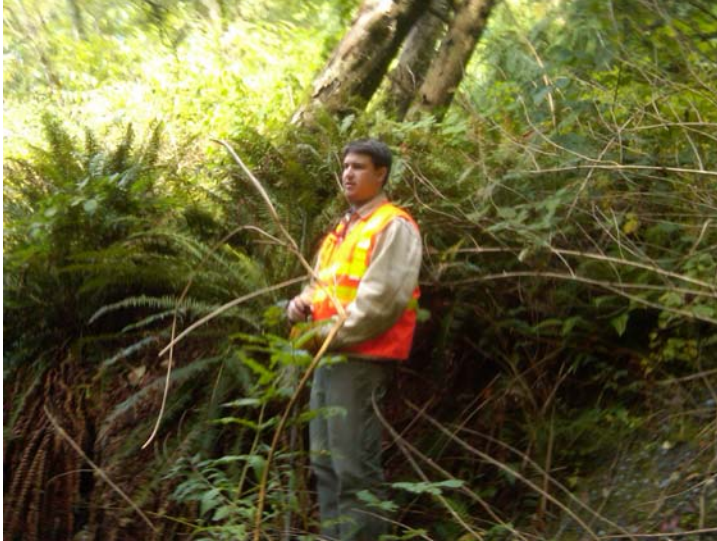
**Photo D10:** Evidence of slope stability within the Darrington Phyllite geologic unit is prolific and very recent.

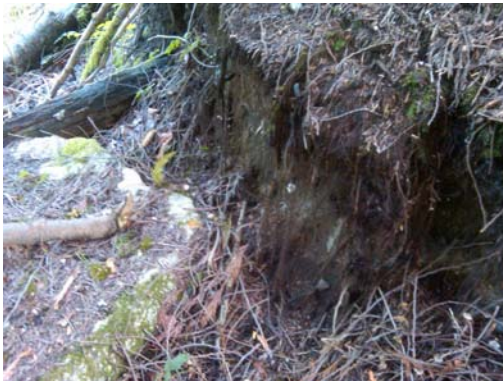
**Photo D11:** Evidence of recent slope instability

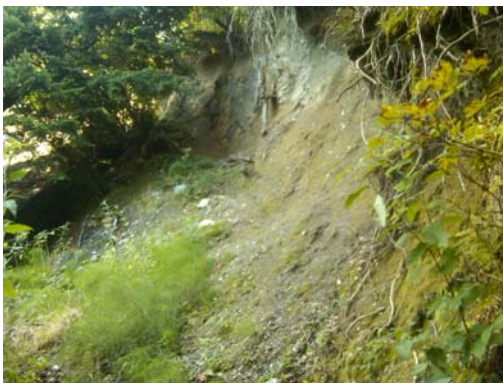
**Photo D12:** Evidence of recent slope instability

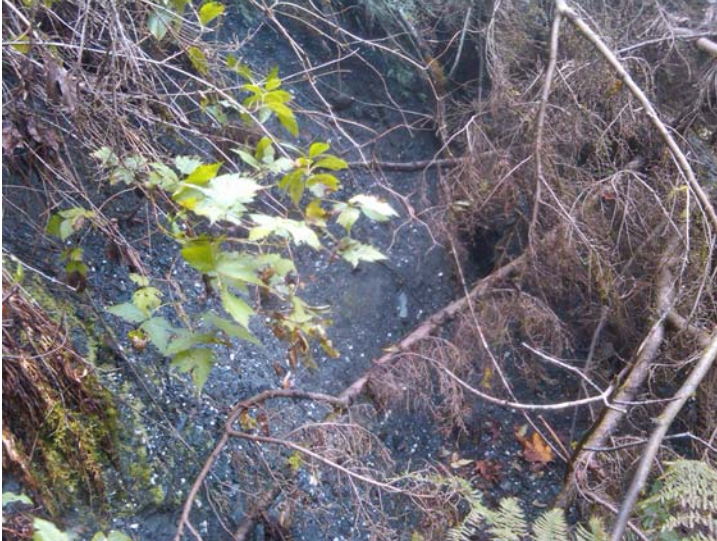
**Photo D13:** Virtually unlimited sediment supply results from mass wasting, channel incision, and lateral migration of Coal Creek through the unstable Darrington Phyllite geologic unit and Holocene landslide deposits.

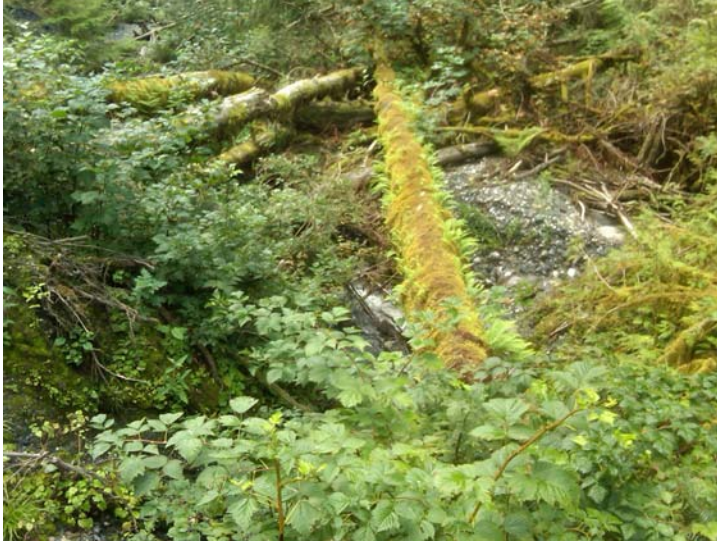
**Photo D15:** Virtually unlimited sediment storage within the channel.

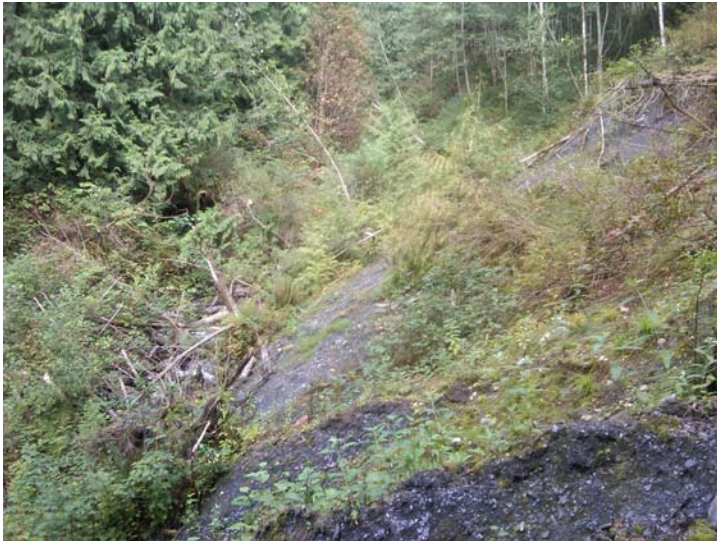
**Photo D16:** The potential for larger sediment releases via debris flows is high. Debris flow magnitude and frequency was not part of this project scope, but should be considered for land use decision.
