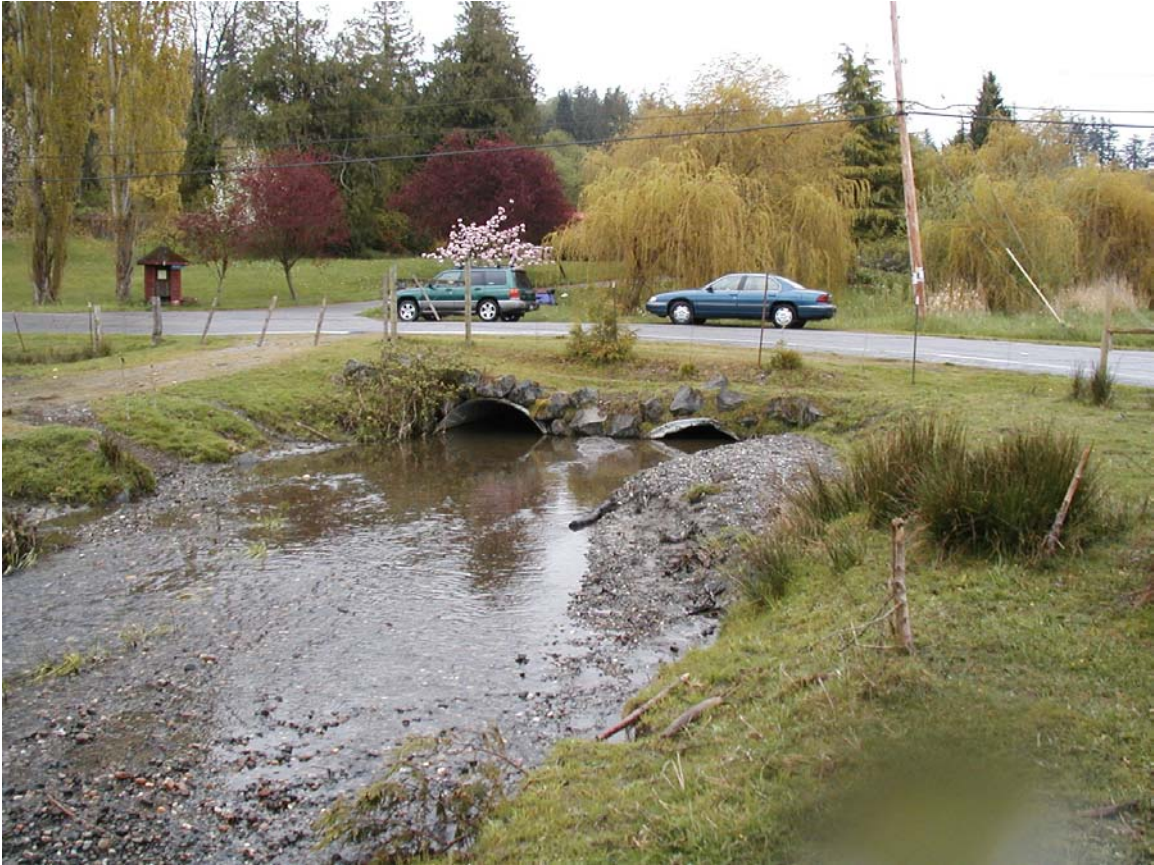
Photo 1. Viewing upstream (east) to the twin 7-ft diameter CMP culverts under Colony Mountain Road.

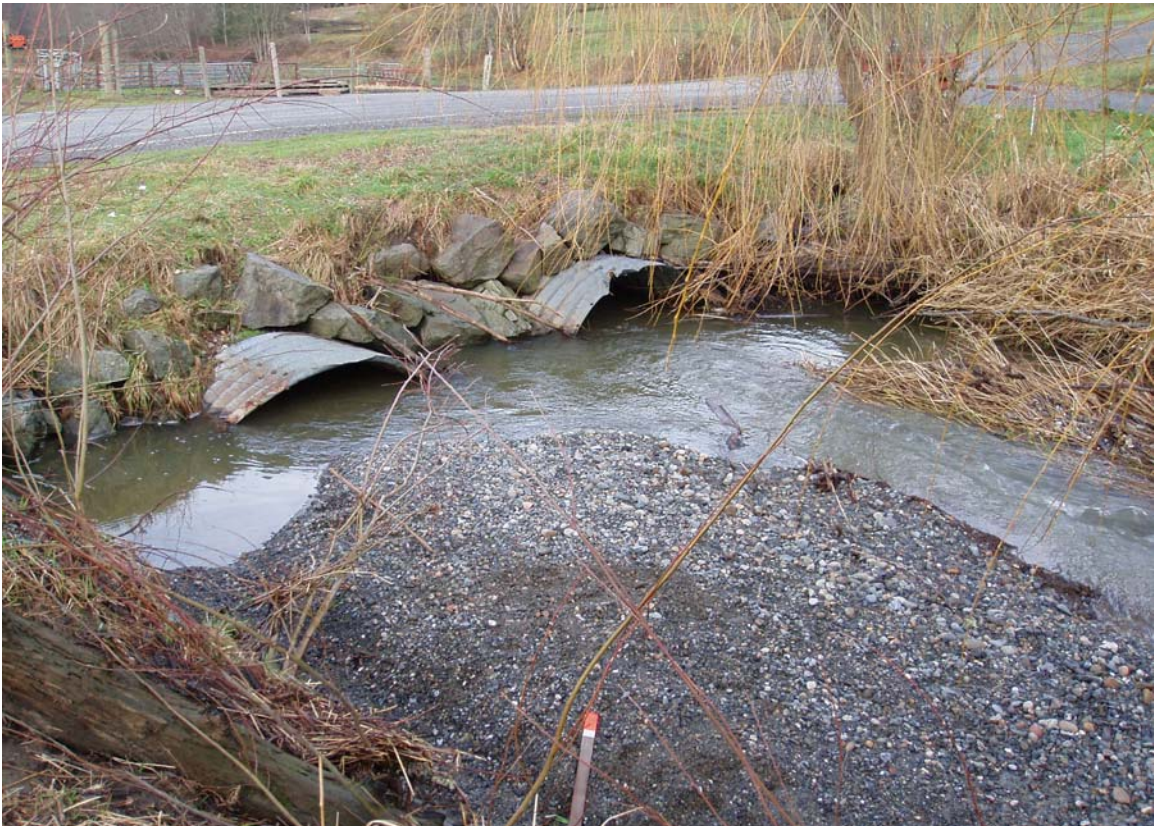
Photo 2. Viewing downstream to the entrance to the culverts under Colony Mountain Road.

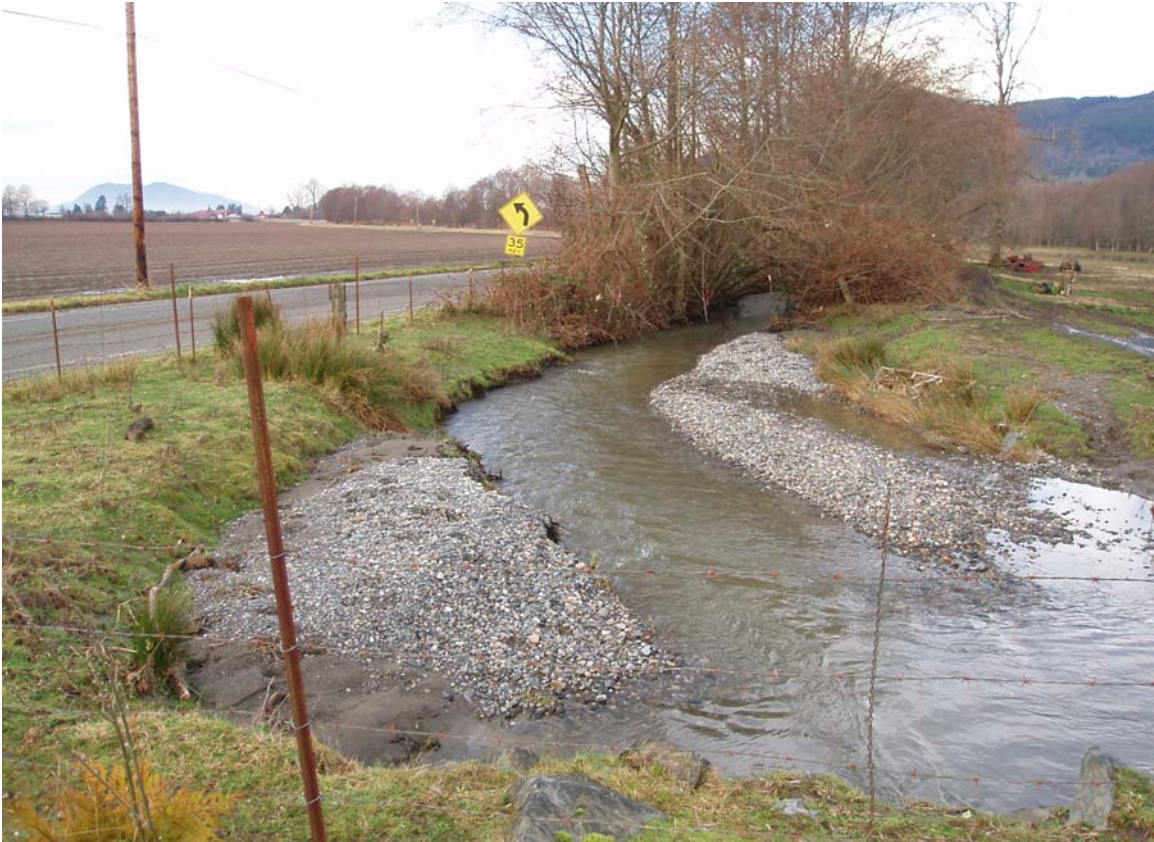
Photo 3. Viewing downstream from the crossing at Colony Mountain Road.

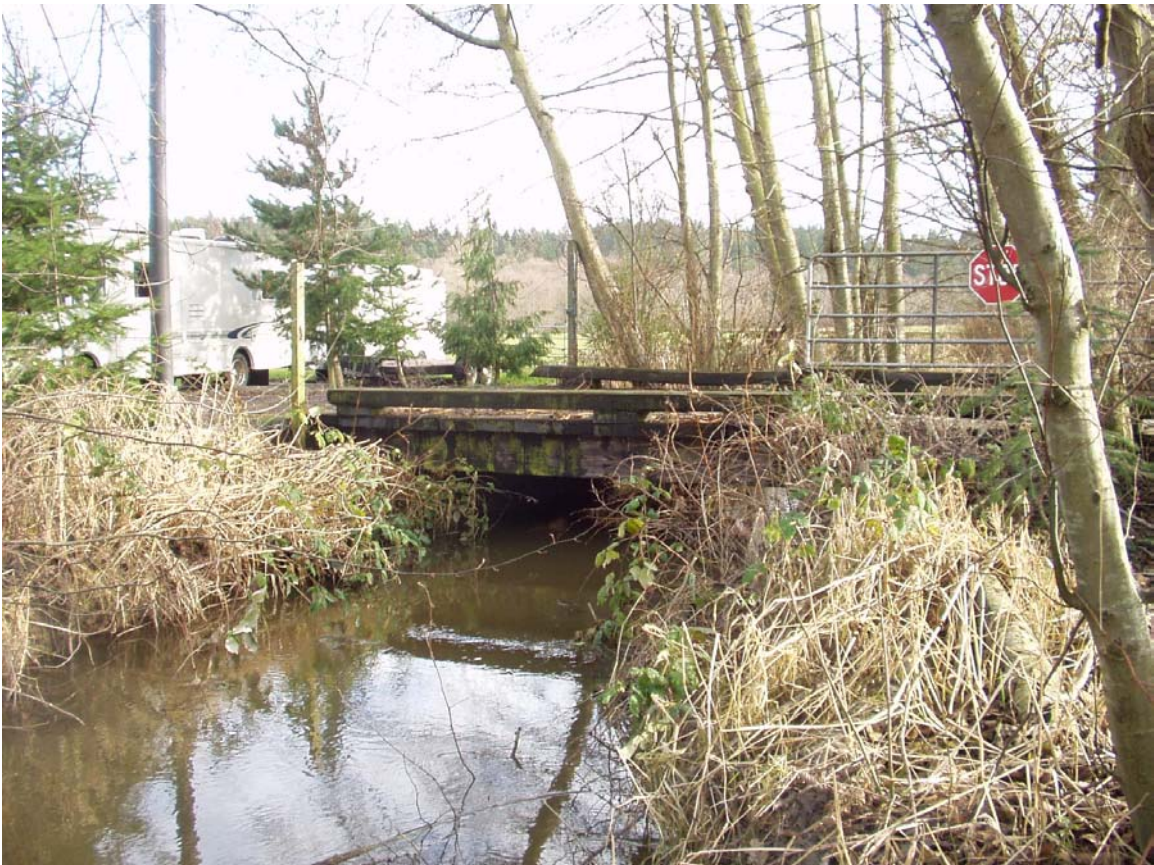
Photo 4. Viewing east to the upstream driveway bridge near the downstream end of the project reach. Water is nearly stagnant and bed material here is mucky silt.

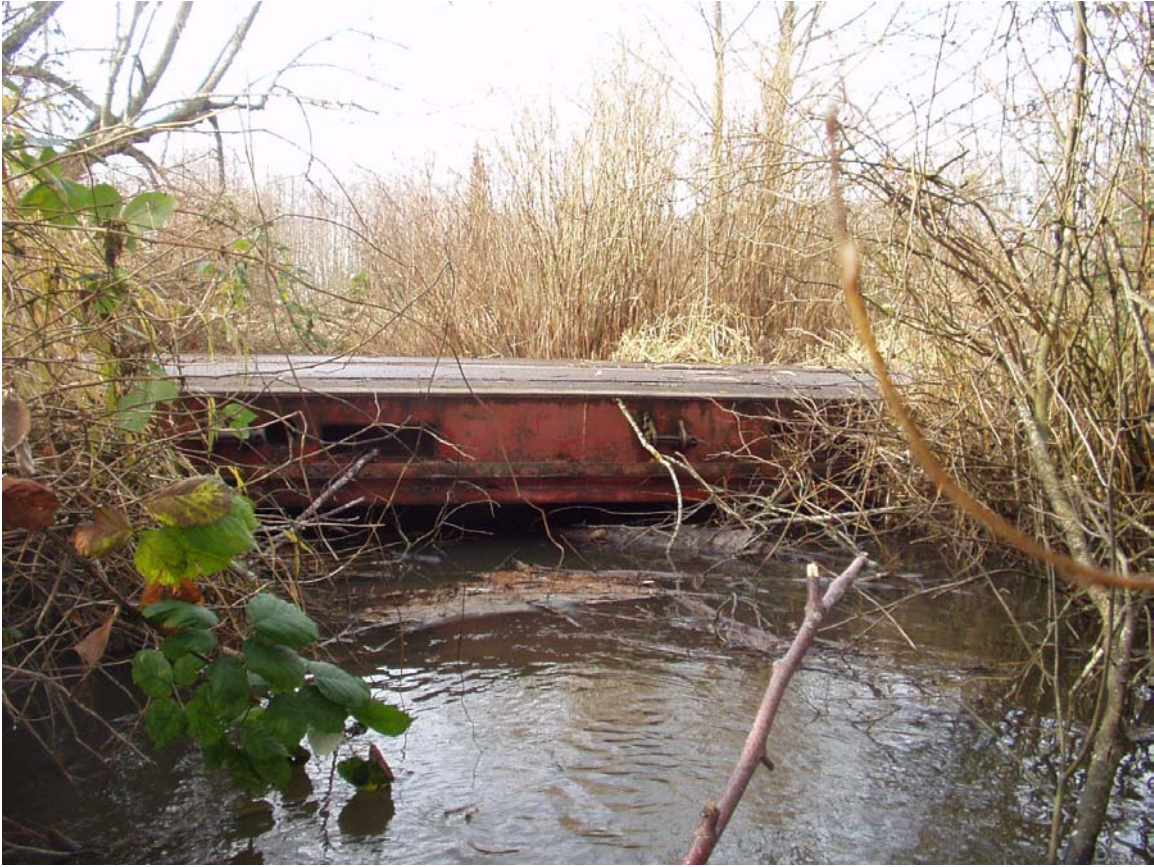
Photo 5. Viewing west to the downstream driveway bridge near the downstream end of the project reach. Water is nearly stagnant and bed material here is mucky silt.

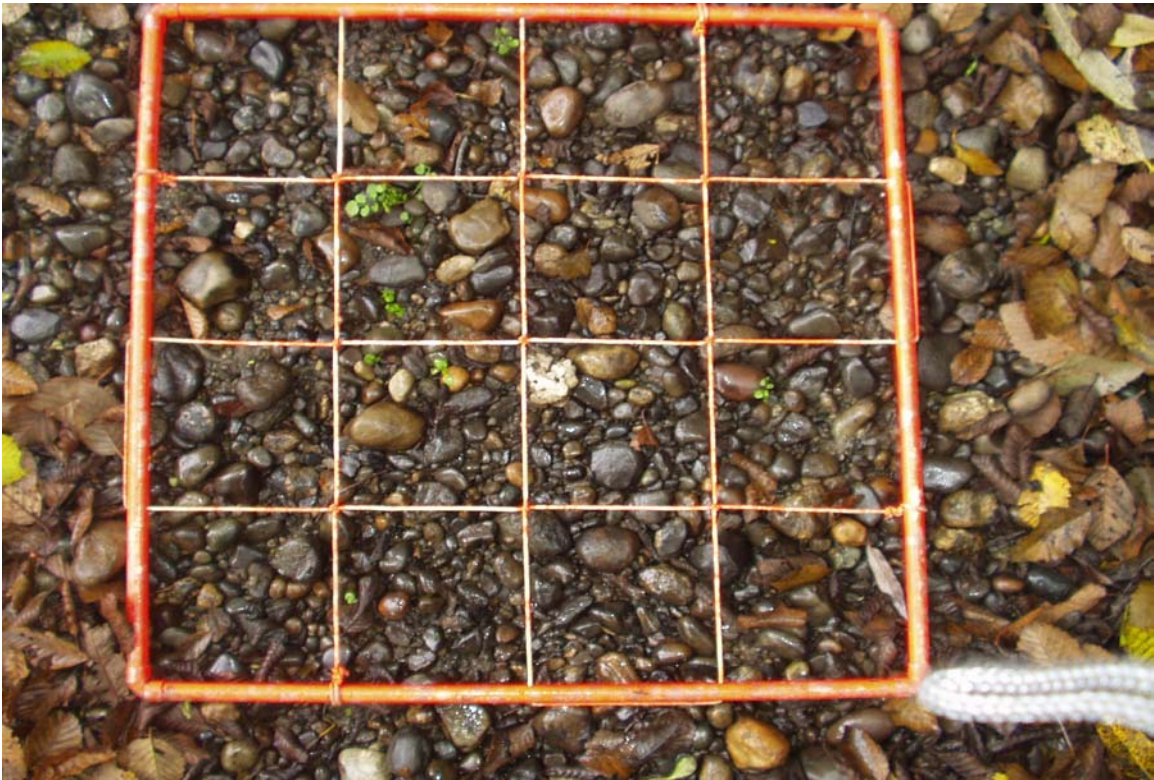
Photo 6. Typical gravel material found on the stream bed within the first 1000-ft downstream from Colony Mountain Road.

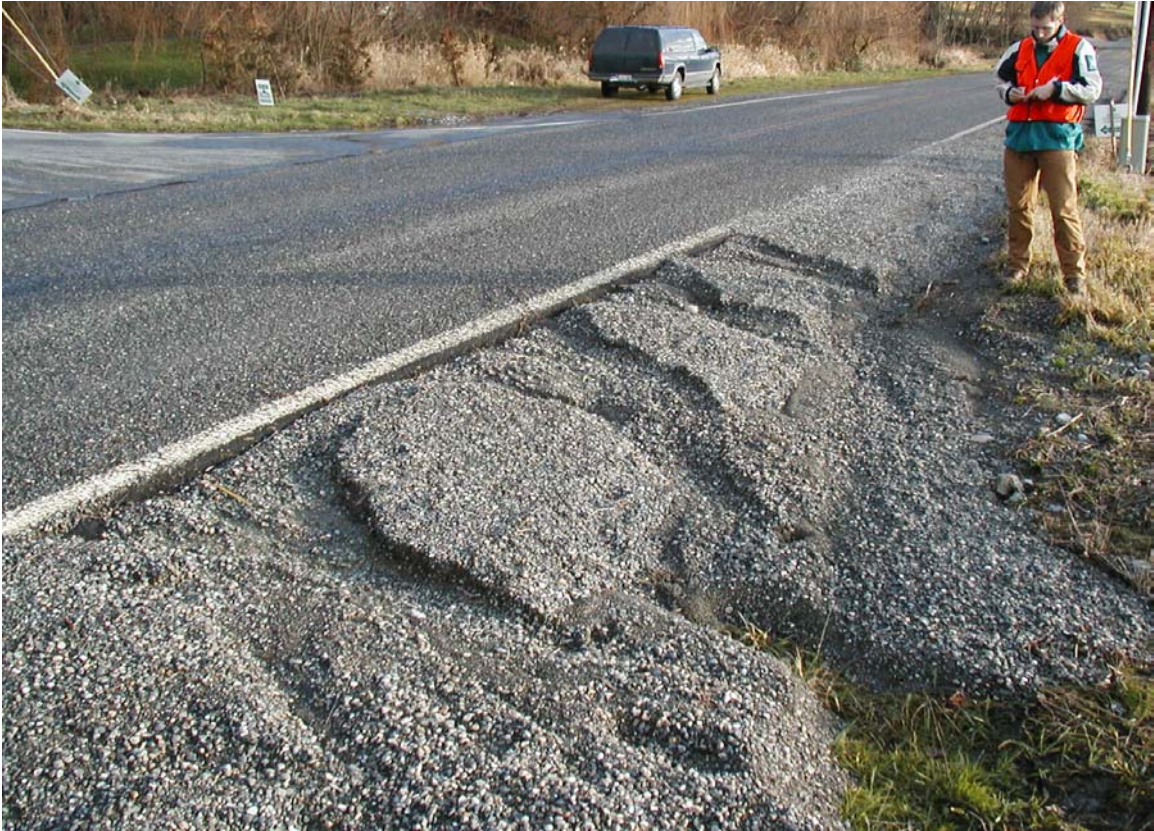
Photo 7. Erosion scars along the south edge of Colony Road at Colony Mountain Road. Scars were caused by water ponding upstream of the culverts and overtopping the road during the January 3, 2007 flood.

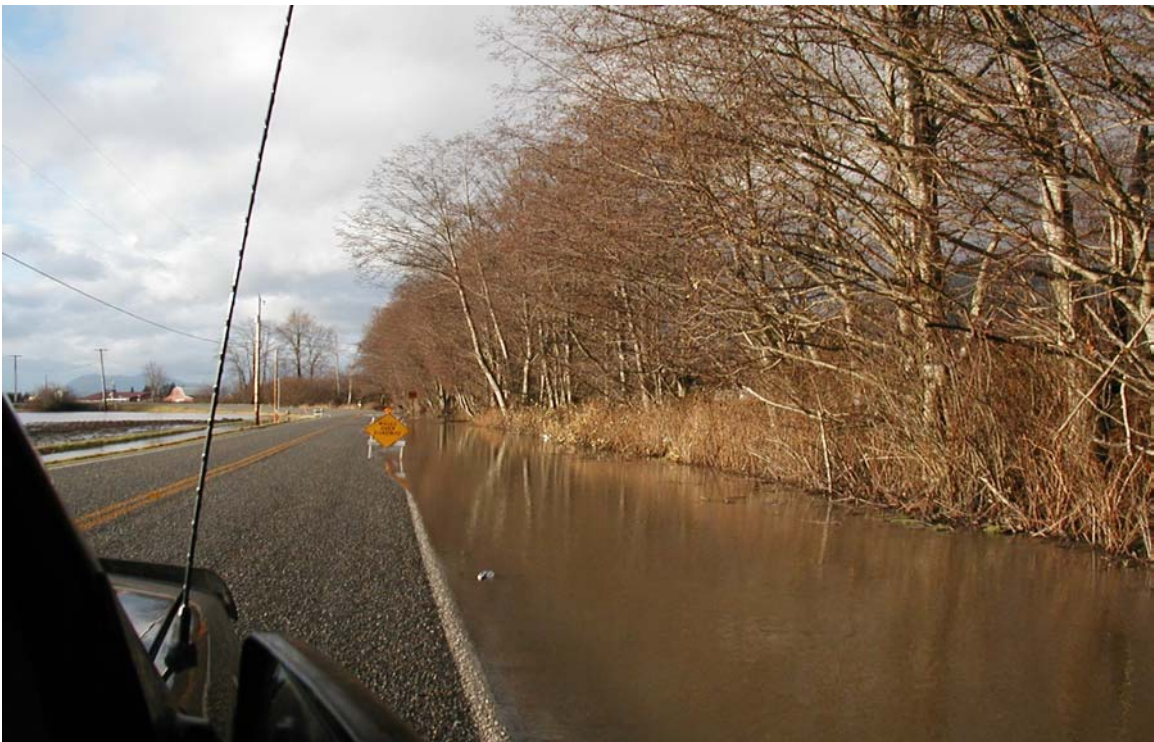
Photo 8. Receding limb of the January 3, 2007 flood. Viewing west along Colony Road near the middle of the project reach. Colony Creek is located within the trees.

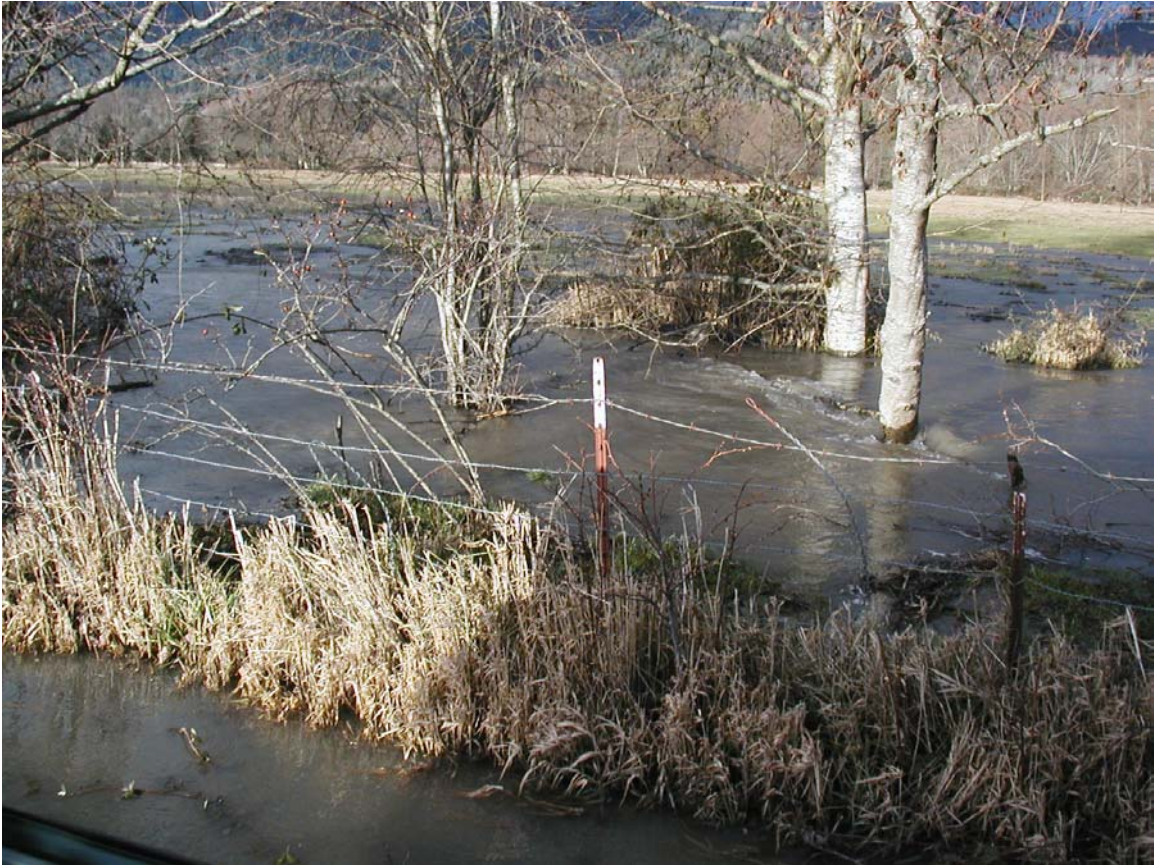
Photo 9. Receding limb of the January 3, 2007 flood. Viewing north across Colony Creek near the middle of the project reach.

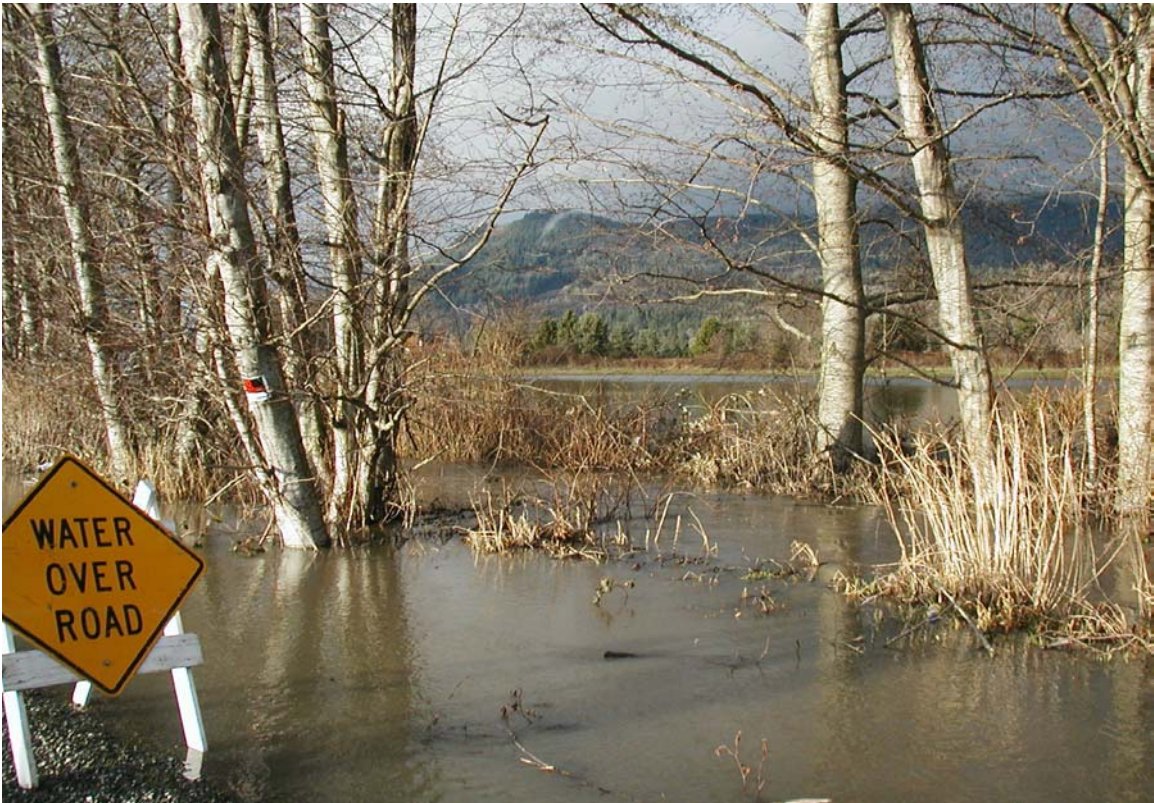
Photo 10. Receding limb of the January 3, 2007 flood. Viewing north across Colony Creek. Photo was taken slightly further downstream than Photo 9.

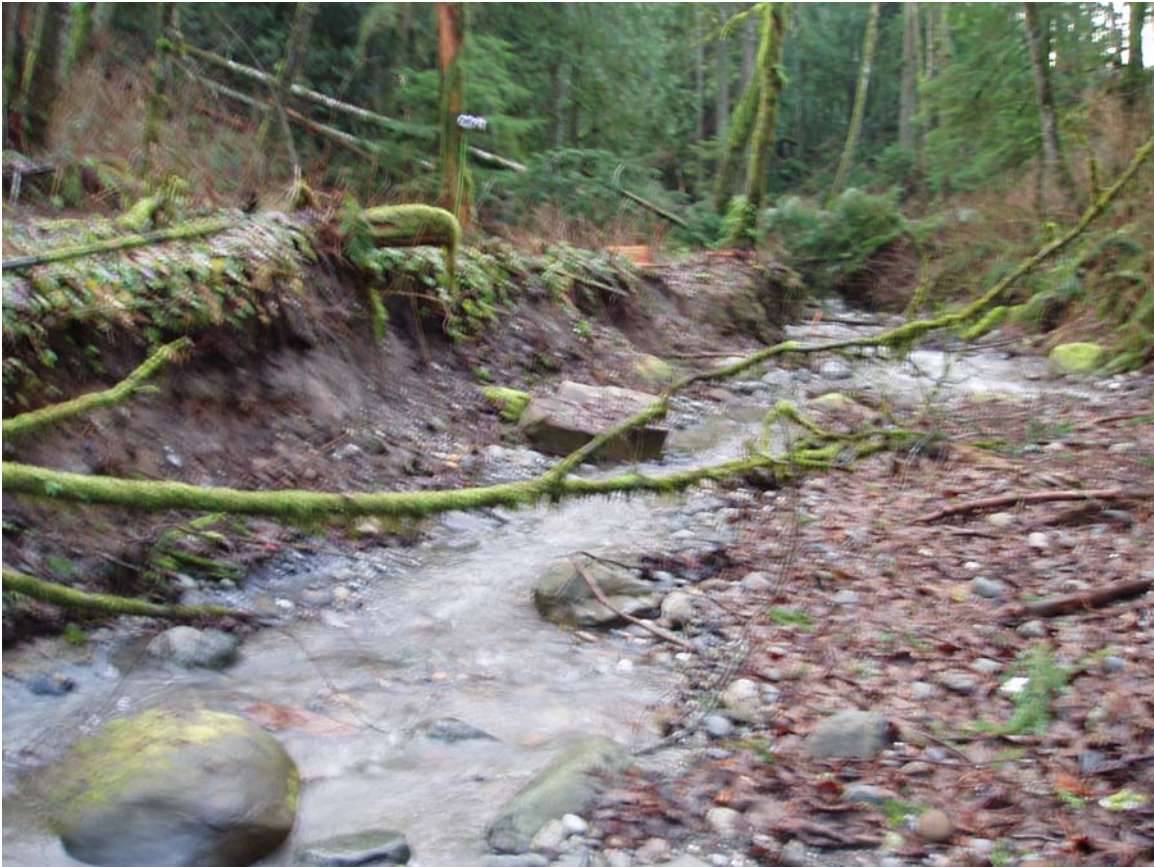
Photo 11. Typical channel section downstream from Wood Road. Note the exposed banks. Bed material is a relatively thin layer of gravel and cobbles over clay.

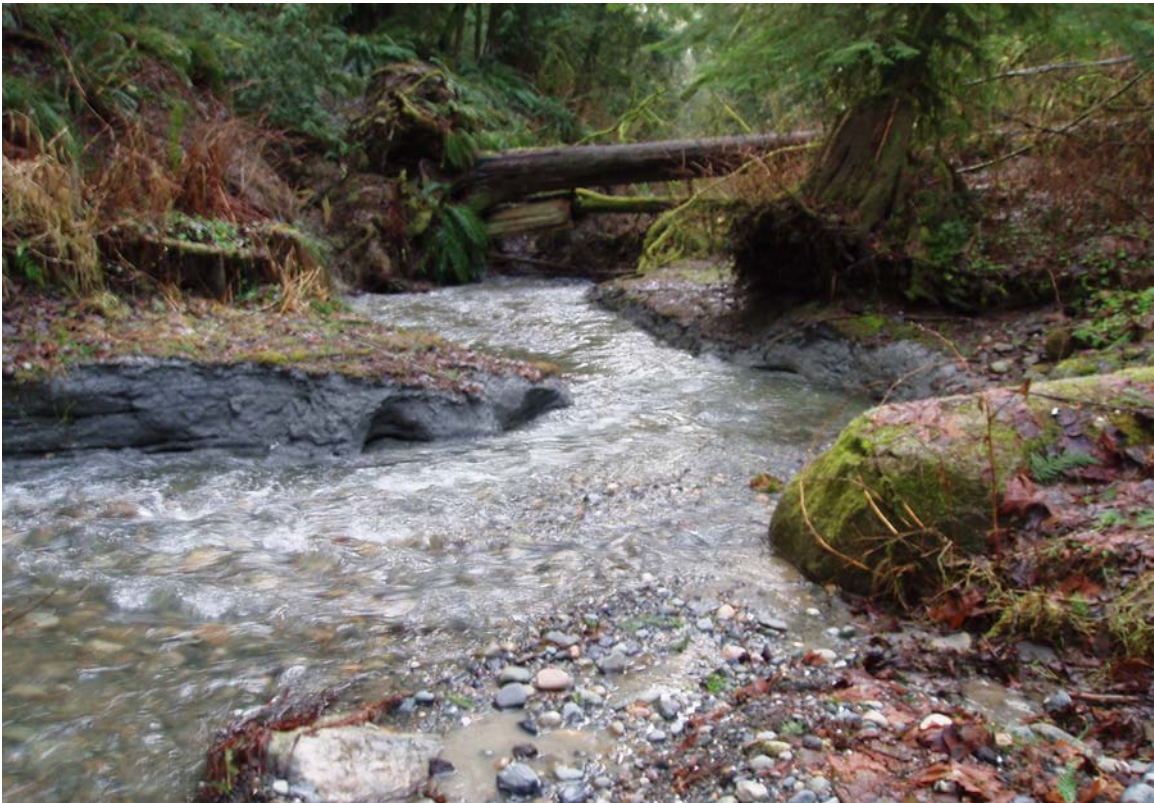
Photo 12. Typical channel section downstream from Wood Road. Note the exposed dark gray clay.

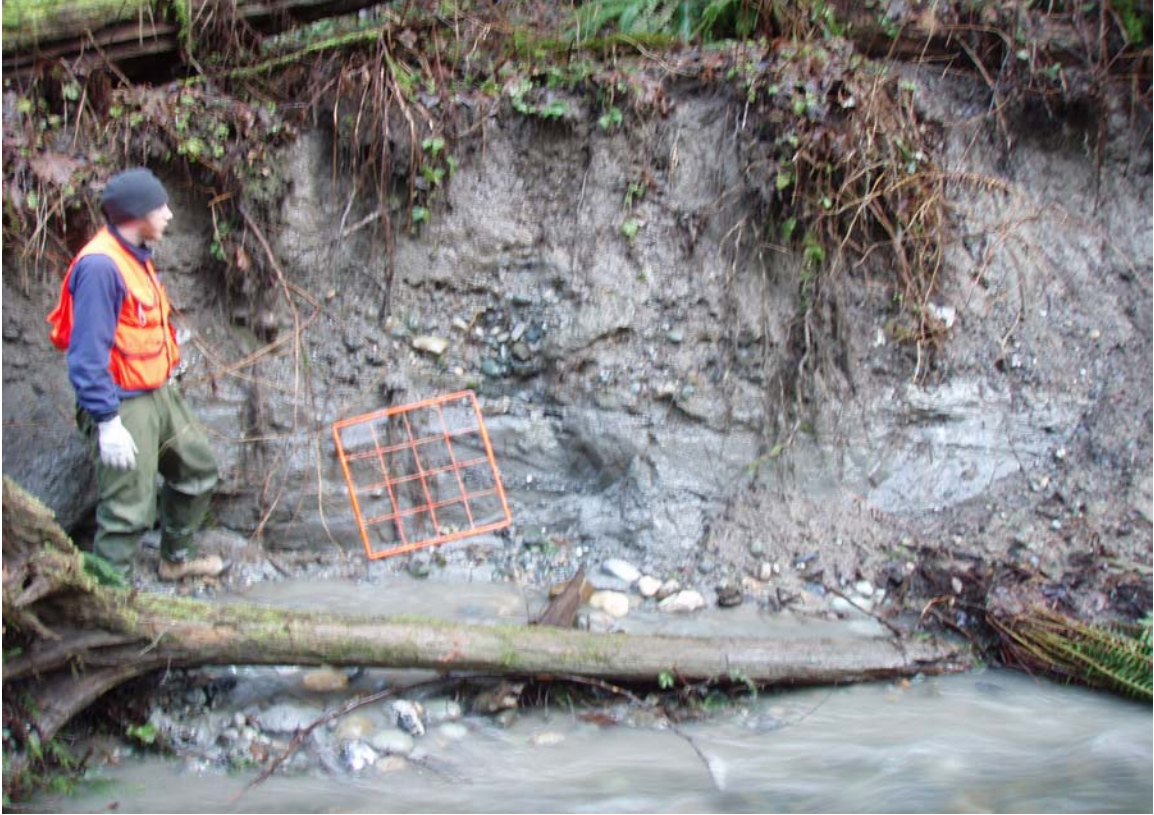
Photo 13. Typical exposed bank. Material is mainly silty clay with lenses of gravel and scattered cobbles.

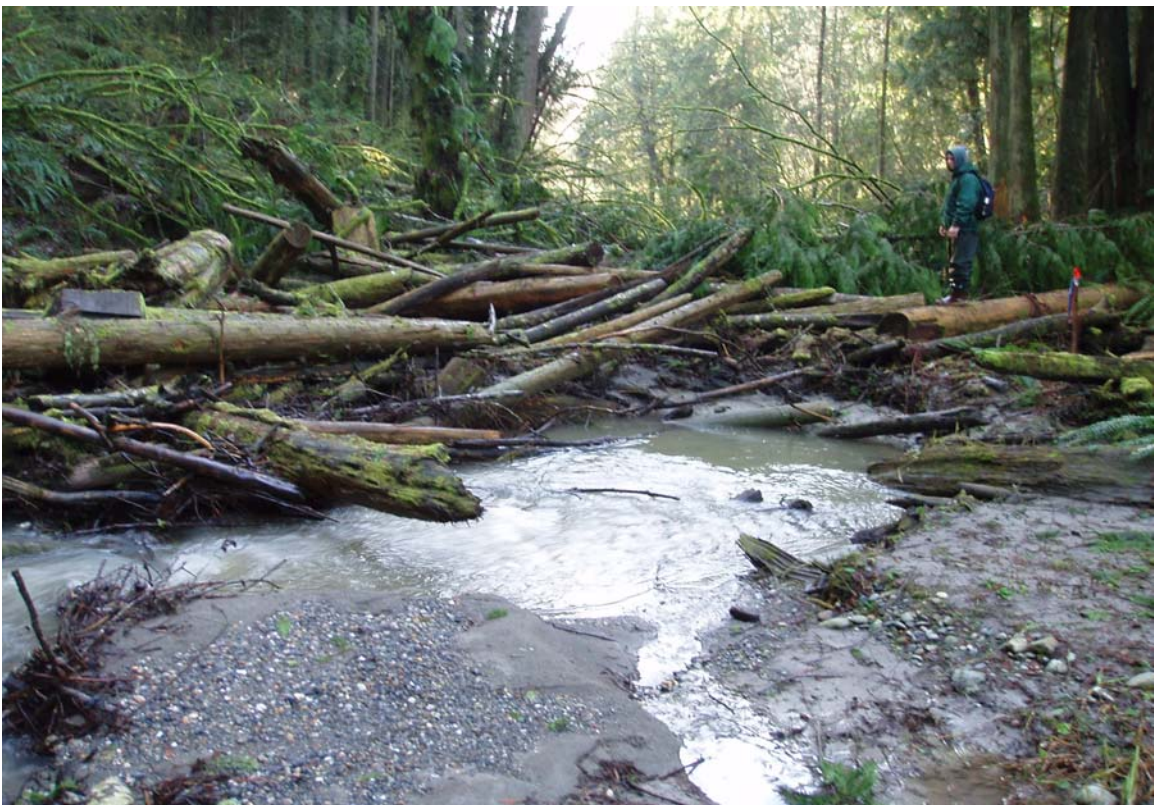
Photo 14. Large woody debris (LWD) jam formed mainly by the beaver dam outburst floods.

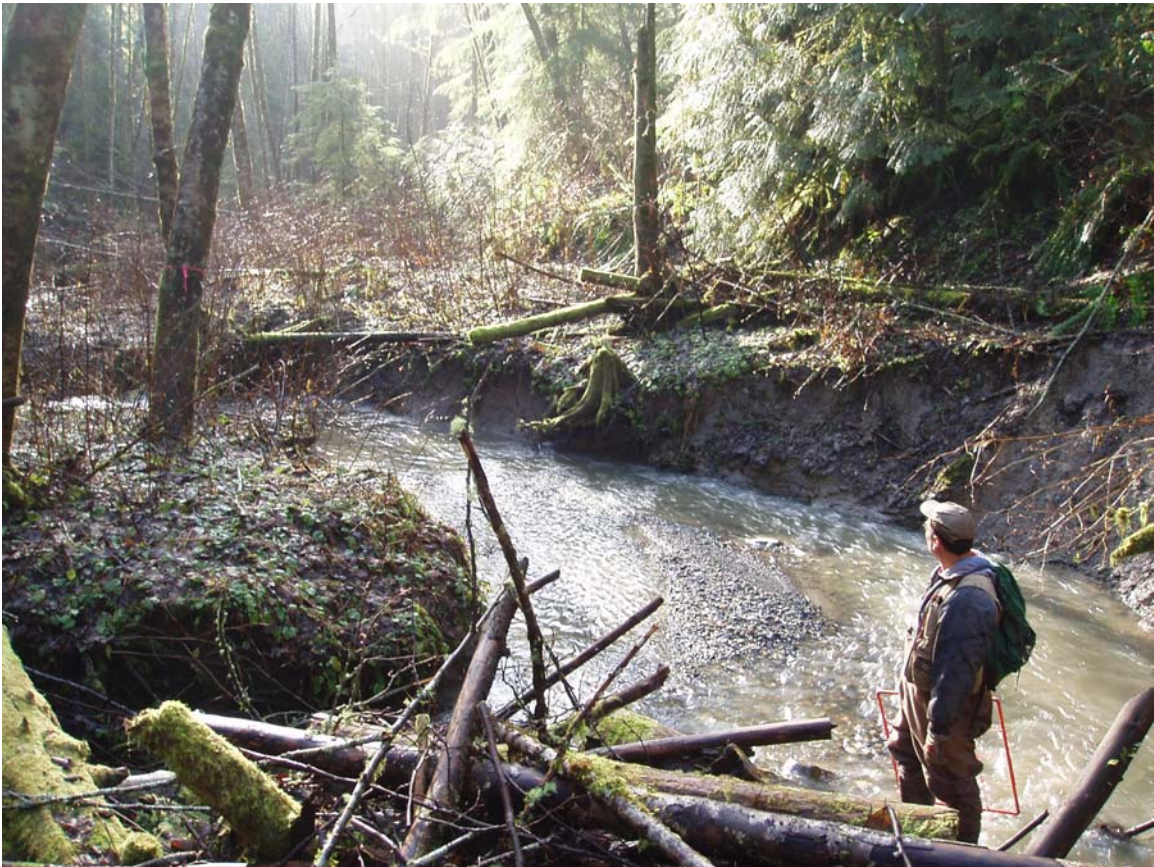
Photo 15. Typical channel. Note the exposed banks and the LWD that sits atop the historical terraces. The LWD was carried there by the beaver dam outburst floods.

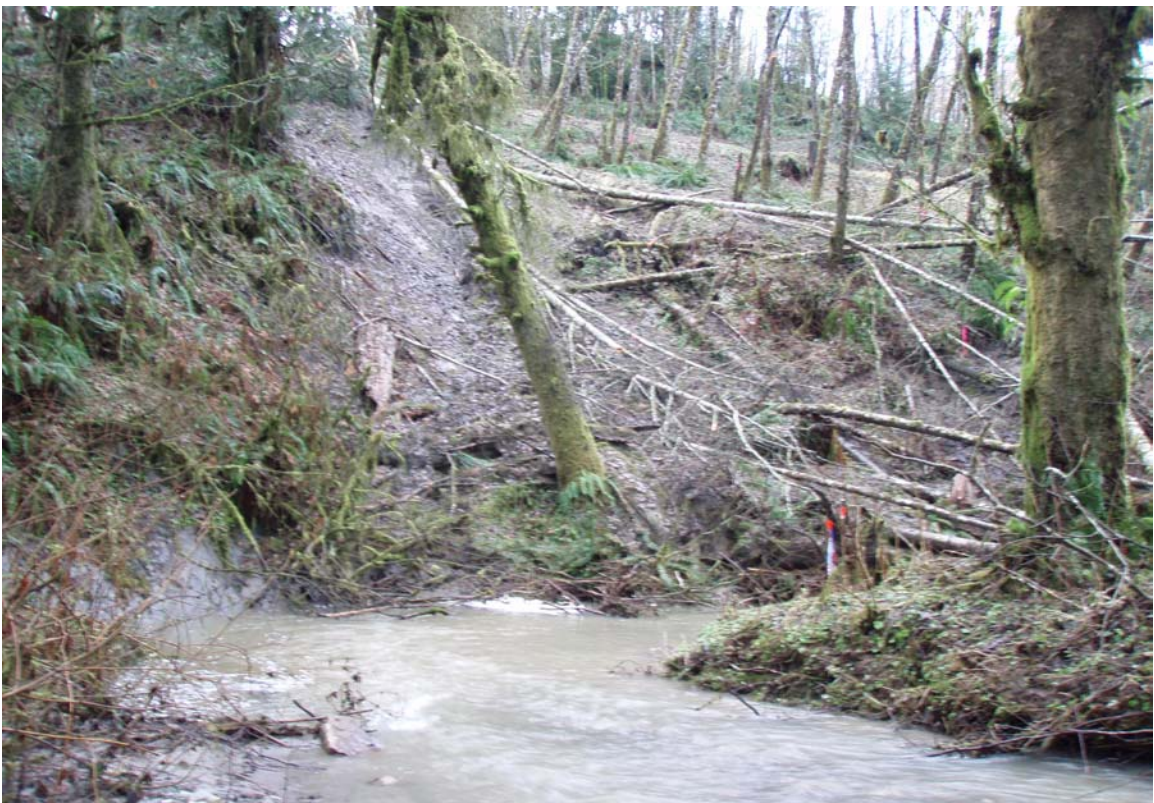
Photo 16. Example of a high bank slide that is contributing sediment to the stream.

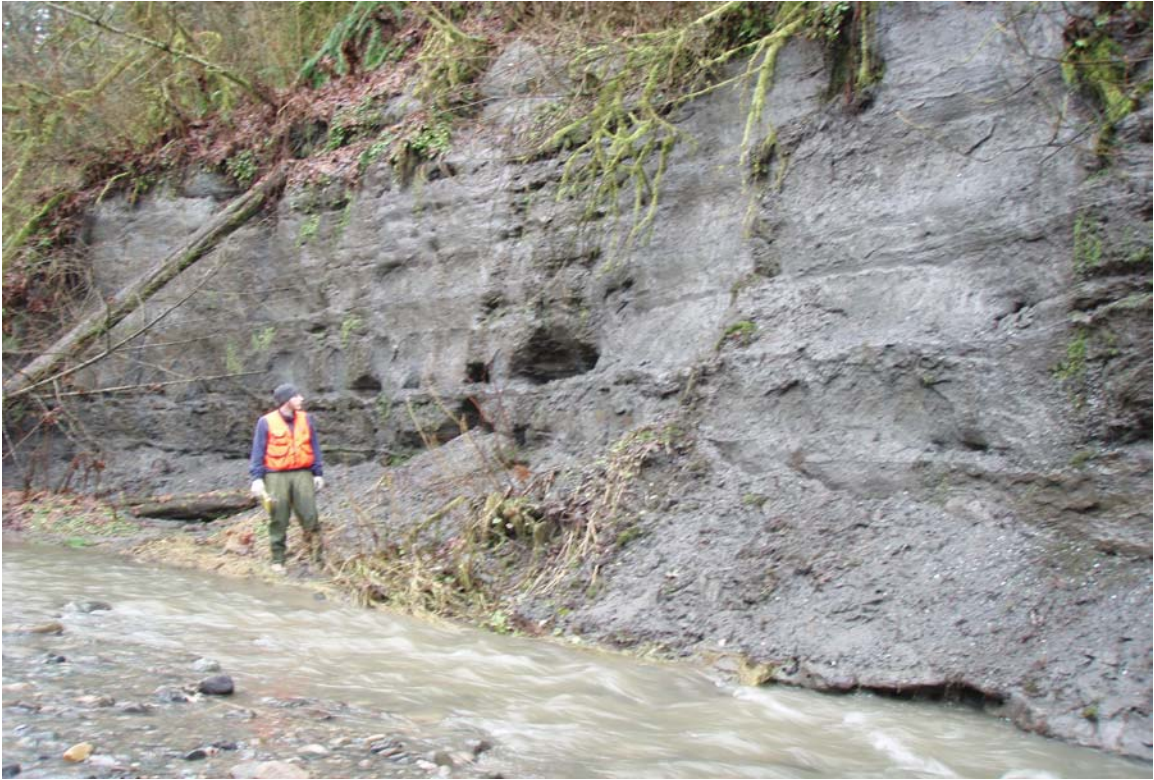
Photo 17. Exposed bank that is contributing mainly sand and silt to the stream.

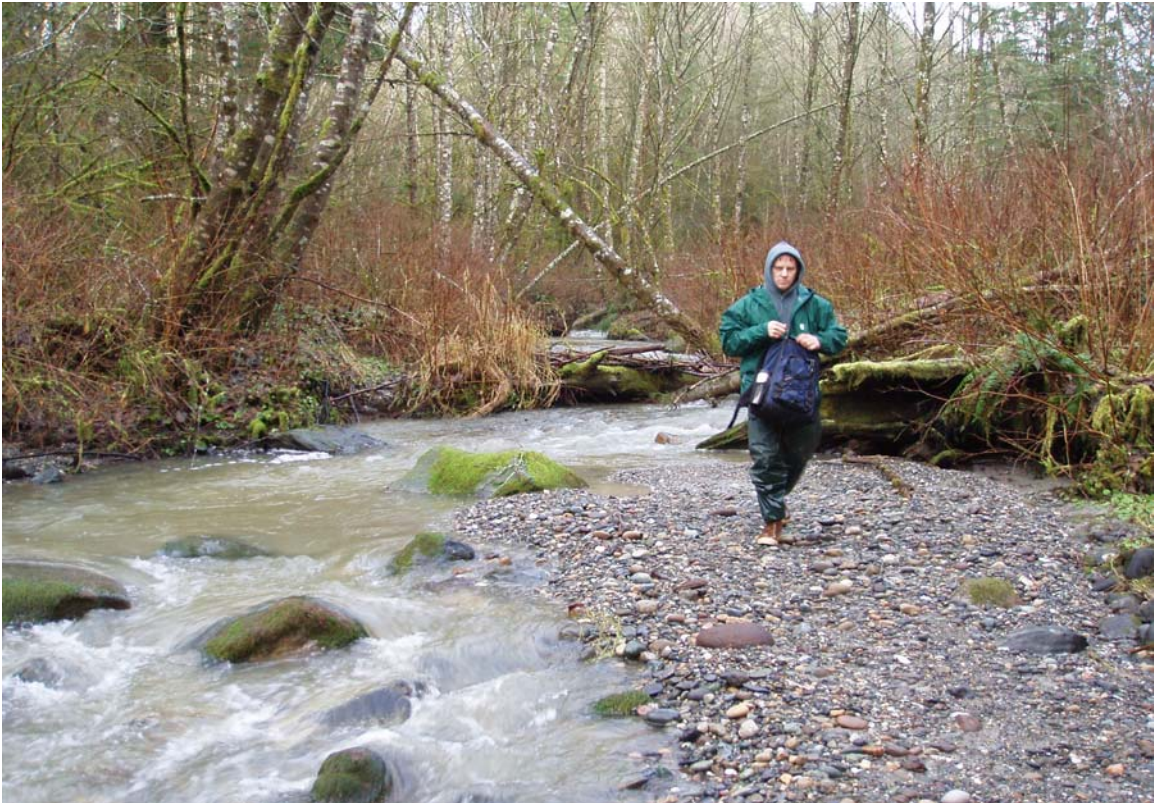
Photo 18. Typical channel section upstream from the project reach near where the stream emerges from the hills.
