Skagit County 1923 Courthouse Windows

Window Material Condition, Surface Preparation, and Paint Requirements

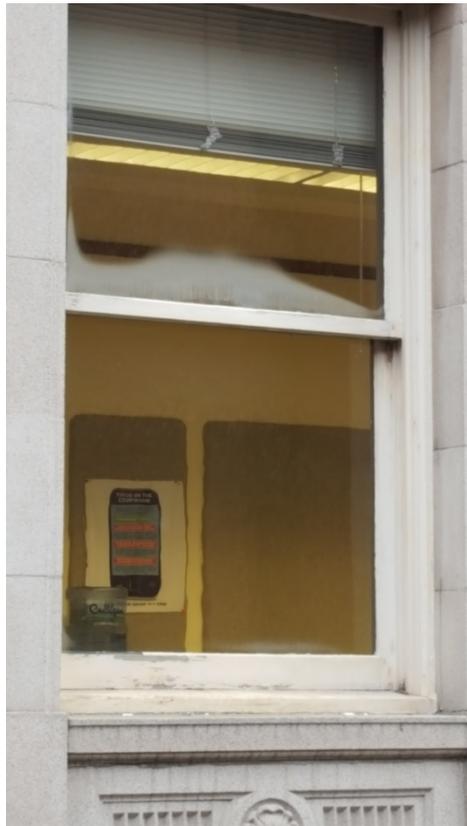
Original Wood Double Hung

- Degraded glazing on several windows
- Wood and paint in decent condition
- Lead tests indicate 11-14%

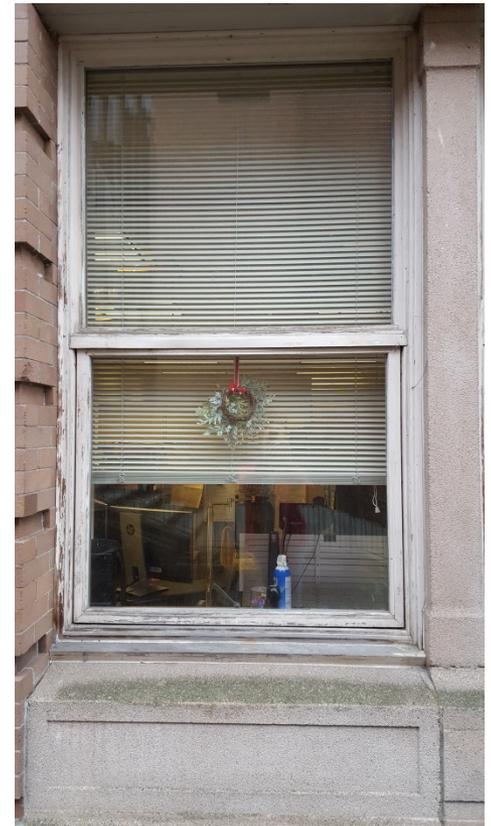
Replacement Wood Window

- Wood glazing beads used in lieu of clay glazing
- Paint condition is often poor and has exposed wood
- Installation dates unknown, most likely about 2000
- Lead tests show no lead in this paint

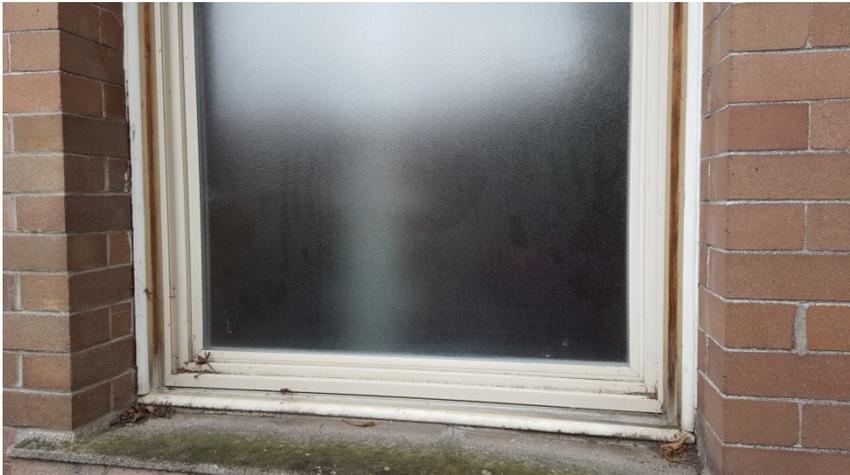
Vinyl Double Hung Window

- Multiple window styles and manufacturers
- Unknown installation dates or use of original frame
- Some require no painting, while others have wood in perimeter framing that requires surface preparation for paint to match window color
- Caulking may be required between brick and window perimeter
