Native Growth Protection Easement Agreement
The Reserve at Channel Landing

Title: Guemes Channel Trail Bigleaf Maple Tree Assessment, Revised 6-10-14
Anacortes, Washington

Date: June 10, 2014

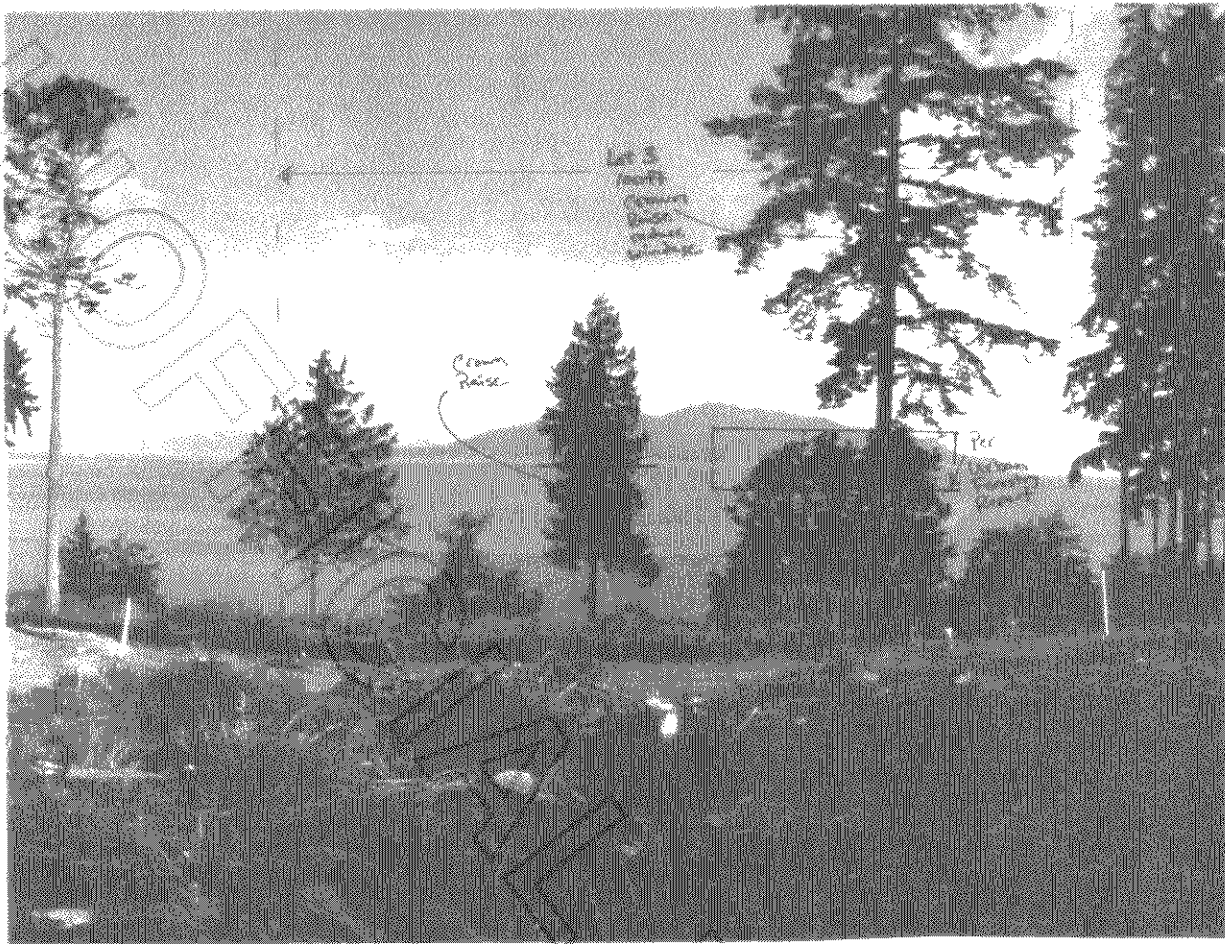
Lot 3
4216 Navigator Lane Anacortes, WA 98221
Picture Taken on 6/9/2014
Picture Taken 10' in the Air
Mid Point on Lot at Top of Bank

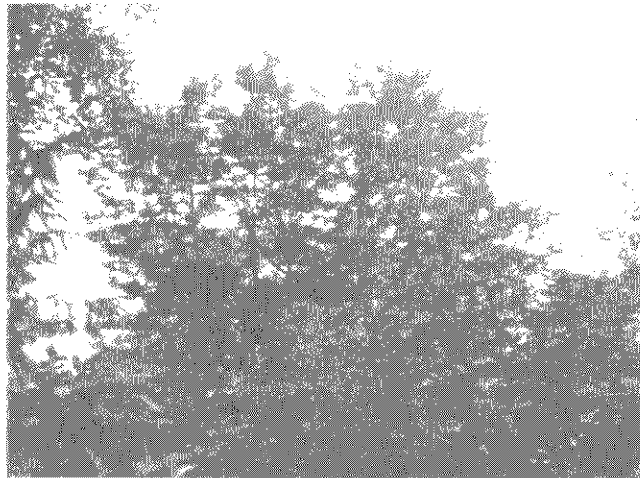
I was asked to determine if this tree could be cut to provide a view. Currently the upper level of this tree's crown obscures a clear view over Guemes Channel towards Cypress Island and the Bellingham Channel.

Photo 1: The upper canopy obscures the view from the Channel Landing development over Guemes Channel and north to the islands.

Prune to reduce the height of the upper canopy so that it matches the height of the lower canopy. This pruning should use techniques for habitat pruning to mimic the condition at the previous failures observed in the crown and trunk. This tree has repeatedly recovered from multiple past failures, and it is my expectation that recovery will also occur after pruning to reduce the upper canopy. This work will not be noticeable from the trail.

1. Perform canopy reduction in the upper crown to match the height of the lower canopy. See the enclosed "Channel Landing - Canopy Reduction Illustration". The use of a "coronet" cut is recommended for reducing the main leaders. A "natural fracture" pruning cut is recommended for reducing branches within the remaining upper canopy. Both types of pruning cuts mimic the branch conditions after naturally occurring failures, as observed in this tree.

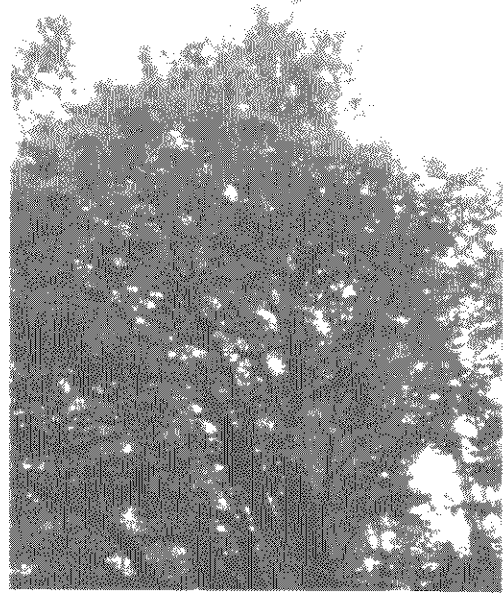
This bigleaf maple is comprised of six trunks measuring 16 to 24 inches in diameter at 4.5 feet above grade. The canopy extends more than 50 feet to the north, across the trail and shoreline bulkhead. This canopy has two main parts, with two vertical trunks supporting the portion of the crown obscuring the view, and four trunks supporting the lower canopy that arches over the trail.

Photo 2: The upright / vertical trunks form the upper canopy which obscures the view.

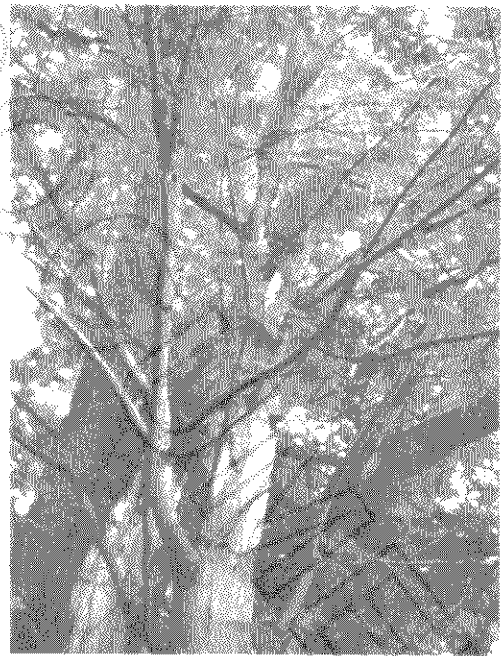
- Past trunk failures, with new growth at or below the failure points (See photo 3).
- Significant branch failure, with several large tear-out injuries on the trunks (See photo 3).
- Trunk cavities which appear to contain decay.
- A basal trunk cavity caused by the failure of a codominant trunk.
- The crown contains larger diameter dead branches which overhang the trail.

The risk of failure in this tree is moderate for dead branches, and sections of trunk containing decay. The recommended pruning will reduce the risk of failure in this tree.

Photo 3: Multiple defects from previous failures were observed in this tree. The tree has recovered from these failures.

2. Perform crown cleaning to prune out or significantly shorten dead branches over 2-inches in diameter to reduce the risk of failure onto the trail below the tree.

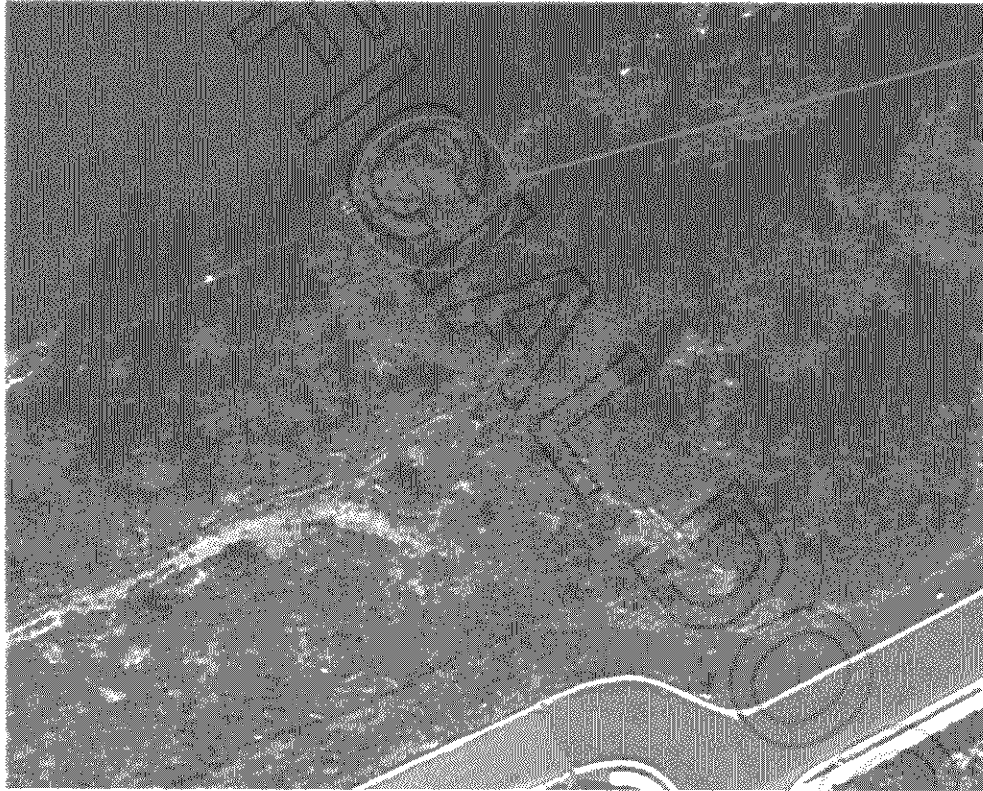
Title: Site Plan
Channel Landing LLC - Guemes Trail Bigleaf
Maple Tree Assessment

Location of the bigleaf maple, *Acer macrophyllum*. Multiple trunks 16 to 24-inches diameter.
