Glosten

**INNOVATIVE
MARINE
SOLUTIONS**

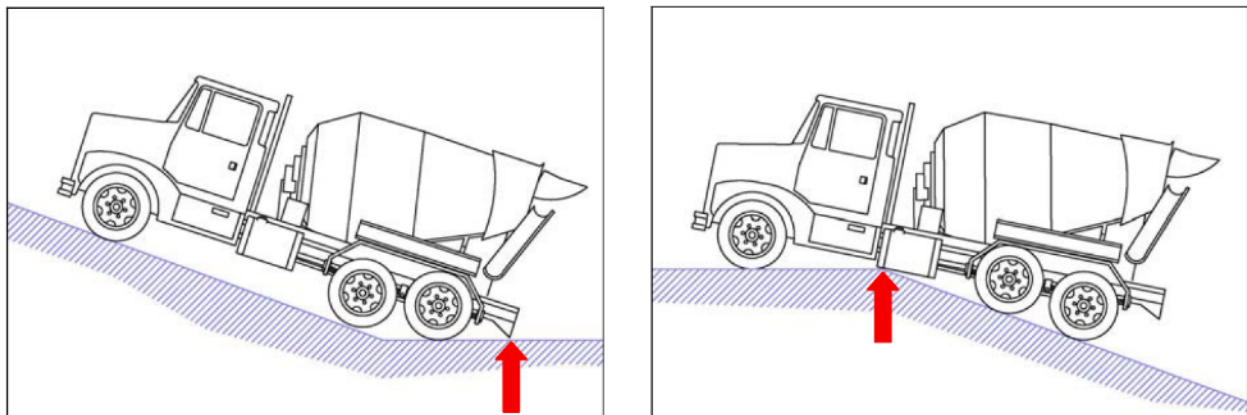
Figure 7 Negative grade break (left) and positive grade break (right)
 (Source: PND Report; see Appendix A)

Another factor that was considered in the freeboard study was the abrupt changes in angle, or grade breaks, between different parts of the terminal ramps. Too abrupt a change can result in a vehicle bottoming out when traveling across the ramp, as illustrated in Figure 7. It was reported to Glosten that at extreme tides, some vehicles cannot be loaded on the existing ferry for this reason.

PND Engineers investigated this issue and found that, for a vessel with a freeboard of 6 feet, the negative grade break limit is exceeded at a tide of +1.0 foot above MLLW (see Appendix A for more details). Such a tidal condition exists 11.5% of the time. The positive grade break limit is never exceeded. Increasing freeboard reduces the percentage of time the negative grade break limit is exceeded.

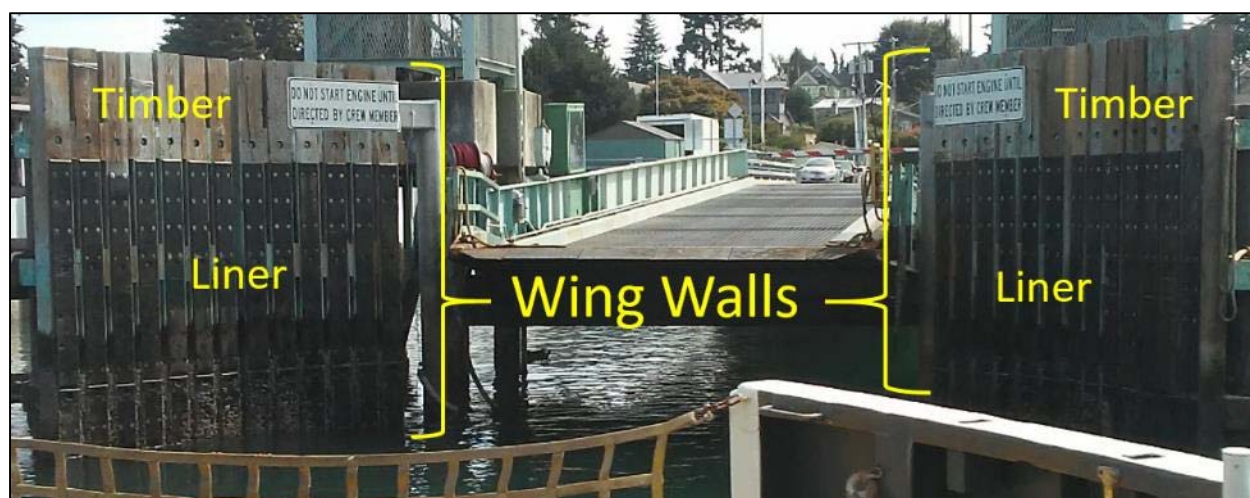
Figure 8 Wing walls at Anacortes terminal

Freeboard compatibility with the existing wing walls and dolphin fenders was examined. Specifically, the maximum height of vessel guards above the water without exceeding the height of the wing walls and dolphin fenders was calculated. The wing walls have a maximum height of 19'-8" above mean lower water (MLLW). The dolphin fenders have a maximum fender height of 20'-6" above MLLW. Extreme high water (EHW) is 11'-0" above MLLW, so the maximum guard height to be compatible with both wing walls and dolphin fenders in all tidal conditions is 8'-8". Using the replacement ferry concept design (Reference 1) as a reference vessel, and assuming 1 degree of trim and 3 degrees of list, the maximum rub rail height is 6'-1", limited by the height of the wing walls. In this scenario, almost half of the guard's 18" height is above the outermost section of the wing wall. Depending on the final replacement vessel design, it may be necessary to increase the height of the wing walls, and possibly the dolphin fenders, to ensure that the height of the replacement vessel guards never exceeds the wing wall and dolphin fender heights.

At the very least, it will be necessary to increase the height of the fender liner material on the wing walls (the black material shown in Figure 8 below). Although the wing walls are designed to accommodate the design impact load along the full height of the structural timber section (Reference 7), the wing walls currently only have fender liner material extending to roughly 11'-0" above MLLW.

If the fender liners are replaced, it also may be desirable to change the material. The existing fender liner material is ultra-high molecular weight polyethylene (UHMWPE), which is strong, long-lasting, and has a low coefficient of friction (it is slippery). Operators of the existing ferry report that a higher friction coefficient may be desirable to help restrict vessel motion when the ferry is actively pushing on the wing walls.

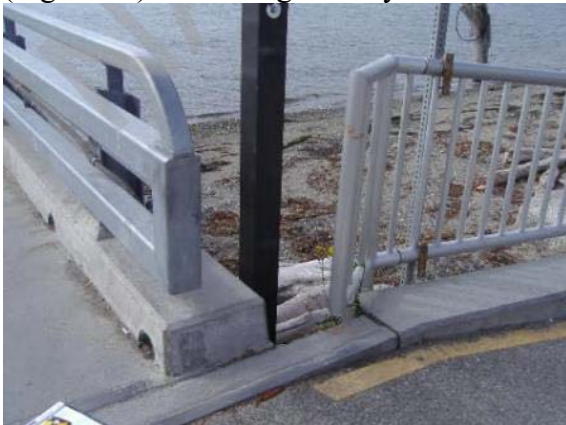
Figure 15 Non-compliant gap at Guemes Island terminal (Source: Reference 5)

- The Anacortes terminal is in compliance.
- The Guemes Island parking area likely qualifies as meeting the “maximum extent feasible” compliance criterion, but the slope of the paving leading from the old bus shelter to the transfer span should be reduced if there is a practical opportunity. Such an opportunity may exist during the upcoming modifications discussed in Section 2.1.1.2 (also see Reference 10).
- The Guemes Island pedestrian walkway has a railing with a gap that is out of compliance (Figure 15). Installing a safety mesh would resolve the issue.

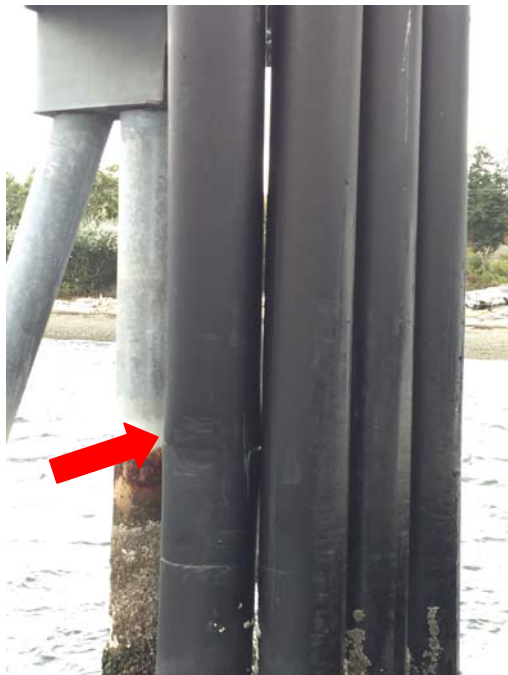
Figure 5: Damage to Guemes Dolphin 'C'

One fender pile on Guemes Dolphin 'C' was found to be damaged. The southernmost fender pile has been struck and plastic yielding is visible at about elevation +9' MLLW. The HDPE plastic sleeve pipe is split around the full circumference of the pipe at the same elevation as the steel pipe damage. See **Figure 5** and **Figure 6** for photos of the observed damage.

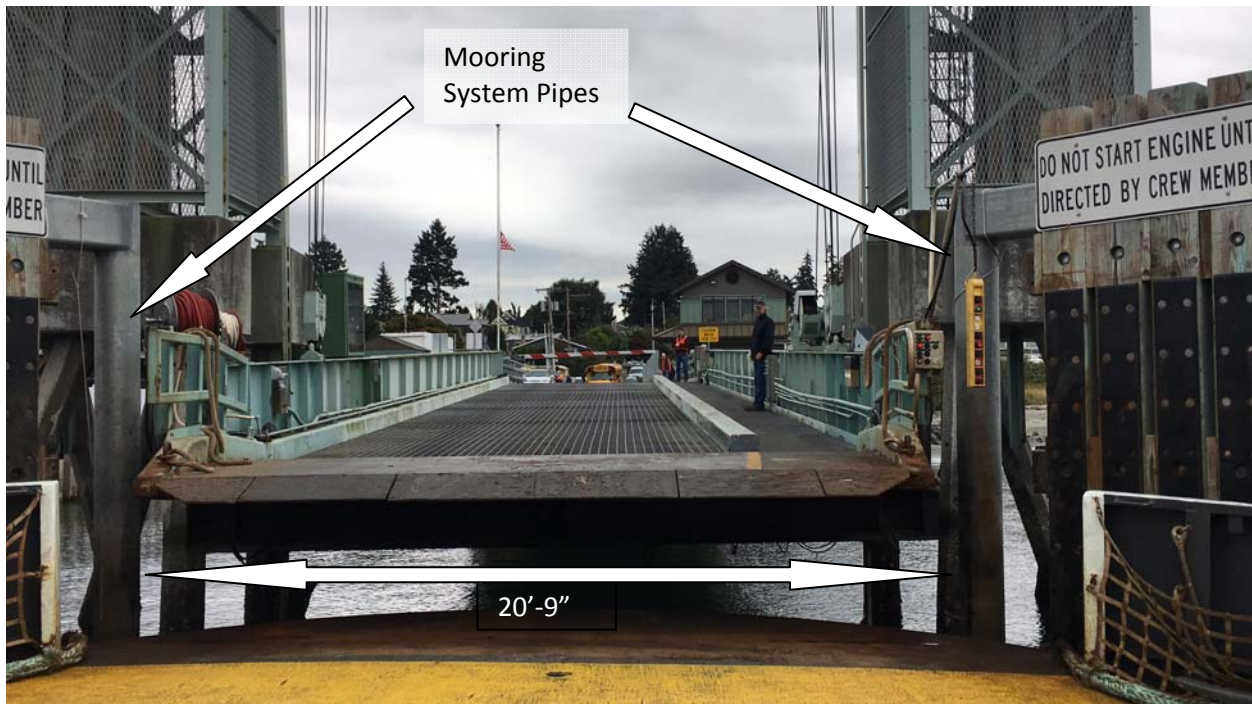
Figure 11: Photo of Anacortes Ramp and Wingwalls

The configuration of the wingwalls however is a concern. Currently the gap between the wingwalls at the Anacortes terminal is too tight to allow replacement with a wider apron. These wingwalls were recently modified to add a mooring line system for overnight moorage of the ferry while the ramp is hoisted to its upper limit. The existing gap between mooring pipes is about 20'-9", excluding the mooring lines that are permanently attached to the pipes. **Figure 11** is a photo of the apron ramp, wingwalls and referenced mooring pipes.
