# Memorandum

Date: December 9, 2019

Re: Flow Obstruction Assessment on Edens Road

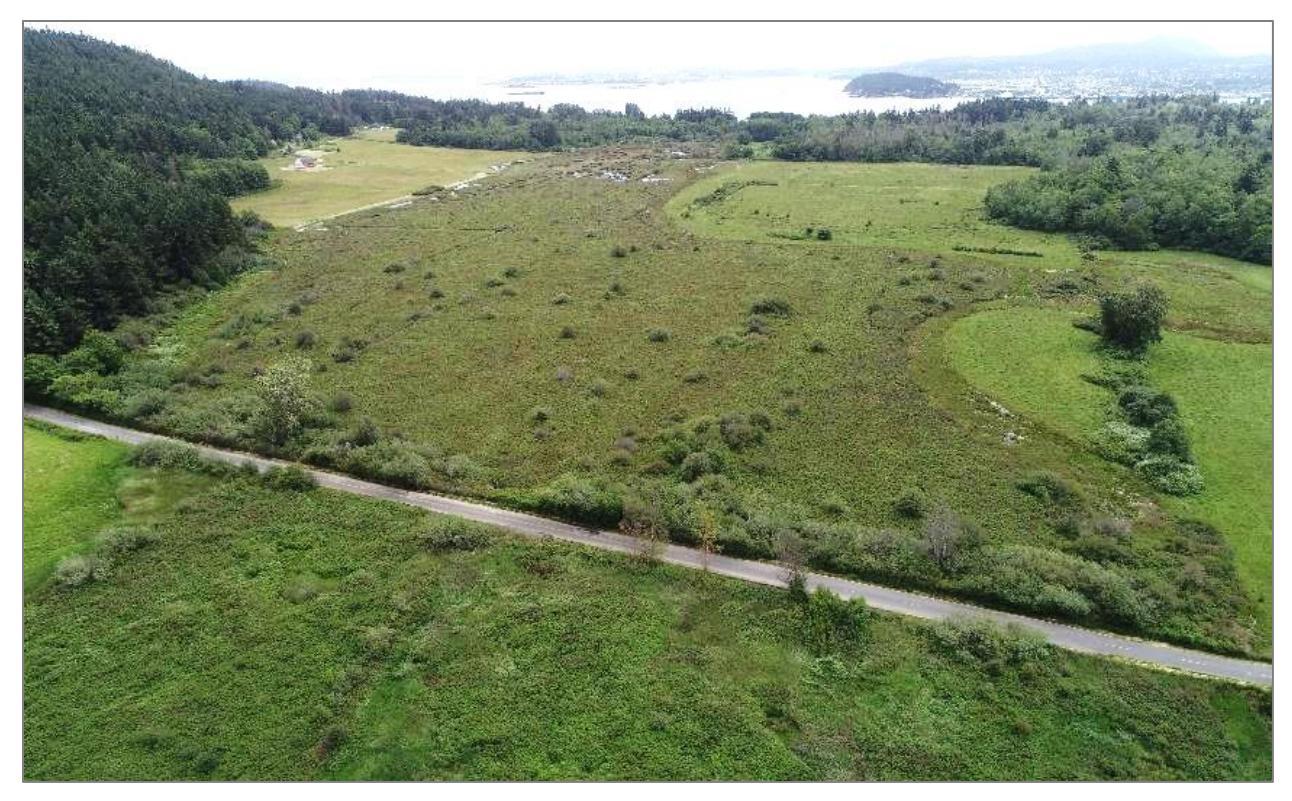
Figure 4 is an image from the north end of the wetland looking south, with the impacted section of Edens Road crossing through the center of the photo. Figure 5 is an image from the south end of the wetland looking north showing more visible ponding near the wetland outlet. Edens Road is not visible in this photo.

Figure 4 – View south from Edens Road toward the wetland outlet at Cayou Creek

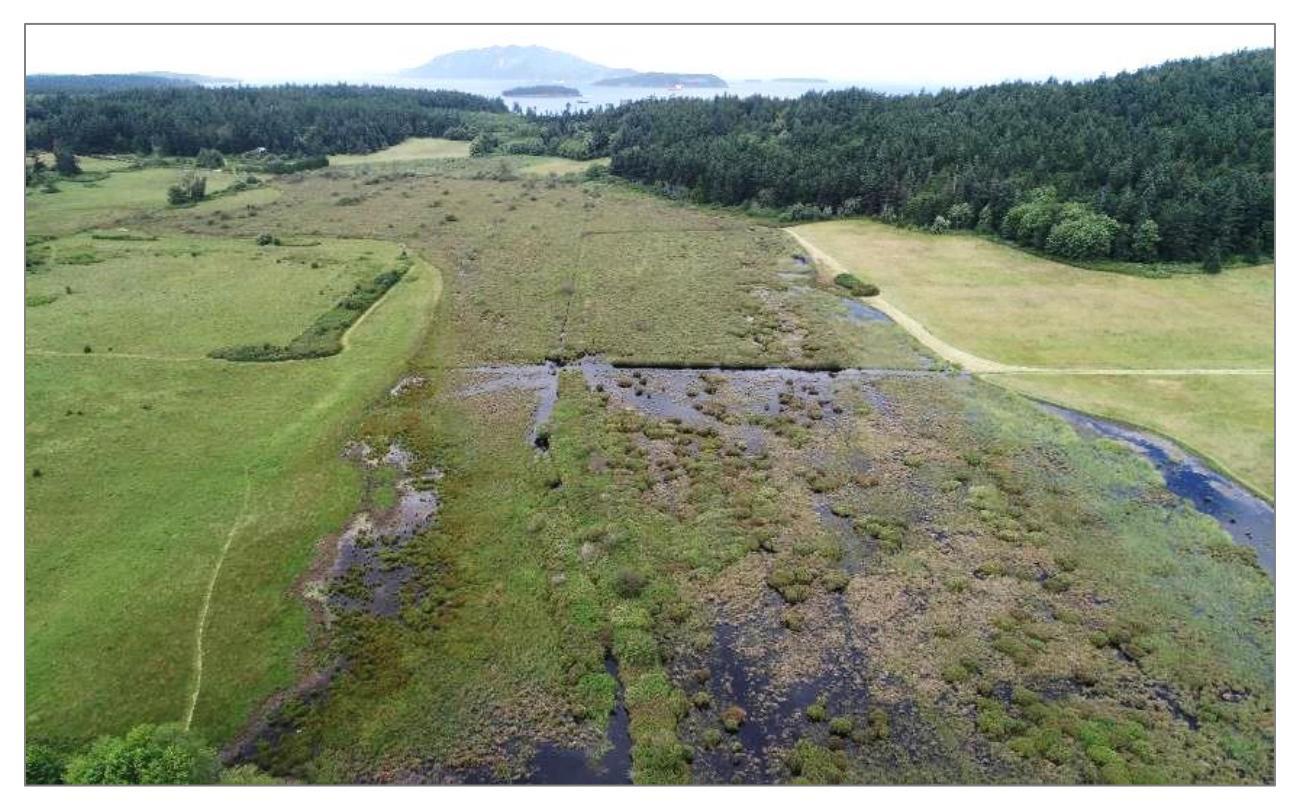
Figure 5 – View north from the wetland outlet at Cayou Creek (Note: Edens Road is hidden by vegetation and not visible in this photo)

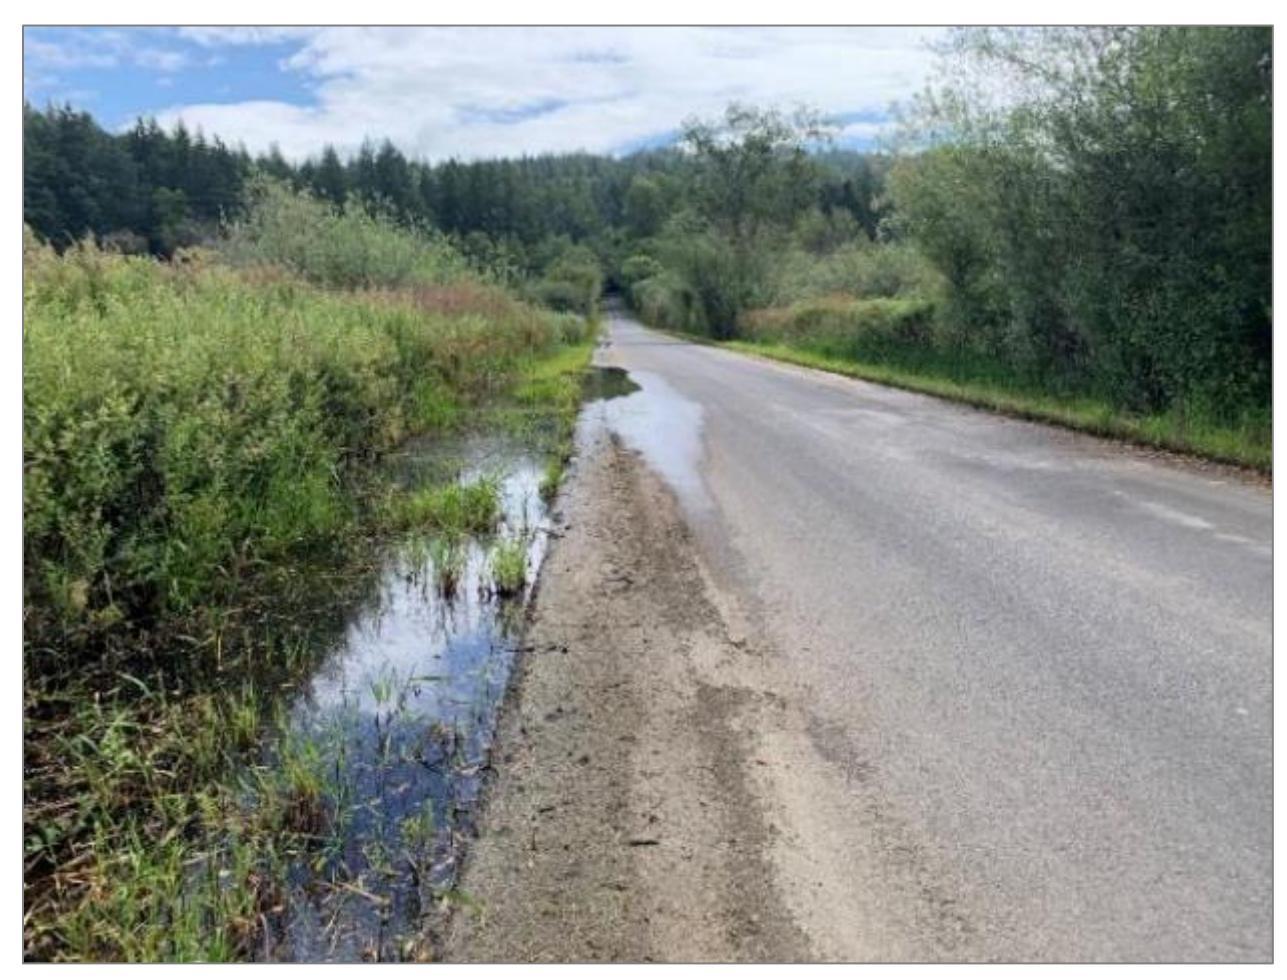
WSE staff conducted a site inspection in June 2019 to assess the extent of flood impacts and to see if the cause of the flooding could be identified. WSE staff walked the section of Edens Road that passes through the wetland and observed ponding on either side of the pavement with some water covering a portion of the travel lanes (See Figure 6). No water was crossing the roadway, but there were obvious signs of sediment deposition from previous overtopping and the county had received service requests as late as May. There was an attempt to confirm the location of two 18-inch CPEP culverts installed when the road was raised in 2010, but they could not be found in the ponded water. The County has them mapped in the database by milepost (MP 0.152, 0.213, 0.214, and 0.571) with the road mileage running from Nootka Lane towards Section Avenue. The culverts at MP 0.213 and 0.214 were installed in 2010.

Figure 6 – Edge of pavement on the north side of Edens Road (looking east)

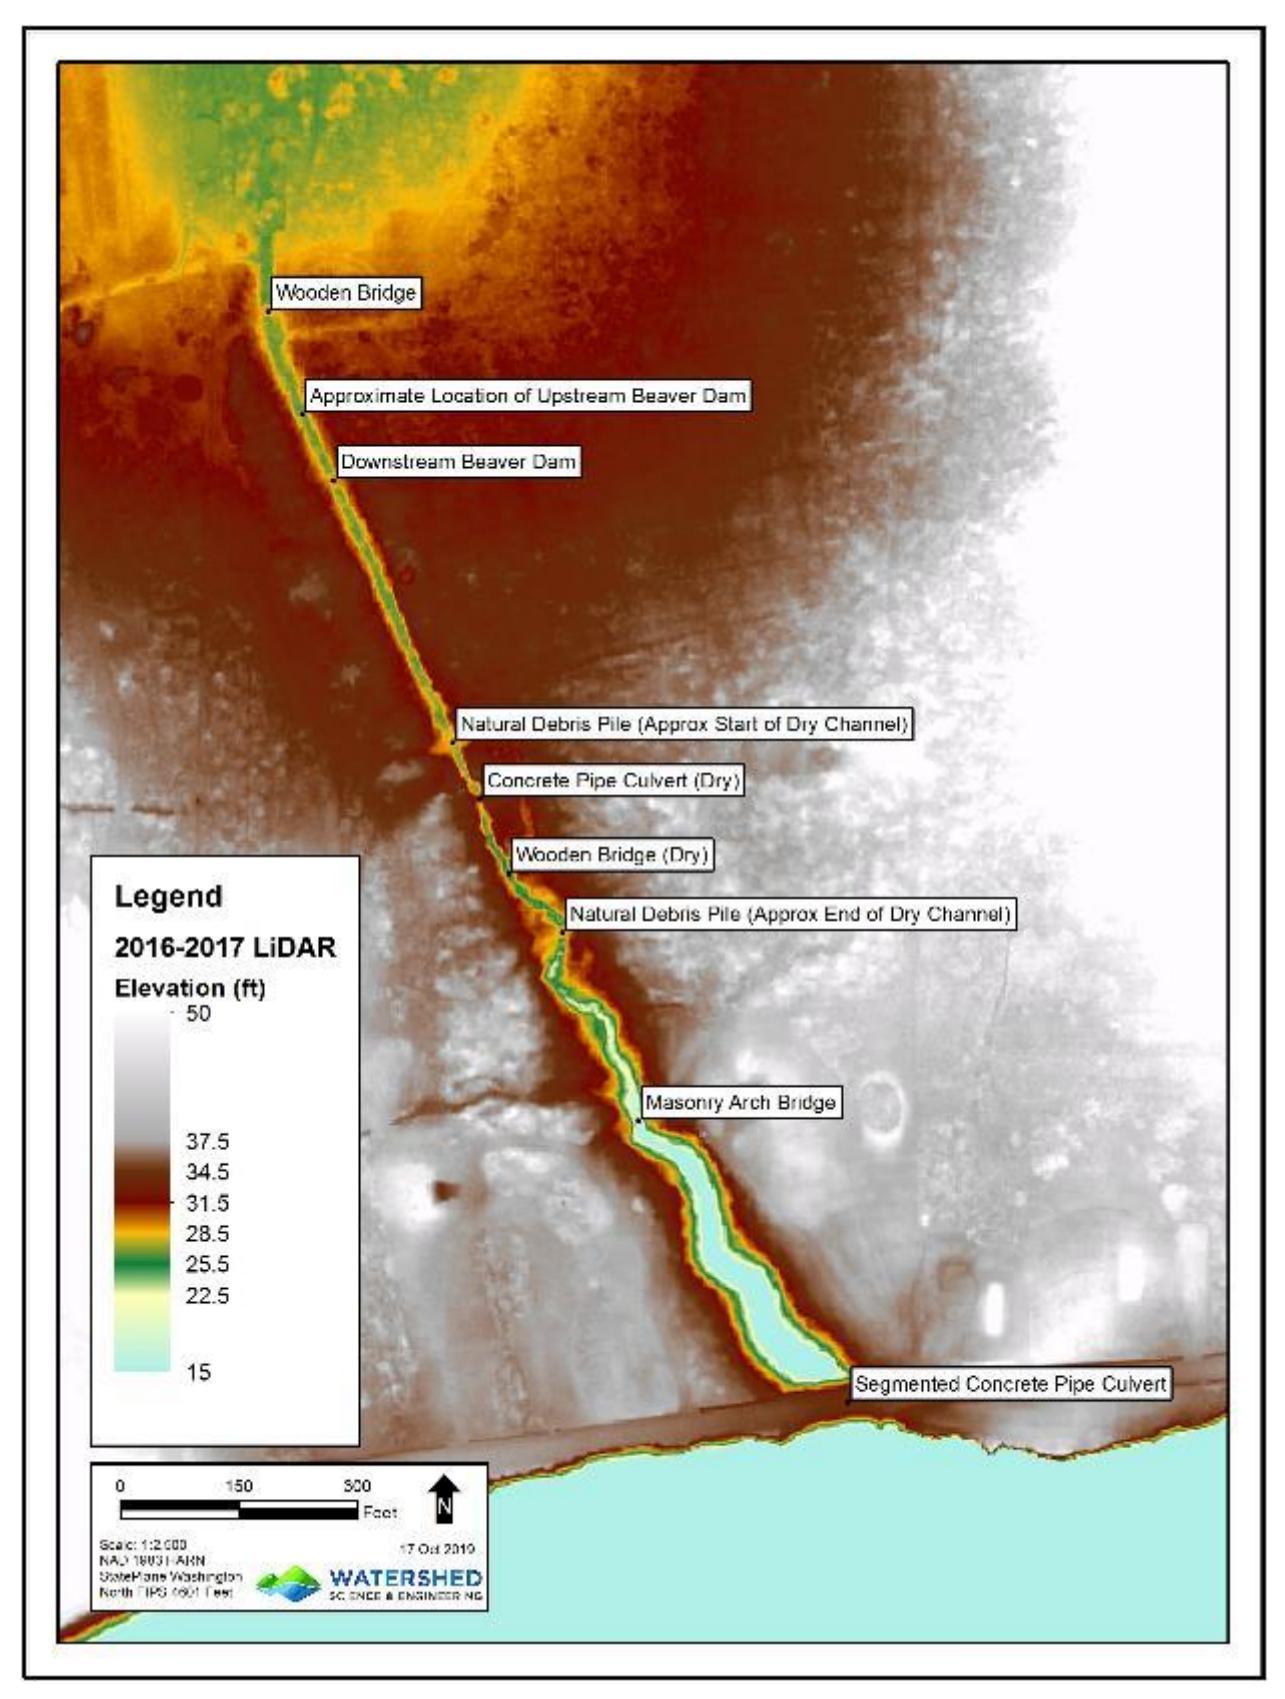
- Private Wooden bridge Partially submerged structure with a dry deck and wet low chord
- Upstream beaver dam (See Figure 8)
  - Approximately 13 feet long and 2 feet high

- 2-inch drop in water level from upstream to downstream side of dam
  - Wetted channel is 13 feet wide upstream and downstream
- Downstream beaver dam (See Figure 9)

- Approximately 10 feet long and 3 feet high
  - o 23-inch drop in water level from upstream to downstream side of dam
  - Wetted channel is 10 feet wide upstream and 4 feet wide downstream

- Natural debris pile in channel The channel went dry at this location
- Concrete pipe culvert Dry channel with 30" diameter concrete pipe (Figure 7 shows a LiDAR elevation that represents the earth covering the top of the pipe culvert)

- Wooden bridge Dry channel with 5 feet between channel elevation and bridge low chord
- Natural debris pile in channel Water reappeared in the channel at this location

- Masonry arch bridge
- Segmented concrete pipe culvert
  - 30" diameter sections under South Shore Road
  - Unobstructed inlet
  - 40% blocked outlet

Figure 7 – Features of hydraulic significance identified in Cayou Creek

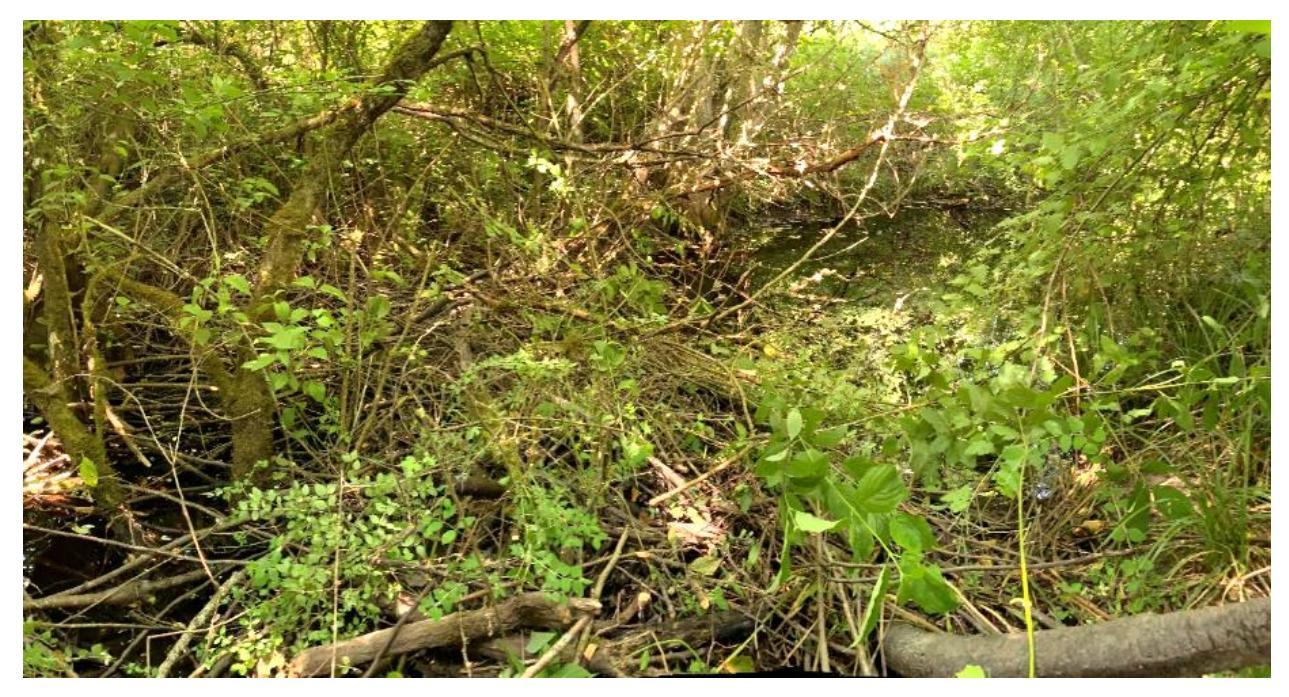
Figure 8 – Viewing west across Cayou Creek along the crest of the upstream beaver dam

The two beaver dams, especially the taller and narrower downstream dam, have created a significant obstruction across the outlet of the wetland at the start of Cayou Creek. These dams are the reason water levels have increased in the wetland and Edens Road experiences flooding. This finding is confirmed in Figure 9 below, which shows the ground profile through the wetland and in Cayou Creek obtained from 2016-17 LiDAR data. The location of Edens Road and the downstream beaver dam are identified on the plot, and the solid horizontal line represents the elevation of Edens Road while the dashed horizontal line represents the top of the downstream beaver dam. These elevations indicate that the beaver dam crest is approximately 8 inches higher than the road in the 2016-17 LiDAR. The exact relationship between the beaver dam crest elevation in the LiDAR and the current crest elevation is not known as no physical ground survey was collected during the 2019 site inspection.

The most direct solution would be to remove all or part of both dams and implement a beaver management program. However, due to the incised character of the stream and the fact that there are many locations along its length where beavers could build dams, common techniques like beaver deceives likely will not be successful. Notching or removing the dams is also unlikely to be a long-term solution because beavers are capable of repairing or rebuilding dams very quickly. Short of trapping and removing the beavers, it is our opinion that any beaver management allowing the beavers to remain on site will likely not resolve flooding across Edens Road. If trapping and removal is not an acceptable solution, we recommend that the County pursue another alternative such as one of the following:

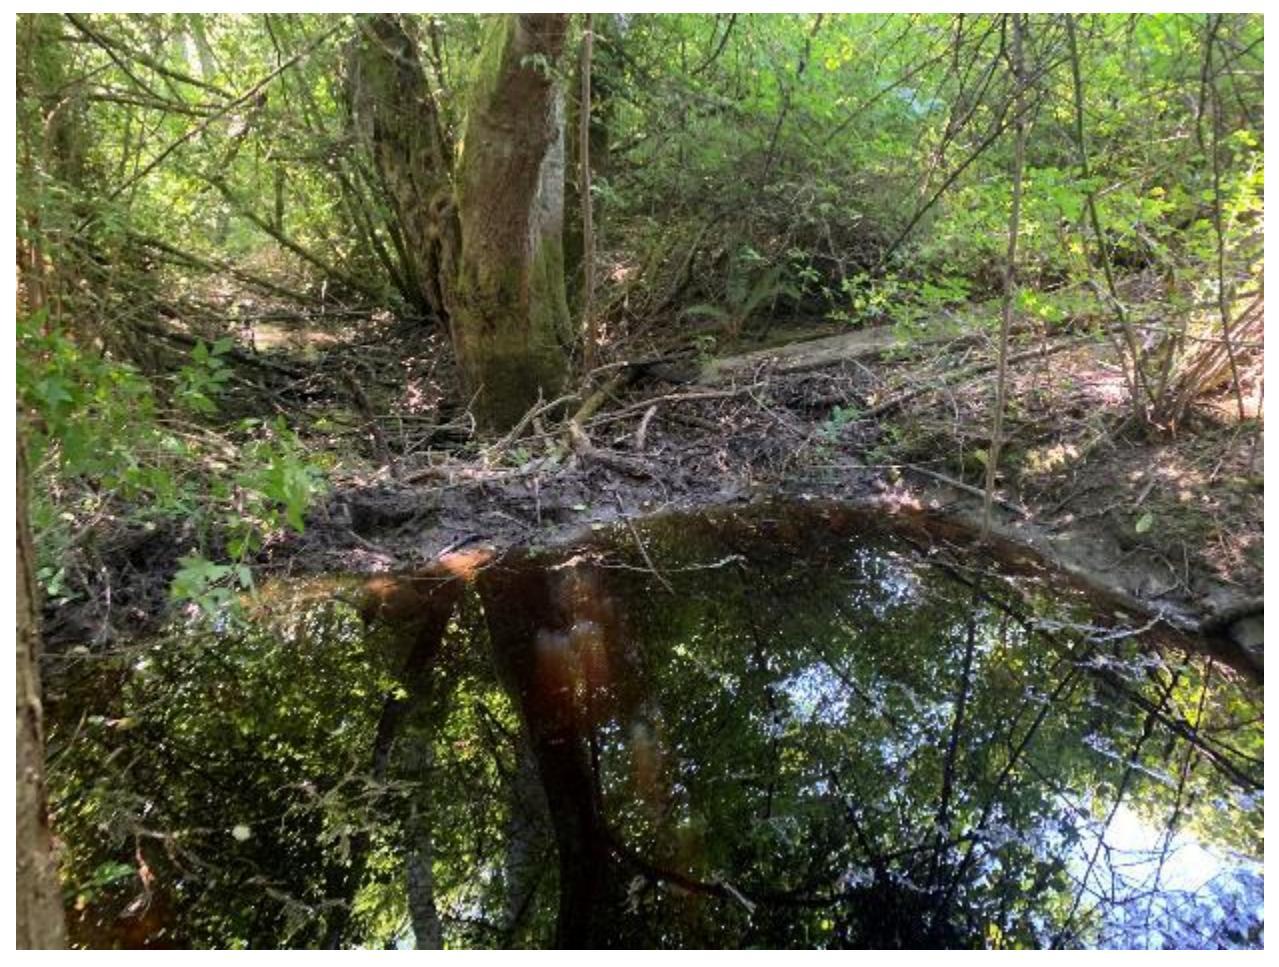
Figure 9 – Viewing south (downstream) across the crest of the downstream beaver dam

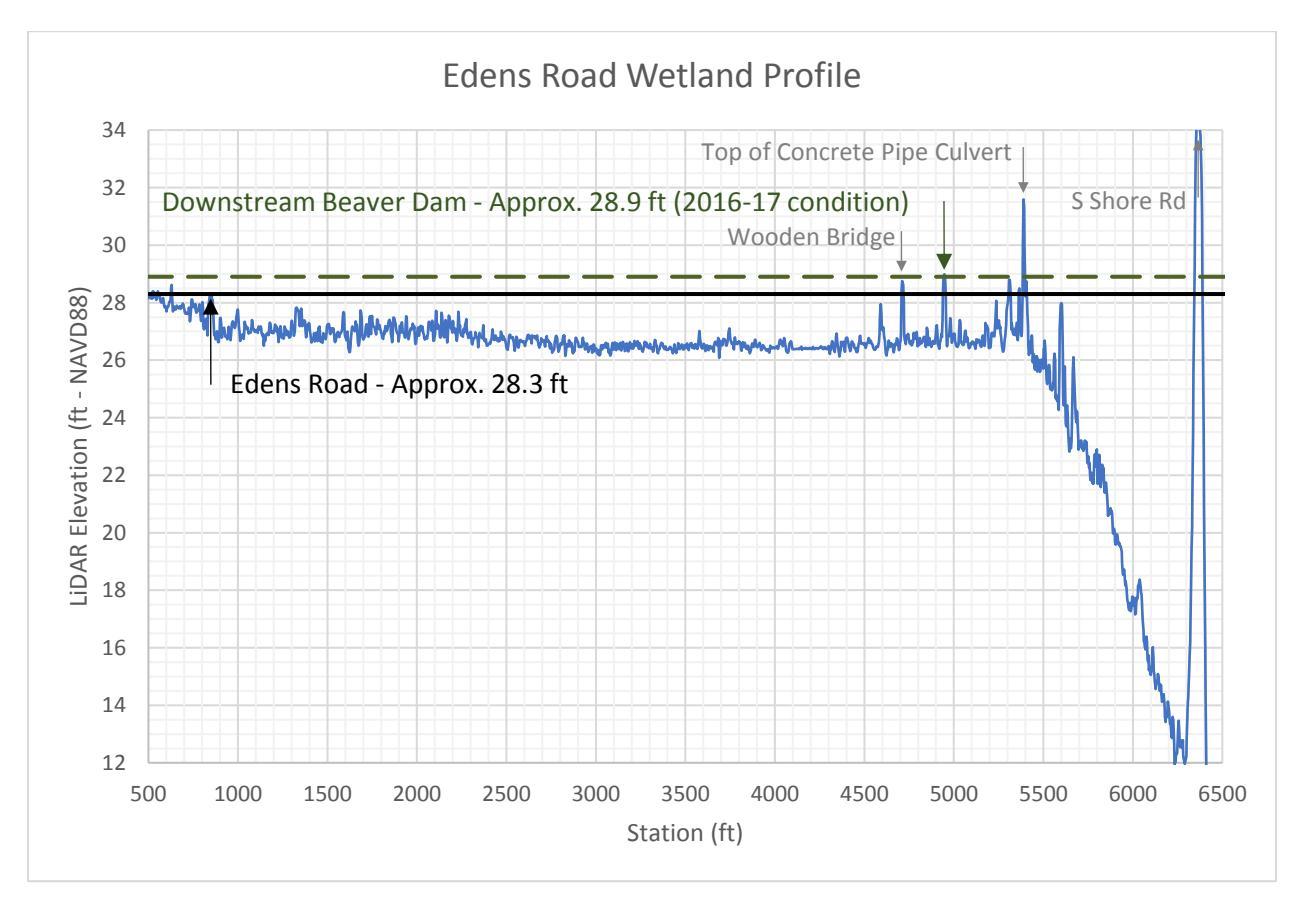
The LiDAR elevation data is not as precise as a physical survey, but we believe it does confirm that the beaver dams are the cause of the flooding at Edens Road based on elevation comparisons from the wetland profile. Note that the upstream beaver dam apparently did not exist when the LiDAR was collected as it is not visible in the in the profile below, but there are a handful of elevation peaks in the profile that correspond to other hydraulic features of significance and are labeled accordingly on the figure. Based on approximate measurements from the 2019 site inspection, the upstream beaver dam contributes approximately two inches of hydraulic head to the wetland, meaning the downstream beaver dam is still the primary feature controlling wetland water levels.

Figure 10 – Edens Road wetland profile with specific elevations and hydraulic features listed

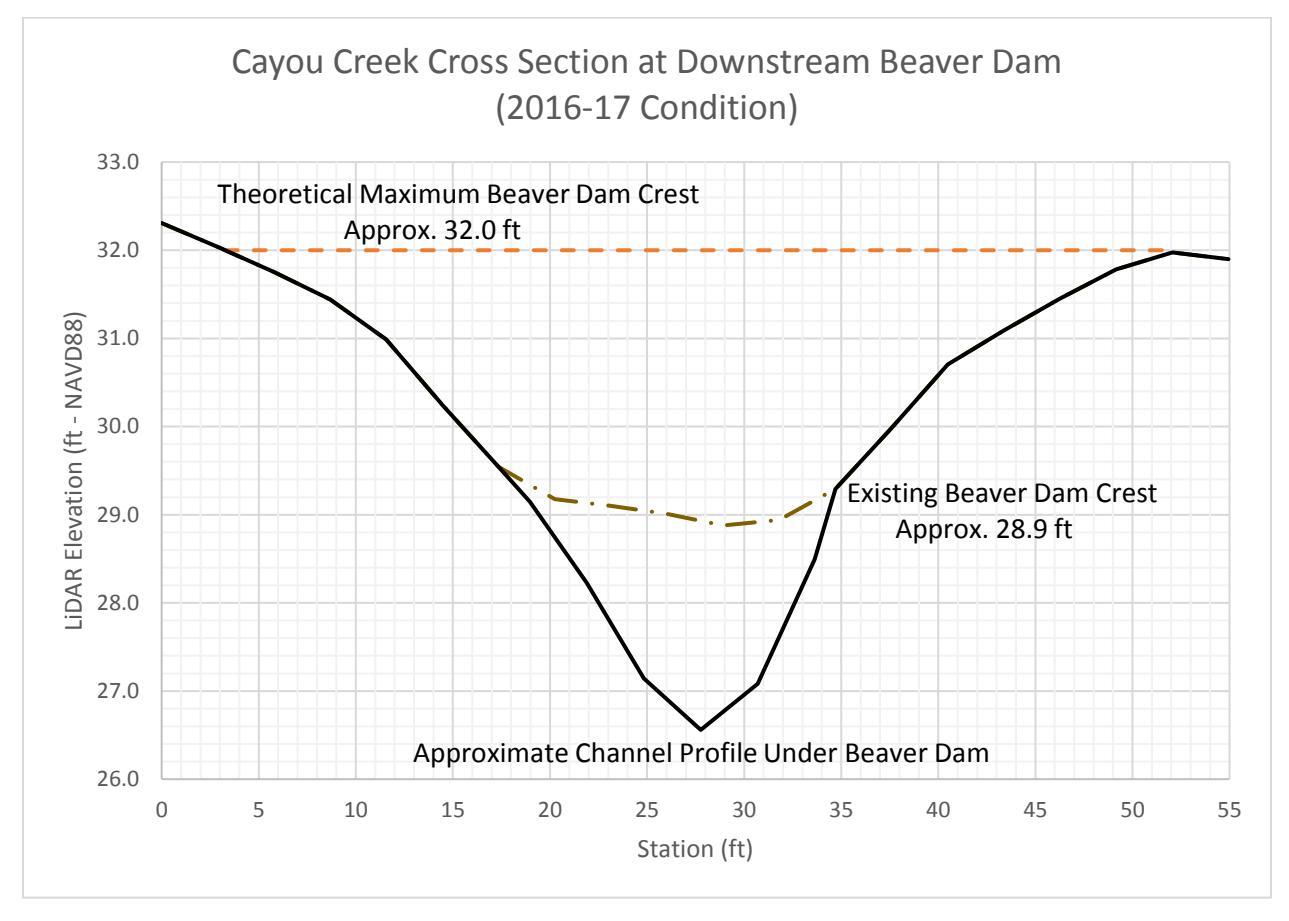
Figure 11 below shows a cross section of Cayou Creek looking downstream at the location of the downstream beaver dam. The lowest profile line represents an approximate channel cross section under the beaver dam, the middle dash-dotted line represents the beaver dam crest with a minimum elevation of 28.9 feet, and the highest dashed line represents the top of bank elevation based on the Cayou Creek channel profile at the right side of the plot. The cross section reveals that the beavers could theoretically build their dam upwards of three feet higher than it is today to the highest dashed line at an elevation of 32.0 feet, which in-turn would increase the frequency and depth of flooding at Edens Road. An expansion up to the top of bank elevation would require a beaver dam that is more than 45 feet long and is unlikely to occur, but the site characteristics indicate that it is possible nonetheless.

Figure 11 – Cayou Creek cross section along the crest of the downstream beaver dam, approximately showing the channel profile under the dam, the crest of the dam, and the theoretical maximum elevation of the beaver dam.

Based on our investigation, it is clear that beaver dams in Cayou Creek at the wetland outlet are the cause of flooding at Edens Road. It is also clear that water levels at Edens Road could rise even further in the future if the beaver dams are raised. The 2016-17 LiDAR cross section shown on the previous page suggests that the lower beaver dam could theoretically be raised an additional 3 feet, meaning there is the possibility that water levels at Edens Road could exceed the recent record levels that have inundated the road. However, the road would only need to be raised approximately 8" to be above the current inundation level seen in the 2016-17 LiDAR (i.e. the beaver dam crest elevation).

- Raise Edens Road through the wetland more than 3.7 feet to an elevation above 32.0 feet, higher than the theoretical maximum elevation of the beaver dam as indicated in Figure 11. This would require expanding the road footprint into the wetland due to the wider road prism of an elevated roadway. The mitigation requirements and resulting costs could be significant.
