**Carpenter Creek, Hill Ditch and Fisher Slough Watersheds
Initial Flood and Sediment Study**

Skagit County, WA

Final Report

March 2007

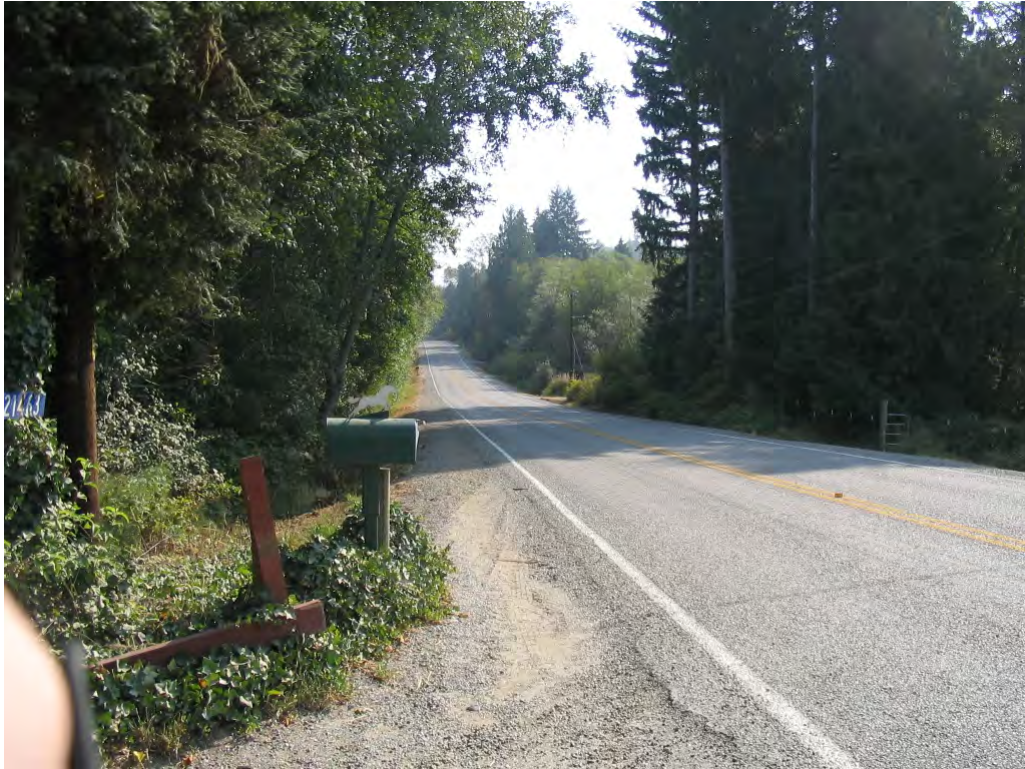
Figure 7. Little Mountain Road looking towards problem culvert area near Lang Pony Farm driveway

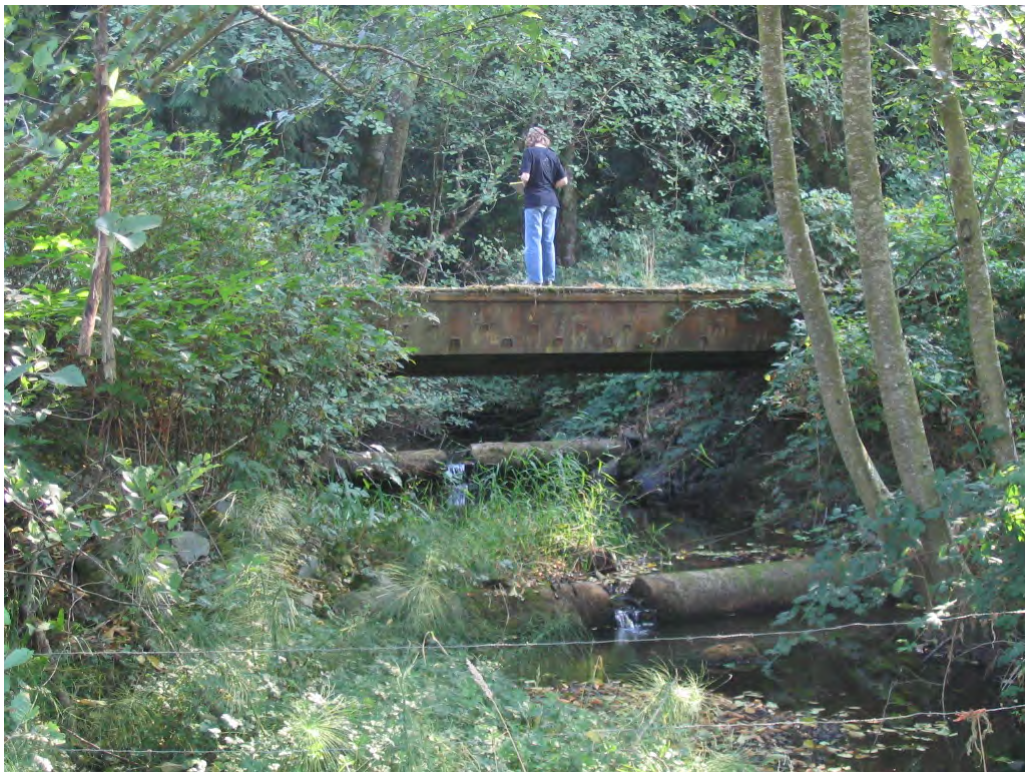
The next major feature is the State Haul road crossing where a railroad car bridge has been installed with a series of notched log weirs in the channel (**Figure 8**). Currently the bridge decking has several large holes, is in disrepair and could be a safety hazard. During inspection the upstream notch log weir was a fish passage barrier with drop heights greater than 1 foot. The area between the State Haul road railroad bridge and the Carpenter Creek ravine is primarily rural reserve, horse pasturelands. The pasture areas have potential for floodplain enhancement and riparian restoration along streamside grazing and horse access areas.

Figure 8. State Haul Road Bridge

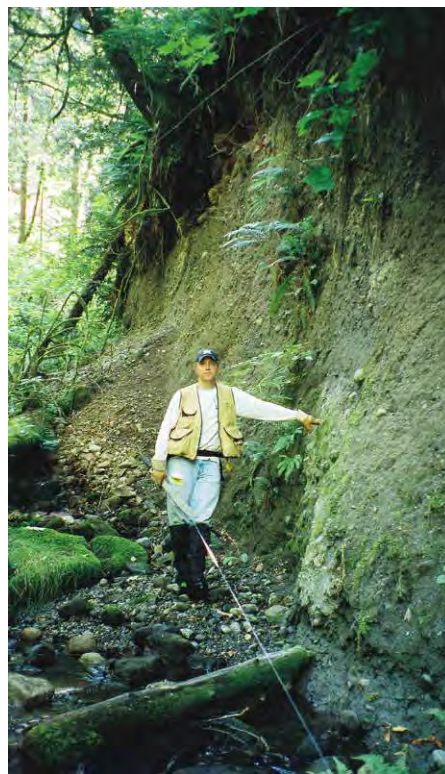
Figure 15. Photo of eroding glacial till streambank in ravine

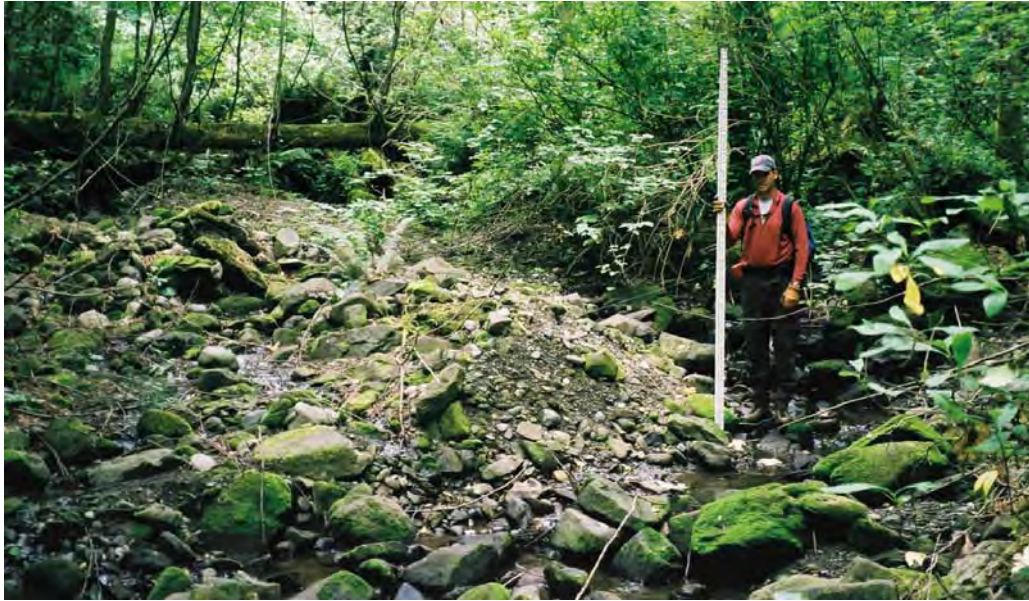
Figure 22. Photo showing boulders in transport positions a short distance upstream from the fan apex.

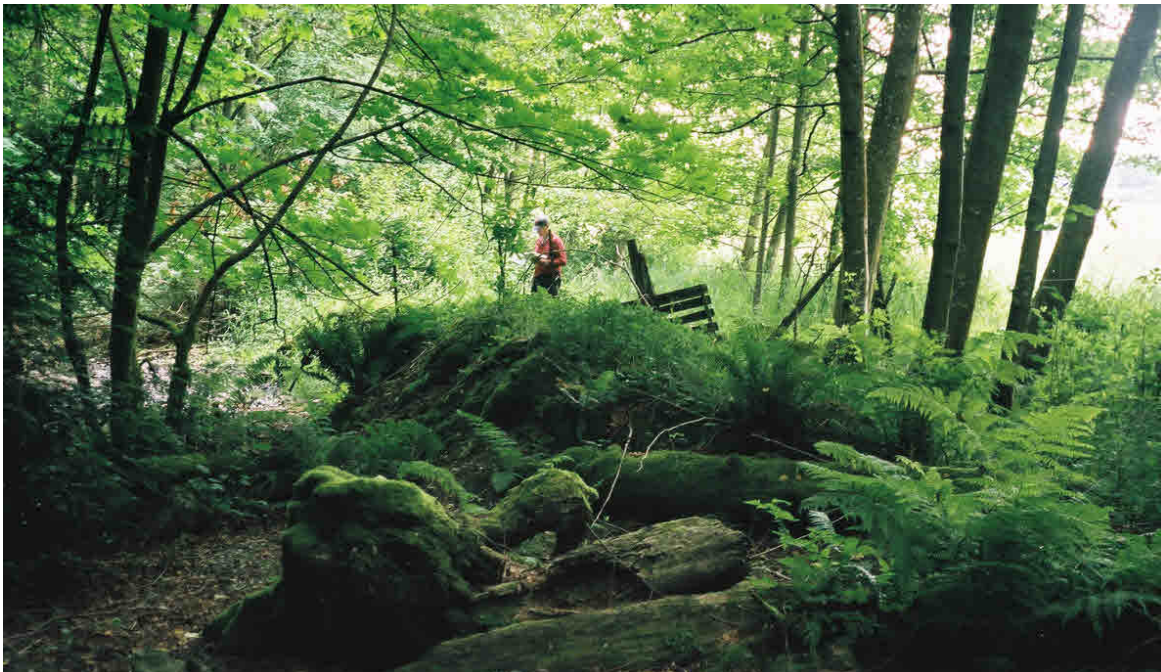
Figure 23. Boulder berm in the fan apex area

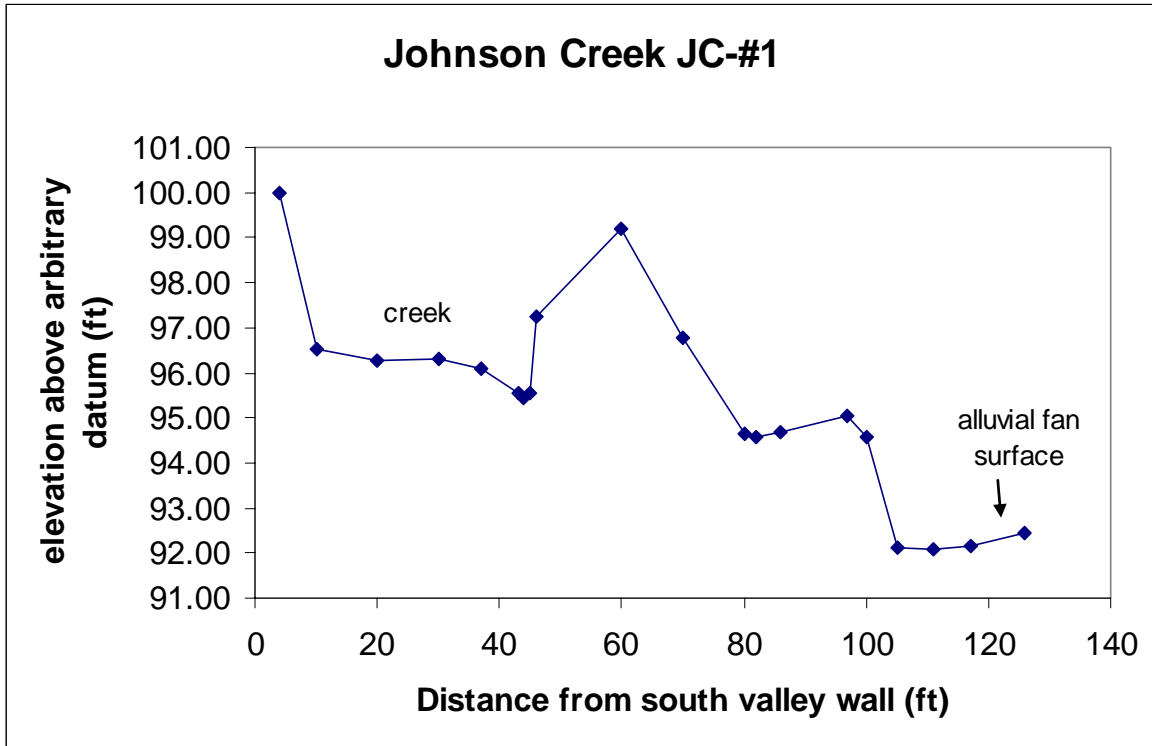
Over the decades since Johnson Creek was diverted there, the creek has deposited well over 10,000 cubic yards of sediment. The creek is now perched about four feet above the rest of the alluvial fan (**Figures 25-27**). This causes flow to go subsurface and the creek dries up at times during the summer. In most locations, an irregular combination of old, constructed and natural levees keeps the creek in its present location. Gaps in the levee break out when the flow comes up and water crosses the fan and floods the two clusters of buildings on the fan on its way to Hill Ditch. The County has dredged and placed sandbags in the downstream 500 feet of the private road next to the creek during emergency flood operations (Tom Sheehan, Skagit County Emergency Management).

Figure 25. Cross-section JC-1 of Johnson Creek showing stream channel perched on sediment deposits

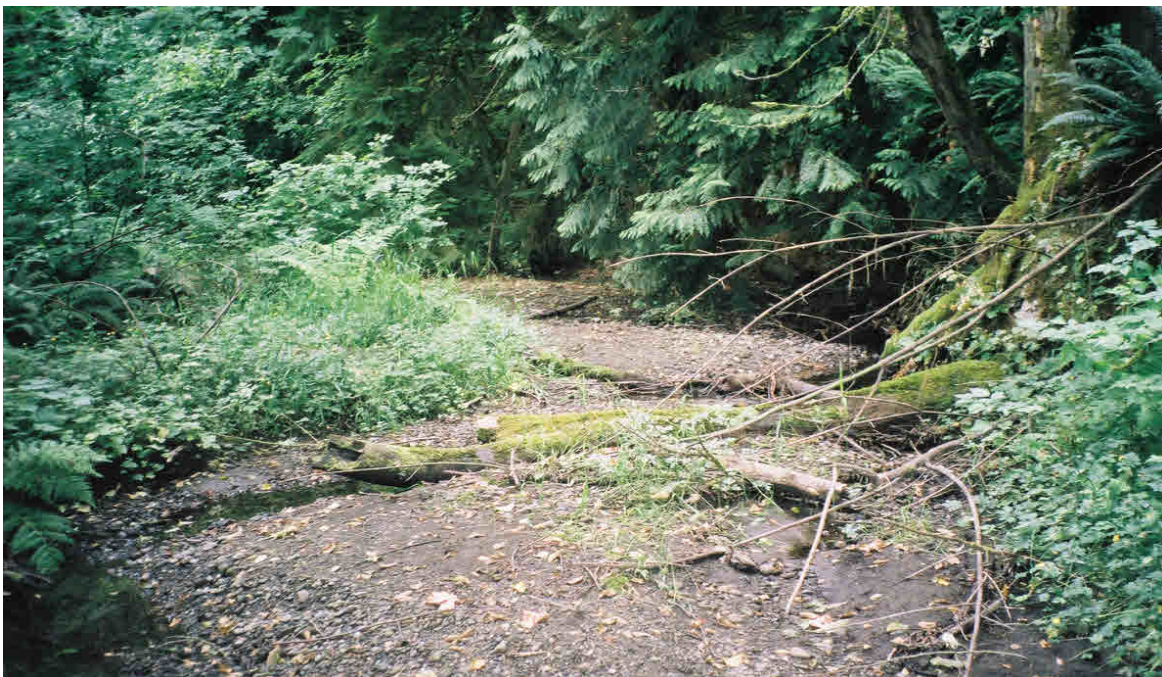
Figure 26. Photo of perched channel and deposited sediments

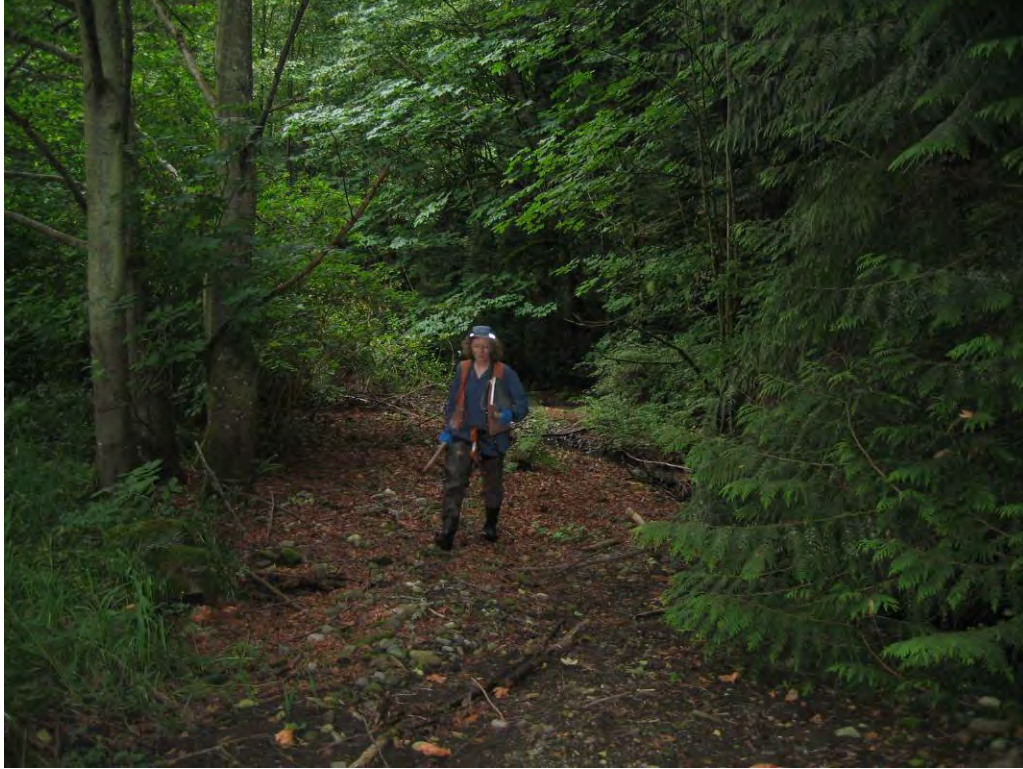
Figure 27. Photo of perched channel and deposited sediments

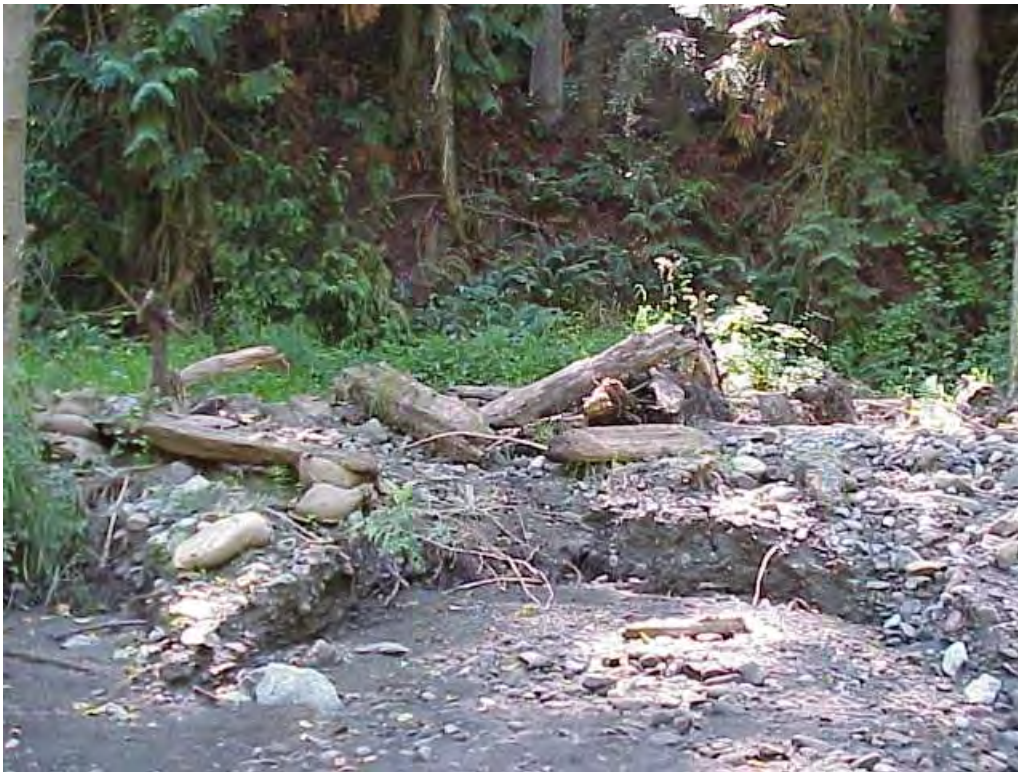
A dam-break flood reportedly occurred in July 2004. **Figure 31** shows the deposits from that flood near the fan apex. This flood has been attributed to beaver dam failure because it occurred in summer, according to initial interviews. However, field evidence suggests it was probably caused by a landslide in a steep part of the ravine downstream from the flatter reach that beavers could inhabit.

Figure 31. Photo showing deposits a short distance below the fan apex from a dam-break flood in July, 2005. Photo provided by Tom Slocum, Skagit Conservation District.

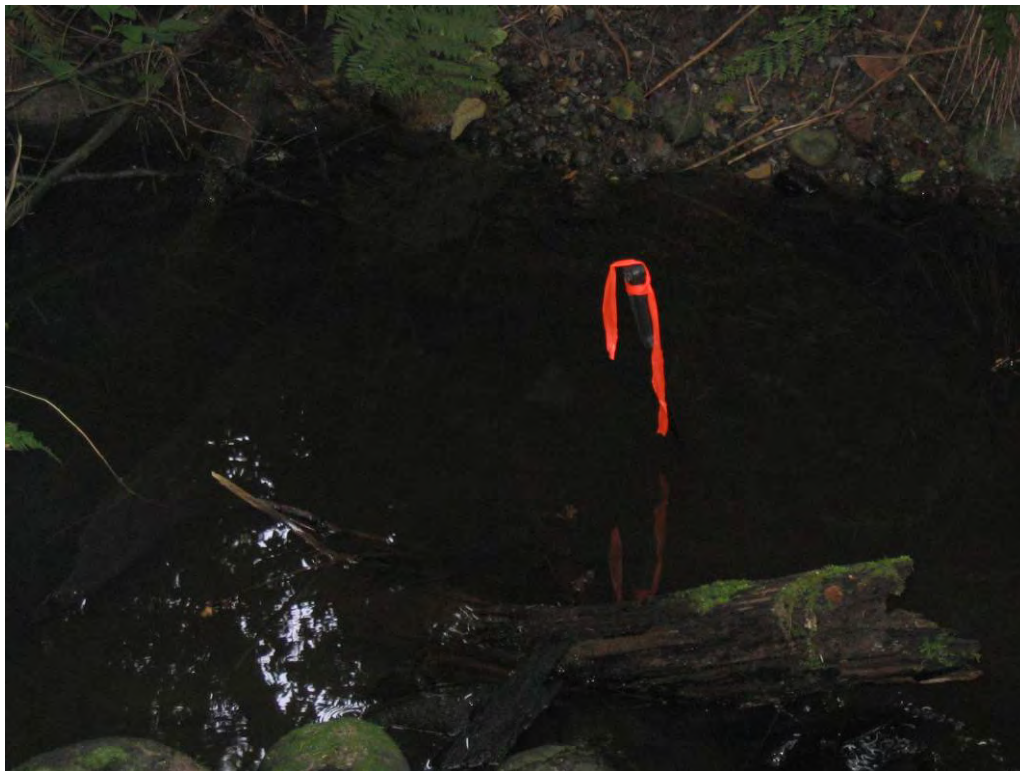
Figure 36. Bulson Creek, Downstream side of West English Road Culvert, fully submerged and partially blocked with debris

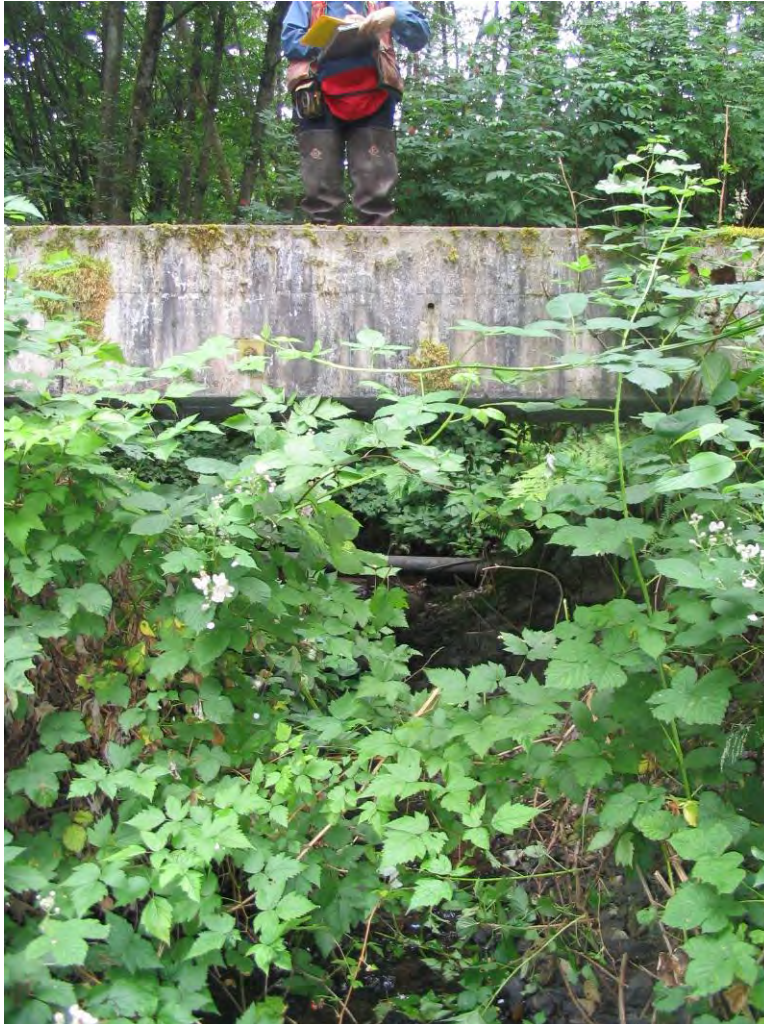
It was reported that the Bulson Road culvert does experience flooding and overtopping (SCD, 2006). The sag of the road is in a low lying area, where the stream gradient is low. Raising the roadway and constructing larger culverts is a potential solution to this problem (**Figure 41**).

Figure 41. Sixteen Lake Camp Road, note exposed sewer main in middle of picture

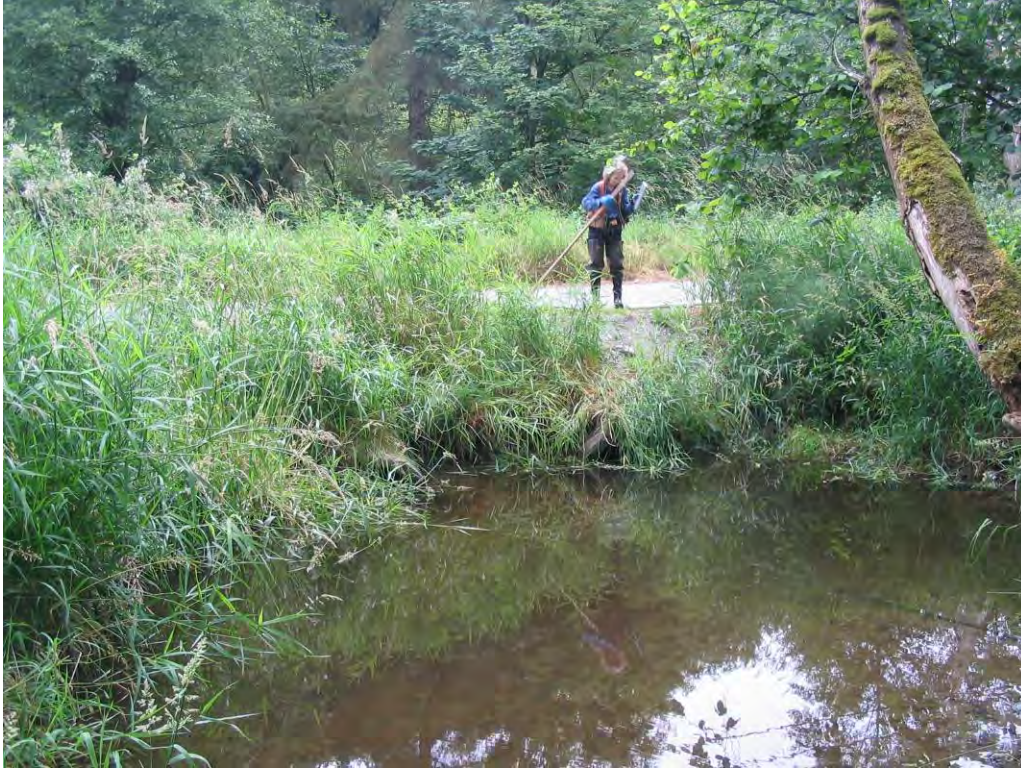
Figure 42. Bulson Road Culvert Crossing

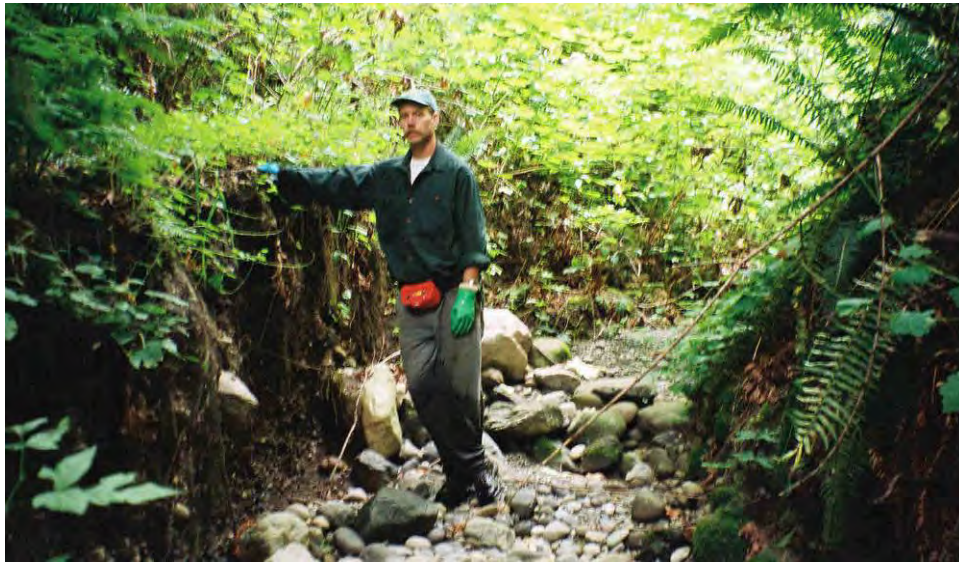
Figure 45. Photo showing channel erosion of the southeast fork of Big Fisher Creek

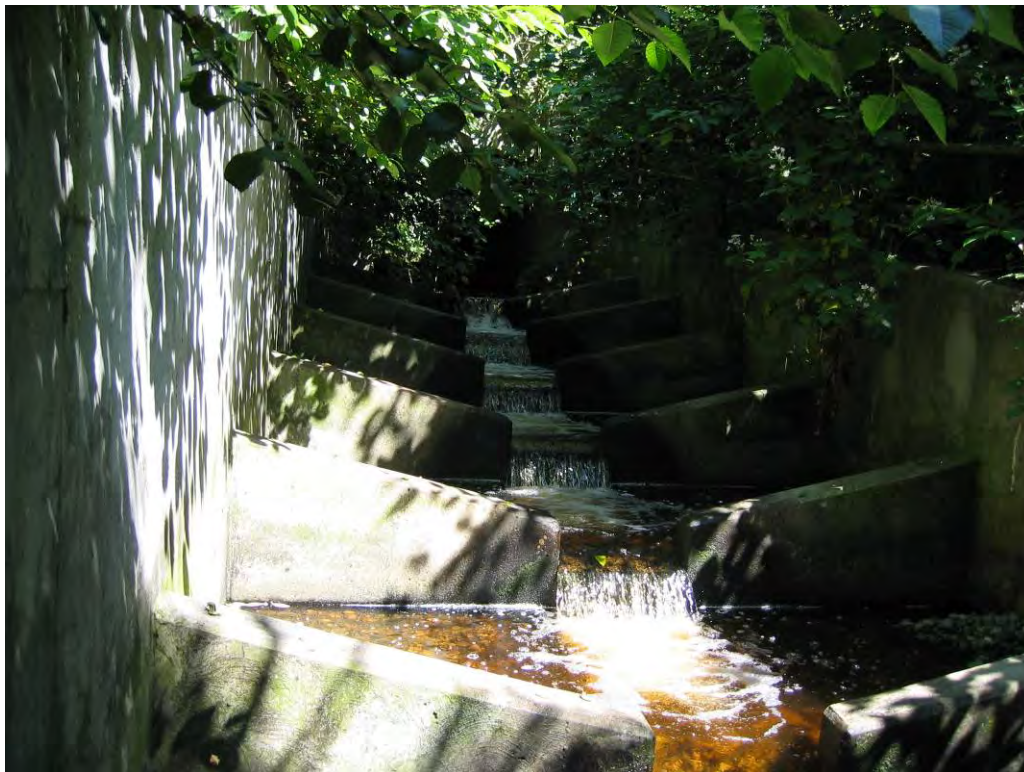
Another area visited during the assessment was the newly constructed fishway under Cedardale Road, just east of the I-5 Crossing. The structure appears to be passing bedload material downstream to Hill Ditch (**Figure 46**). Gravel and cobbles were observed in the pools and along the bed of the 72” CMP culvert crossing under I-5 and the culvert appears to be functioning properly.

Figure 46. Photo showing fishway underneath Cedardale Road near I-5 crossing

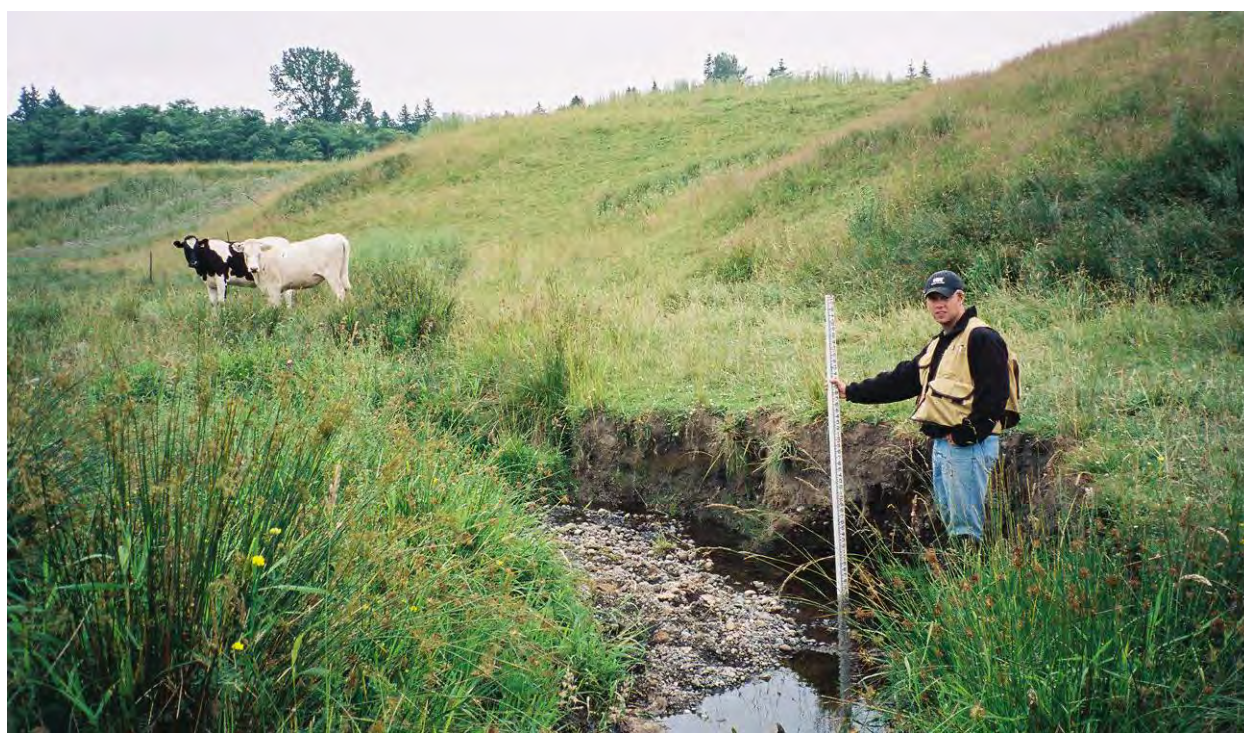
Figure 48. Livestock access and pedestal erosion, Little Fisher Creek

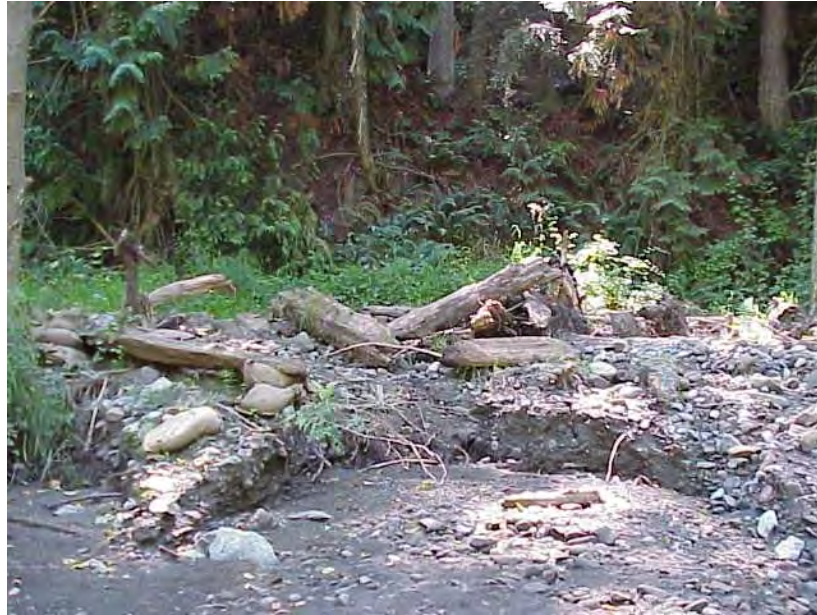
Figure 2. Photo showing deposits a short distance below the fan apex from a dam-break flood in July, 2005. Photo provided by Tom Slocum, Skagit Conservation District.

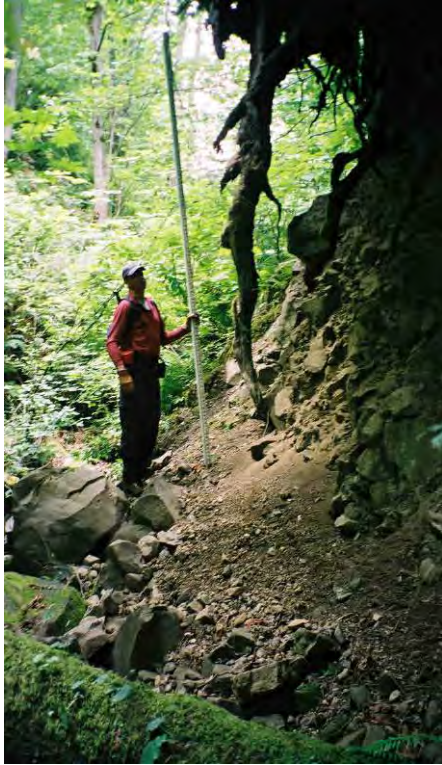
Figure 4. Photo showing incised channel eroding a landslide deposit in the ravine

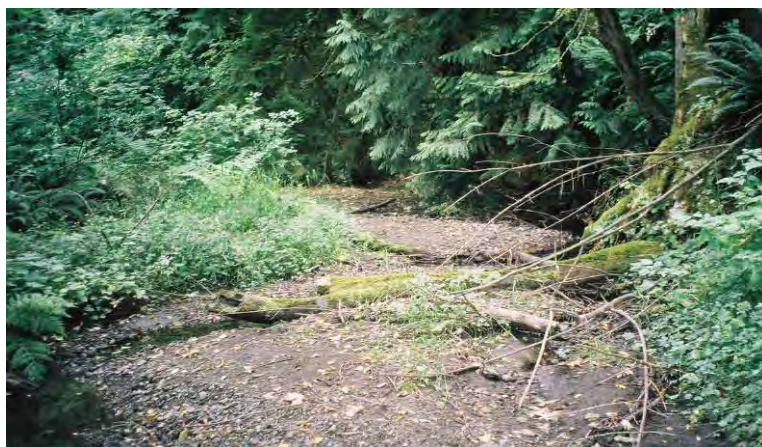
Figure 6. Photo of perched channel

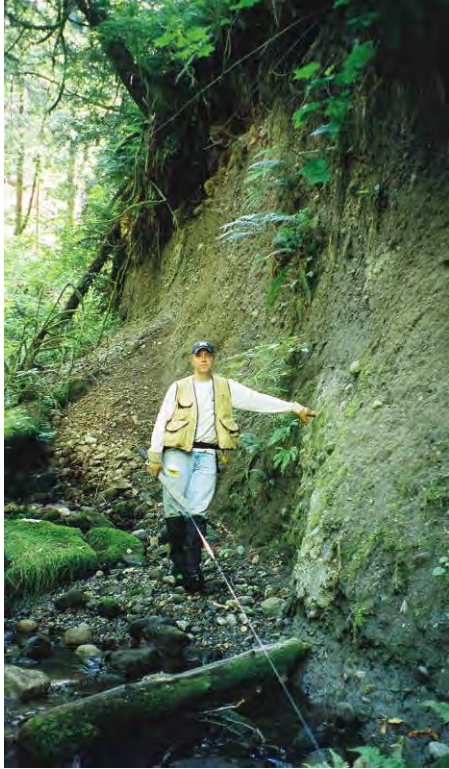
Figure 8. Photo of eroding glacial till streambank in ravine.
