JARPA Attachment F: Wetland and Waters of the U.S. Delineation Report

**Project Name: Fisher Slough - Tidal Marsh Restoration, Levee Setback, and Siphon Realignment;
Skagit County, Washington**

WETLAND AND WATERS OF THE U.S. DELINEATION

FISHER SLOUGH - TIDAL MARSH RESTORATION, LEVEE SETBACK, AND SIPHON REALIGNMENT SKAGIT COUNTY, WASHINGTON

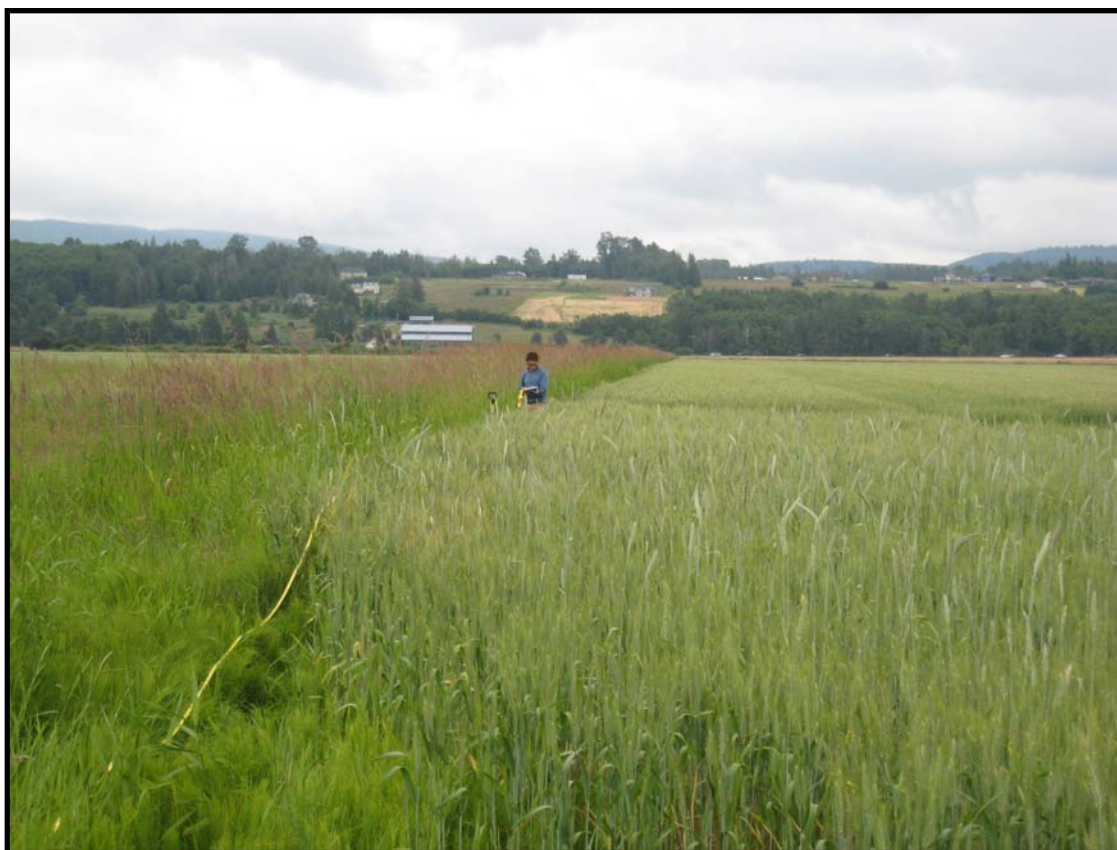
Figure 5. Along North Ditch Looking East from Pioneer Highway

North Ditch forms the northern border of Site 1 and features a cross section that becomes less pronounced from east to west. A deeper channel with high side-cast berms was present in the eastern half, whereas in the western half, the channel was shallower with virtually no berms. While superficial evidence of flooding and standing water was obvious in many locations along the western portion of the North Ditch and along the West Ditch (Figure 7), the eastern third of the site did not have evidence of standing water. However, H&H data and observations from the site (Cline 2009) indicate that Big Ditch and the associated North Ditch have water levels at or near the top of bank during significant periods of the winter and early spring. Additional sample plots in the eastern portion of the site showed mottling and other evidence of a seasonal high water table. Thus, we determined that the entire area of Site 1 was wetland, and no actual boundary was delineated. It will be assumed for preparation of permits that all fill or excavation areas and quantities within Site 1 are within wetlands, except for that which is located on existing road fill for Pioneer Highway.

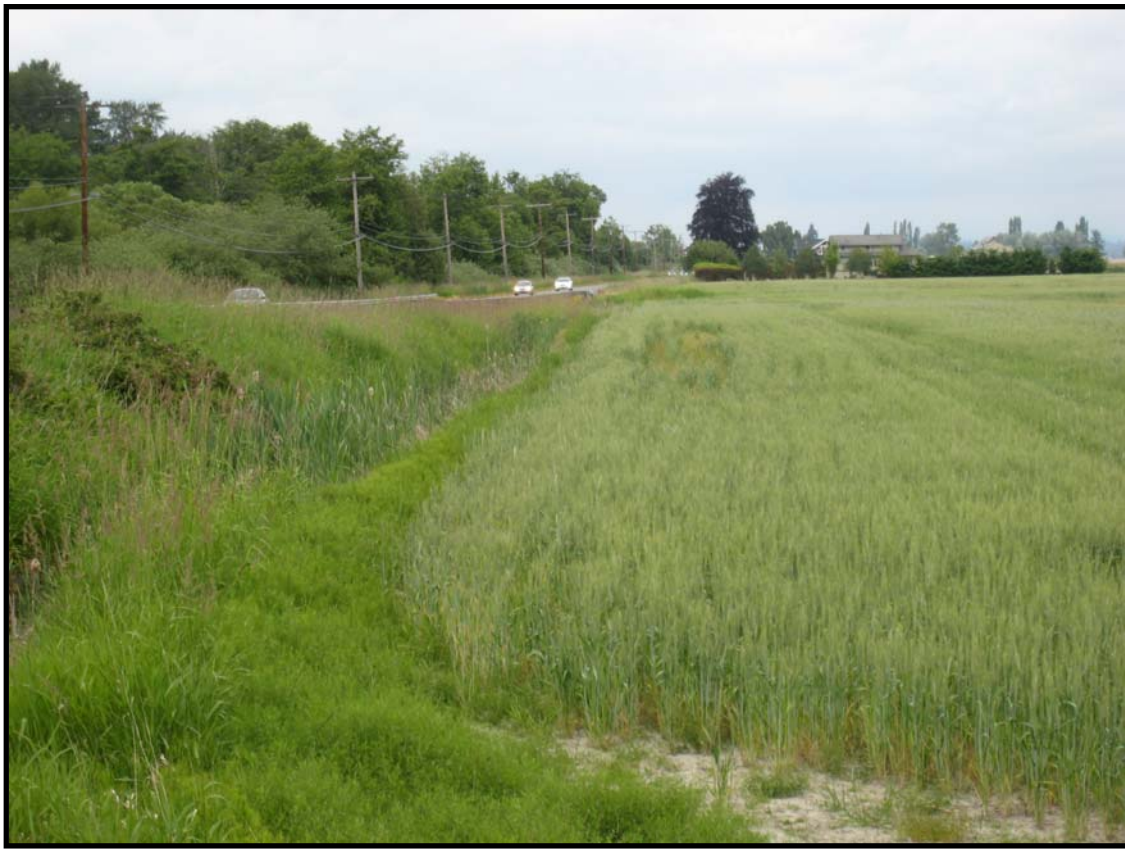
Figure 6: Southern End of West Ditch Looking North (Proposed Staging Area)

The only proposed construction work for Site 1 will be realignment of Big Ditch along the route of the existing North and West Ditches, plus a proposed staging area in the southwest corner. Thus sampling within Site 1 consisted of six transects along the proposed Big Ditch alignment with 16 sample plots, one additional sample plot, and two vegetation only plots. In general, the topography, vegetation, soil, and hydrology appeared to be mostly uniform with wetland indicators found throughout the planted field that dominated the majority of the site (Figure 5 and Figure 6). This planted wheat crop resulted in difficulty in identifying hydrophytic vegetation in some locations. Despite this, 44% of the survey plots still had greater than 50% dominance of plant species that were FAC or wetter. Species common to areas close to the ditches were reed canarygrass (FACW), panicled bulrush (*Scirpus microcarpus*; OBL), and common rush (*Juncus effusus*; FACW) while in the drier areas near or in the field, wheat, spotted ladysthumb (*Polygonum persicaria*; FACW), colonial bentgrass (*Agrostis capillaris*; FAC), prostrate knotweed (*Polygonum aviculare*; FACW-), and slender vetch (*Vicia tetrasperma*; N.L.) were dominant.

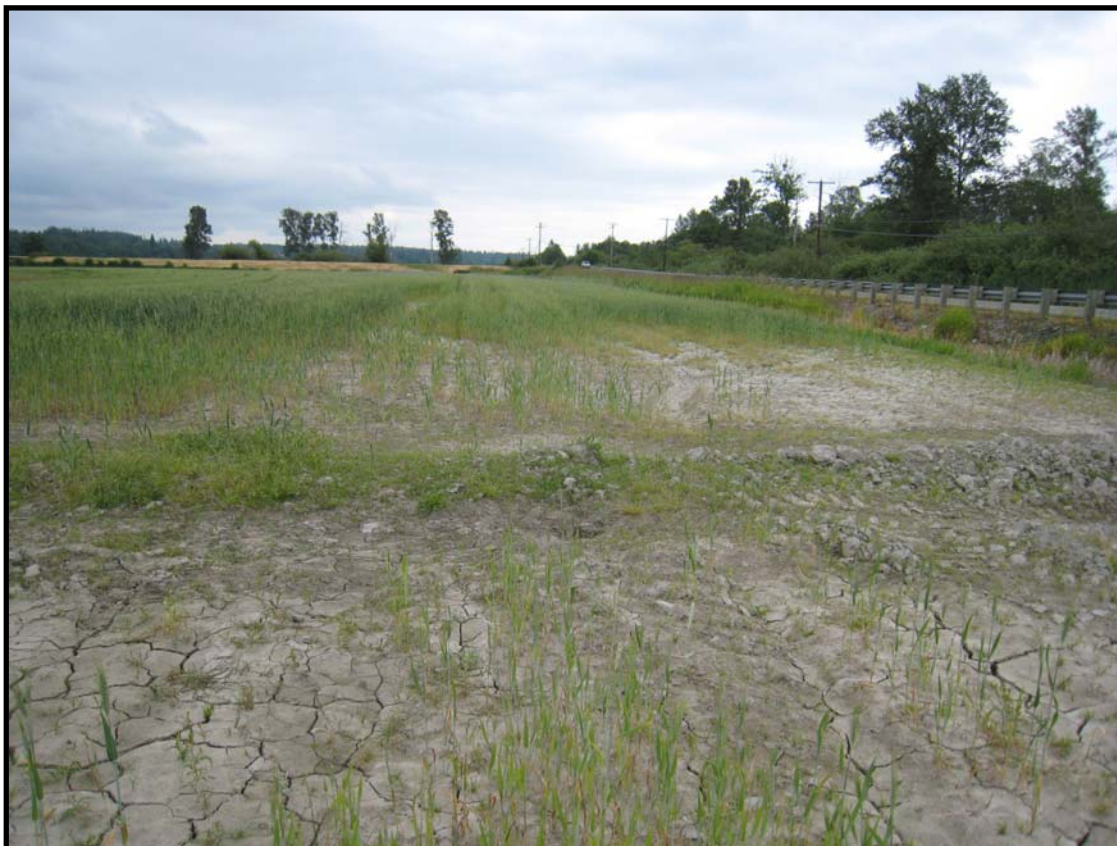
Figure 7: Soil Cracks and Sparse Vegetation in the Northwest Corner of Site 1

masking of mineral soil colors. The adjacent sample plots taken within the fields such as ND2-3 and ND2-1 had a dominance of wheat (indicator status of N.L.), so had problematic vegetation, but had silty soil with a depleted matrix and color of 10YR 3/2 or 7.5YR 3/2 with a 5% presence of redoximorphic mottles with a color of 7.5YR 4/6. Hydrology indicators included surface soil cracks and oxidized rhizospheres along living roots.

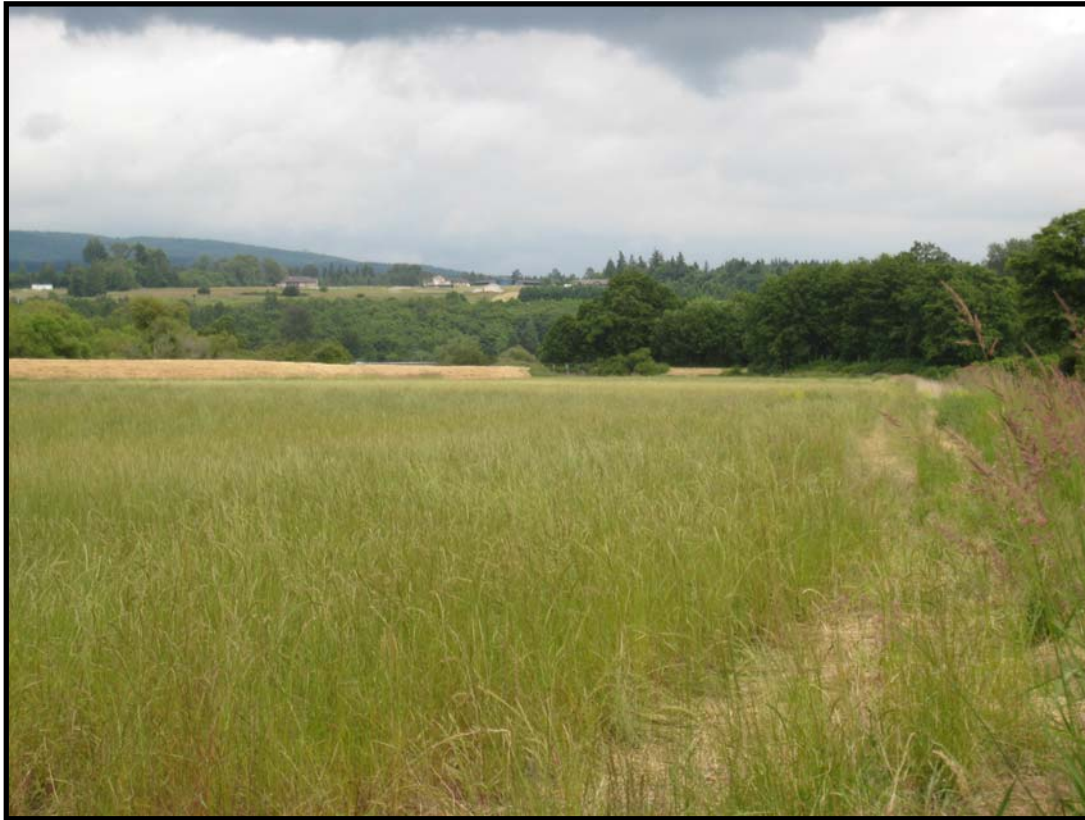
Figure 8: Looking to the East along Southern Edge of Site 2

Site 2 is located south of Fisher Slough and will be the area where the entire south levee will be removed and setback. The existing channel of Fisher Slough will be realigned to the south in this area, and a staging area is proposed for the southwest corner of the site. Sampling within Site 2 consisted of six transects with 15 sampling plots and one additional vegetation only plot. Similar to Site 1, Site 2 had mostly uniform topography and vegetation dominated by a planted field which still displayed wetland characteristics (Figure 8). We also included within Site 2 the Fisher Slough Channel and Big Ditch Channel areas, small forested stands behind or between the levees, and the area of Fisher Slough located just west of the floodgate between Pioneer Highway and the railroad tracks, where the proposed new Big Ditch inverted siphon will be constructed.

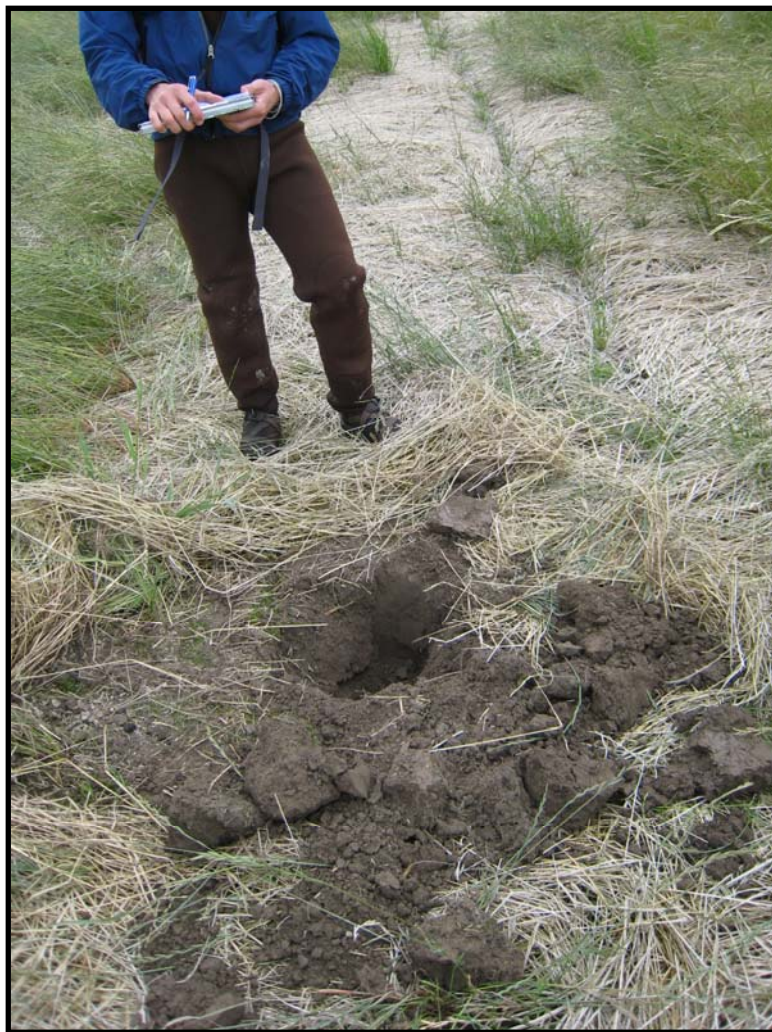
Figure 9: Sample Plot SMA4-4

One sample plot within the field in Site 2 was determined to be upland; SMA4-4. None of the criteria for wetlands were met for Sample Plot SMA4-4 despite it being located adjacent to Sample Plot SMA4-5 which was determined to be wetland. SMA4-4 was located in the crop field in a shallow swale dominated by a mat of dead ryegrass (Figure 9). The upland determination of SMA4-4 was most likely due to its proximity to Big Ditch which may provide more effective drainage than the other ditches on the site. It was determined, however, that since all the other sample plots on Site 2 (except on the levees themselves) were determined to be wetland, it is likely that SMA4-4 is a small patch of upland within the greater wetland area of the site. Thus, we will consider all of Site 2 (except for road and levee fills) to be wetland.

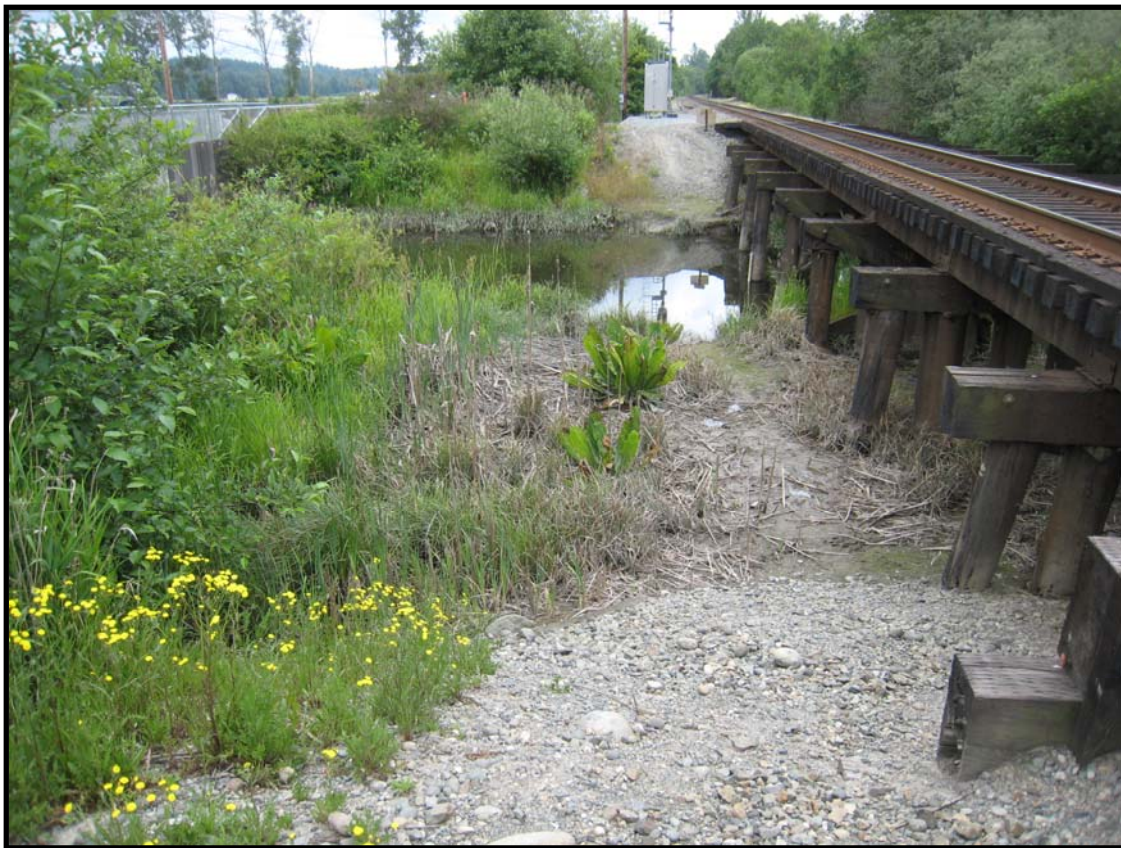
Figure 10: Railroad Crossing Looking South over Fisher Slough (at Low Tide)

The area of Site 2 located west of the tide gates on Fisher Slough had characteristics largely unique to the site (Figure 10). Plant species such as Hooker's willow (FACW-), American skunk cabbage (*Lysichiton americanus*; OBL), baldhip rose (FAC), Douglas' spirea (FACW), narrowleaf cattail (OBL), and slough sedge (*Carex obnupta*; OBL) dominate the site. The extensive road and railroad fill that is present in the area made collecting soil data problematic. Despite this, Sample Plot RR-1 which was located mostly away from the fill had silty clay soil with a depleted matrix color of Gley 1 4/N and significant redoximorphic mottles with a color of 5YR 5/8. Hydrology indicators including soil saturation, surface water, and an obvious high water mark located well above the sample plot elevation strongly indicated wetland conditions. In total, RR-1 was determined to be wetland. The boundary of the wetland is at the mean higher high water line on the road and railroad fill.

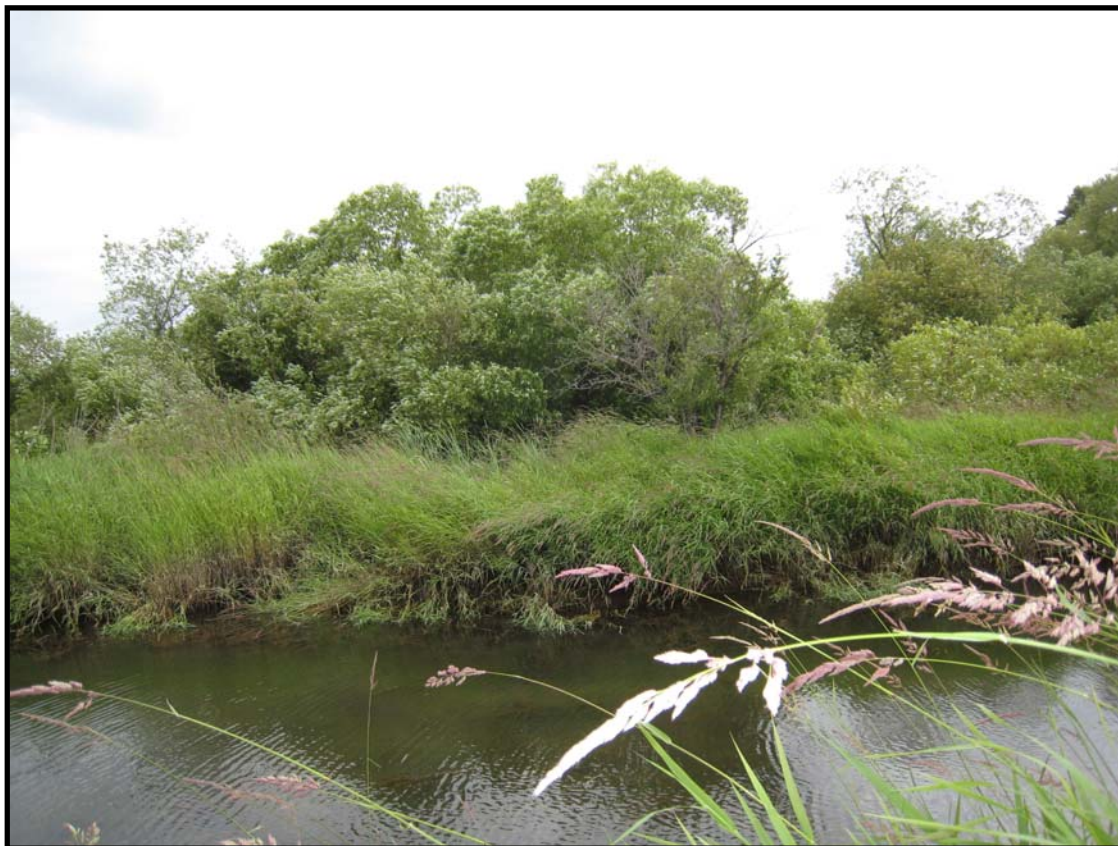
Figure 11: The South Side of Downstream Island

Fisher Slough itself, which is contained between the north and south levees is delineated based on the OHW from hydrologic data and modeling. However, two islands are located in Fisher Slough within Site 2 that have woody vegetation and are thus above the OHWM. These sites were not accessible for sample plots (Figure 11). However, vegetation data forms were filled out for each of the islands (described as “Upstream Island” and “Downstream Island” on the datasheets). Both islands hosted the same dominant plant species including Pacific willow (FACW+), Hooker’s willow (*Salix hookeriana*; FACW-), peafruit rose (*Rosa pisocarpa*; FAC), and reed canarygrass. An obvious physical characteristic that was noted in the field was that both islands had high water marks near the top of each island. The combination of the high water mark and the presence of dominant FAC or wetter vegetation indicate that both islands were wetland. We have identified all areas within the north and south levees in the project area along Fisher Slough to be either wetland or below OHWM.

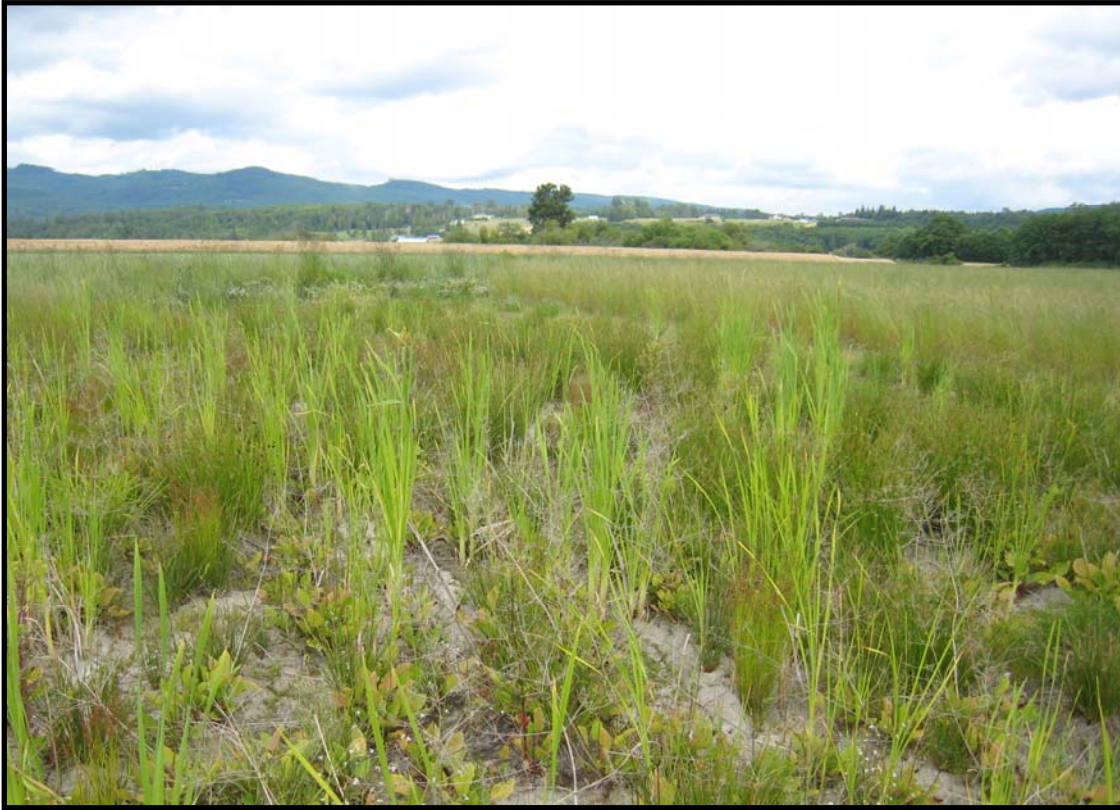
Figure 12: *Juncus* Community Found in Southwest Corner of Site 2

An obvious wetland plant community 0.13 acre in size was present in the southwest corner of the field within Site 2 (Figure 12) and while the entire field is considered wetland, this was a unique native community. Dominant species included common rush (FACW), daggerleaf rush (*Juncus ensifolius*; FACW), and narrowleaf cattail (OBL), and significant areas of bare ground. Soil indicators included depleted matrix color of 10YR3/2 with redoximorphic mottles of 10YR4/6. Hydrology indicators included soil cracks and sparsely vegetated concave surface (see Sample Plot SMA2-1).

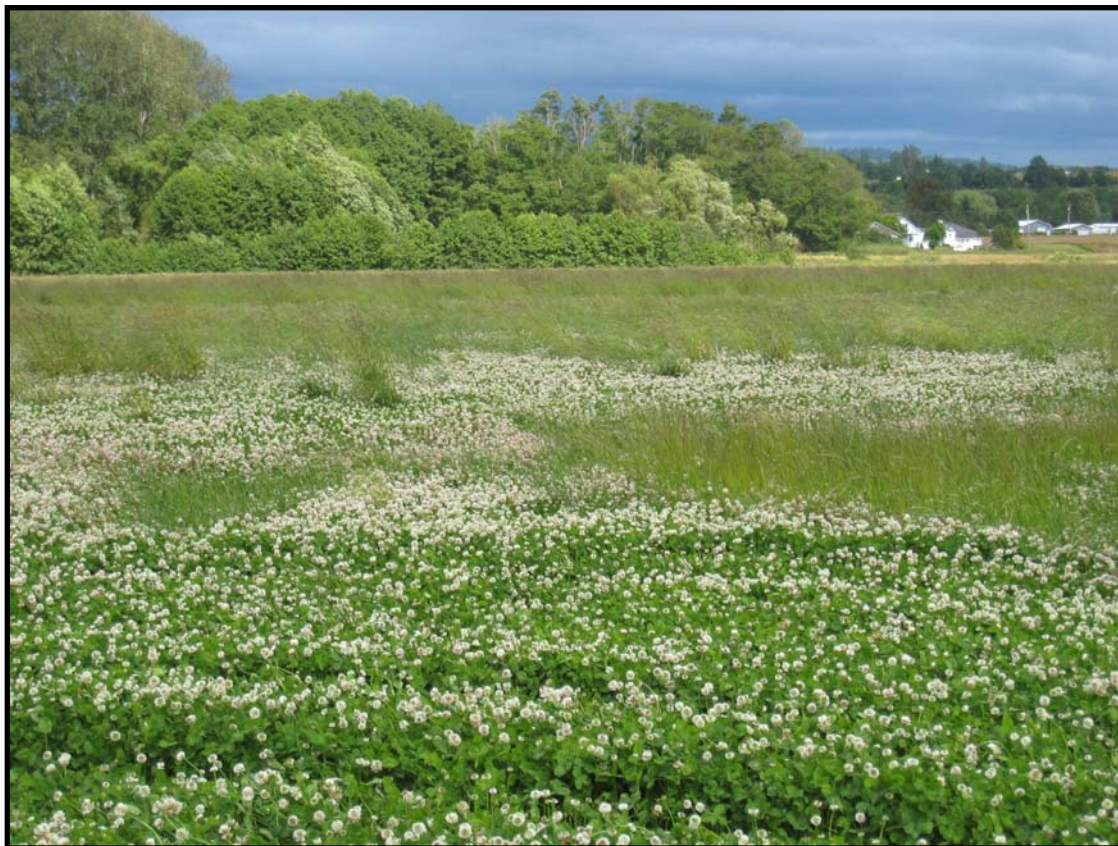
Figure 13: Looking East across Site 3 towards Little Fisher Creek

Site 3 is located east of Site 2 and extends along the area known as the Smith-B parcel. Sampling within Site 3 consisted of six transects with 17 sample plots and three vegetation-only plots. In general, Site 3 had relatively more diversity in vegetation than Site 1 or 2 but maintained mostly uniform topography due to the majority of the site consisting of a fallow field (Figure 13). Site 3 also included a forested area between the north and south levees along Fisher Slough. Sample plots in Site 3 showed that 40% of the plots had 50% of more dominant species that were FAC or wetter. Plant species common to areas close to the ditches were field horsetail (FAC), reed canarygrass (FACW), stinging nettle (FAC+), narrowleaf cattail (OBL), red elderberry (FACU), salmonberry (FAC+), Himalayan blackberry (FACU), and red alder (FAC). In the field area, dominant plant species were meadow fescue (FACU+), reed canarygrass (FACW), ryegrass (FACU), white clover (FAC), and lady's thumb (FACW).

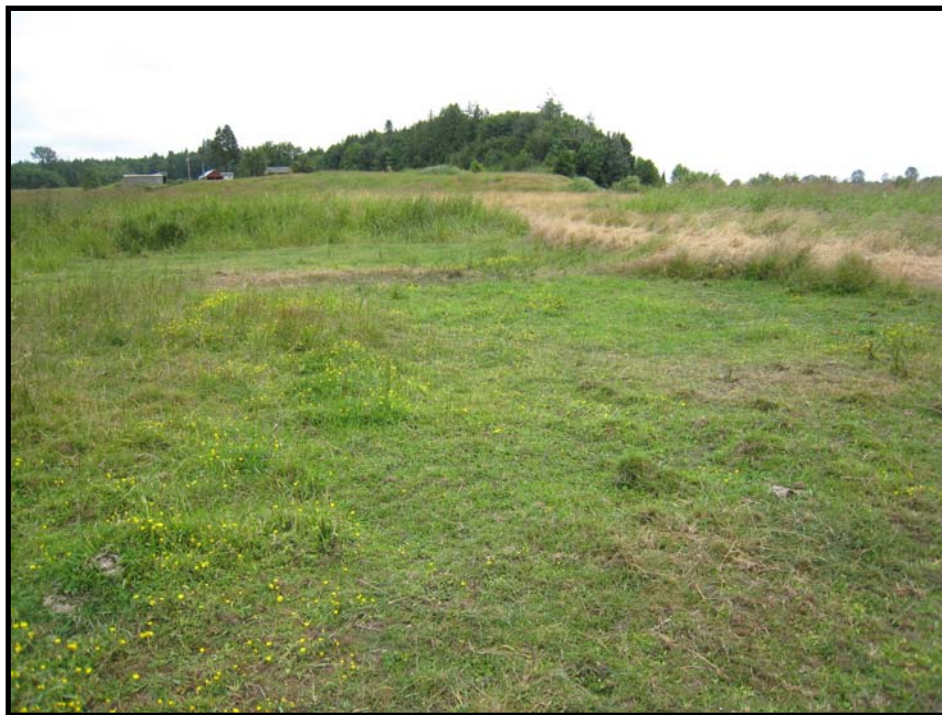
Figure 14: Looking Southeast across Site 4 Pastureland

Site 4 is located east of Site 3 and generally follows the alignment of Little Fisher Creek and Big Fisher Creek down to the confluence with Fisher Slough. It includes the pasture west of the levee along Little Fisher Creek and the channels of Little and Big Fisher Creeks. Little Fisher Creek has been channelized into a ditch with an adjacent levee to the west. Sampling within Site 4 consisted of five transects with 12 sampling points and six additional vegetation-only plots. Like Site 3, Site 4 had a relatively high diversity of vegetation because there several distinct subareas, including the pasture (Figure 14), channel, and riparian zone along Little and Big Fisher Creeks. Sample plots in Site 4 showed that 91% had greater than 50% dominant species that were FAC or wetter. Plant species common to areas close to the ditches were field horsetail (FAC), reed canarygrass (FACW), stinging nettle (FAC+), narrowleaf cattail (OBL), red elderberry (FACU), salmonberry (FAC+), Himalayan blackberry (FACU), and red alder (FAC). In addition to these species, the forested riparian areas were also dominated by black cottonwood (FAC), Pacific willow (FACW+), and Hooker's willow (FACW-). In the pasture, dominant species consisted of reed canarygrass (FACW), Canada thistle (FACU), redtop (FAC), and meadow fescue (FACU+).

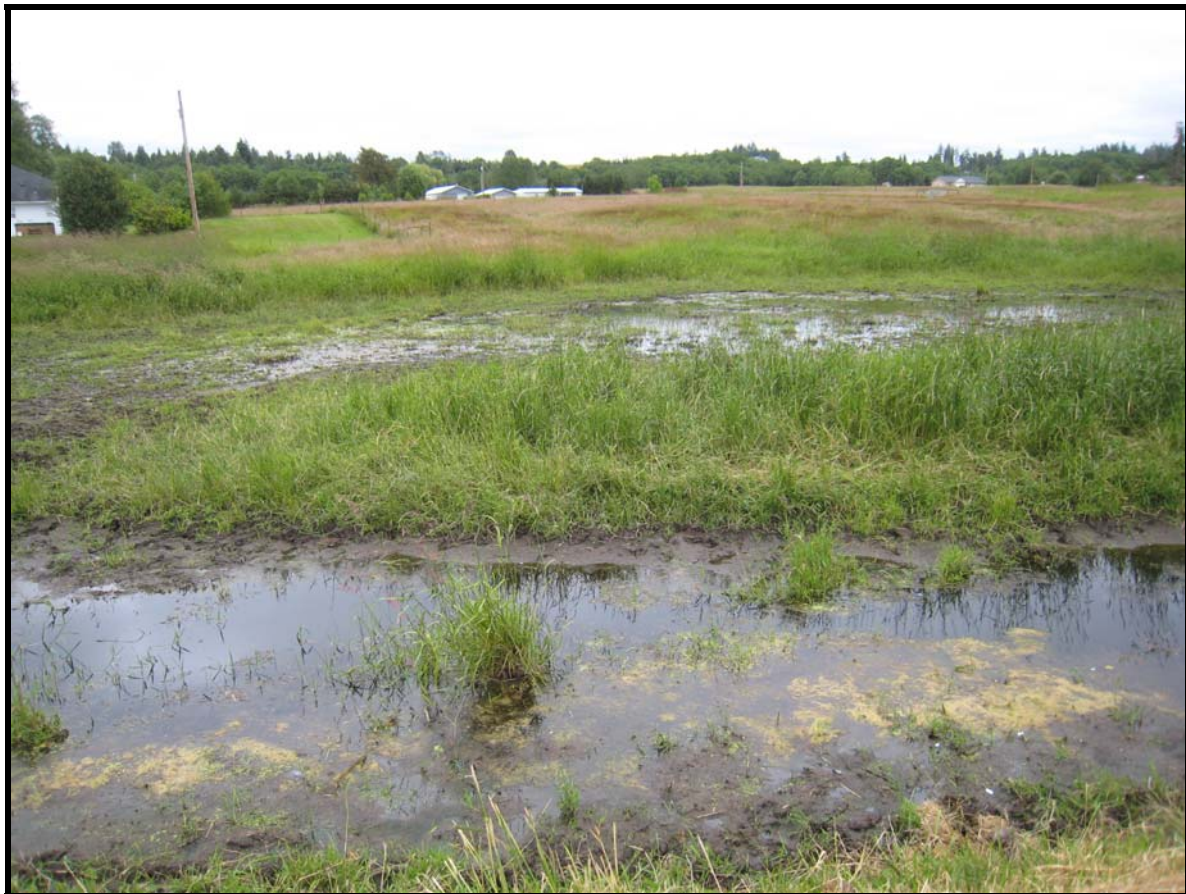
Figure 15: Looking East across Little Fisher Creek

A higher portion of Site 4 was covered with riparian forest than the other sites examined during the delineation. Forested area was found in a thin strip bordering the east side of Little Fisher Creek and around the area of realignment in the north part of Site 4 where Big Ditch, Fisher Slough, and Big Fisher Creek converge (Figure 15 and Figure 16). A typical sample plot that represents the forested areas of Site 4 is SR-3. Dominant plant species that occurred at SR-3 were black cottonwood (FAC), red alder (FAC), red elderberry (FACU), reed canarygrass (FACW), and stinging nettle (FAC+). Consistent with other sample plots taken from the forested areas of Site 4, SR-3 had distinctly different soil characteristics from Sites 1, 2 and 3, consisting of a cobble-loam matrix with a color of 10YR 4/2. The soil is distinctly coarser in Site 4 and was likely part of the historic alignment and deltas of Big and Little Fisher Creeks. Hydrology characteristics were absent at SR-3. The lack of hydric soil and wetland hydrology characteristics determined SR-3 to be upland riparian zone.

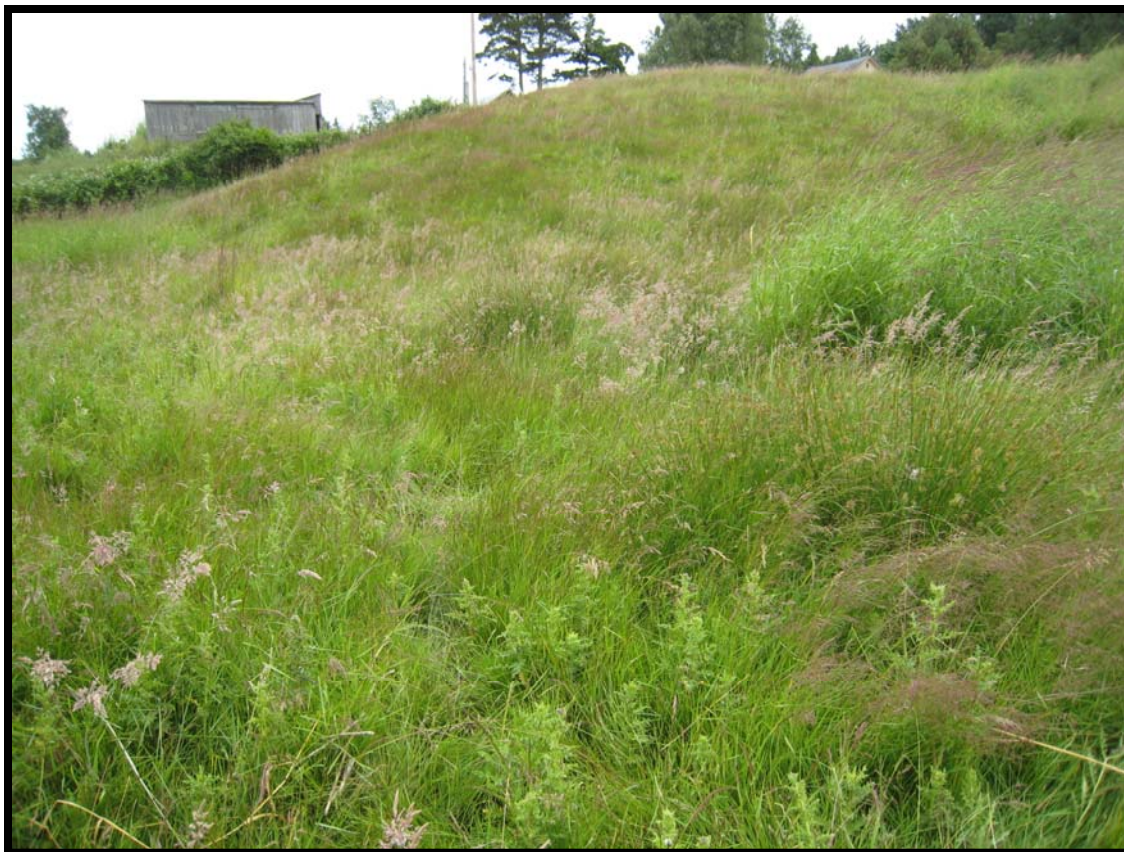
Figure 17: Upland Area West of Little Fisher Creek in the Southern Portion of Site 4

The pasture area of Site 4 was delineated as mostly upland and dominated by reed canary grass (FACW), white clover (FAC), and ryegrass (FACU). In nearly all plots, the dominant species were 50% or greater FAC or wetter species. However, in general, hydric soils and hydrology indicators were lacking. The area located adjacent to the upland area of Site 3 shares the same topography of being located at the base of the small hill (Figure 17). With two exceptions, the sample plots taken in the pasture area were determined to be upland. The two sample plots found to be wetland were both located in small swales that appeared to receive drainage from the adjacent hillslope and may pond water long enough to show wetland indicators (M5-2 and M6-2). However, these wetland areas represent less than 10% of Area 4 and no fill or excavation are proposed in the vicinity of M5-2 or M6-2, thus, the only areas specifically delineated as either wetland or other Waters of the U.S. within Area 4 are the ditches adjacent to the levees and Big and Little Fisher Creeks (delineated by OHWM).
