VISUAL RESOURCES REPORT

MARBLEMOUNT QUARRY

Submitted to: Chuck Nylund
Kiewit Infrastructure Company
January 17, 2019

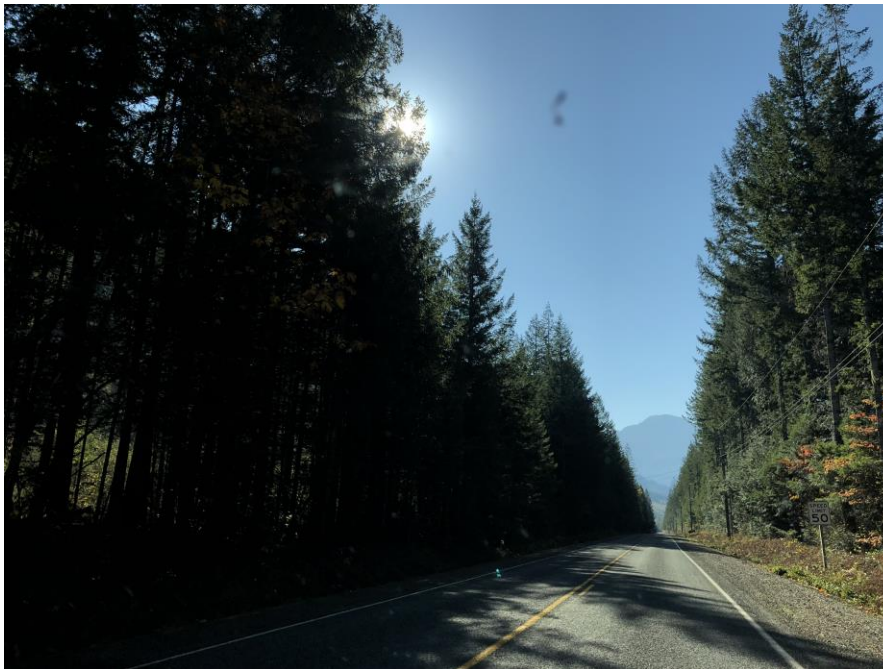
Photo Point 2: See Figure 3 for location on map.

This photo shows the vegetation that obscures the view of the quarry on Rockport Cascade Road. These trees would be retained and provide visual screening.

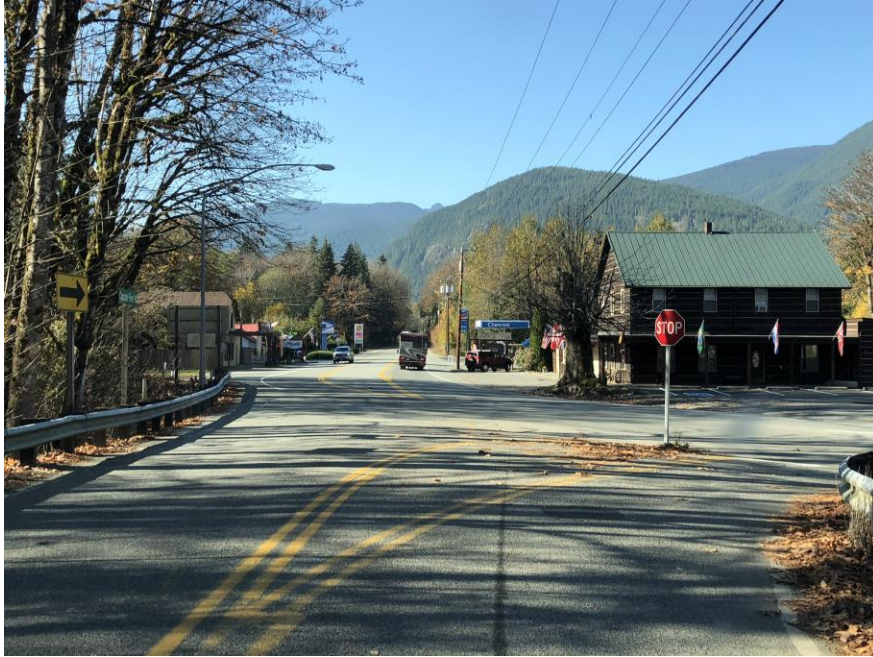
Photo Point 3: See Figure 3 for location on map.

View facing southwest on SR-20 at the intersection of Cascade River Road and SR-20. The quarry is not visible from this location.
