Request for Critical Areas Review

Proposed Quarry Activities

SKAGIT COUNTY CRITICAL AREAS REPORT GEOLOGICALLY HAZARDOUS AREAS (SCC 14.24.400) MARBLEMOUNT QUARRY

Marblemount Quarry
Geologically Hazardous Areas

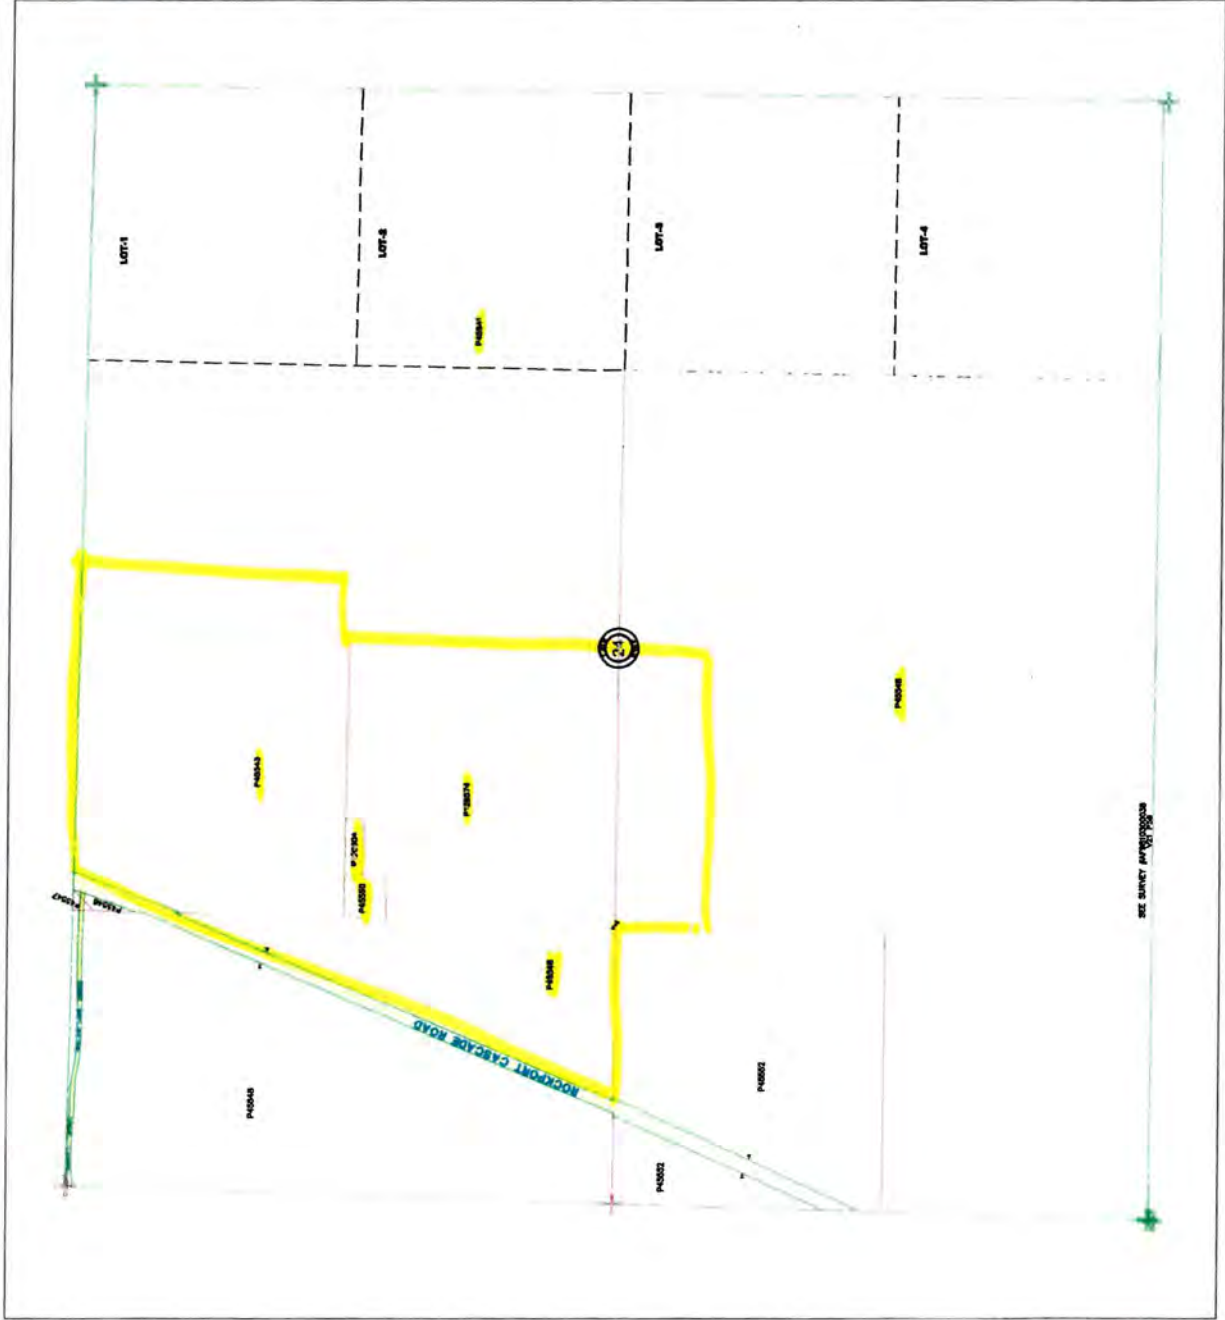
Section 24
T 35 N R 10 E

- Proposed Culvert
- Watercourses
- Talus
- Snags
- balds
- Project Boundary

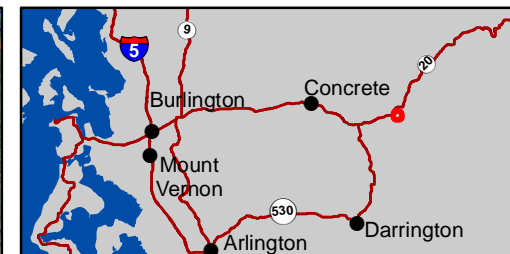
- Project Boundary
- ✱ Infiltration Areas
- Field-verified Watercourses
- WDFW Fish Bearing Streams Data
- USFWS NWI Wetland Data

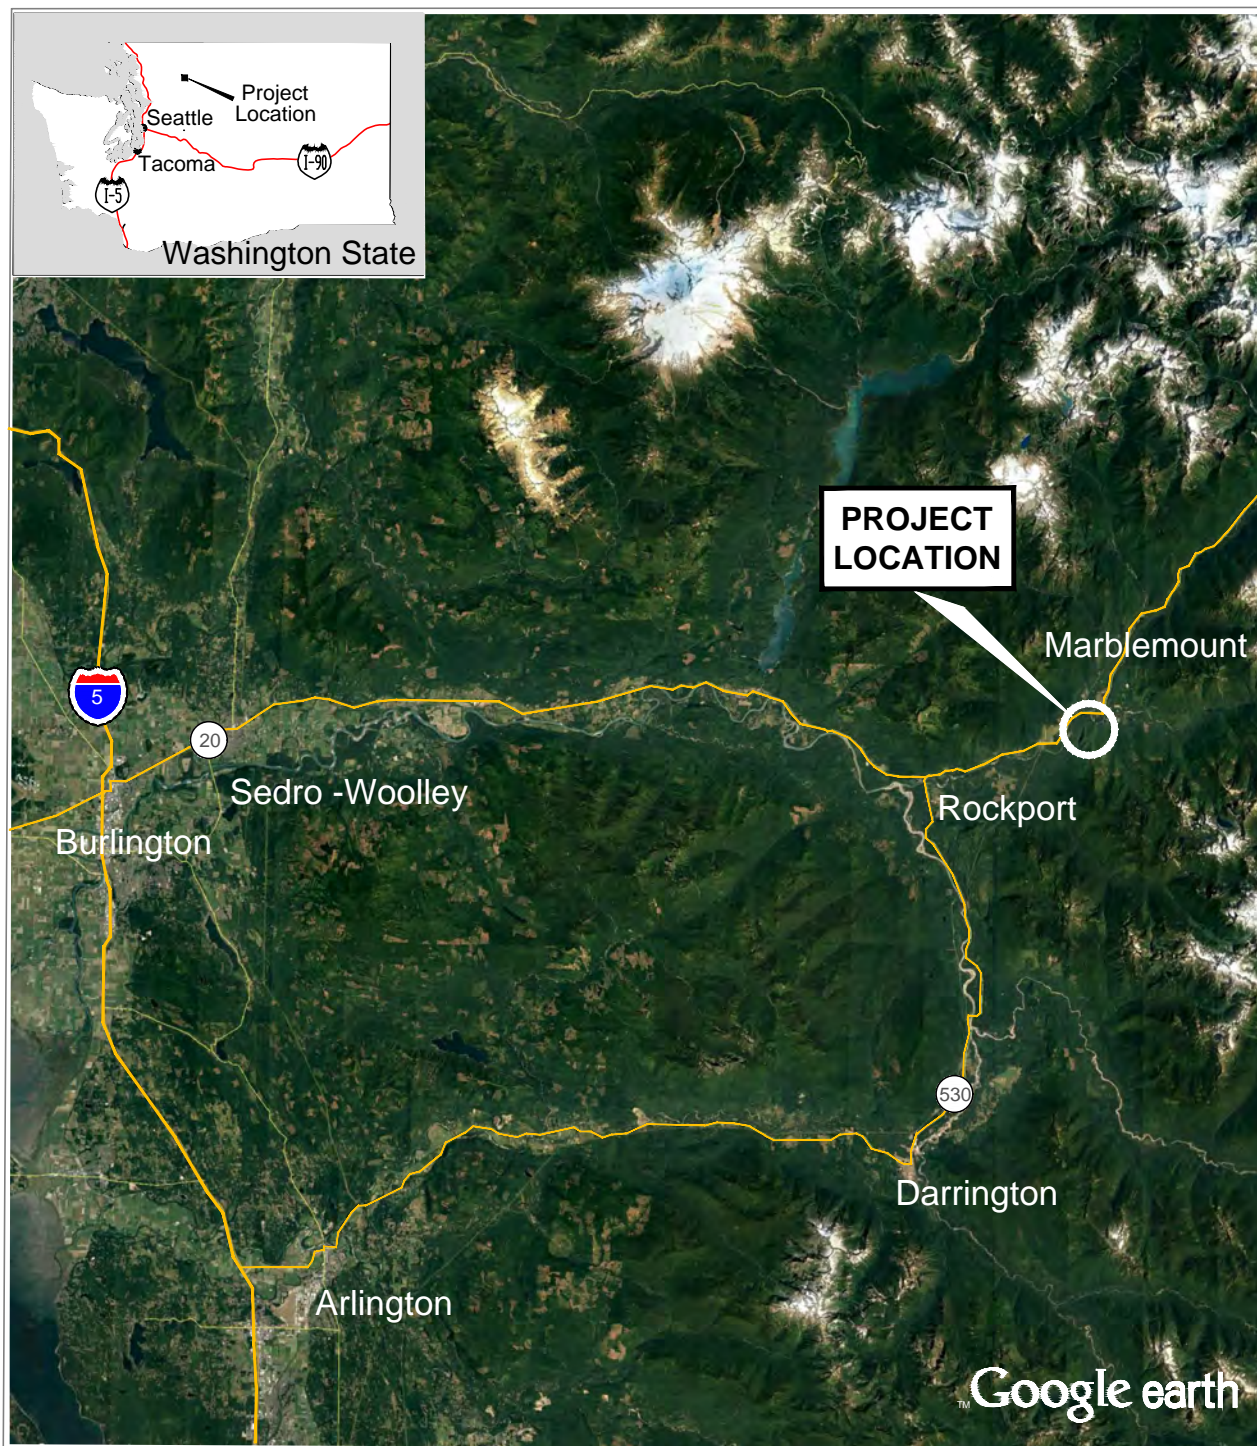
Map adapted from aerial imagery provided by Google Earth Pro, reproduced by permission granted by Google Earth™ Mapping Service.

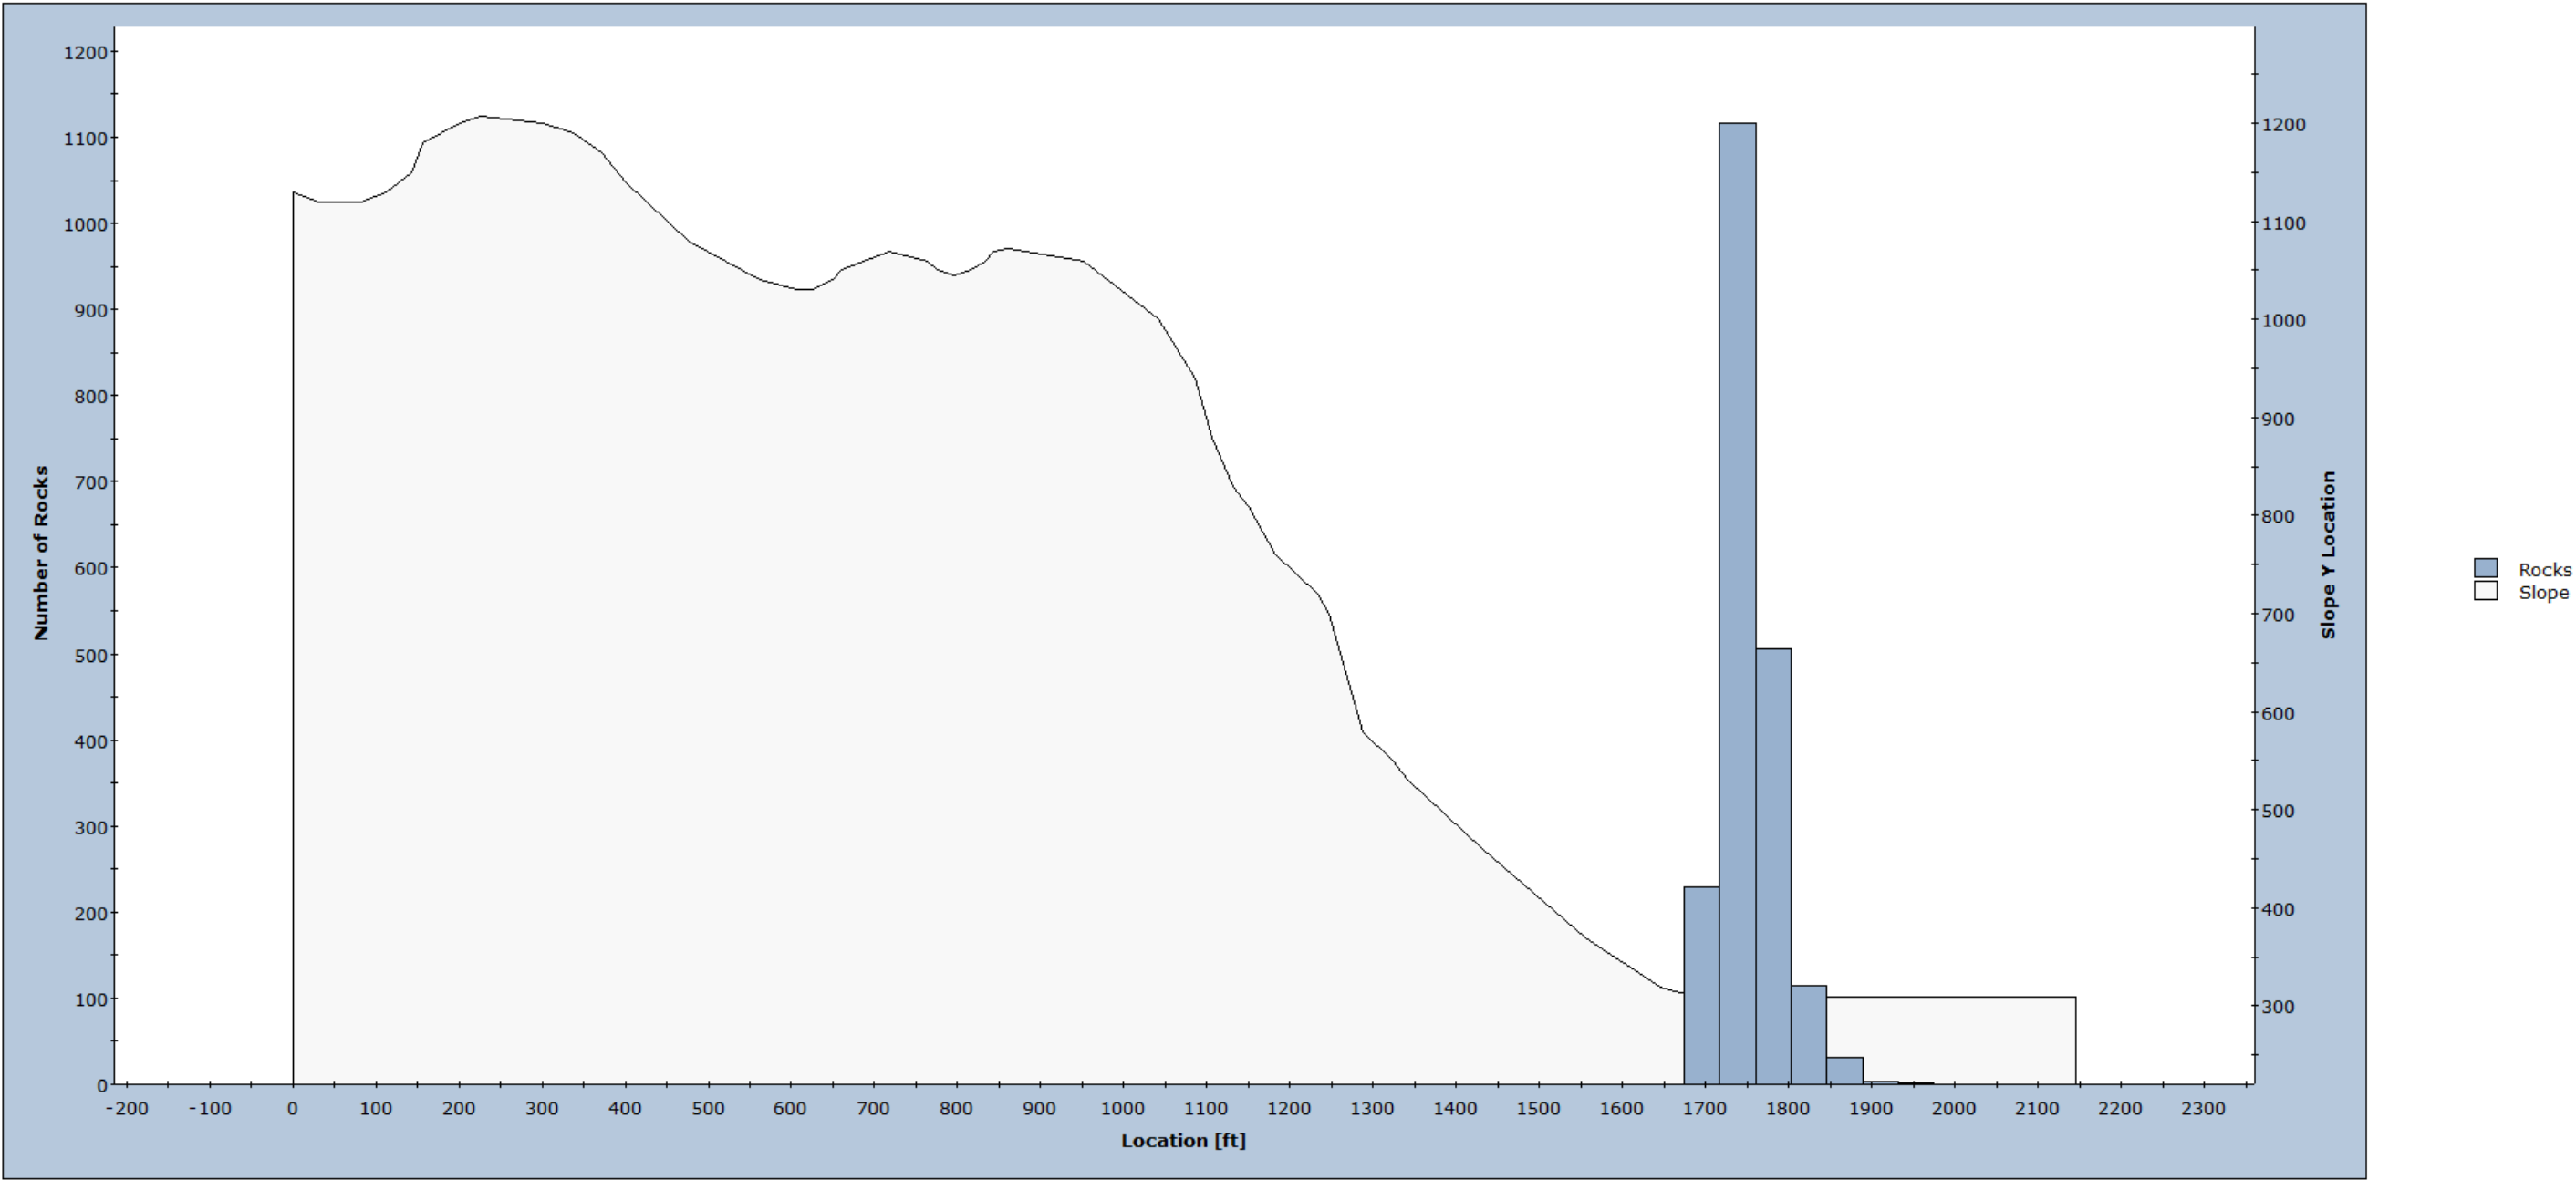
Distribution of Rock Path End Locations

1. Figure not to scale.
2. Surface topography developed from AutoCAD file titled "ACAD-2017008_ecP_RP_2018.12.10.dwg" provided by Pacific Survey & Engineering on December 10, 2018.
3. Rockfall trajectories and display obtained with RocScience RocFall™ version 6.011 software.

Total number of rock paths: 2000

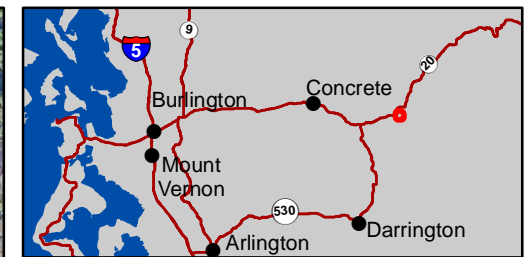
- Project Boundary
- Watercourses
- Recommended 50-foot Protective Buffer
- Impacts
- Phase I Stream Mitigation Areas
- Recommended 50-foot Protective Buffer
