# Human Bacteria Source Tracking With Trained Dogs

## Skagit County, 2015-2016

## *Human Bacteria Source Tracking with Scent-Trained Canine April 22 and 23, 2015*

## REPORT OF ILLICIT DISCHARGE DETECTION CANINE INVESTIGATION RESULTS

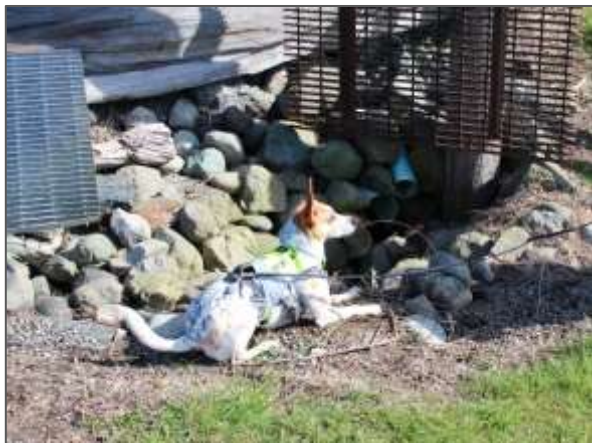
**Figure 1. Crush sits or lays down to indicate that she smells sewage in Bay View.**

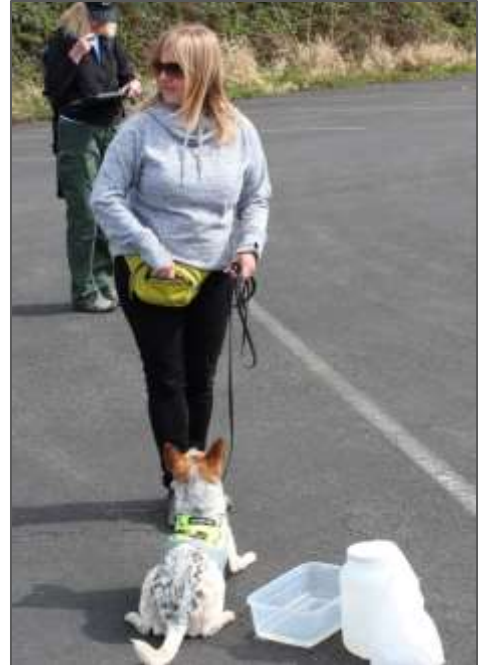
Figure 2. Crush indicates that she smells sewage during the parking lot trials.

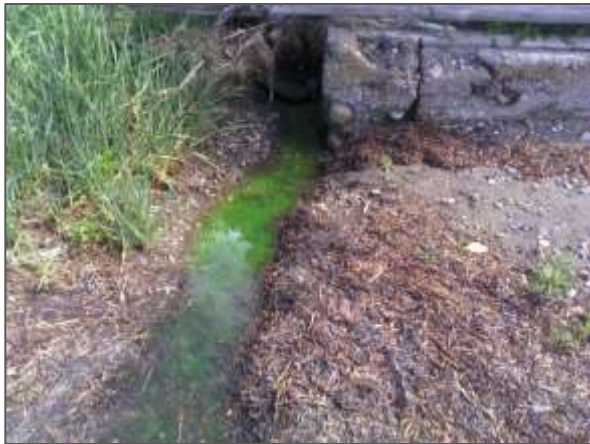
Figure 3. A positive septic system dye test at a house previously indicated by Crush.

Following Crush's 2015 visit, 30 septic systems were identified for dye tests. Two property owners denied access and 28 dye tests performed. Six of those dye tests were confirmed failures (four in downtown Bay View and two in the Samish). Repairs are complete for several of the failures, and are in process for the rest. Follow up dye testing is still continuing in the downtown Bay View area.

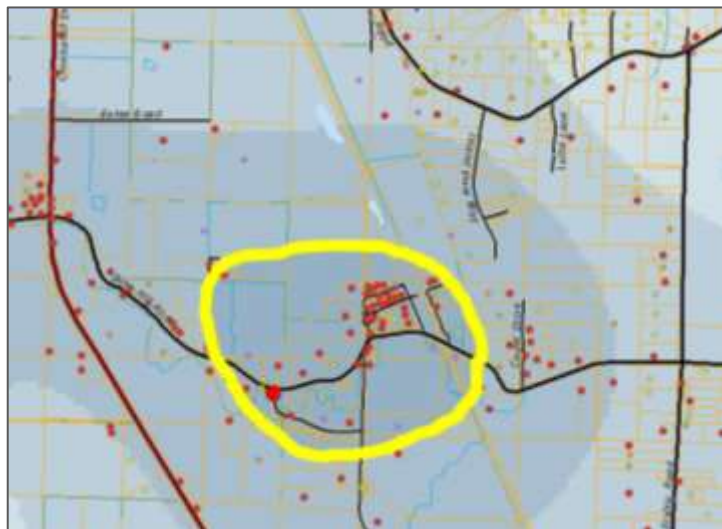
Figure 4. The Bow Cemetery Rd focus area. Darker blue colors are higher densities of 30+ year old septic systems, and dots are locations of septic systems. The focus area is highlighted in yellow.

Under the assumption that older septic systems are more likely to fail, and following the example of a similar mapping project done in Kitsap County, septic program staff worked with our GIS Department to produce a map that showed the density of 30+ year old septic systems in the Samish watershed. Those maps were then combined with Crush's results, and "septic focus areas" were drawn around areas that had a large density of old systems and positive results from Crush. Seven areas were identified following this method. In order to keep the number of letters to be mailed manageable, four were prioritized to receive enforcement first, and the remaining three would receive enforcement once the majority of the high priority areas had been completed.

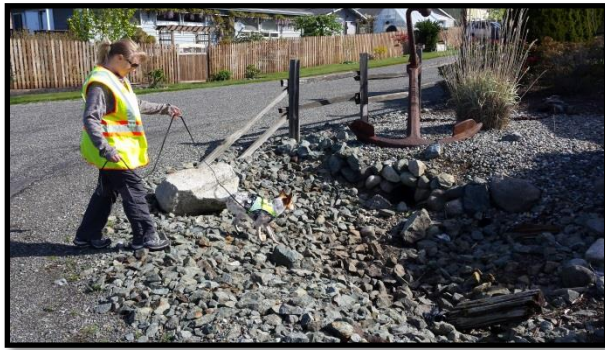
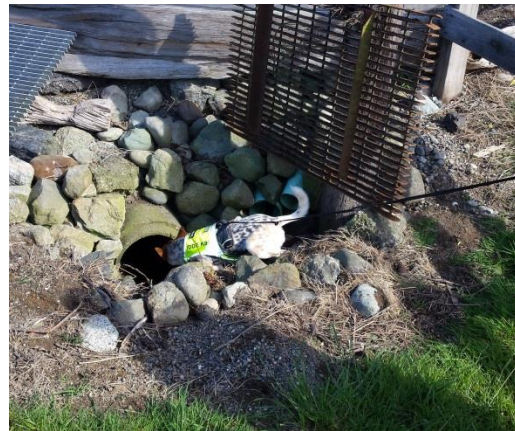
During the morning of April 22, ECS and SCPW personnel conducted field investigations in the Bay View, WA area. The first investigations were conducted in Bay View residential areas. Crush alerted to the presence of human sewage contamination in several locations at roadside ditch drains, ditch pipes, and/or bottles of water samples collected at a site (see Exhibit A).

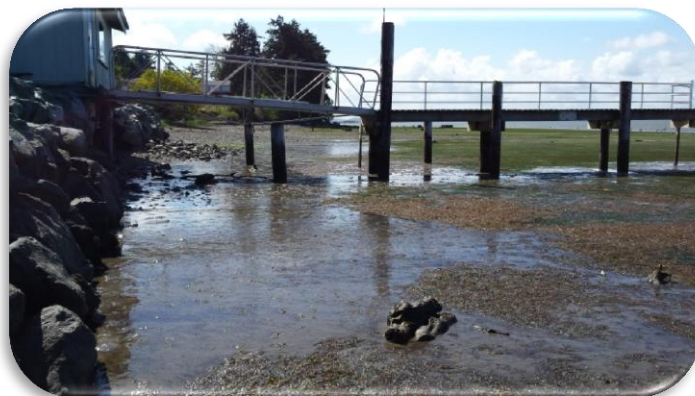
Additional investigations were conducted on the beach in Bay View near the Bayview Edison Road/B Street boat ramp. Crush did not alert to the presence of human sewage contamination at the large outfall near the ramp but did alert on a possible seep in the rock retaining wall between the ramp and a pier north of the ramp (see Exhibit A).

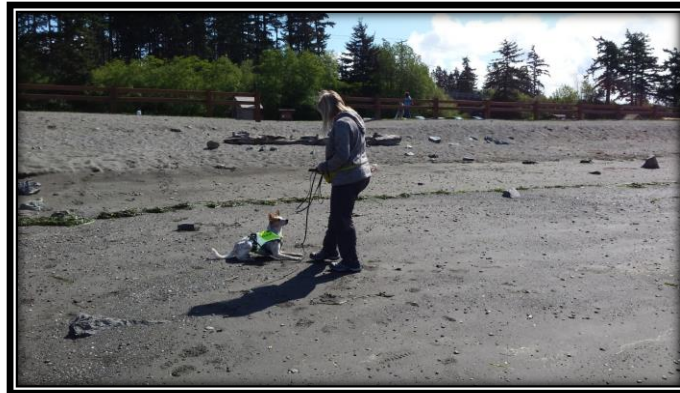
Final investigations in Bay View were conducted at the Bay View State Park beach. Crush was interested in the air scent in the area of the drain field located next to the parking lot, above the beach. She followed the scent down to the beach and alerted to the presence of human sewage contamination at a specific location on the north end of the beach. In addition to her alert, Crush dug in the sand at that location, indicating that the scent was probably coming from under the sand. The rest of the beach was investigated, and Crush alerted at a specific location on the south end of the beach and dug in the sand at that location. (See Exhibit A).

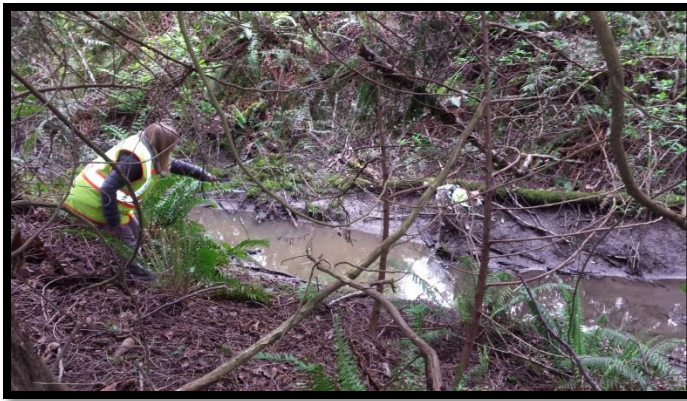
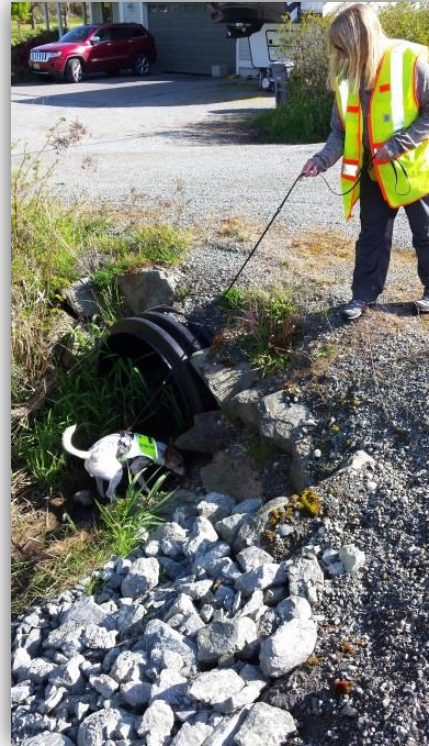
During the morning of April 23, ECS personnel worked with SCPW, Health Department, and Samish Indian Nation personnel on field investigations in the Thomas Creek area. Many of the sites were follow ups to field investigations conducted by ECS and SCPW in May 2014. New investigations on F & S Grade Road sites were also conducted. Crush alerted to the presence of human sewage contamination in several locations at roadside ditch drains, ditch pipes, and/or bottles of water samples collected at a site (see Exhibit C).

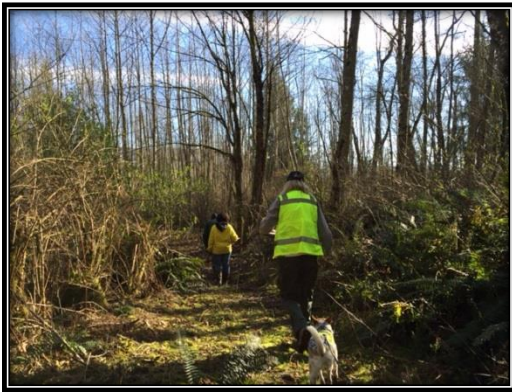
Additional investigations were conducted in Mt Vernon. The team parked in the parking lot on Anderson Road and Crush investigated the ditches and catch basins along Anderson Road, View Ave, Melody Land and Park Ave. Crush alerted on a concrete cover over a catch basin at 19728 Anderson Road. She did not alert on the ditch with running water across the road from 19728. Crush alerted in two locations in front of 19696 Anderson Road, one alert was at a pipe going from the property into the ditch and the second alert was at the west end of the property. She showed interest at the intersection of View and Anderson (SE side of intersection) but did not alert. Crush investigated the ditches along View Avenue and alerted on the south side of the culvert going under the driveway at 17063 View Ave. She showed interest at 17101 View Avenue but did not alert. Crush alerted on the catch basin at 19672 Melody Land. The catch basin is on the south side of the road, east of the 19672 driveway. There is a culvert going under the driveway and a small pipe coming from the property into the culvert. Crush alerted again on the 19696 Anderson Road property on the way back to the car.

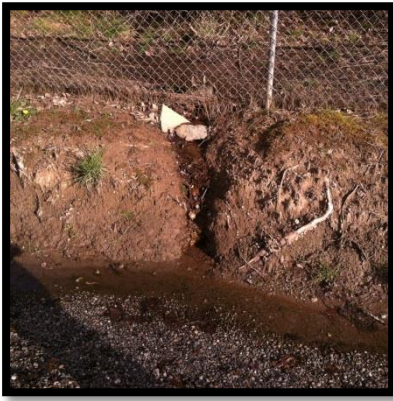
**Alderson Trickle**

The creek was followed to the east and Crush alerted on a muddy/boggy area that feeds into the creek. Crush alerted at a trickle coming from the Alderson property (Alderson trickle site ID) at 23034 Moiser near the crossroad with Grip Road. She alerted on a second location (Alderson pipe site ID) at the culvert going under Moiser (at the 45 mile/hour sign). At this location there was a corrugated metal pipe entering the ditch

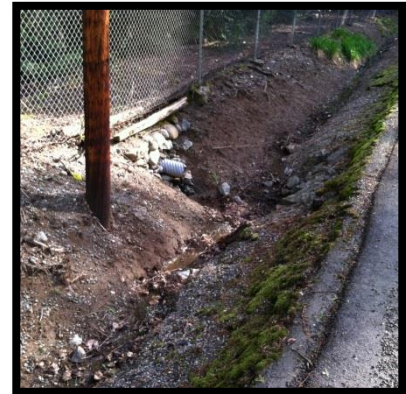
**Alderson Pipe**

from the property. She did not alert on this pipe but did alert on the ditch at the culvert going under the road. Crush alerted on the east side of the driveway at 22211 Grip Road on the north side of the road in the ditch near a pipe entering the ditch (Garcia site ID).
