MARINE SURVEY

REPORT No. CMS-14-4002

M/V "GUEMES"

Condition & Valuation Report

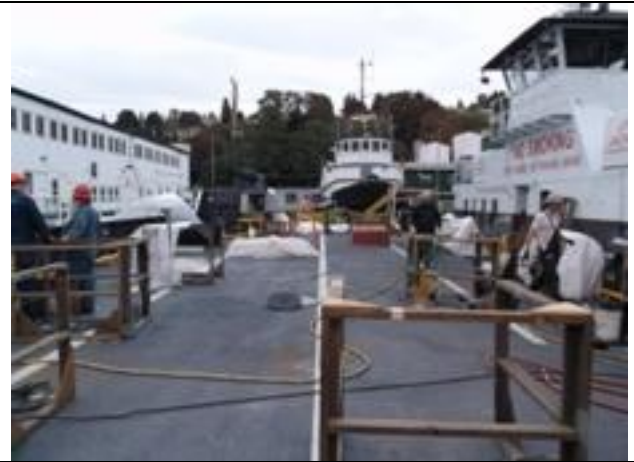
02 Deck View

Decks: Guard rails and bulwark are up to industry standard and in satisfactory condition; weather deck, engine room and other ladders and/or stair treads are covered with a high traction coating; Deck anti skid surface renewed; Deck insert 1-ft X 2.5-ft X 1/2-in Corten steel in No. 2 end engine compartment; All coatings are newly applied.

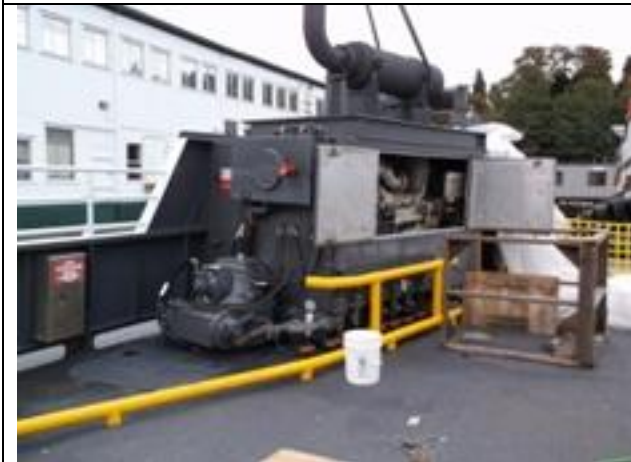
03 Port Forward Engine

Propulsion Machinery: Found to be clean and appeared to be subject of an adequate maintenance program. Sufficient oil supply and extra oil and fuel filters on board for expected usage; engines reportedly operate without excessive exhaust smoke or crank case back pressure; exposed moving machinery parts are equipped with safety guards.

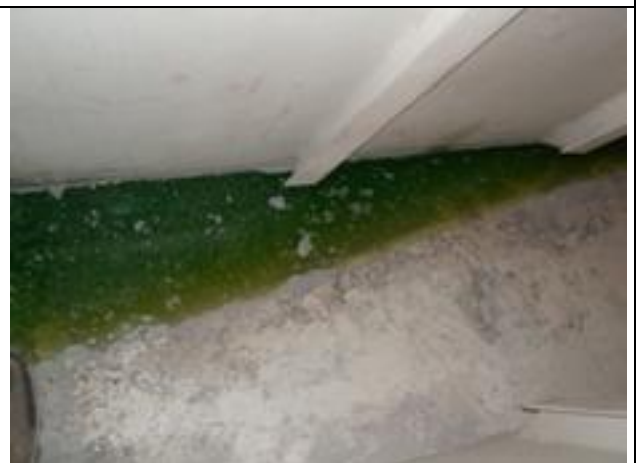
18 Aft Rake Antifreeze in Bilge

- j. Maintain EPIRB and hydrostatic release (NOT APPLICABLE).
2. Remove antifreeze like liquid from aft rake compartment.
3. Complete final welding and close bulkhead penetrations related to new piping.
