Childs Creek Sediment Management Alternatives Feasibility Study

Prepared for Skagit County Public Works
December 17, 2012

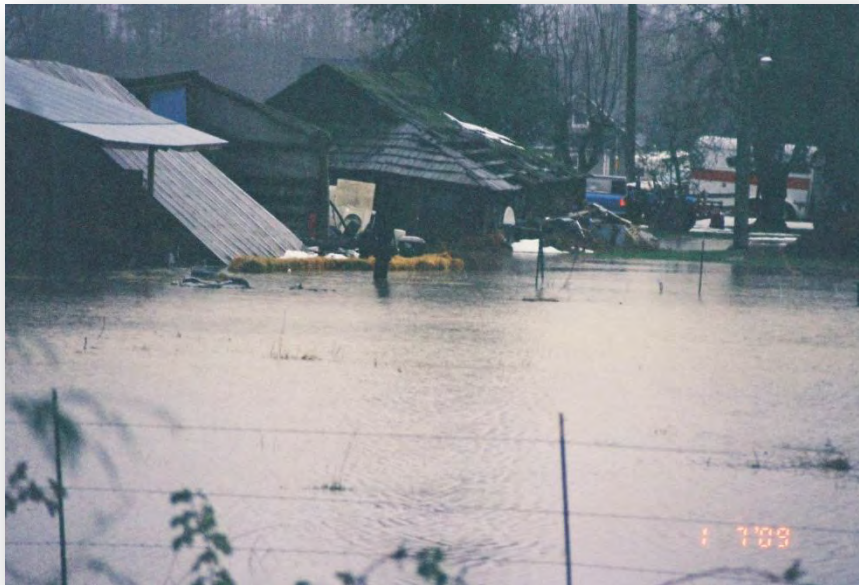
Photo 1: Flooding from Childs Creek near Robinson Road in 2009. Photo courtesy of Cynda Garver.

The residences located on the banks adjacent Childs Creek upstream of the Lyman-Hamilton Highway Bridge report to have been flooded several times in the past 10 years and they claim that the frequency of flooding has increased since 2009 (C. Garver, personal communication) Cynda Garver who own property on the eastside of the creek directly south of State Route 20 reported that the 2009 a rain on snow event caused Childs Creek to flood and sent 0.5 to 2 feet of water running through their property, which damaged their house and barn and necessitated the evacuation of humans and livestock (Photo 1; Figure 5). Topographic depressions south of their home also allow the flooding to extend across Robinson Road and flood properties to the east of Robinson Street.

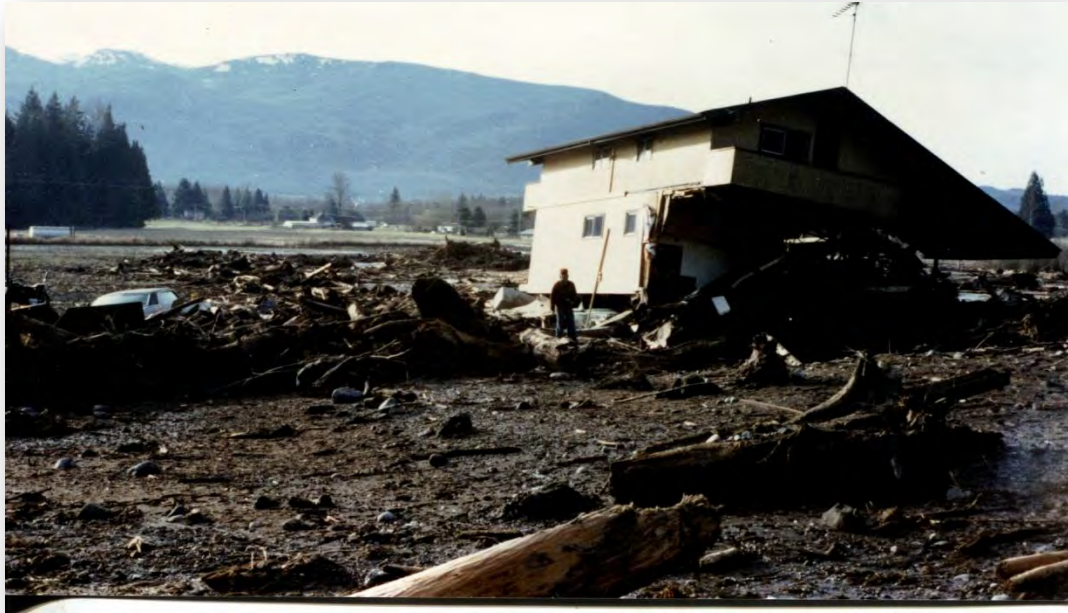
Photo 2: Hamerski residence, 1983. The house was unoccupied at the time it was impacted by debris and transported 100 feet downstream of its foundation. In the same storm event, a debris flow fatality occurred in Skagit County near SR 9.

In particular, we learned through historic research that debris flows from the upper watershed occur with moderate frequency and we saw evidence of fairly large debris flows occurring within the watershed. Large debris flows have the potential to carry significant debris (rocks, logs, sediment) long distances with velocities that can damage or destroy infrastructure and property (homes, cars). Debris impact and burial can create potentially lethal conditions to those caught in the path of a debris flow (Photo 2 below).

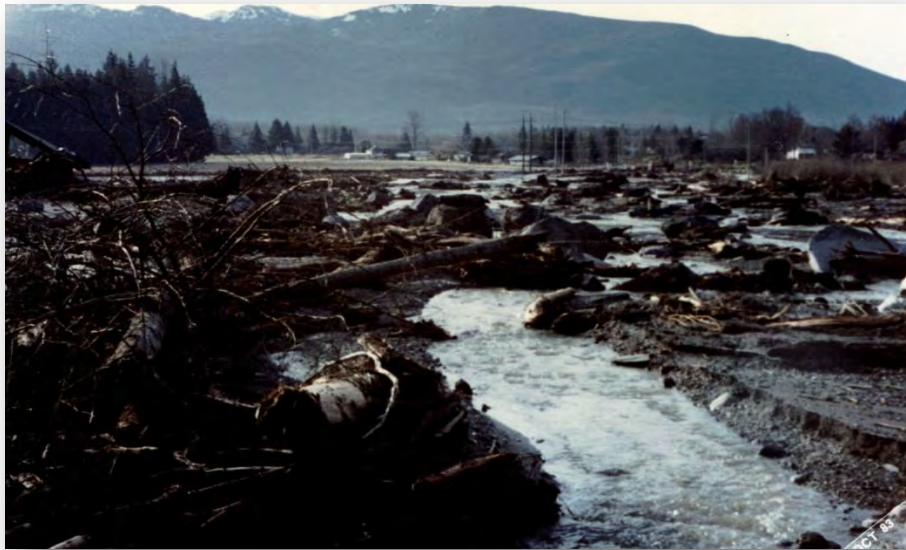
Photo 5:
Debris broadcast
across the
alluvial fan
included “car-
sized” boulders,
gravel, mud, and
wood debris.
Looking south
across the
alluvial fan
toward SR 20.
Photo by A.
Hamerski.

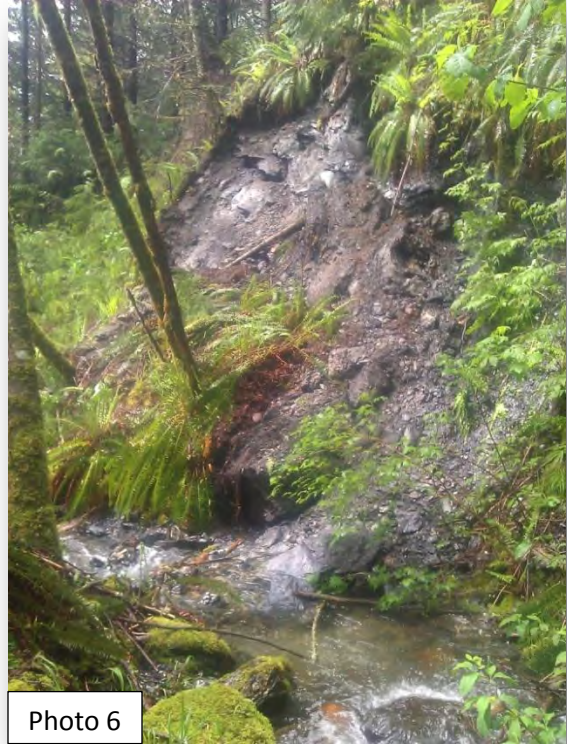
Photo 6

The upper watershed is step and the channel has incised into the bedrock and glacial geologies. Channel form is generally straight with little to no floodplain and the channel stores very little material over the long-term as storage is temporal in nature. Large boulder lag remains in the channel and sediment wedges form behind boulder lag or woody debris. The upper watershed is, over the long-term, supply limited and incision is still occurring. Sediment delivery occurs as steep inner gorges collapse and erode. Evidence of shallow rapid landslides (photo 6 at right), larger rotation failures, and colluvial creep are the primary forms of mass wasting delivering sediment to the channel. Tree-throw and bioturbation also deliver

sediment, but at a small level when compared to the other inputs. The effects of logging are difficult to quantify, but literature and observations overwhelmingly supports that the changes in hydrology and surface water routing resulting from timber harvest and road construction do affect hill-slope processes and stability, and therefore increase contribution of sediment to the system.

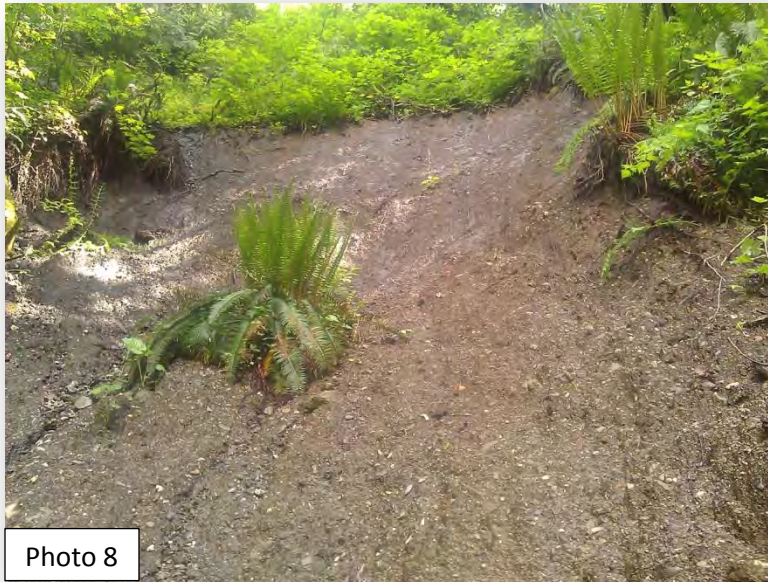
Photo 8 Example of mass wasting of glacial deposits within the Mid-Basin Reach. Note that the bulk of material is fine grained and will not be deposited within the project management reach.

The Mid-Basin, while less steep than the Upper-Basin from a stream profile standpoint, has a greater surface area of steep, unstable inner-gorge morphology adjacent to the stream. The reason for this is there is a change in geology from bedrock to glacial sediments, and the glacial sediments are more erodible and less stable at steep slopes. While bedrock (Darrington Phyllite) was observed locally within this reach, the reach is dominated by glacial sediments exposed in the channel banks. Mass wasting events in this reach tend to be of a larger scale and include more deep seated rotational failures, thus there is a larger overall volume of sediment contributed to the stream episodically (Photo 8).

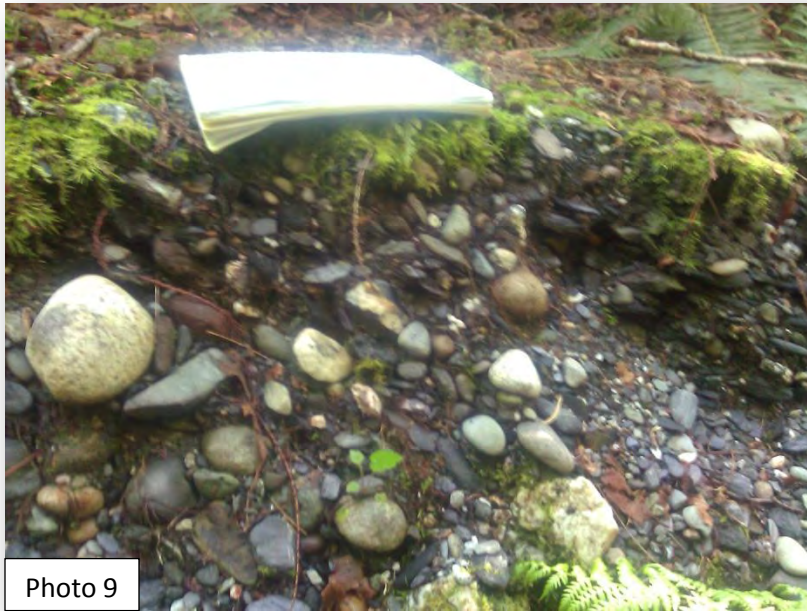
Photo 9 Example of erosion and “re-recruitment” of a former alluvial sediment deposit temporarily stored at the margin of the channel as a terrace deposit.

In addition, there is a larger volume of stored in-stream sediments occurring in high flow terraces/floodplains and larger debris wedges. We estimate that approximately 5 cubic yards of sediment storage per 1 lineal yard of channel exist, on average, in this reach, totaling approximately 20,000 cubic yards of stored material in the three forks. Similar to the upper-basin, this reach is incising and therefore vertical erosion is contributing to sediment as is the inner-gorge widening process (lateral erosion, mass wasting) (Photo 9).

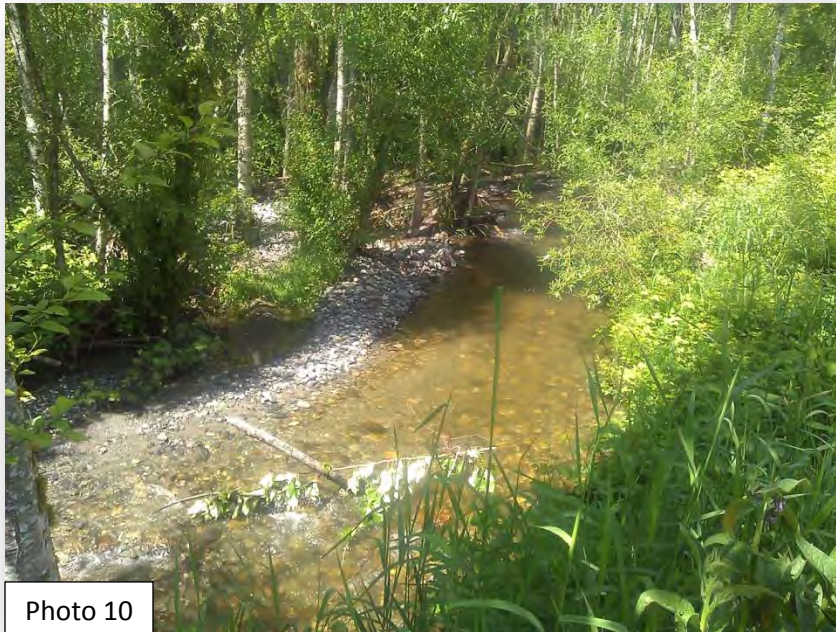
Photo 10
Example of
deposition near
the apex of the
alluvial fan
inundating the
forest in
sediment.

The Lower-Basin is predominantly transport limited, and therefore depositional landforms (alluvial fan and floodplain) have formed (Photo 10). As a result of the net deposition, the development of an alluvial fan extends onto a relict fluvial floodplain with the distal extent of the geomorphic alluvial fan reaching just south of SR 20. While the net sediment process is transport limited, periods of supply-limited conditions may occur and thus erosion and incision in portions of the alluvial fan. When this occurs, the upper portions of the alluvial fan can contribute sediment to the lower portions of the alluvial fan. Alluvial fans are convex in cross-sections perpendicular to the stream profile, so that water that leaves the banks often exists the watershed, thus at times the alluvial fan reach has a hydrologic loss.

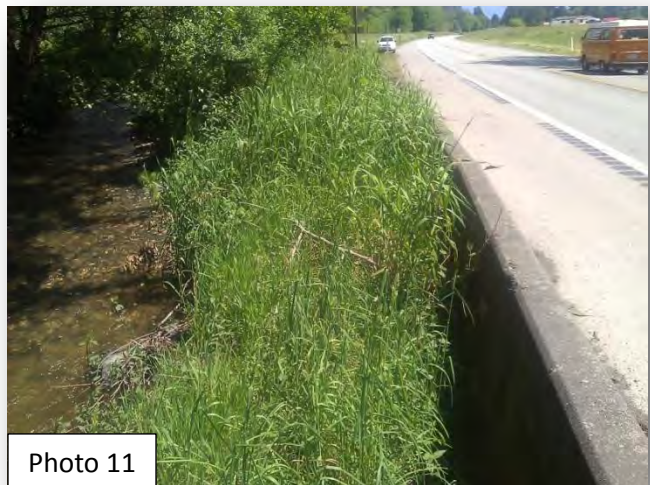
The “project reach” conditions from an infrastructure management perspective can be characterized as severely impacted by bedload sediment deposition. Channel bed elevations, locally, are higher than the surrounding floodplain and even major infrastructure (Photo 11 at right: SR 20 looking east observed to the right or south of Childs Creek where the base channel elevation is several feet above the adjacent highway). These channel conditions require WSDOT to address more frequent flooding of SR 20 and property owners and in response, “Jersey Barrier Levees” and sandbags have been utilized to reduce the flooding frequency. Erosion of the box culvert passing under SR 20 is currently damaged from erosion and hydraulic capacity through the culvert is currently reduced.

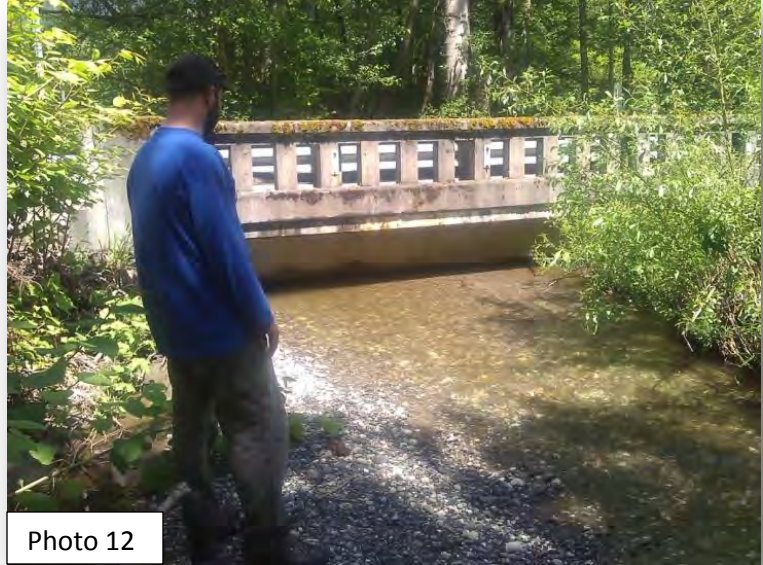
Photo 12

The current bedload conditions have greatly affected channel conveyance capacity at the Lyman Hamilton Bridge (Photo 12 at right). The capacity is so greatly reduced that we estimated that it cannot pass even less than a two-year event under these conditions without backing up and increasing water surface elevations and exacerbating flooding upstream.

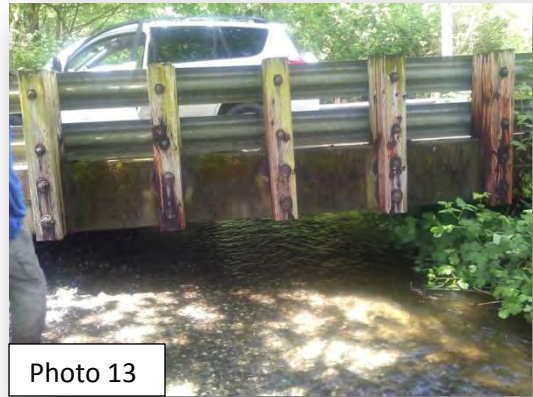
Photo 13

Capacity beneath the Nicholson Bridge, while reduced, is of a relatively lesser impact than to the Lyman Hamilton Bridge, although overtopping of this bridge also occurs relatively frequently with overflow paths evident to the right of the bridge. Flooding at this location frequently impacts private residences (Photo 13 of Nicholson Bridge capacity in May 2012 shown at right).

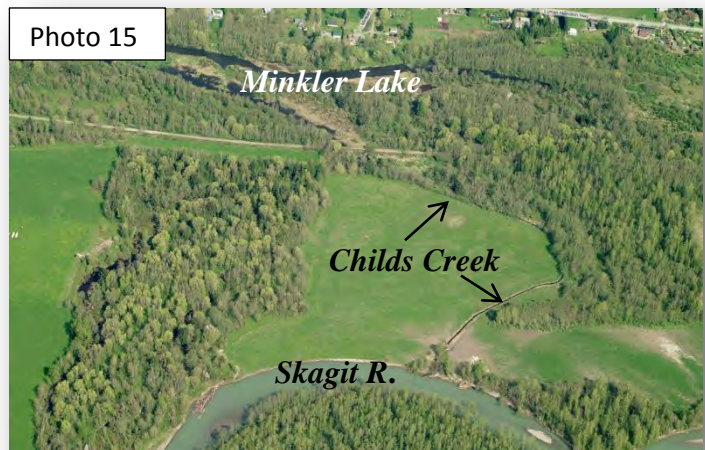
channel consisting of two disconnected reaches, the lowest (Reach 1) beginning at the confluence with the Skagit River upstream to the Centennial Trail at Minkler Lake (approximately 0.5 miles)(Photo 15, above; courtesy of Skagit County (Pictometry)). Reach 2 began from a few hundred feet downstream of the Lyman Hamilton Bridge up to the apex of the alluvial fan (approximately 0.7 miles). Minkler Lake, because of its accessibility, was excluded from the quantitative analysis. The complete Habitat Assessment report is presented in Appendix B.

A habitat assessment of the alluvial fan and low-gradient floodplain reaches of Childs Creek was conducted to inform future sediment management strategies and possible restoration efforts, using the Field techniques generally followed guidelines described in Washington Forest Practices Board Manuals (1997 and 2004). The habitat assessment was conducted on September 6th and covered approximately 1.2 lineal miles of

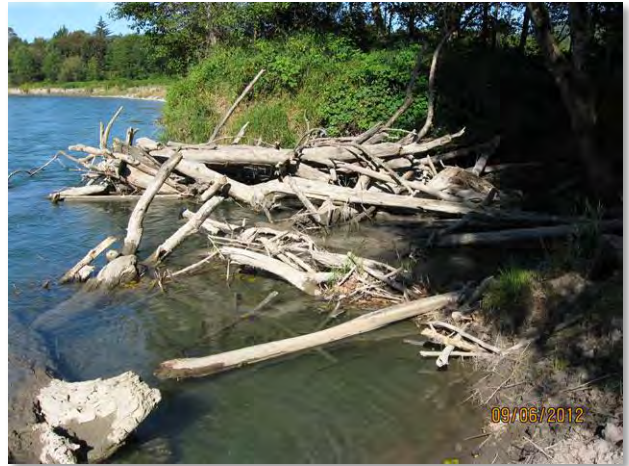
Figure 3. Reach 1 - mouth at Skagit River

exceptions were found at the mouth (Figure 3, Waypoint 001) where the channel opens up to the Skagit River, a small pond formed by an inactive beaver dam (Figure 4, Waypoint 004), a short cobbled reach near an old stream gauge structure (Figure 5, Waypoint 005), and where the channel opens up into the Minkler Lake reach (Figure 6, Waypoint 006). Despite the exceptions, flatwater habitat made up virtually 100 percent of the habitat by channel length and by area.

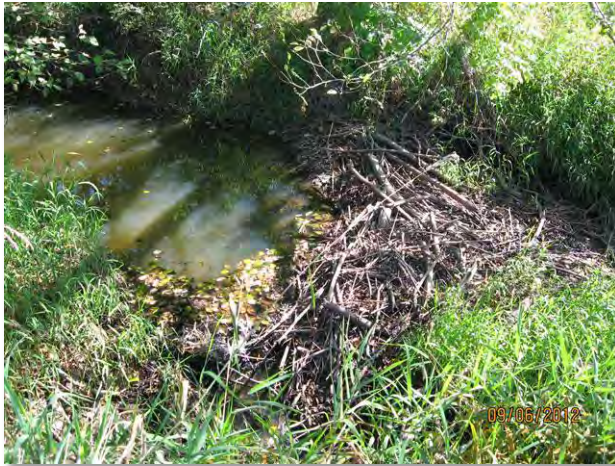
Figure 4. Reach 1 - beaver dam

3. A small beaver dam is located at Waypoint 004, approximately 1,050 feet upstream of the confluence (Figure 4). The dam did not appear to be currently active based on the absence of new material. Water was flowing over the dam and dropping a foot or two

into the channel downstream. While the dam might block some fish, at some flows, the drop was not high, and alternative migration pathways appeared to be present.

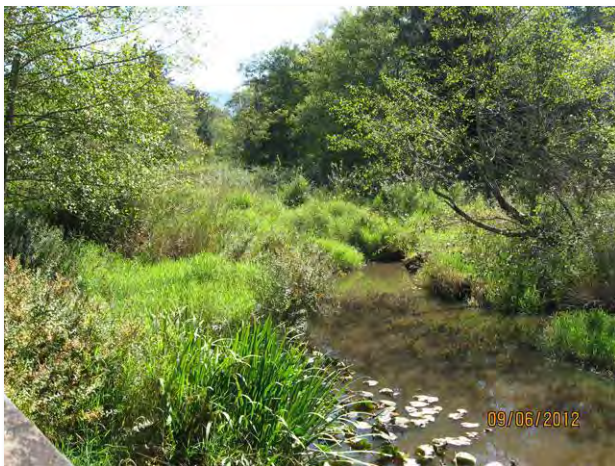
Figure 6. Reach 1 - nearing Minkler Lake

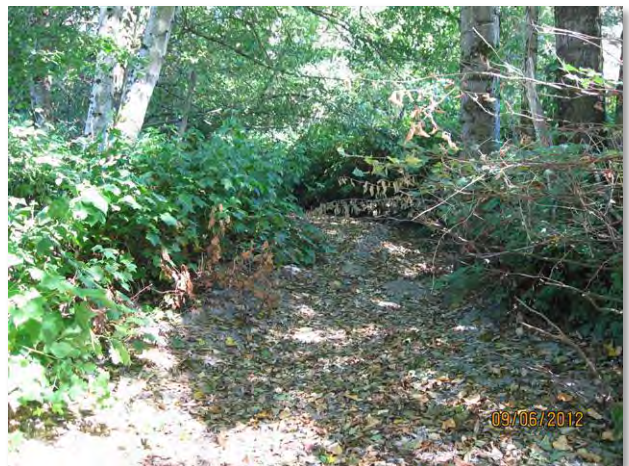
Figure 7. Reach 2 - dry channel area

Habitat classification in Reach 2 was complicated by the lack of surface flow downstream of Waypoint 009 (just downstream of the Nicholson Road crossing). The 1,135 feet of dry channel between Waypoints 007 and 009 was relatively flat and lacked diversity (Figure 7). However, a number of small depressions in the substrate may qualify as pools when the reach contains flow.

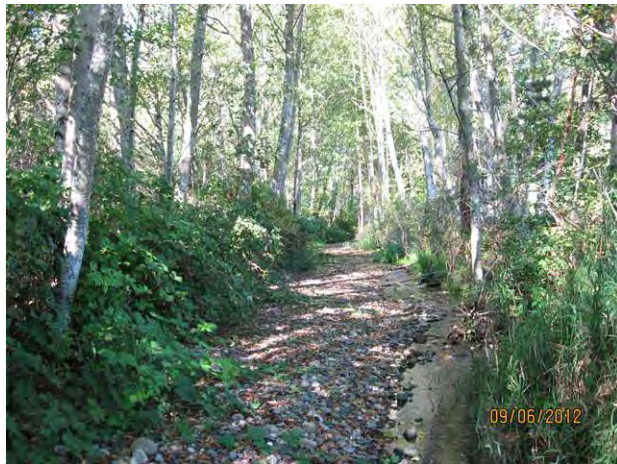
Figure 8. Reach 2 – flat water area

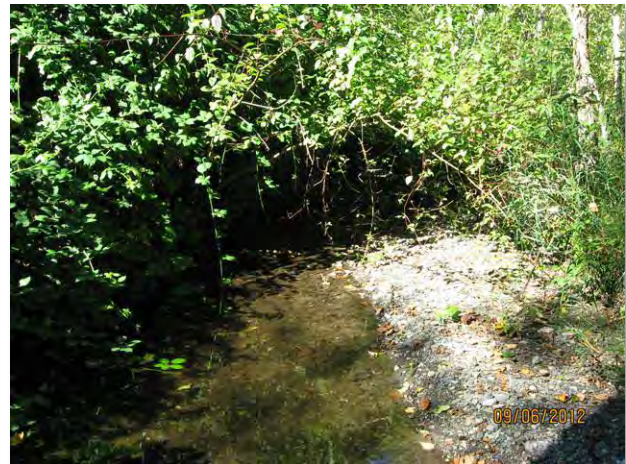
Figure 9. Reach 2 – typical shallow pool

A total of 12 pools were identified in this reach for a pool frequency of 24.6 pools/mile (Figure 9). Logs were the primary formative element for five (42%) pools. Bed scour as a result of constriction or around bends in the channel caused four (33%) pools and the remaining 3 pools (25%) were formed by scour around boulders.

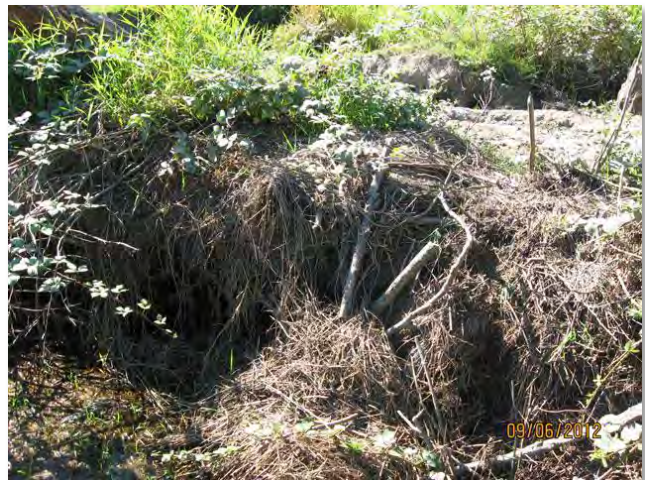
Figure 10. Partially plugged culvert (RM 0.04)
