EDISON SLOUGH DRAINAGE IMPROVEMENT PLAN

Prepared for: Skagit County Public Works
1800 Continental Place
Mt Vernon, WA 98273

March 5, 2015

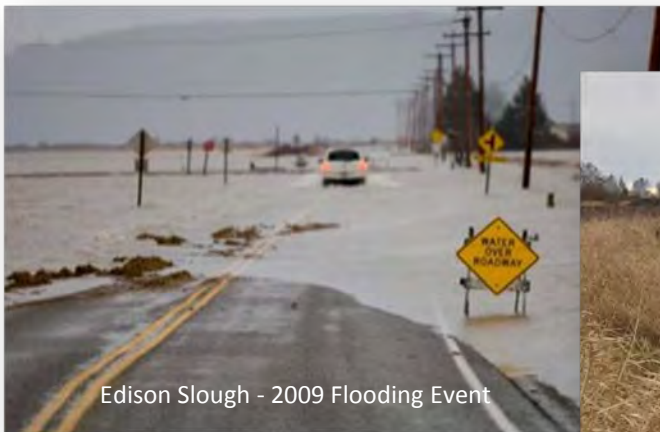
Edison Slough - 2009 Flooding Event

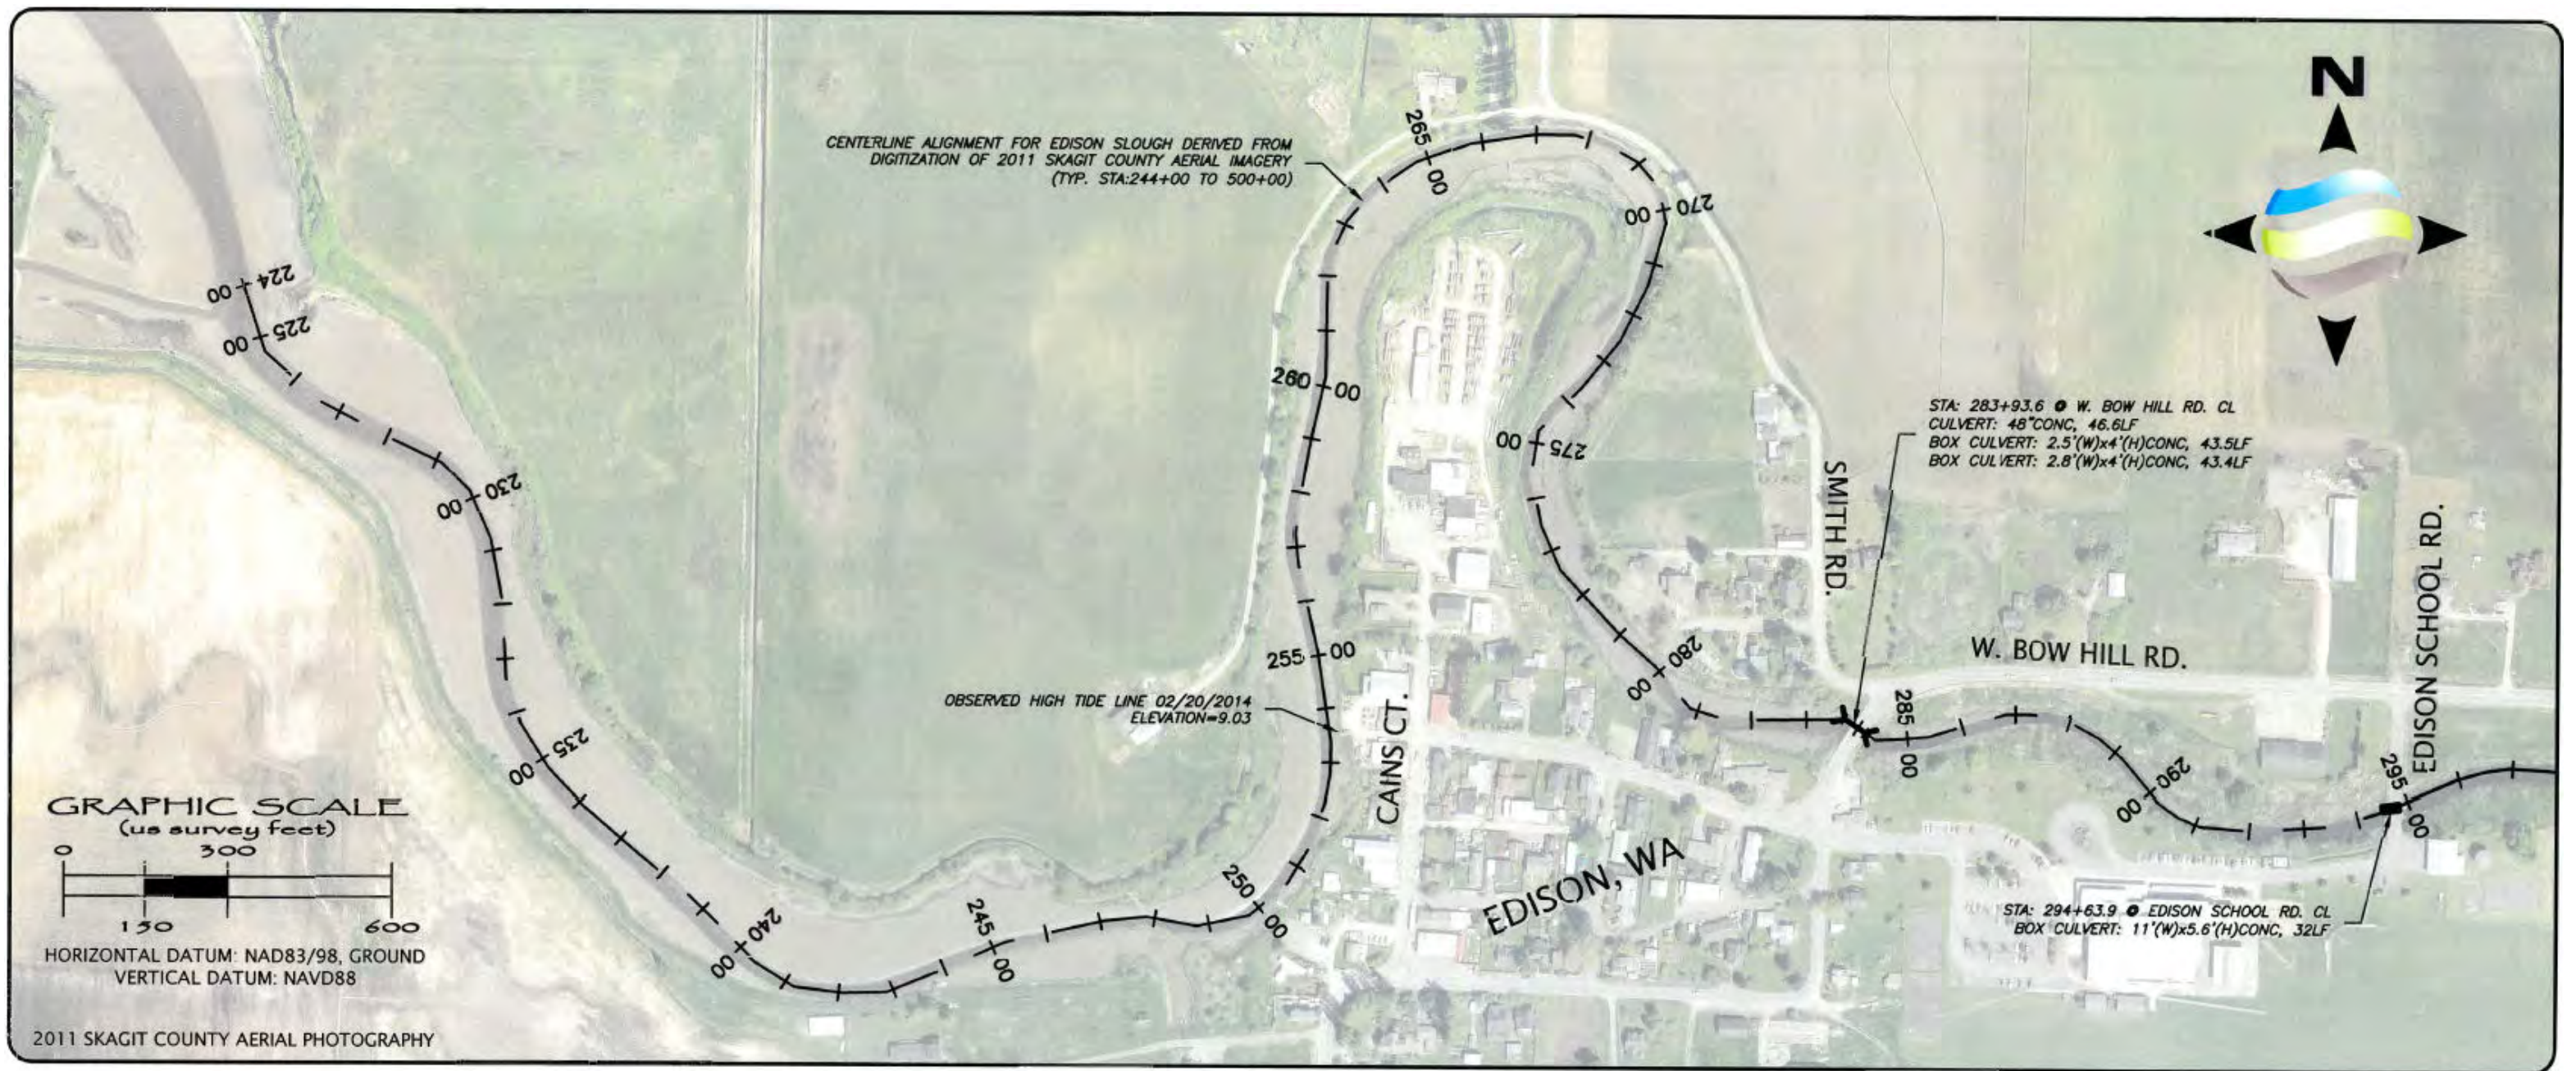
HORIZONTAL SCALE: 1"=300 VERTICAL SCALE: 1"=20'

A channel profile and cross section survey was performed at culvert crossings on properties where right-of-access was granted (Figure 3). The survey data is presented in Figure 10, Sheets 1 through 12. The survey datum is in NAD 83 (horizontal) and NAVD 88 (vertical) and was performed using Real Time Kinetic (RTK) GPS with centimeter level accuracy. The profile survey noted top of soft-bottom and top of firm bottom. A comparison of the 2013 profile to the circa-1998 channel profile with surveyed culverts is also shown in Figure 10, Sheets 1 through 12. In summary, the survey showed that no significant accumulation of firm-bottom deposition has occurred in the channel between 1998 and 2013; however, there is a significant accumulation of “soft bottom” sediment (organic mud/muck, root mass, and silt). The survey data revealed that cross sectional areas at some locations are greatly reduced by road crossings and culverts. During the survey, a “king tide” high water mark was surveyed and is shown in the cross section profile. The elevation of the king tide (~9.5 feet NAVD 88) intersected the channel bed profile upstream of Worline Road, indicating that at high tides or when the tide gates are closed, ponding can be expected to extend upstream several miles.

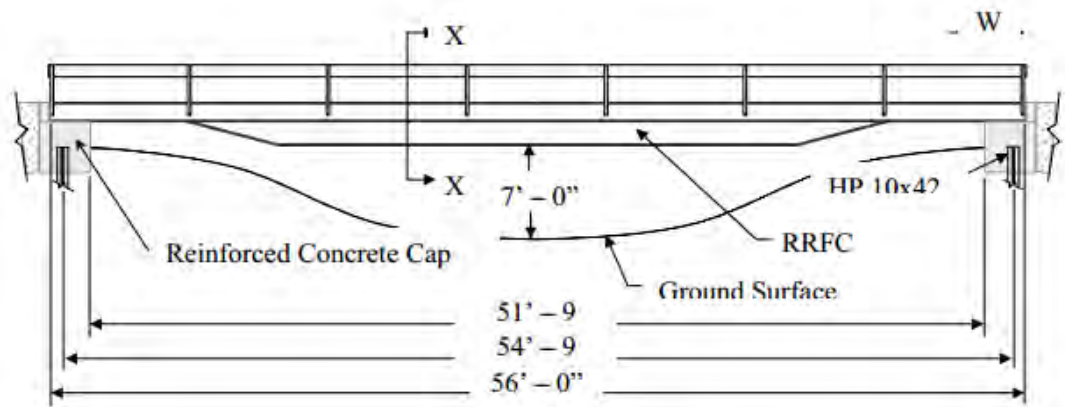
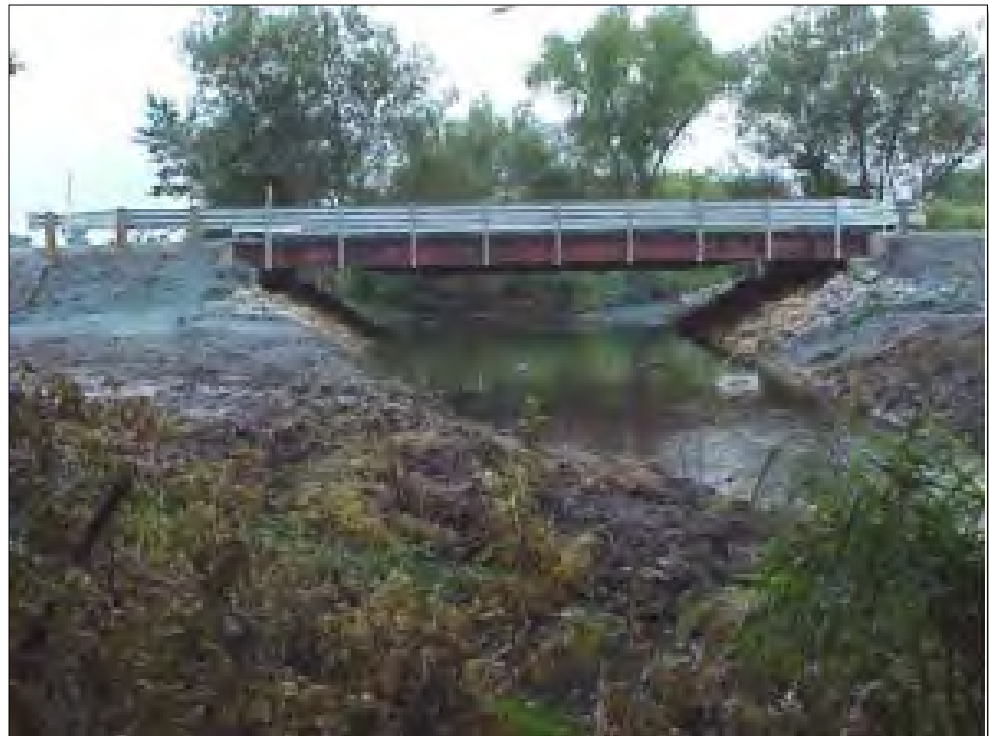
Railway Flat Car Bridge (RFCB) for Agricultural or Low-Volume Road Crossings

Technical Notes: Flatcars properly installed will provide HS-25 load capacity. Flatcars can be available in matched pairs for side by side installation. Flatcars can be custom cut to length. Concrete abutment are typically 2' x 2' x 11'. Typical material costs range from \$10,000 to \$20,000. Install can be completed with a hydraulic excavator.
