Muddy Creek Sediment Management Alternatives Feasibility Study

Prepared for Skagit County Public Works
August 27th, 2011

ELEMENT
solutions

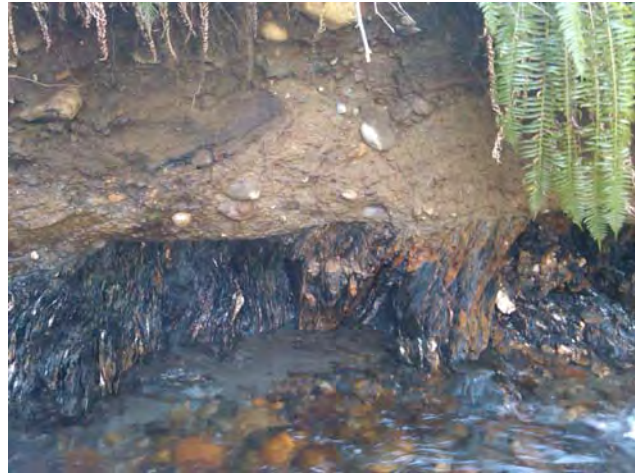
East Fork Muddy Creek

The steep upper watershed meets abruptly with a low gradient (0.02% slopes) landform that we interpret as a glacially eroded bedrock landform overlain by a veneer of Pleistocene glacial basal till (Figures 11; image at right). Both of these geologic units are overlain by Holocene deposits, either alluvial fan, debris flow deposits, or depressional accumulations of biomass and silt.

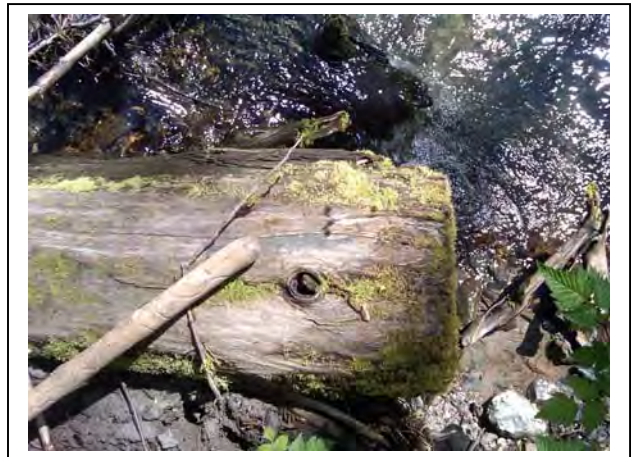
We interpreted that one of the debris flow was recent because we observed cut timber ends in some of the buried wood (photo at right). In the air photos we could locate for this study, we were not able to see evidence, either source or deposition, of this deposit, but we estimate it to be early 20th century. Evidence of older debris flow layers could also be seen in some of the cuts in this eastern fork of Muddy Creek. The floodplain of this fork of Muddy Creek was occasionally inundated and is poorly drained, as evidenced by the vast area of skunk cabbage and standing water. Part of this floodplain drains east and exits the Muddy Creek watershed, entering Carey Creek watershed. The alluvial fan at the transition between upper and mid-watershed is part of the basin boundary. Future events may result in the east fork of Muddy

We observed that the eastern sub-watershed drains onto an alluvial fan and then onto a very low gradient landform with adjacent depressional basins. The channel network across this basin is low gradient, meandering morphology that is incising into silty matrix laden organic (wood) debris that we interpreted to be debris flows.

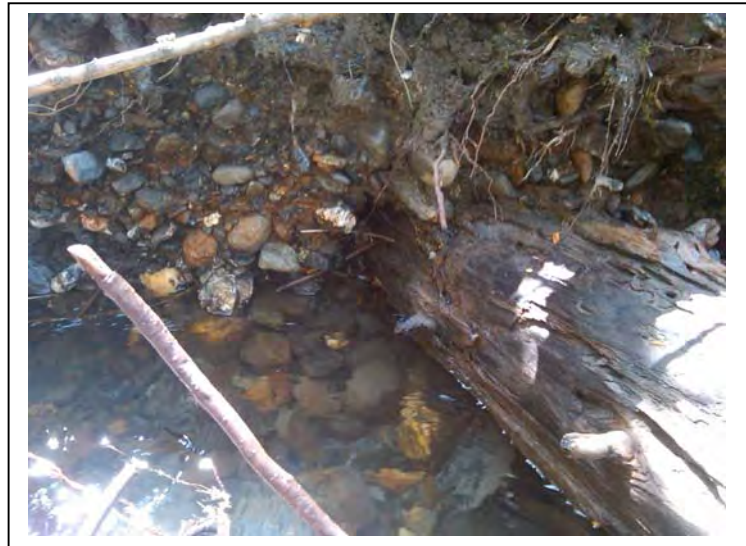
We observed some minor erosion of glacial deposits within the reach. We estimated that the stream velocities of the west fork were greater than the east fork and we observed that bedload size fractions were larger (average range of 1-3 inches, B-axis). The west fork was observed flowing across the phyllite bedrock in many locations. An alluvial fan at the transition between the upper watershed and the mid-watershed topographic break was less prominent than in the east fork; however, the potential for channel avulsion at the alluvial fan could create conditions where the west fork of Muddy Creek escapes its watershed and joins another, Red Cabin Creek in this instance (Figure 12). Similar to the east fork, the west fork had evidence of debris flows, but rather than being of a silty matrix, the debris flow matrix was of courser size fractions (image at

above). It is anticipated that most debris flows from the upper watershed attenuate through the low gradient reaches of both the west and east forks.

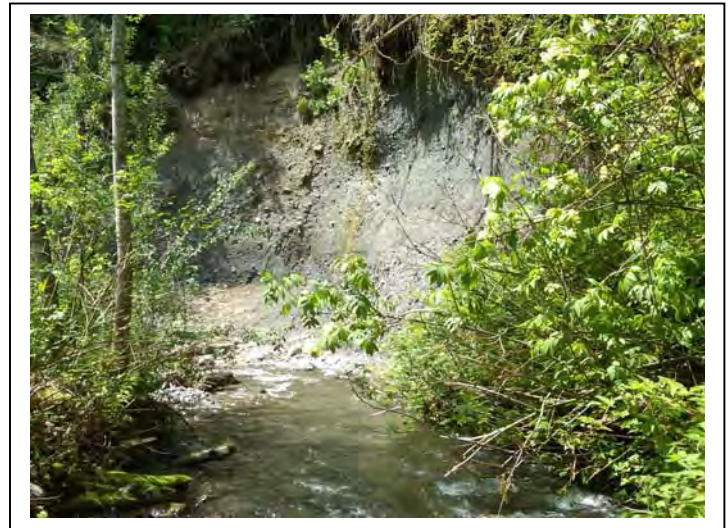
We observed sediment recruitment (colluvial/hillslope, mass wasting, erosion – image at right) within the lower mid-reach reach in addition to storage of bedload sediments (boulder through course sand). The confinement of the lower mid-reach is less than the upper reach with a decreased slope and therefore supports the storage of sediment in this reach. We interpreted that sediment storage in this reach is temporary because we observed only very few terraces and none with old growth trees or stumps. In addition, most high flow bar deposits had young deciduous trees species growing on them. It is possible that very large flood events or debris flows can remobilize this stored sediment and transport it to the alluvial fan. Potential releases of stored sediment from this reach can dramatically increase the sediment volumes delivered to the alluvial fan and deposited at the project site.

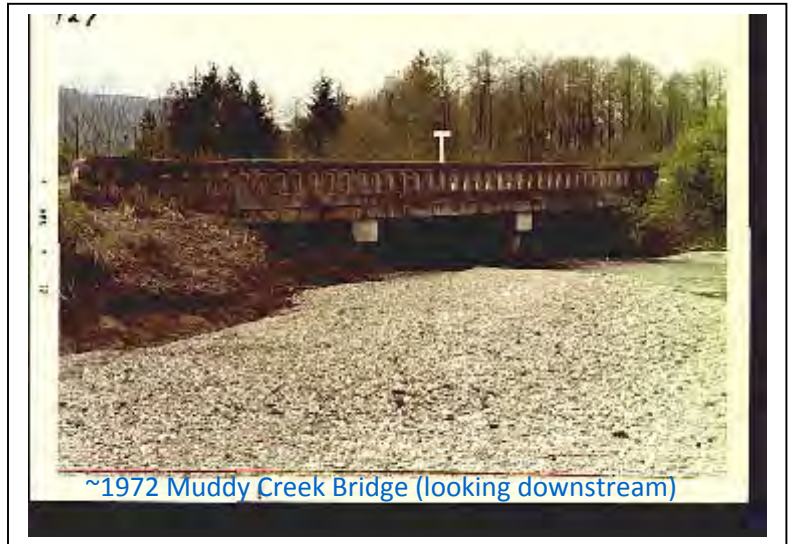
~1972 Muddy Creek Bridge (looking downstream)

Photographs from the 1970’s and 1980’s show significantly more conveyance beneath the Lyman-Hamilton Highway Bridge than currently exists (photo at right versus front cover image). By simple comparison of these images, net deposition at the bridge site is the long-term trend.

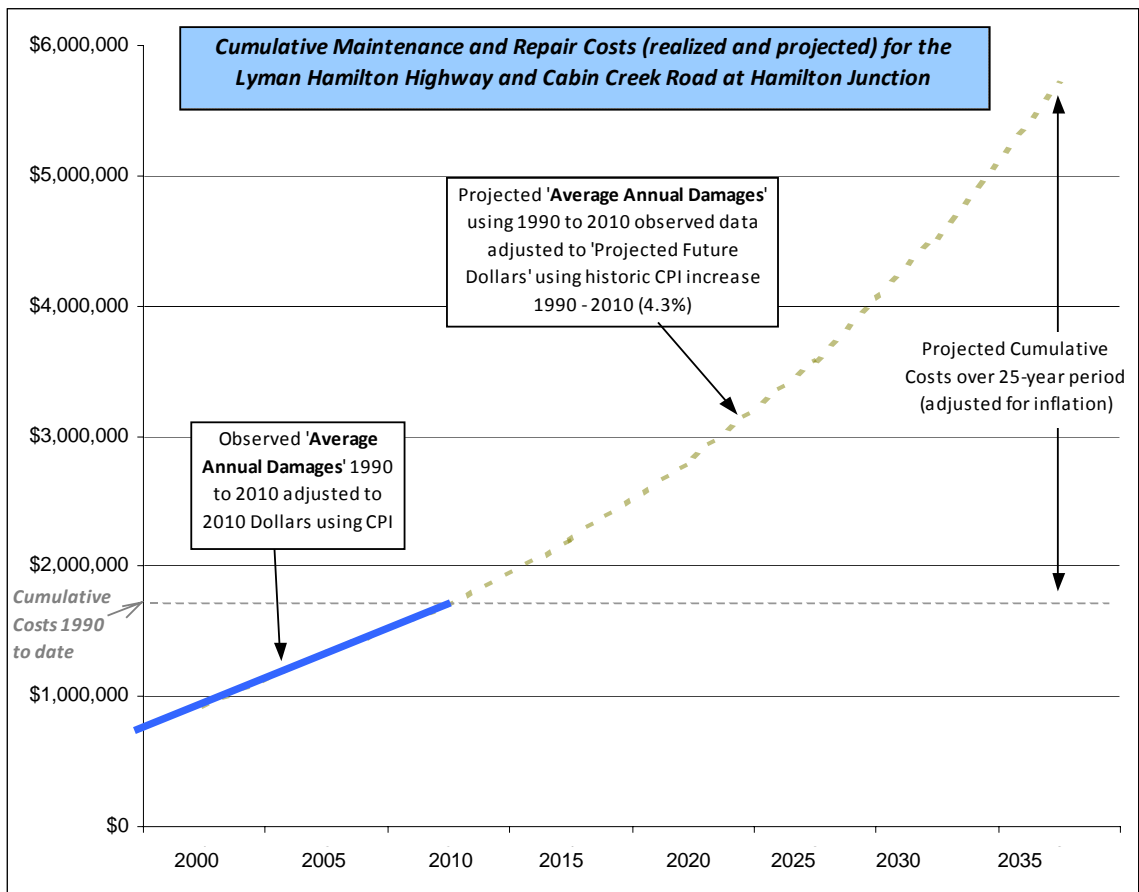
The 25-year forecasted project costs are presented graphically as a plot below.

Note: These costs do not include annual dredging.

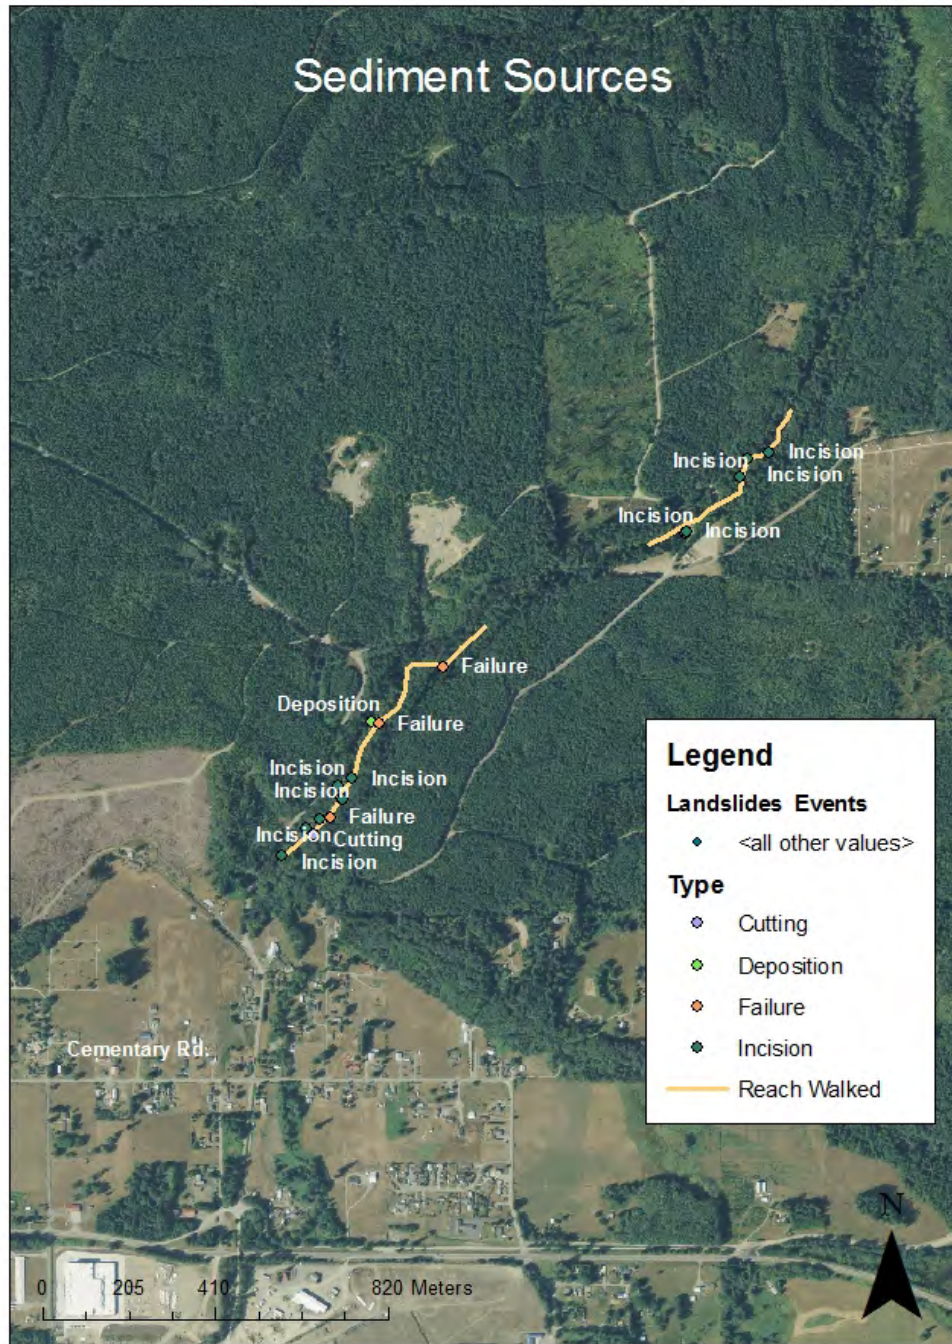
Figure 2. Sediment sources and addition stream walked.

We identified many notable sediment sources on the forest lands that are actively contributing semdiment (Figure 2). Most of the sediment sources observed have no evidence to be anthropogenically caused. Slope incision is the most common source of sediment where Muddy Creek is cutting at the base of the hill slope (Picture 7). One major landslide was observed contributing significant amounts of sediment to Muddy Creek (Picture 9). Large benches of sand, gravel, and cobble many feet above the bankful depth were observed (Picture 6). These large benches were probably formed by historic sediment flows down the valley and are allowing for areas of sediment recruitment over a large expanse of Muddy creek.

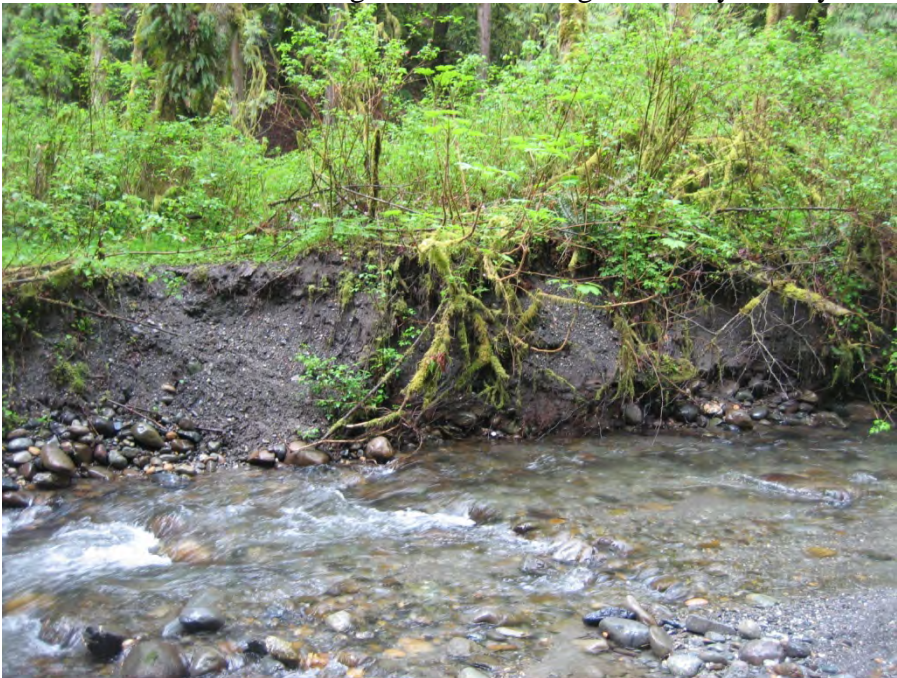
Picture 9. Hillslope failure into the creek.

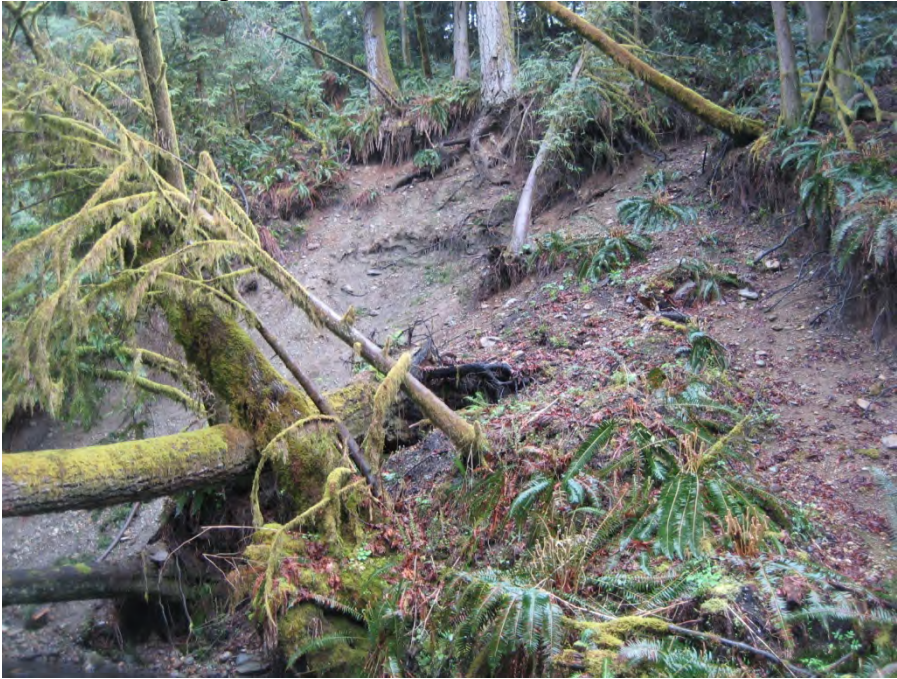
Picture 10. Gravel bench that recruits sediment at bankful discharge.

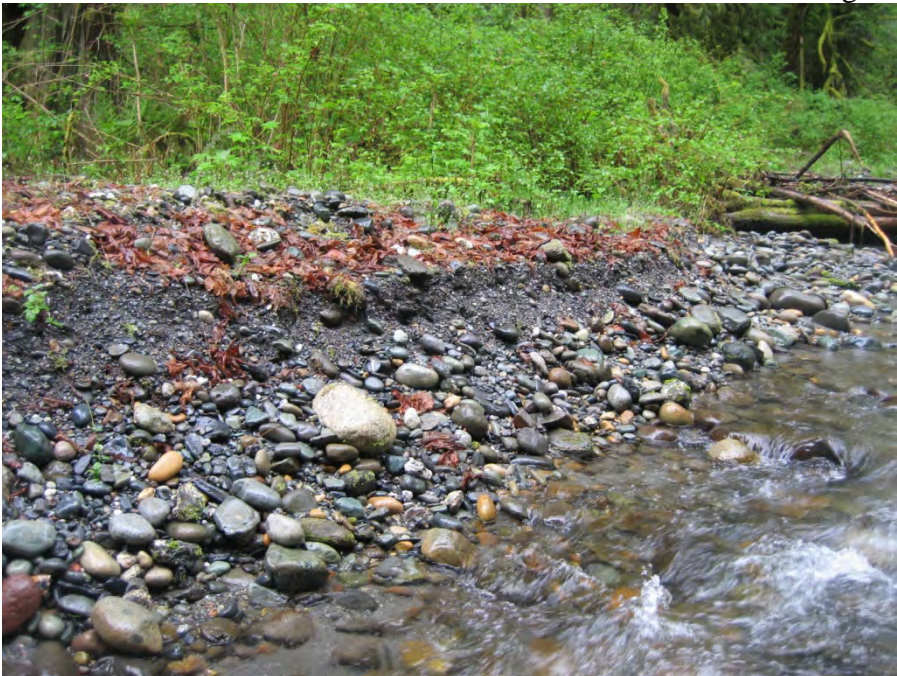
Picture 12. High embeddeness from a hill slope failure, just upstream.

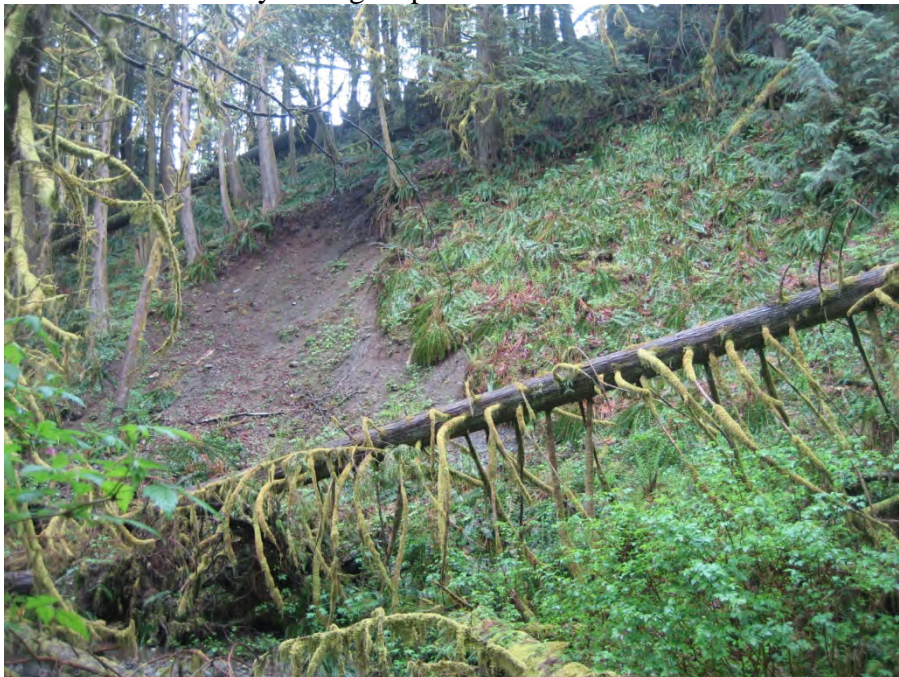
Picture 14. Active erosion that is possibly human caused, near horse camp bridge.

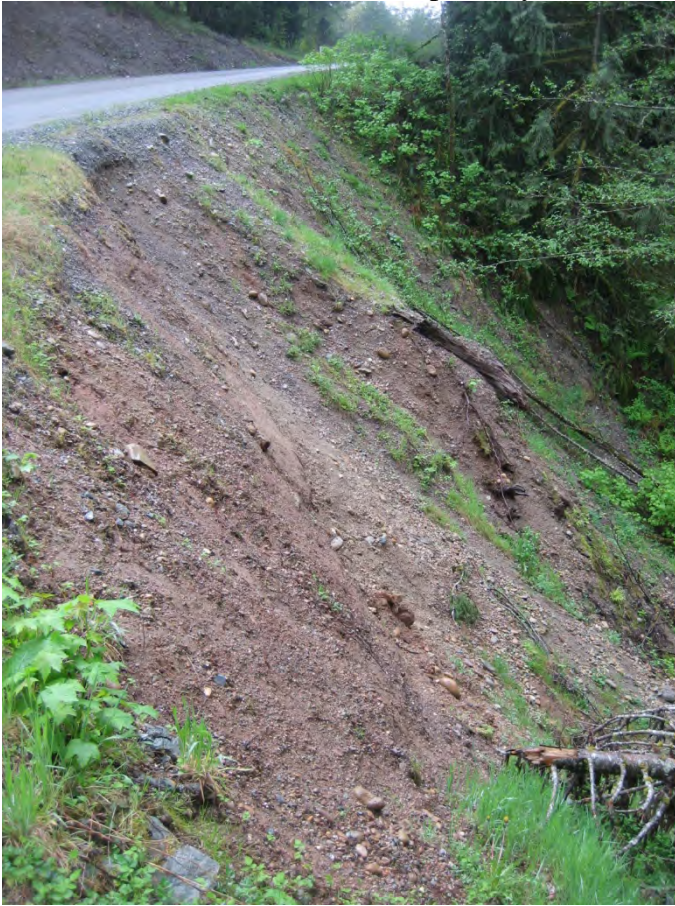
Picture 15. Large, 75 meter high, incision on right-bank just below horse camp bridge.

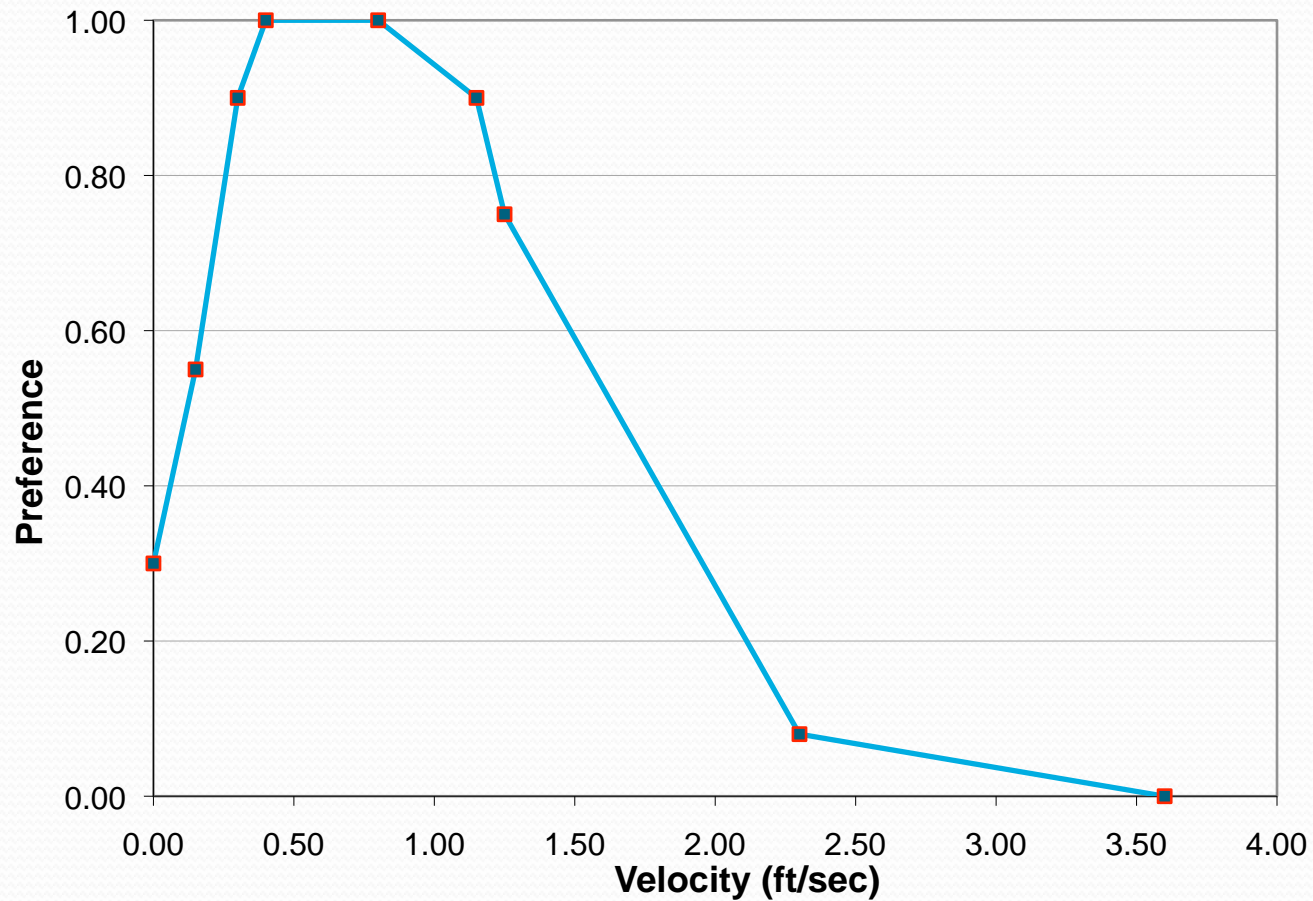
Velocity Preference Curve for Juvenile Chinook
