Skagit River Delta Flood Drainage Project Flood Modeling, Mapping, and Mitigation Analysis

May 10, 2023
Draft Report, Rev. R0

NHC Reference 2002084

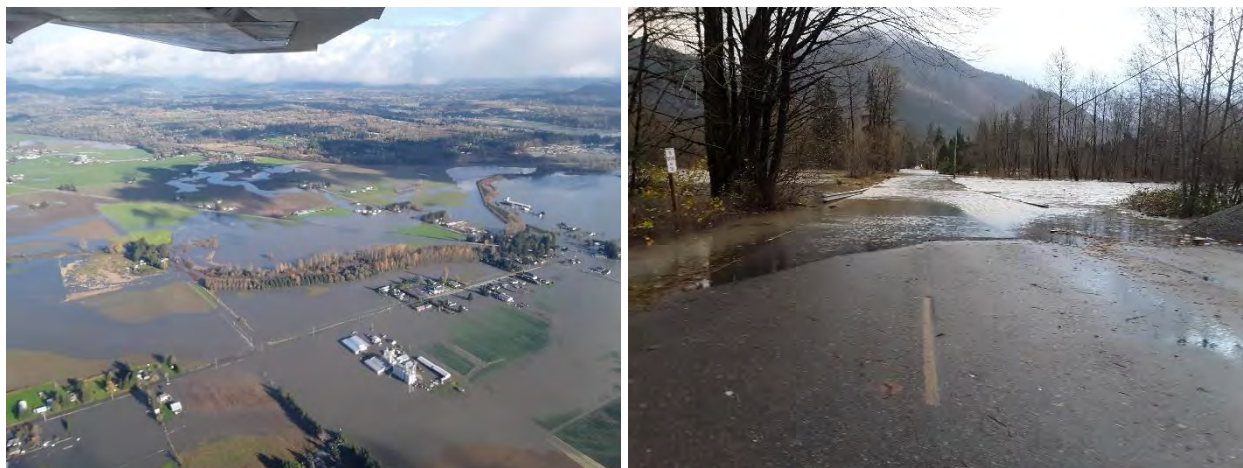
Photo 2.3 Samish River flooding at Allen, taken November 16, 2021 (left).

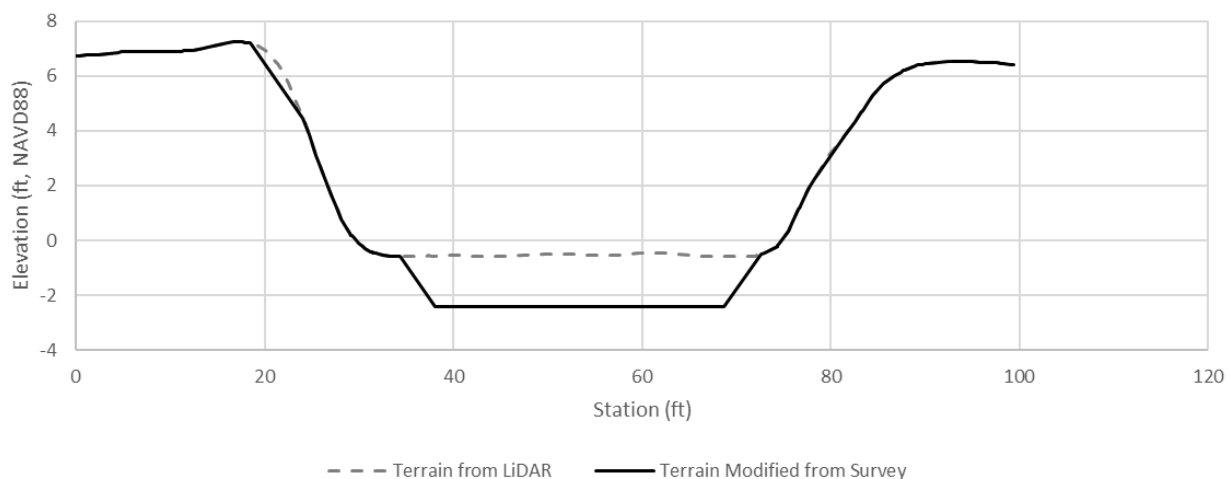
Figure 4.4 Cross section through Sullivan Slough north of La Conner. The dotted line represents LiDAR of the channel which was consistently shallower than the surveyed channel geometry (solid line), with an approximately 2:1 side slope which agrees with the survey.

From the inspection of available data, performed surveys and the aerial maps, in case of discrepancies, the location, size, or invert elevations of drainage structures was updated based on the most recent available data. For example, within Sullivan Slough and canal at La Conner LiDAR bare earth elevation data indicated higher channel elevations (i.e., shallower depths) than were observed in the field, resulting in an underestimation of channel conveyance. Survey was conducted at several locations, from the tide gates at 3rd St. out to the confluence with the main slough, east of La Conner-Whitney Road. Survey data provided correct channel elevations and side slopes, allowing for better representation of conveyance capacity of the existing channel. The model was modified to represent a 2:1 bank slope throughout the channel, with channel depth set as a straight line between surveyed points. Figure 4.4 provides a cross-section at one example location sampled from the Sullivan canal.

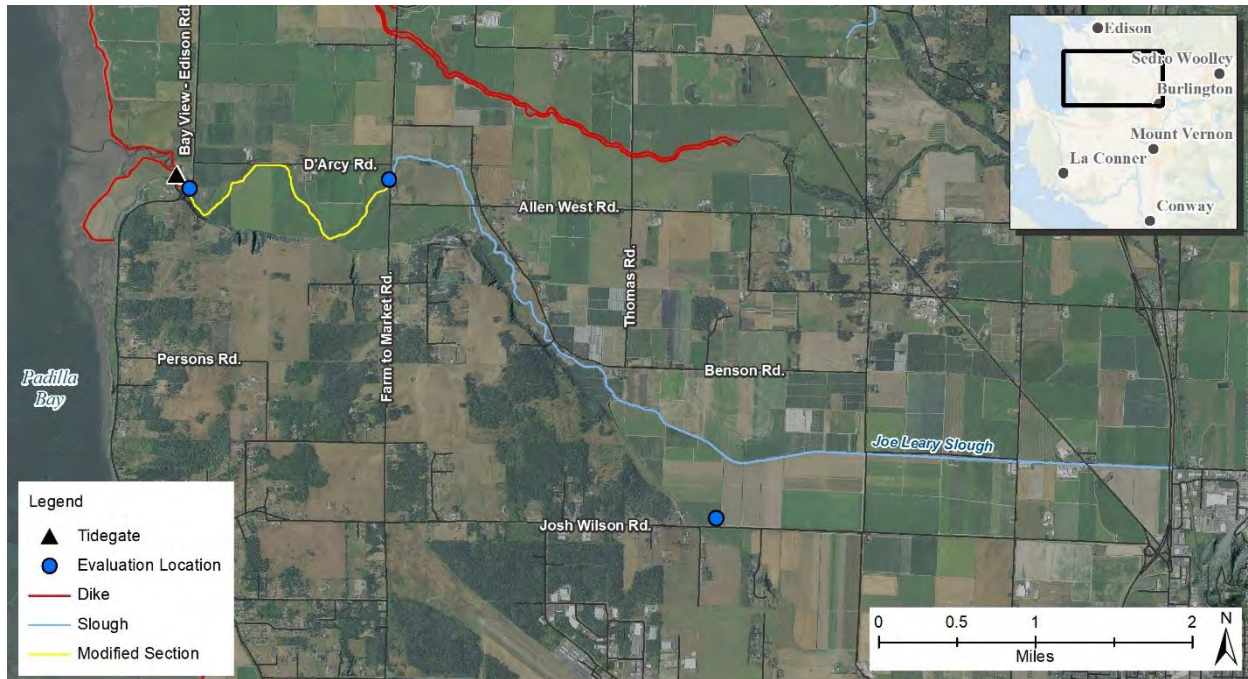
Figure 5.11 Overview of Joe Leary Slough area.

Alternative	Channel Condition	Tide Gate Configuration
Existing	No maintenance (existing channel)	2 side hinged tide gates (existing)
Alternative 1	Maintained channel – 20' channel bottom, 2:1 side slopes	2 side hinged tide gates (existing)
Alternative 2	Maintained channel – 25' channel bottom, 2:1 side slopes	2 side hinged tide gates (existing)
Alternative 3	Maintained channel – 30' channel bottom	2 side hinged tide gates (existing)
Alternative 4	No maintenance (existing channel)	4 side hinged tide gates (double existing opening area)

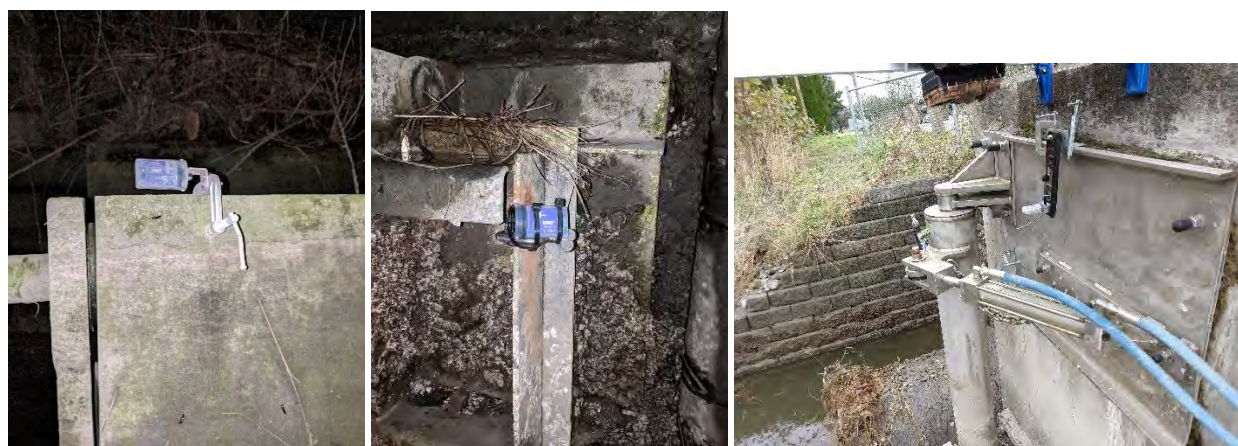
Figure 2.2 Gate Position Sensors and downward looking trail camera (top hinged gates left and center; SRT control arm at right)

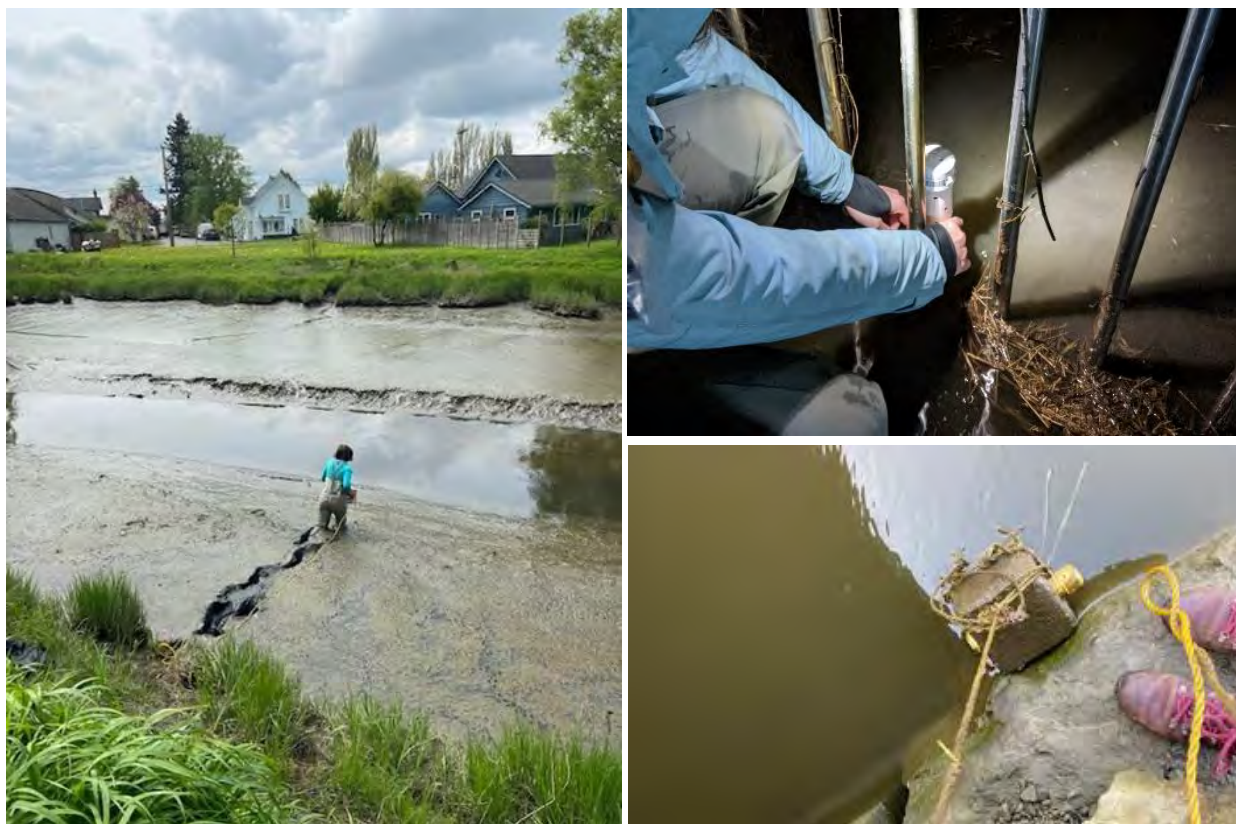
Figure 2.6 Deployment of conductivity sensor at west end of Doser Street (left) on upstream side of Main Street (upper right), and at the Bus Access Road Bridge to Edison Elementary School

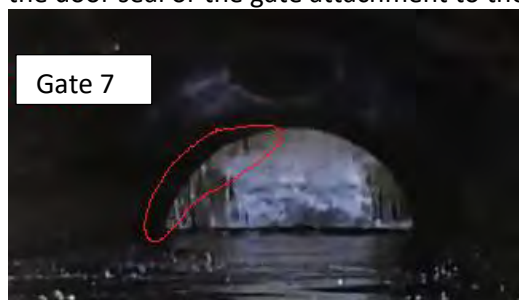
Figure 2.10 Leakage through top of Gate 7 (from video DSCI16004.MOV)

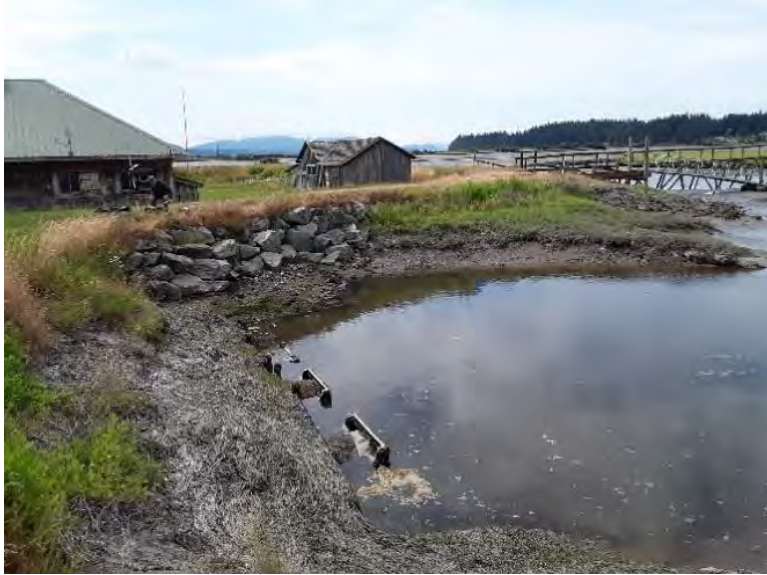
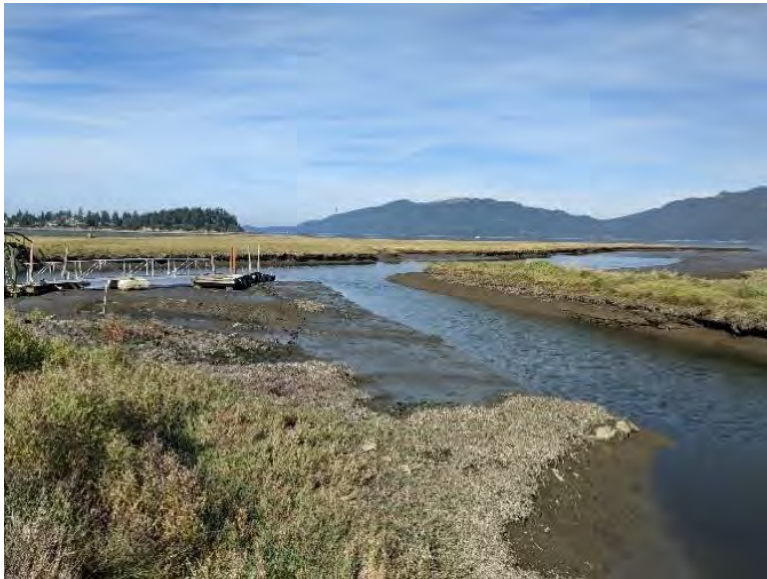
Photo I12.3 Alice Bay Top Hinge Tide Gates Proposed for Replacement (left) Alice Bay channel on seaward side of gates (right)

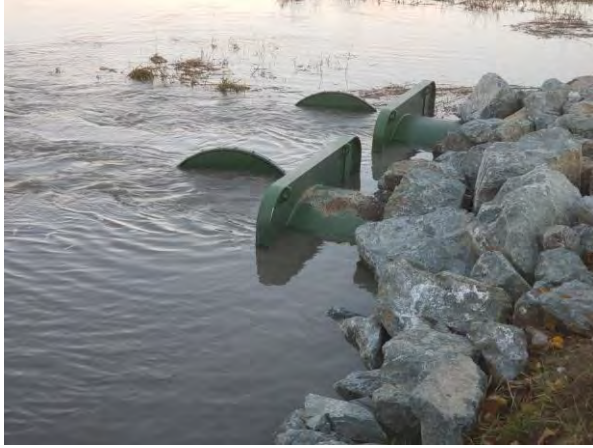
Photo I12.4 Farm to Market Replacement with Side Hinged Tide Gates (left)

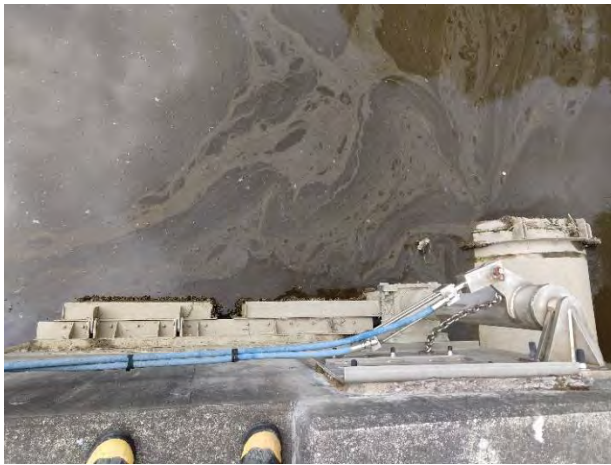
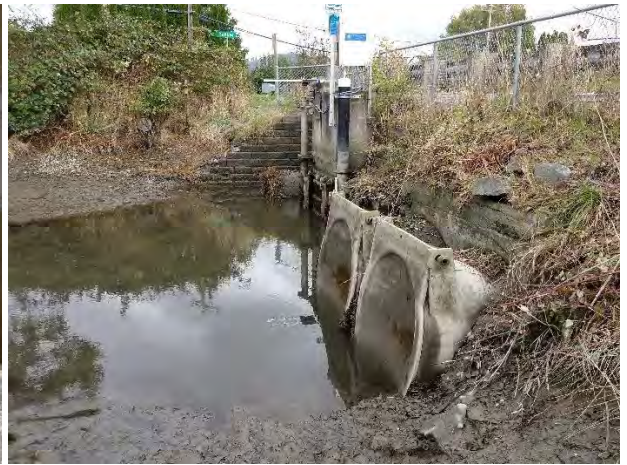
Photo I12.5 Left: Top view of Edison Slough SRT gate. Right: Side view of traditional top-hinged gates (near) and SRT gate (far) at Edison Slough
