# **2016 Big Lake Aquatic Weed Control Program**

**Big Lake LMD #1  
Skagit County Public Works  
Mount Vernon, Washington**

Northwest Aquatic Eco-Systems, Inc.  
855 Trospen Road SW #108-313  
Tumwater, Washington 98512  
Pondweeds@comcast.net  
Telephone: (360) 357-3285

December, 2016

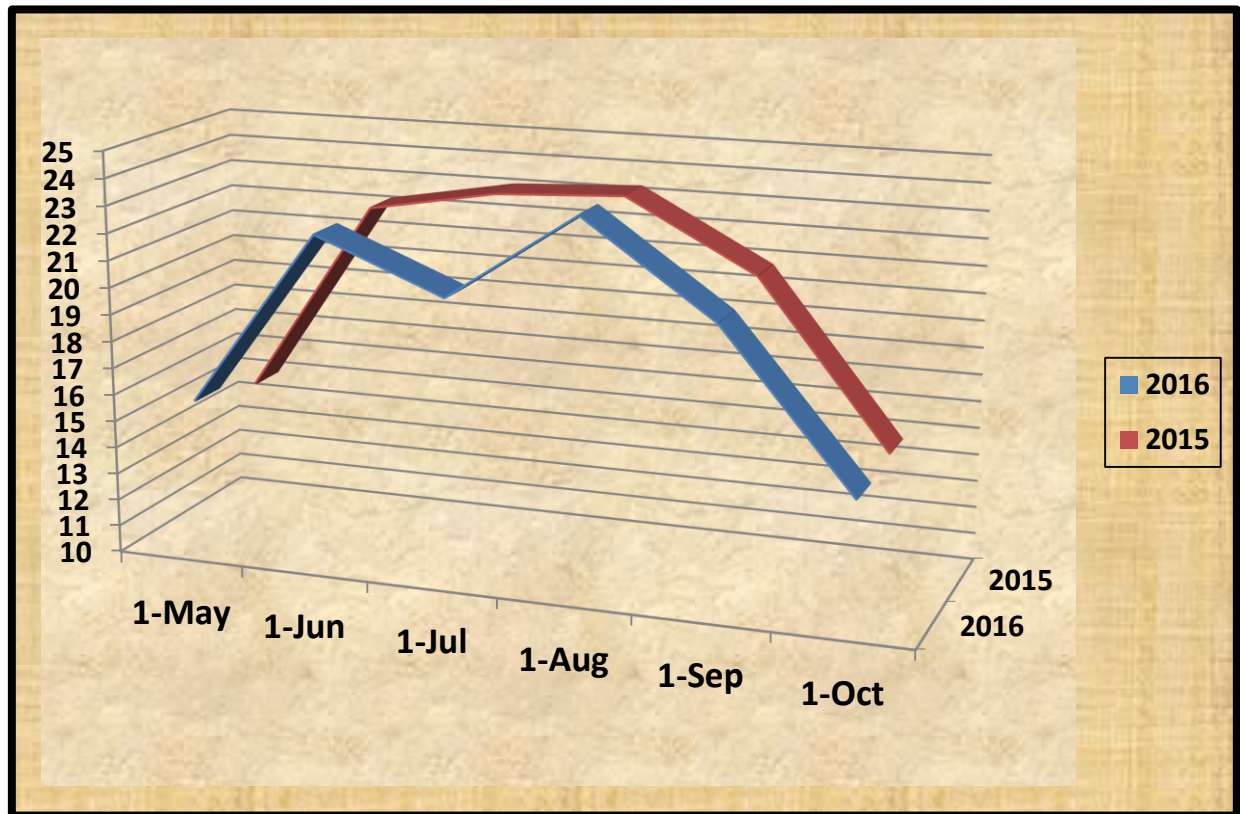
Unlike 2015 when water temperatures increased throughout most of the summer months, the year 2016 identified an increase through mid-May then a three degree centigrade decrease over the next 30 days until water temperatures began to rise again. The same surface temperatures noted during mid-May were not again obtained until mid-July.

Note : Taken from Steilacoom Lake data set

Water temperature fluctuations have an impact as to when seed germination will occur, and the rate of weed growth. Warm, early, seasonal water temperatures encouraged timely seed germination and rapid weed growth resulting in problematic shoreline infestations. Although weed growth sites remained relatively the same, density within those growth areas were elevated from 2015 levels. These increased densities are noted on the 2016 survey map as red. It is important to note that the 2015 survey was performed approximately one month later than the 2016 survey so it is rational to assume that if the 2016 survey was performed in conjunction with the 2015 survey timeline weed densities would have been greater than noted on the 2016 map.
