# Clear Lake 2012 Aquatic Plant Control Program

Prepared By  
Northwest Aquatic Eco-Systems  
855 Trosper Road SW #108-313  
Tumwater, WA 98512  
360-357-3285  
[Pondweeds@comcast.net](mailto:Pondweeds@comcast.net)  
[www.nwaquaticecosystems.com](http://www.nwaquaticecosystems.com)

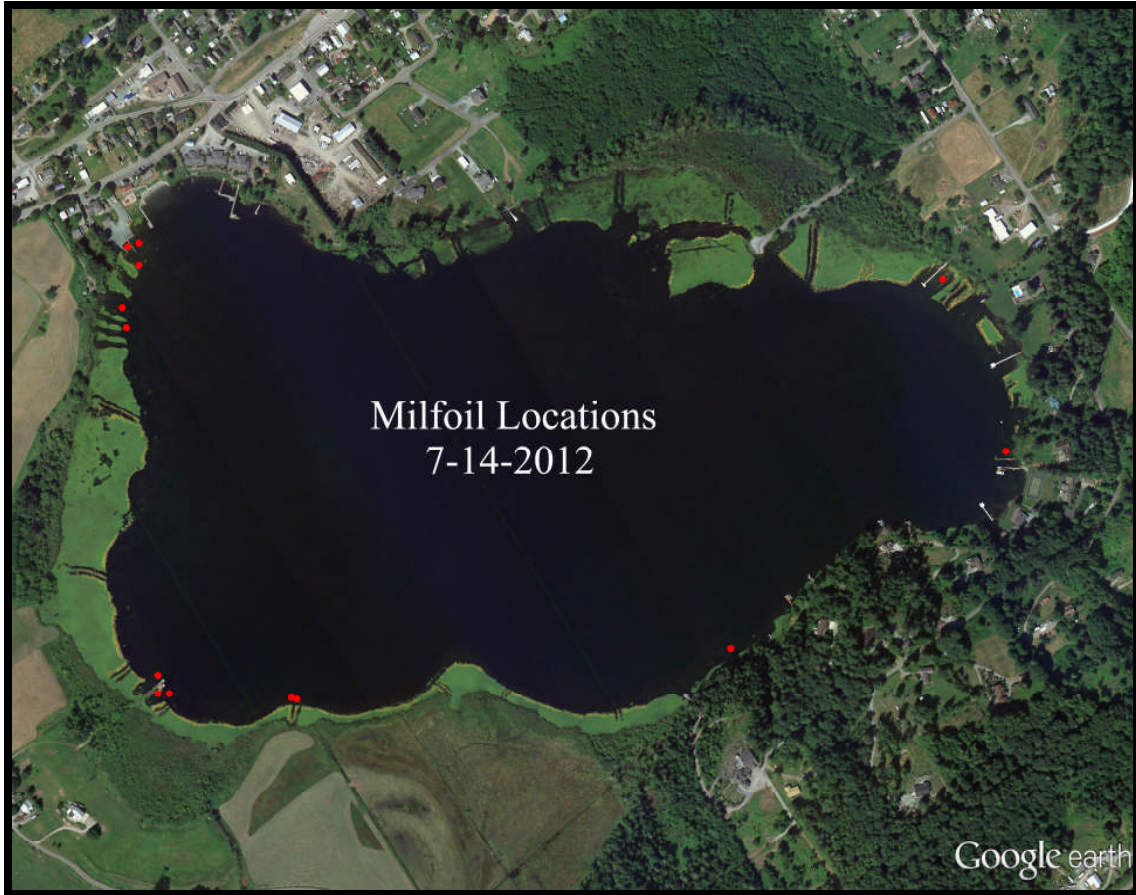
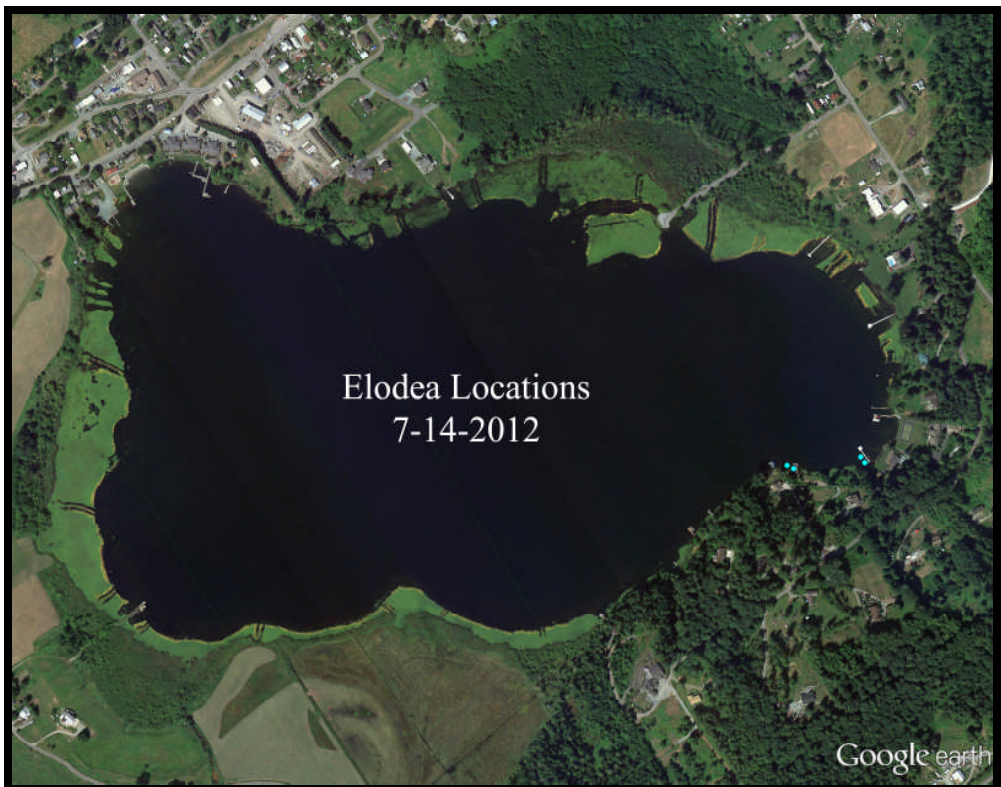
Clear Lake was surveyed on July 14, 2012. Water clarity was excellent with visibility down to the bottom throughout most of the lake's littoral zone. Milfoil was present but was only noted as very sporadic single plants throughout those areas treated during 2011. Approximately one dozen data points noting milfoil were collected. The success of the 2011 effort was evident when comparing the 2011 pretreatment milfoil densities with those noted during 2012. Much of the shoreline was experiencing various degrees of native plant growth. There were no noted extended lake shoreline areas that were not experiencing some form of native plant growth. Nearly all of the residential shoreline areas were already experiencing problematic weed growth that resulted in some degree of restricted use. To a large extent, most of the dense growth extended just beyond the dock areas. Patches of native weeds had already surfaced. Past surveys identified the presence of native species but no references or discussion was included in the yearly reports. The NWAE survey identified a number of native species present *Potamogeton amplifolius*, *P. robbinsii*, *P. natans*, *P. gramineus*, *Vallisneria americana*, *Elodea canadensis* and *Utricularia vulgaris*. The most prolific pondweed was *P. zosteriformis* while there were other thin leafed pondweeds that could not be identified in the field. Similar to other lakes

in the area different shoreline sections of the lake were dominated by dissimilar submersed species.

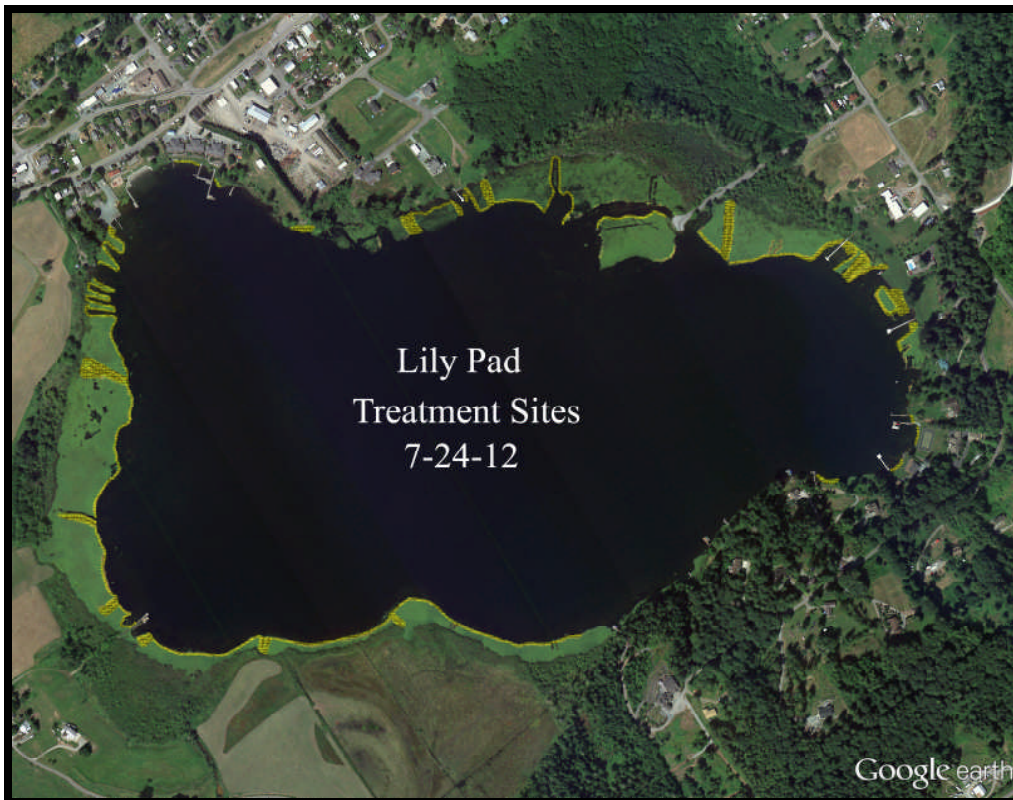
Clear Lake is 200 acres with a shoreline length of 2.4 miles. Under current NPDES guidelines, native macrophyte control is limited to no more than 50% of the shoreline or approximately 6,336 feet. The permit also mandates that “the geographic area where the Permittee intentionally applies chemicals must remain the same for the entire length of the permit coverage up to the maximum percentage of the littoral zone allowed by the water body”. In essence, once native plant treatment sites within Clear Lake reach the 50% threshold level no further expansion of the treatment areas are permitted and the areas treated cannot be changed until 2016.

Our approach during 2012 was to initiate native plant control operations and to ensure compliance with current permit regulations while also affording lake property owners an acceptable degree of control. Since most of the residential areas are located along three basic shoreline areas, development of a compliant treatment model proved to not be an issue. The treatment model was designed to adhere to the 50% rule.

Shoreline posting was conducted on the day of treatment. A two person crew initiated posting of the lake upon arrival in the morning and treatment began approximately one hour later as the application vehicle shadowed the posting vessel. Material was offloaded from a locked truck container and transferred into two 25 gallon spray tanks mounted on the application boat. Containers were triple rinsed on site and returned empty back into the truck. Material was applied utilizing an 18 foot Airgator airboat. Lake water was drawn into the boat through intake ports located in the hull of the boat. Herbicide was then metered into the lake water via an injection manifold. Once the herbicide was injected, the water was then discharged back into the lake. Weighted hoses were then used to place the material at the appropriate depth in the water column. Prior to treatment a lake treatment map, identifying treatment plots, was downloaded into the onboard GPS system. The boat utilized the onboard GPS to identify treatment site boundaries. All of the targeted submersed and floating plant sites were treated on July 24. When floating plants were sprayed both 25 gallon tanks were filled with lake water; herbicide and adjuvant which were then added directly to the tanks. Once mixed, the application boat drove along the shoreline identifying targeted sites and the spray mixture was then discharged using a spray gun. Tanks were refilled and dispensed as needed. One boat driver and two sprayers were used during this phase of the project. Submersed weeds were treated with Diquat at a rate of two gallons per surface acre in waters over three feet deep and one gallon per acre in waters less than 3 feet in depth. Lily pads received a 1.5% solution of glyphosate sprayed directly onto the floating plant surfaces.
