Clear Lake 2013 Aquatic Plant Control Program

Prepared By
Northwest Aquatic Eco-Systems
855 Trospen Road SW #108-313
Tumwater, WA 98512
360-357-3285
Pondweeds@comcast.net
www.nwaquaticecosystems.com

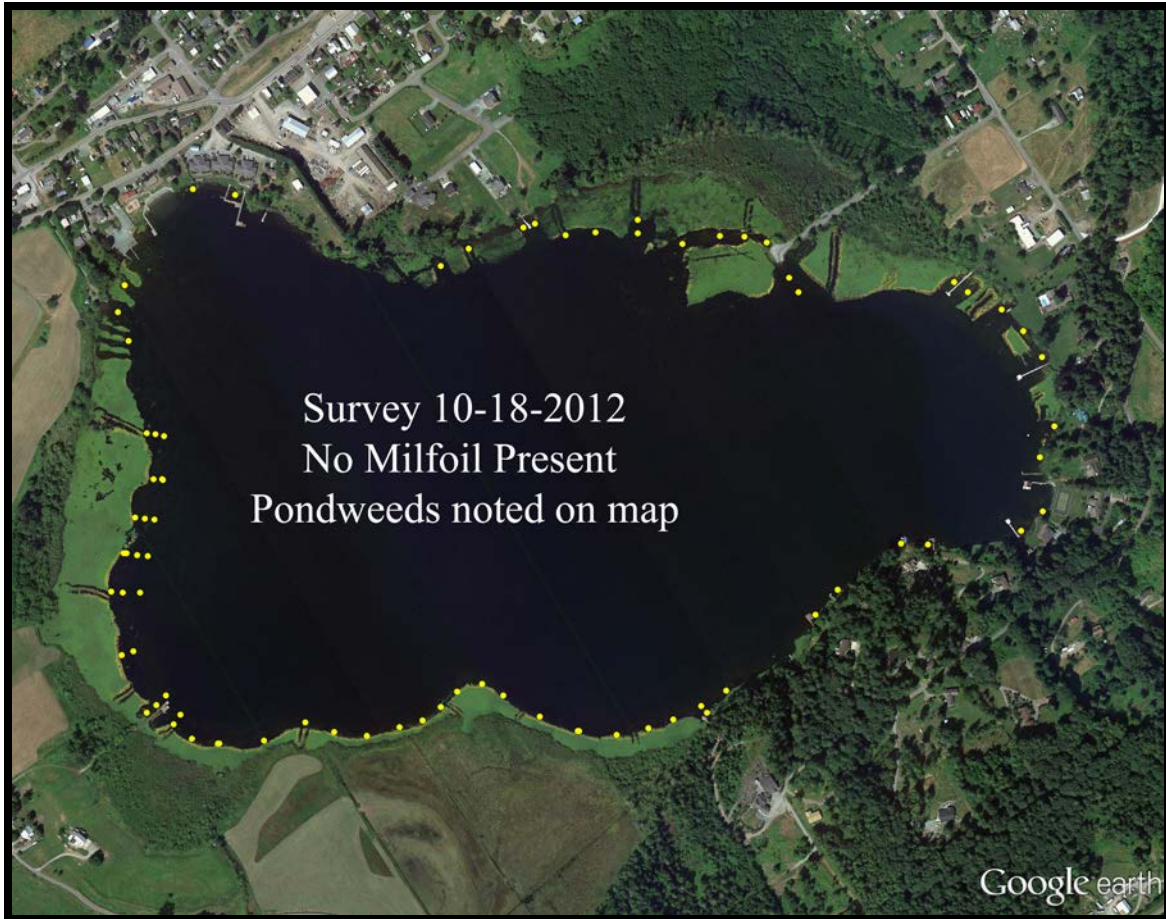
Fall Survey

The fall survey was performed on October 18, 2012. No milfoil was identified throughout the littoral zone of the lake. Many of the pondweeds had already decomposed however patches of *Potamogeton robbinsii* were evident. All of the targeted native sites remained virtually weed free and were exhibiting safe recreational lake waters from the shallow immediate shorelines extending outward to the 15 foot contour line.

It was apparent that native plant biomass had been reduced considerably and that there were no diquat problems associated with wave or wind action. Clear Lake appears to be more of fishing and swimming resource then one used heavily for water skiing and boating. Targeted lily pads throughout the lake responded well to treatments. Obvious visual discrepancies existed between those sites targeted for control and those left untreated.
