# **Lake Campbell and Lake Erie 2013 Aquatic Plant Control Program**

**Prepared By**  
**Northwest Aquatic Eco-Systems**  
**855 Trosper Road SW #108-313**  
**Tumwater, WA 98512**  
**360-357-3285**  
**[Pondweeds@comcast.net](mailto:Pondweeds@comcast.net)**  
**[www.nwaquaticecosystems.com](http://www.nwaquaticecosystems.com)**

## **Project Overview**

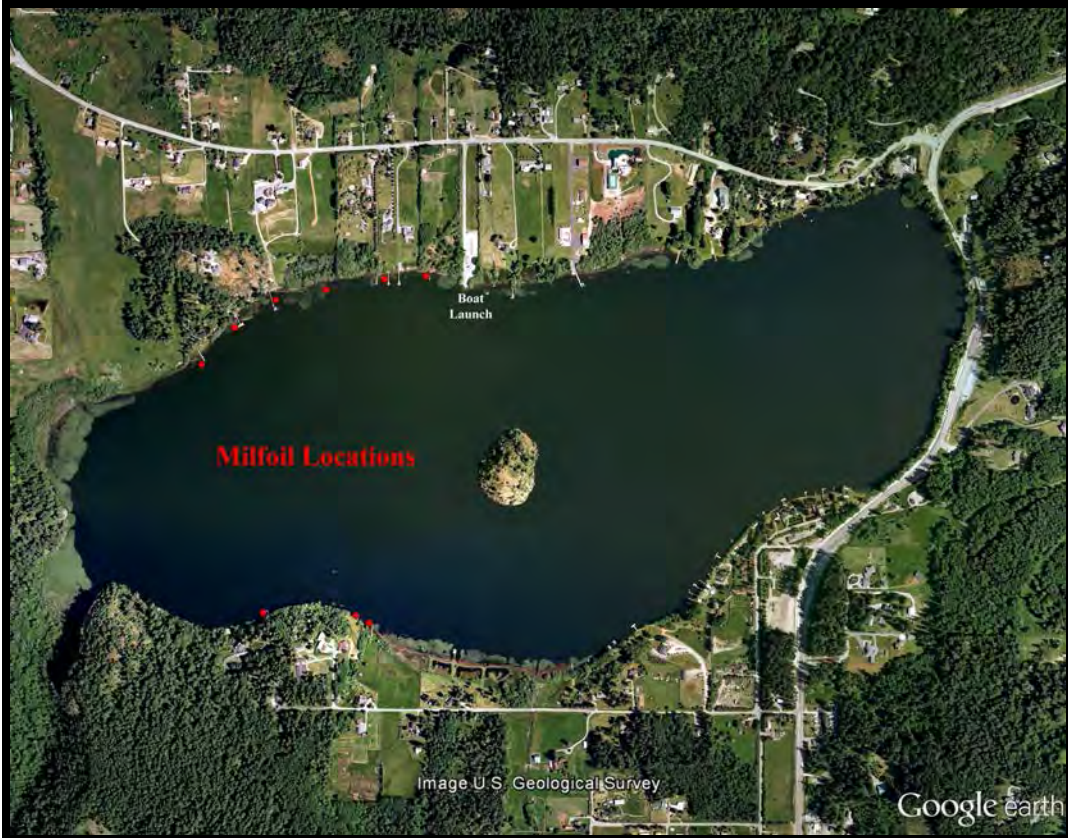
Lake Campbell was visited on June 30, 2013. At the time of the survey, water clarity was below average. Water color was brownish green in color with no surface scums observed. Similar to 2012 limited native macrophytes were noted and only a few single stemmed milfoil plants were noted southwest of the boat launch and at two locations along the south western shoreline. No milfoil fragments were noted on the water's surface or adjacent to the shorelines during the survey.

Lake Campbell Milfoil Locations June 2013

At the time of the June survey, poor water clarity may have restricted our efforts to locate all of the milfoil that had been present during the survey. A decision was made that either the milfoil plants would be manual removed from the system or chemically treated depending on densities and locations. Treatment if required would consist of a granular application of 2,4-D. Emergent noxious species, yellow iris and purple loosestrife would be targeted with a 1.5% tank mixture of glyphosate. Spadderdock populations restricting dock use would be considered for control. No native plant control was scheduled to occur during 2013.

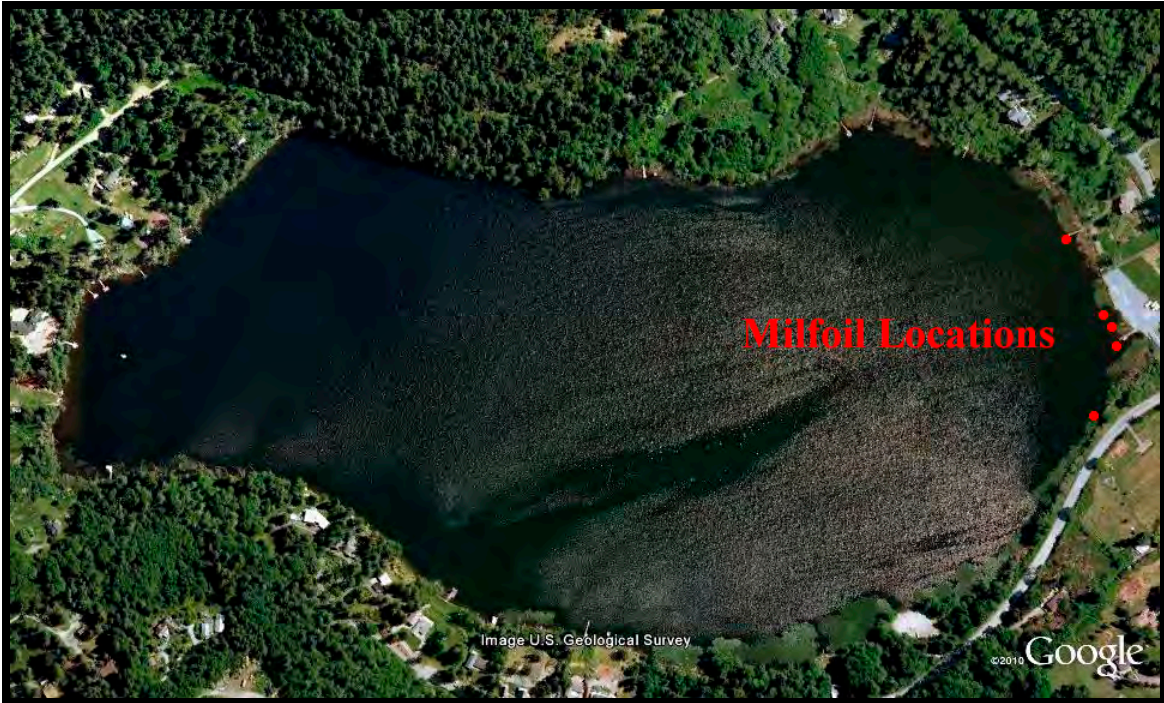
Lake Erie was surveyed on June 30, 2013. There were no observed milfoil fragments floating on the lake's surface or along the shoreline. Only five single milfoil plants were identified. These plants appeared in all the same areas as noted during 2012, along the southeast shoreline closed portion of the lake. Native weed growth had been reduced considerably from that observed during 2012 plants however were still impacting the immediate shoreline residential homes. Najas was the dominant species throughout the system. None of the native species had begun to surface along the surface of the lake.

Lake Erie Milfoil Locations Spring 2013

The limited appearance of milfoil and the problematic occurrences of native weed species lake wide warranted control efforts to ensure safe recreational opportunities lake wide. Limited control of native plants proved very successful during 2011. The success of the 2011 program expanded control to a greater portion of the lake during 2012. These areas were again treated during 2013. NWAEE estimated that approximately 50 acres will require treatment. Since one of the targeted sites also contains the few noted milfoil plants, milfoil within this portion of the lake will also receive treatment.

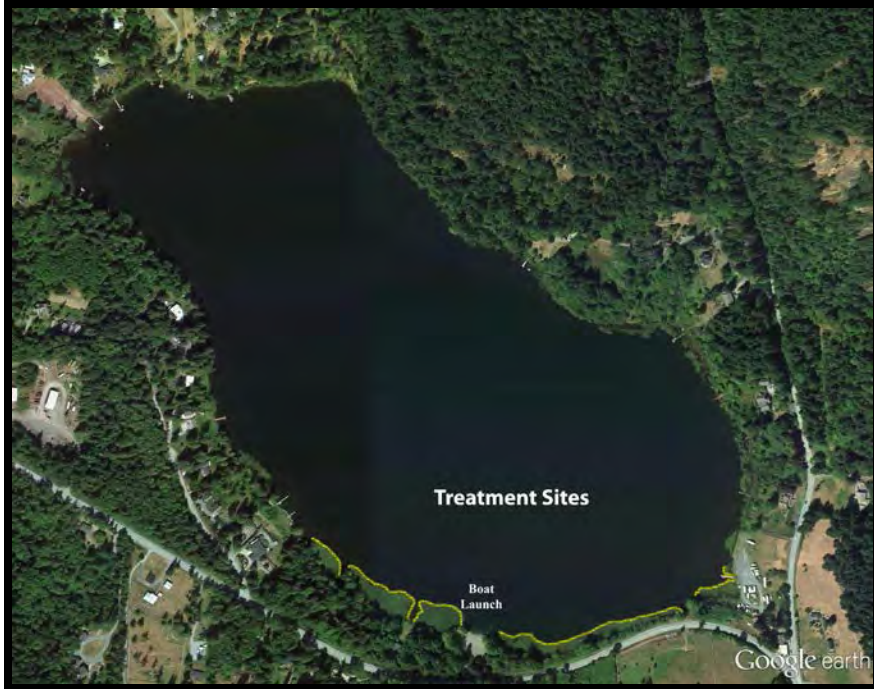
### **Nuphar (Spadderdock) Application Sites**

Spraying of the spadderdock adjacent to the public boat launch will also occur. This is a yearly spraying encompassing no more than a five to ten foot swath along the outside of the edge of the infestation. This limited approach will slow down the plants encroachment into the main lake-body.

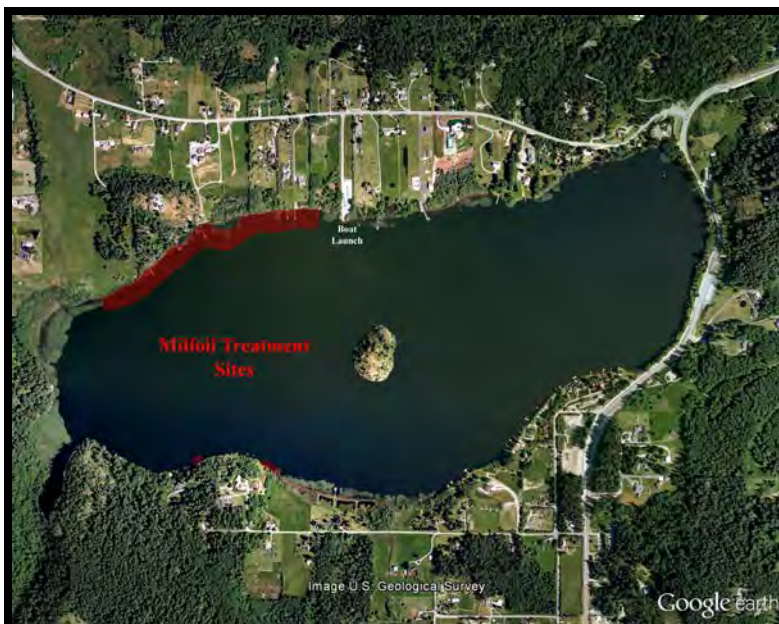
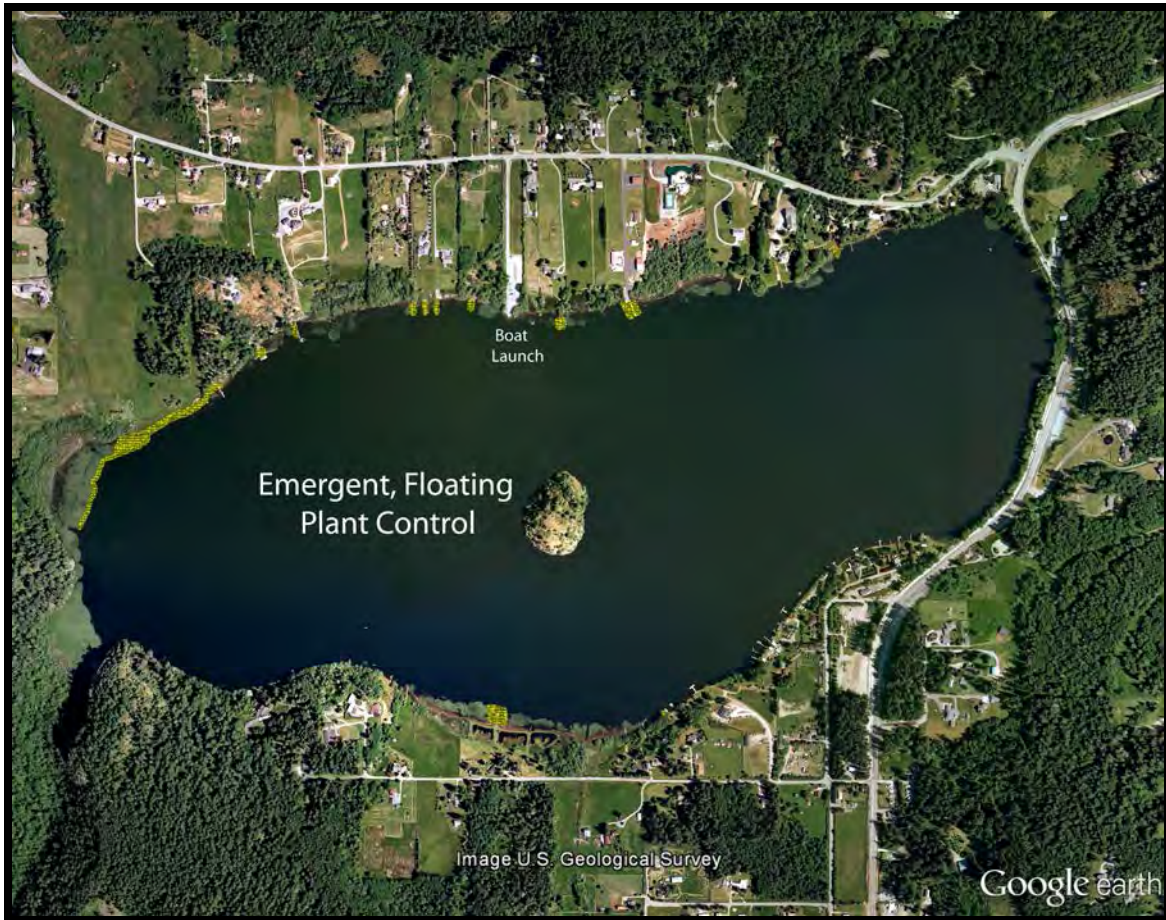
A brief inspection of the prior milfoil locations noted an increase in the number of plants throughout those lake areas previously identified with milfoil. The decision was made to treat the area with a granular formulation of 2,4-D. Twelve acres were treated with the granular material Navigate. A granular spreader attached to the bow of an Airgator airboat dispersed the material as the treatment vehicle transversed the application zone. Once this phase of the application was completed the application boat was then reconfigured for the spraying of the spadderdock, iris and loosestrife.
