Northwest Hydraulic Consultants Inc.

NHC Reference No. 2009051
January 17, 2025

Re: **Mill Creek at South Skagit Highway Phase 1 Design
Geomorphic Summary**

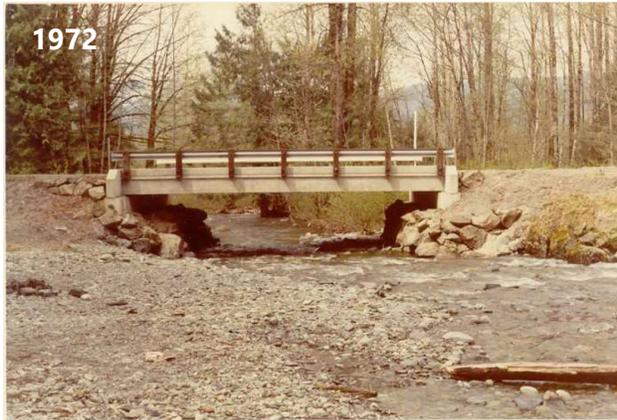
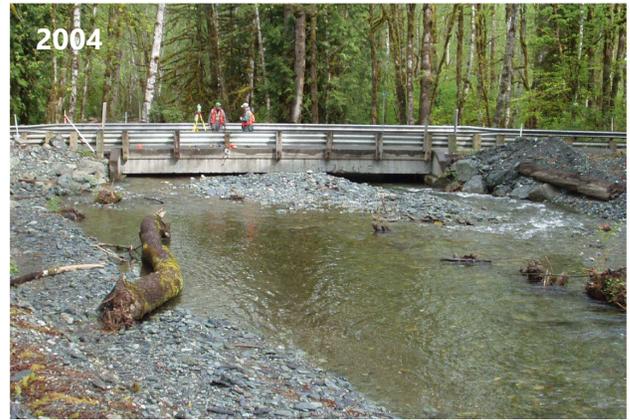
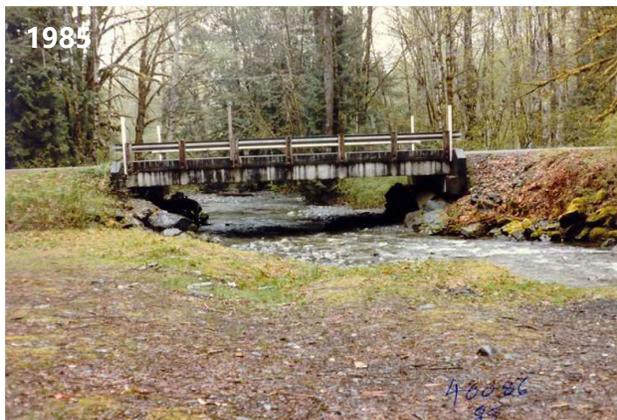
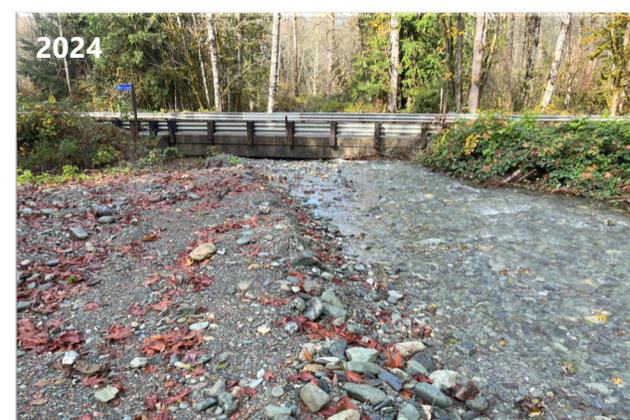
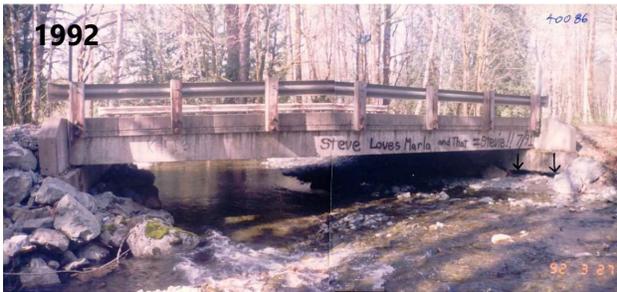
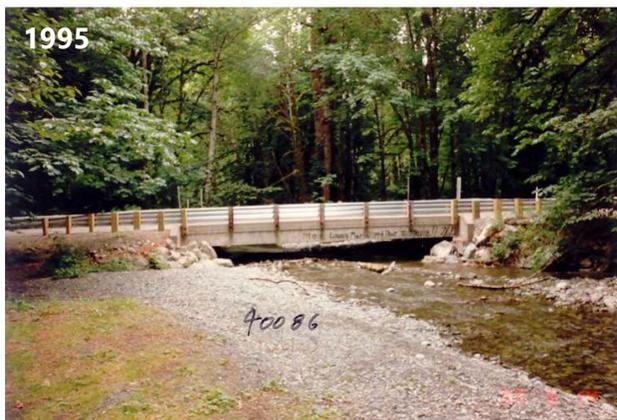
Figure 2: Photos of the Mill Creek Crossing between 1972 and 2024. 1972 to 2004 photos from NHC (2004).

Aerial photos of the site in 1972 (Figure 2) show that a large (~150 ft wide) side channel of the Skagit River meandered to a position about 240 ft northwest of the Mill Creek crossing location and that Mill Creek had built a small delta-fan bar into this side channel. Before this time, periodic high flows in the Skagit River likely transported most of the sediment supplied by Mill Creek out of this side channel, keeping it open. Between 1972 and 1985, however, the slow accumulation of sediment at the mouth of Mill Creek reduced the capacity of flow through the side channel to carry away sediment supplied by Mill Creek, creating a positive feedback cycle where sediment accumulation reduced the amount of flow through the side channel, further driving additional sediment accumulation. By 1985, the Mill Creek delta-fan had prograded completely across the side channel and blocked throughflow from the Skagit River (Figure 2). After this, all the sediment supplied by Mill Creek was deposited locally and Mill Creek began building a larger alluvial fan through a sequence of avulsions downstream of the South Skagit Highway, driving aggradation of the bed at the crossing.
