# Mill and Savage Creeks History, and Salmon and Steelhead Use

Bill McMillan, February 2, 2024

## Part I. Earliest Available History Found for Mill and Savage Creeks & to the Present Time

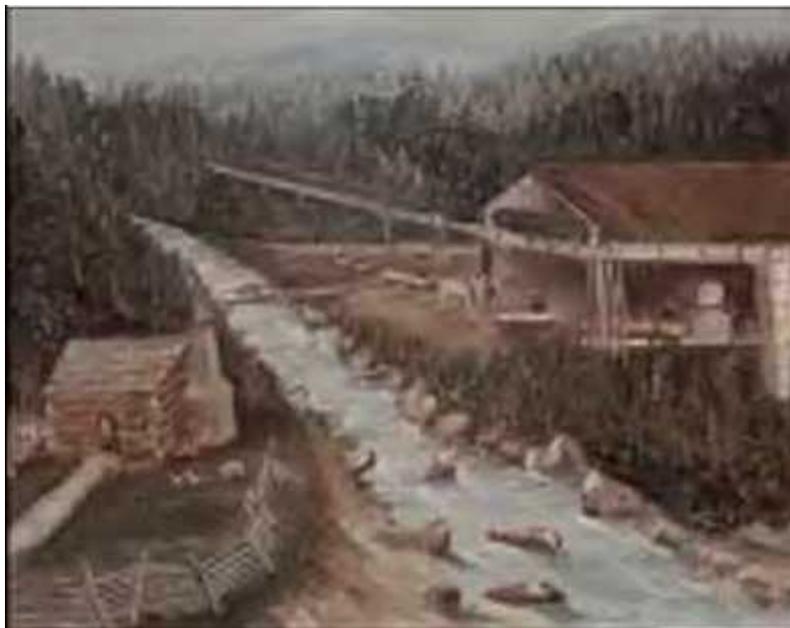
Painting of Mill Creek sawmill as remembered by John Savage (a son of George) showing the flume whose water powered the mill. It perhaps included a dam of some sort upstream on Mill Creek to divert water to the flume.

The Boyd family came to later operate the Mill, with its power further described [<http://www.skagitriverjournal.com/Upriver/Uto-Conc/Birdsvew/Boyd/BoydLA2-Mabel1.html>], also indicated to no longer be secure, but I can otherwise provide]:

*“This little mill was run by water power; the water from the creek fell over a huge paddle wheel, turning the saws in the mill with great power.”*

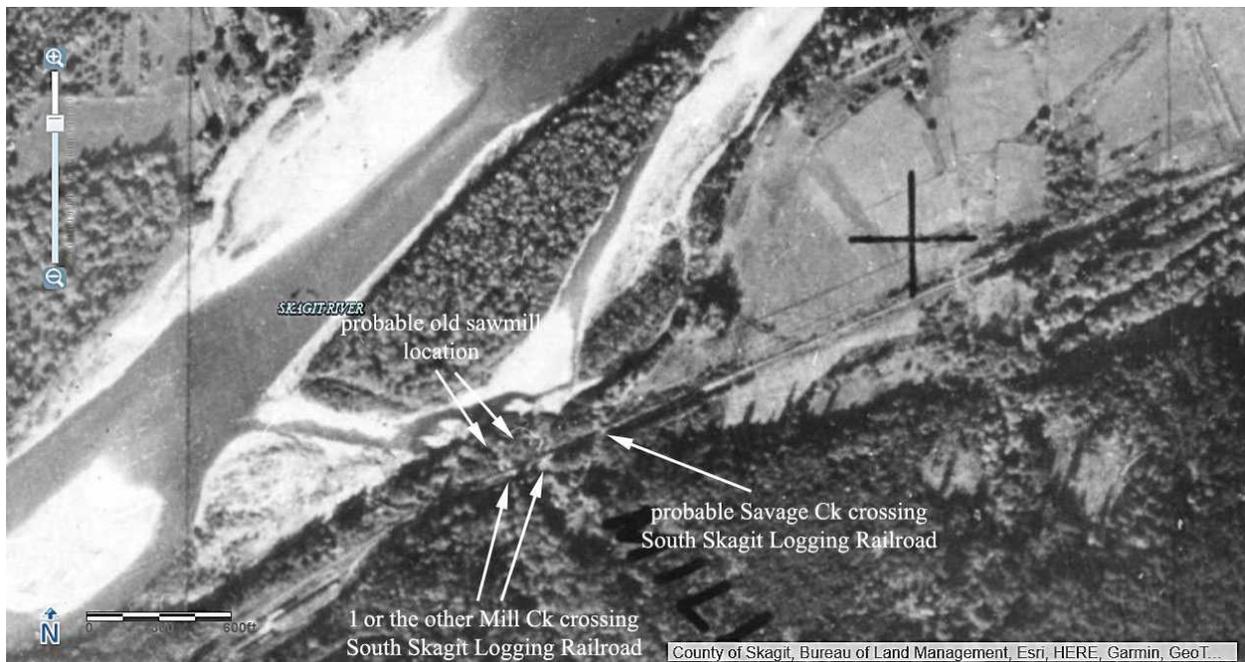
1937 aerial photo of the Mill and Savage Creek crossing areas of the likely logging railroad at that time

The 1937 aerial photo shows the Mill and Savage Creek probable location areas crossing the logging railroad the South Skagit Highway was later built upon, or next to. However, the lack of definition in the early photo makes details difficult to positively determine.

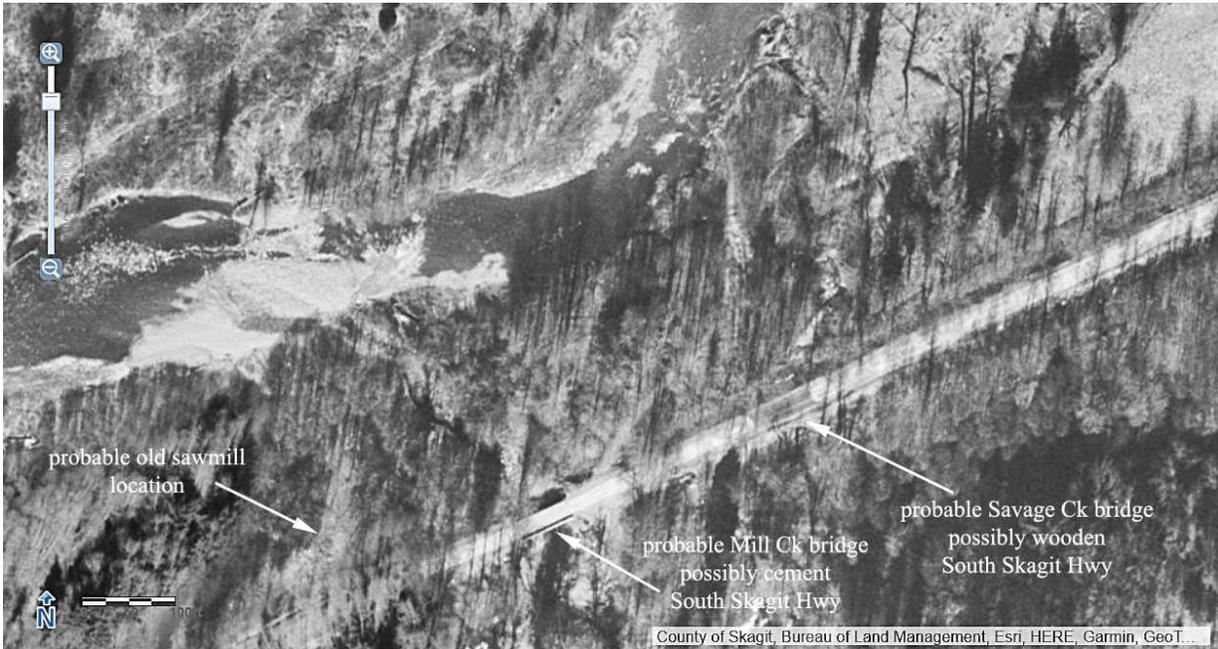
1969 aerial photo showing South Skagit Highway crossings of Mill and Savage Creek at that time

The 1969 aerial photo of Mill and Savage Creek crossings of what was by then the South Skagit Highway appears to show the new cement bridge that likely replaced a former wooden bridge over Mill Creek. The Skagit County 2017 Bridge Report indicates the cement bridge that remains today was built in 1969. The bridge at Savage Creek looks to differ with darker color and may have still been a wooden bridge. Although the photo resolution is much better than that in 1937, it remains that clear determinations about the bridges can't be made.

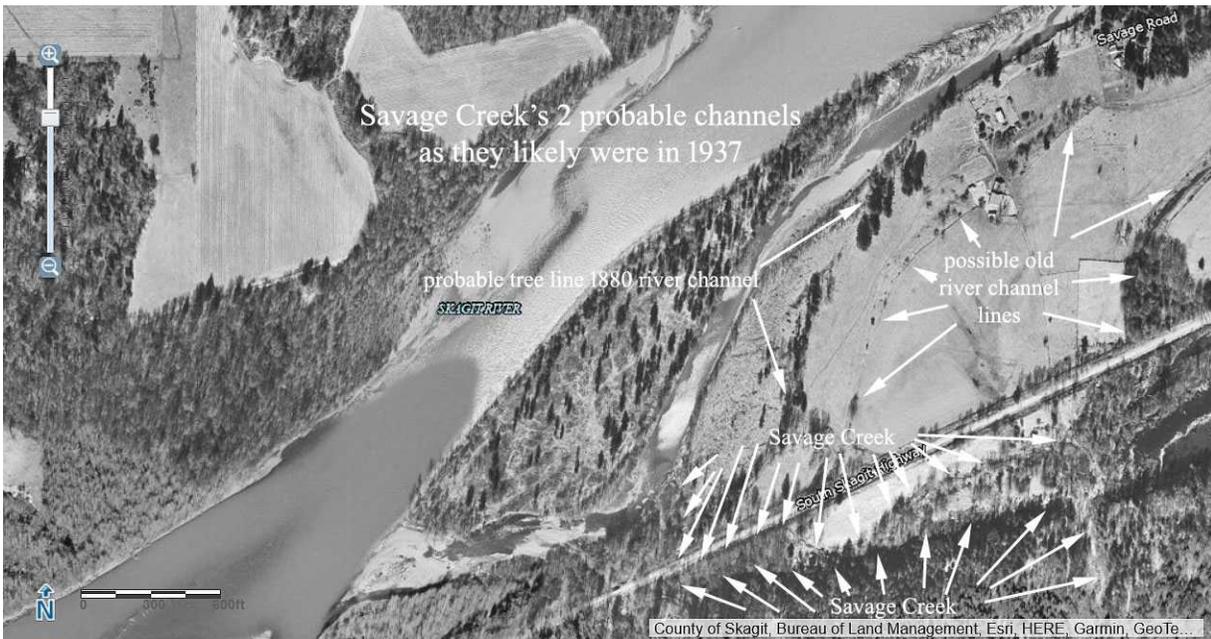
1969 aerial view of Savage Property area & probable Savage Creek channel locations & old river channel lines

The above 1937 and 1969 aerial survey photographs are available from Skagit County at the following link: [https://www.skagitcounty.net/Maps/iMap/?mapjs=buildamap\\_aerial](https://www.skagitcounty.net/Maps/iMap/?mapjs=buildamap_aerial) . A related Skagit County website at <https://www.skagitcounty.net/Departments/GIS/aerialmain.htm> indicates: The historical paper print aerial photos owned by the County have been scanned and archived and can now be viewed by contacting the [Public Works Department](#). These photos include flights from 1937, 1956, 1966, 1978 and 1993. These scans are not georeferenced and are available by sections. The contact for these was Rachel Vaughan [rvaughan@co.skagit.wa.us](mailto:rvaughan@co.skagit.wa.us) . On December 18, 2024 I sent an email to Rachel Vaughan as indicated above but I received no answer. It would be of considerable interest to compare a 1956 aerial photo of the Mill and Savage Creek crossings, if there are comparable views. Those photos might have better resolution than those by cameras used in 1937.

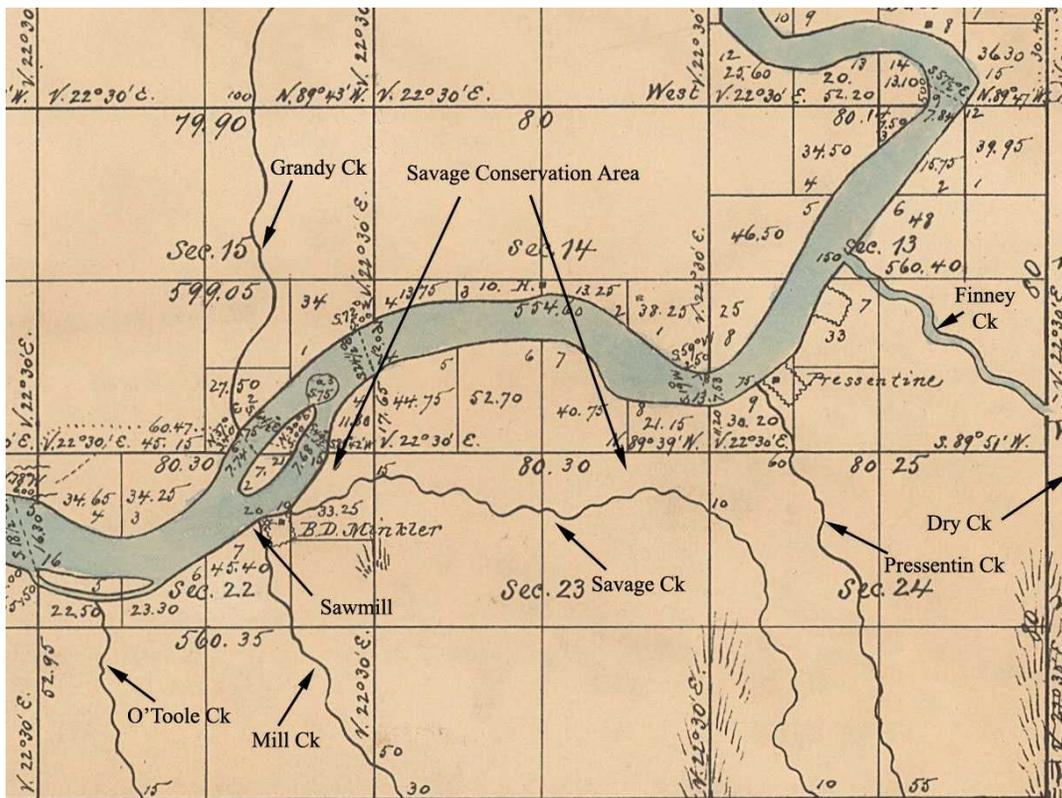
1880 map of O'Toole to Finney Creek of the Mid Skagit River with locations of interest added

The above map is from 1879 surveys as certified in 1880 and cropped from the following source: [https://www.blm.gov/or/landrecords/survey/yPlatView1\\_2.php?path=PWA&name=t350n070e\\_001.jpg](https://www.blm.gov/or/landrecords/survey/yPlatView1_2.php?path=PWA&name=t350n070e_001.jpg) . It is part of, Township: 035-0N, Range: 007-0E, (Willamette Meridian) at the time of earliest land claims along the Skagit River above Mount Vernon. I have added arrows and text to provide geographic reference points for the Mill and Savage creeks historical era, as well as today's Savage Slough Acquisition and Restoration project (shortened on the map to the Savage

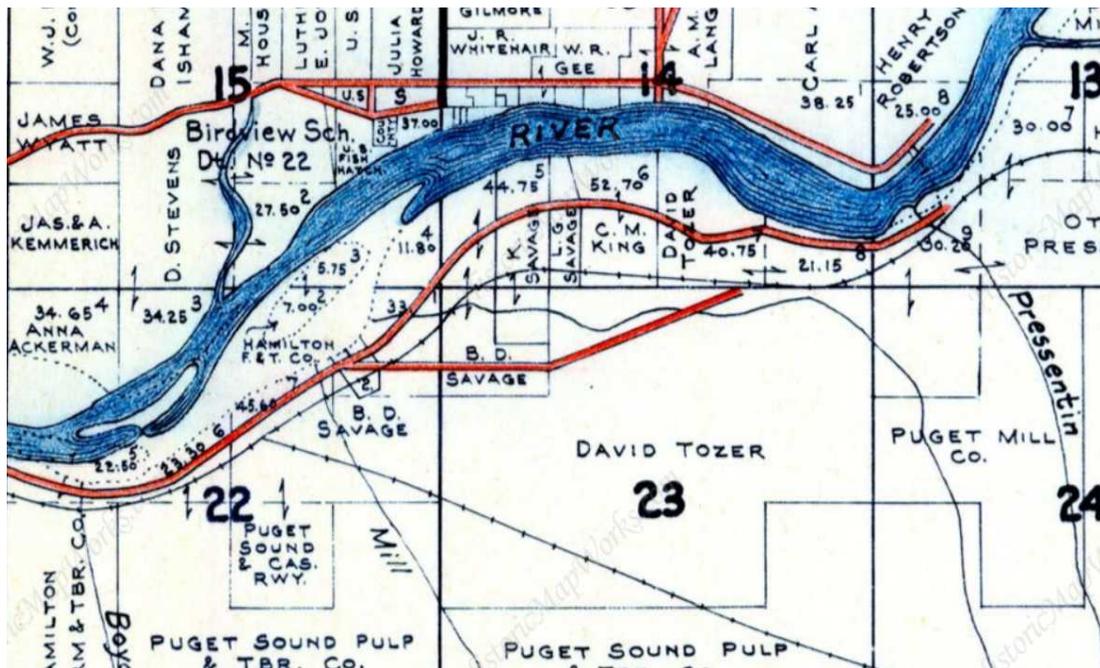
1941 Metzger map of the Savage Property area Mill and Savage Creek and 1880 river channel in dotted lines

The 1941 Metzger map helps to further clarify the 1937 aerial photo of the Savage Property and its division of ownerships by 1941. It also provides the details of where roads were at the time, and that the logging railroad paralleled the South Skagit Highway as far as it went at the time and was along what remains today of Savage Road. Apparently today's South Skagit Highway location was beginning to be extended with its own route that would thereafter connect with Savage Road and beyond Presentin Creek to provide access to the town of Concrete via the 1952 Dalles bridge. Of particular interest, a spur of the logging railroad in its diagonal line from just west of Mill Creek on up toward Savage Creek follows a similar route as today's plans for an alternative South Skagit Highway route intended to alter the present high flow blockage of the Mill Creek bridge by moving the crossing upstream and reducing other present highway impacts.

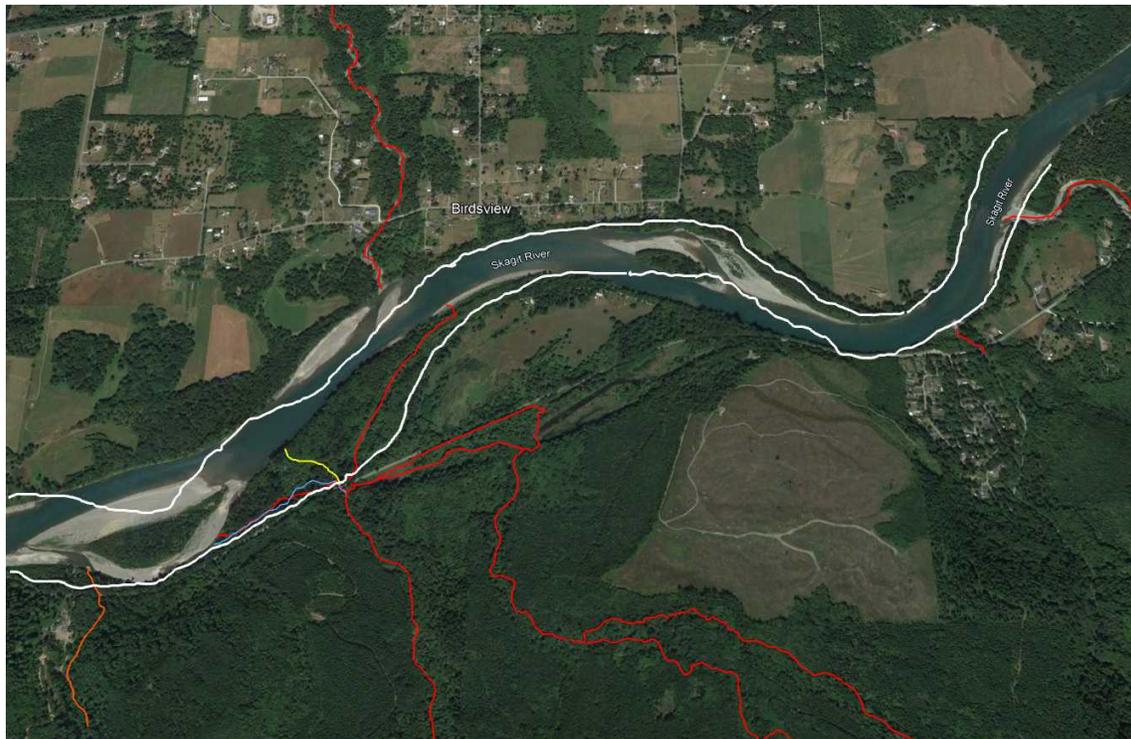
Google Earth Skagit Map of 2019 at Mill-Savage Ck Area Showing Approximate 1880 Channel

The white lines above represent the approximate location of the 1879-1880 Skagit River channel; the red lines indicate from left to right the south-side tributary lengths surveyed for spawning since 2008-09: O'Toole, Mill, Savage, Pressentin, and Finney creeks, and Grandy Creek on the north side. The short yellow and blue lines are the past shifting outlets of Mill Creek below the bridge, now primarily a tributary of Savage Creek entering above the bridge.

The lower section of Mill Creek has come to be diverted in large part to Savage Creek in recent years as a result of the South Skagit Highway bridge over Mill Creek acting as a dam in high flow events trapping gravel, cobble, and woody debris above the bridge with the resulting diversion. This has become a significant limitation for habitat recovery as former ponds associated with Savage Creek for rearing young salmonids, as well as holding areas for anadromous adults, are increasingly filled with gravel and sediment from the diversion. This will be covered in more depth in Part II regarding salmon and steelhead use of these creeks and associated ponds. The scoping that has occurred, and continues to occur, for relocation of the South Skagit Highway is presumably intended to address the associated habitat problems for salmon and steelhead at present, as well as that of continual expenses for highway repair after high flow events with disruption of highway travel for the local community.

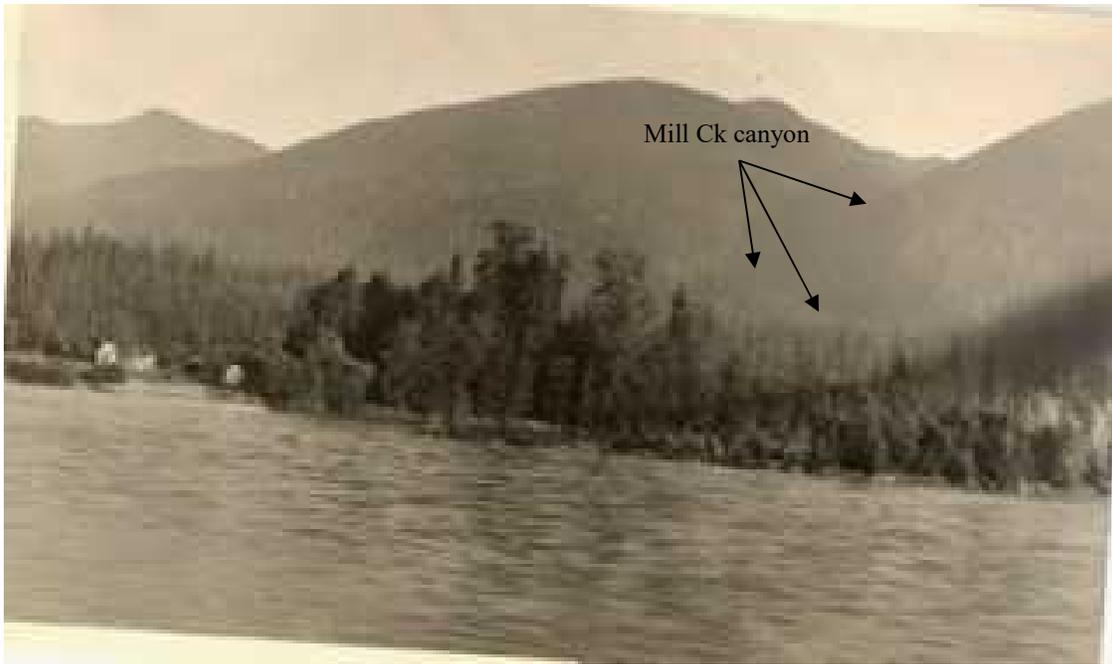
Photo 1: From north side of the Skagit looking at Grandparents home built 1908 on Savage Rd; photo likely ~1910 unlogged hills & dense forest right behind house. [Arrows showing Mill Ck canyon added by Bill McMillan]

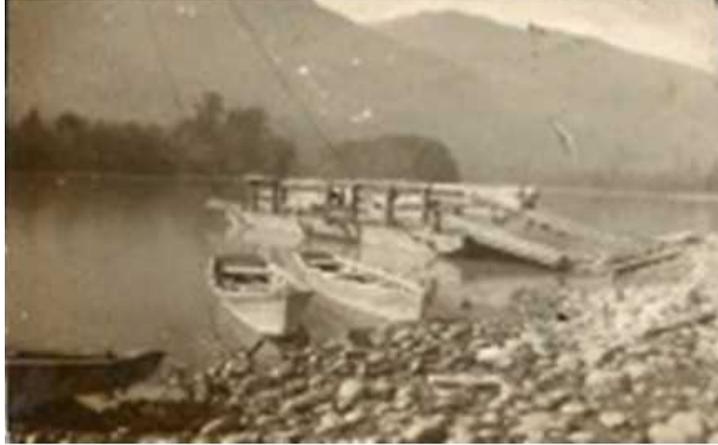
Photo 3. Savage ferry & rowboats from north side looking southwest & downstream, likely 1940s

The first five historical photographs were taken near, or at, where the long-time Savage ferry crossed the Skagit. There was no road at the time of these photos on the south side of the Skagit River, and the Savage family members long used their ferry to cross to the north side with access to school, church, and what stores came to be. In earliest times a canoe was used before the ferry, and gradually over time rowboats replaced them (subsequently equipped with outboard motors) if wagons, tractors, cattle, horses, and etc. were not in need of crossing with the ferry.

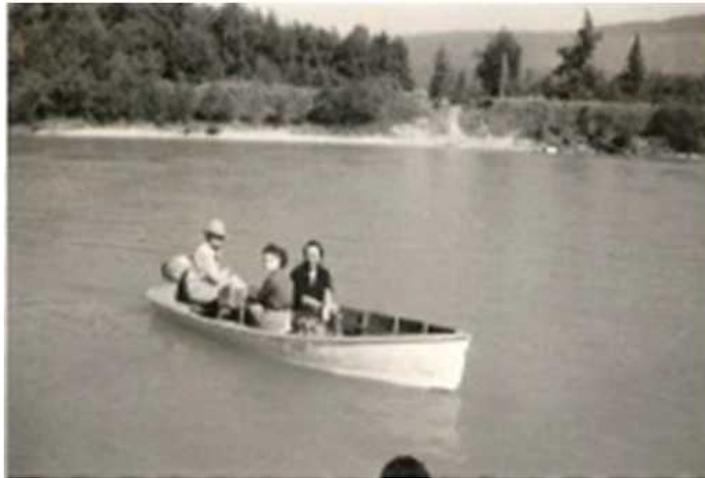
Photo 4. Outboard motor on boat looking from south side to north side with ferry road gap in background late 1940s

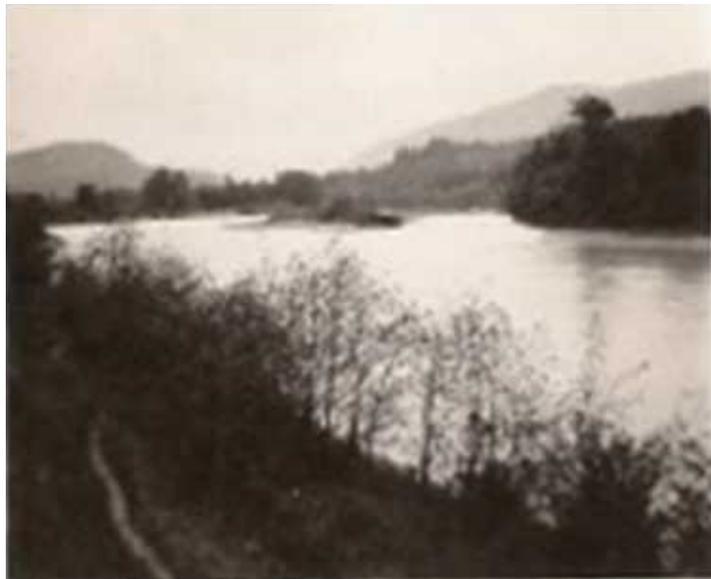
Photo 5. From ferry road on north side looking southeast, upstream, at island at top of Savage Rd ... unknown date.

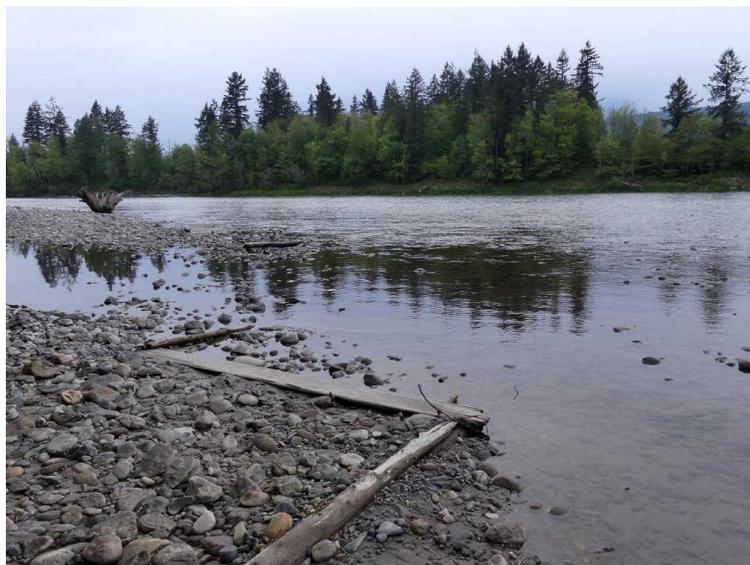
Photo 3: The remains of the old Savage ferry landing on the south side of the Skagit River (May 2024)

The old Savage ferry location on the south side of the Skagit River is now part of the Savage Property acquisition. Flood waters the past 20 years have exposed the old wooden framework, but the cement apron in front of the wooden frame was visible earlier. For a number of years it was a curiosity to me until the frame was exposed. On the Skagit north side there remains the excavated slope down to the river that led to the north-side ferry landing.

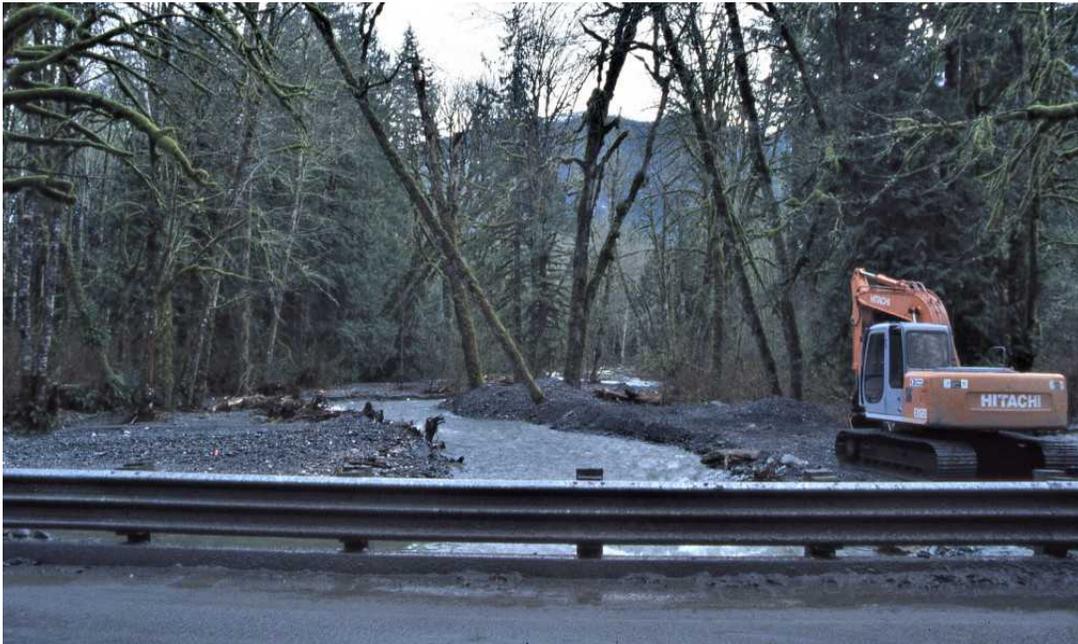
Photo 1. Upstream view of earlier Mill Creek bridge impacts after upstream bank failures (Feb. 2002)

My first species sampling survey with recorded details by species at Mill Creek was in June of 1998 from just above the bridge on upstream to a particularly high gradient shift about one mile upstream. In 1998 Mill Creek below the high gradient reach occupied a very different stream channel of meanders, spaced intervals of low gradient gravel areas, large wood creating pools, and then increasing boulder-drop pools as gradient increased. Although it undoubtedly wasn't what it once was, significant bank failures were absent. As shown in photos 1 and 2, Mill Creek began to dramatically alter about the time of the 2002 event portrayed.

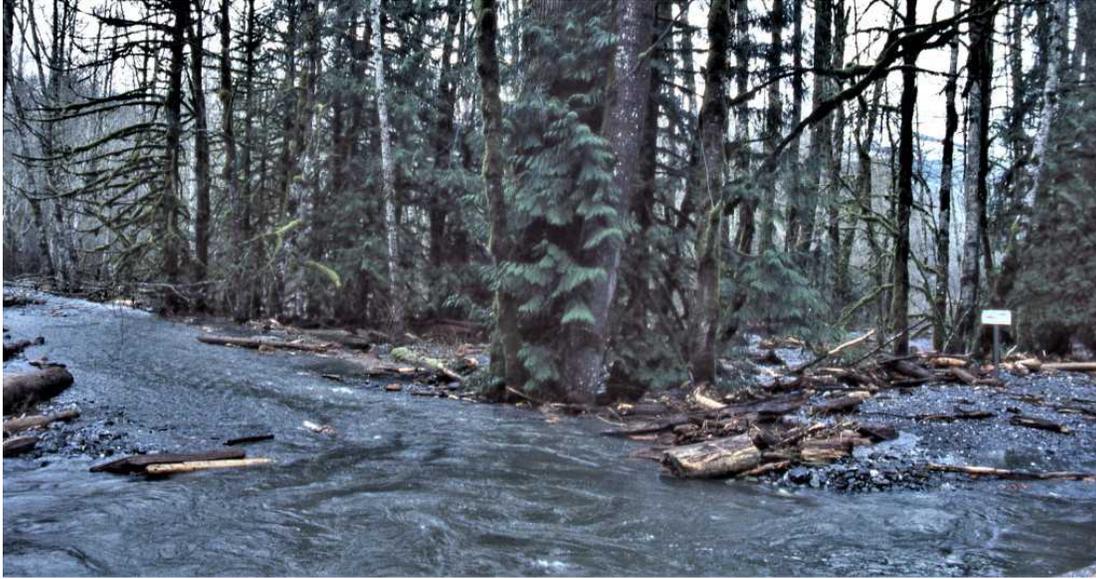
Photo 2. Downstream view of earlier Mill Creek bridge impacts after upstream bank failures (Feb. 2002)

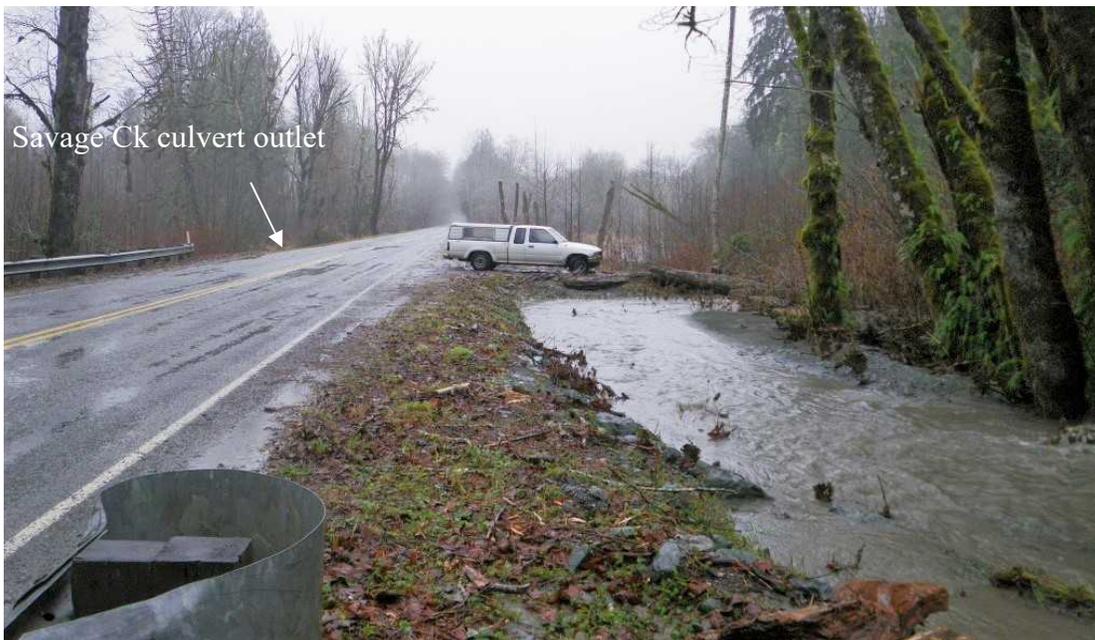
Photo 3. First evidence that bridge diversion of Mill to Savage Creek may become permanent (Dec. 12, 2010)

However, from 2002 to about 2015 (Photos 3-5), while annual changes increasingly occurred at Mill Creek beyond upstream view from the bridge, visually the channel from that point above the bridge to entry to the Skagit was relatively little changed, and likely reflected relative historical continuity back to 1937-1969 aerial views. Nevertheless, the bridge in high flow events continued to result in overflow diversion with evidence of future potential permanence in December 2010 (Photo 3) as the trees and rootwads that had been buried to try to prevent further diversions were dislodged with a deep diversion channel cut to Savage Creek.

Beginning in 2015-16 the deposition from increasing upstream bank failures and dramatic channel shifts continued to raise the streambed just above and below the Mill Creek bridge. As foretold by the December 2010 event (Photo 3), and the vulnerable future (Photo 4), on February 1<sup>st</sup> of 2020 the Mill Creek bridge blocked downstream movement of gravel, cobble, and wood raising the bed behind with a deeply downcut diversion of Mill Creek to Savage Creek as shown on February 2<sup>nd</sup> (Photo 6). A well intended fix occurred in early August 2020 (Photo 7) with positive results as hoped with the first November freshets resulting in most of the flow going beneath the Mill Creek bridge to re-water the west channel to the Skagit (Photos 8 and 9). However, with each freshet there was shifting dominance of flow between the diversion channel

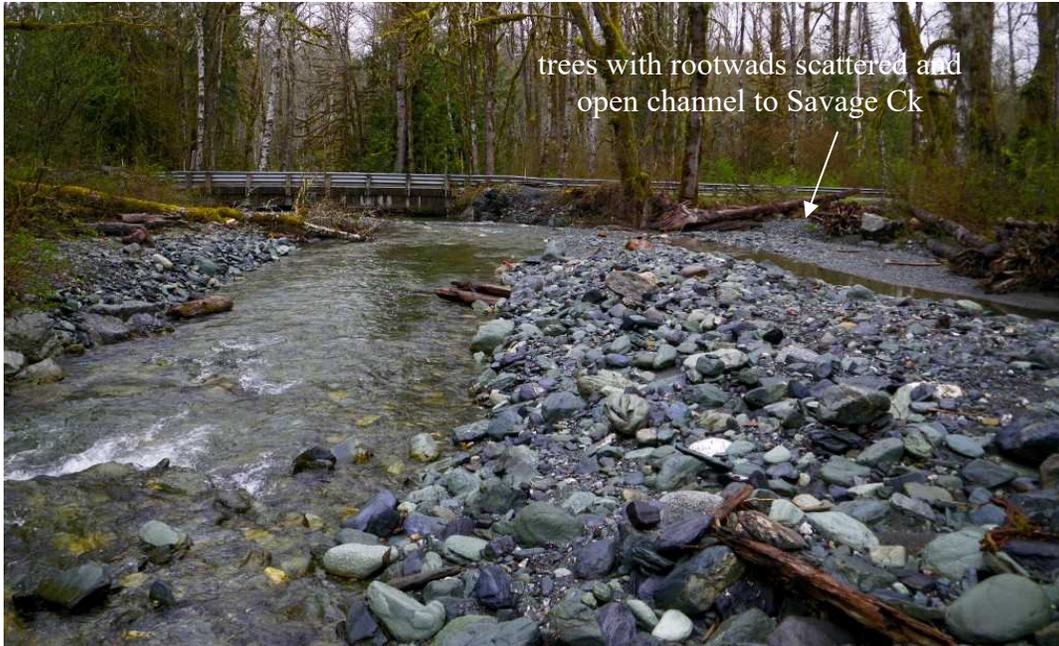
Photo 4. Downstream view to Mill Ck bridge similar to what it historically was but awaiting problem (Apr. 21, 2011)

Although permanence of the diversion channel did not immediately occur, in the winter/spring of 2011 (Photo 4) it was clear that with those former blocking trees and rootwads displaced by the 2010 flow event it would lead to an eventual complete shift of Mill Creek to that diversion. Deposition was increasing below the bridge as well, and an overflow channel turning 90° to the west to the Skagit River about 75 feet below the bridge began to enlarge in the winter of 2014 (Photo 5 shows that overflow channel location before it enlarged). This overflow channel, as with another below it leading west rather than north, followed the Skagit River channel depicted in the 1880 map, and with its remnants still visible in the 1937 and 1969 aerial photos. However, it would not be until about 2016 before this new westward channel below the bridge would come to dominate Mill Creek outflow to the Skagit River with its extended length from that of the northward former channel.

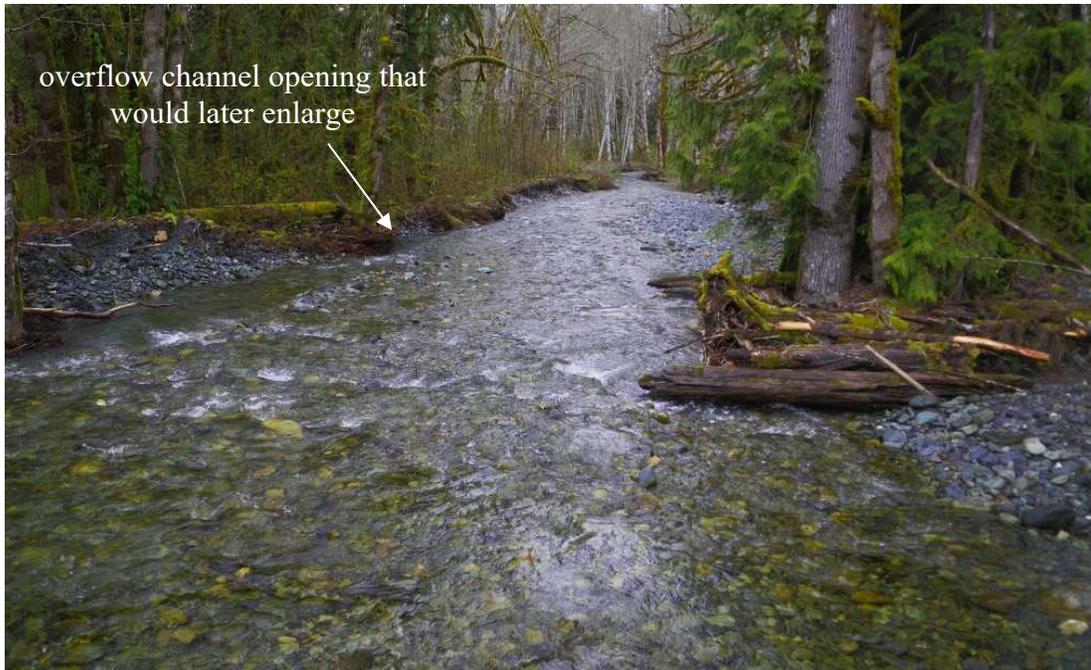
Photo 5. Downstream view from Mill Ck bridge as similar to what it was in the 1969 aerial photo (Apr. 21, 2011)

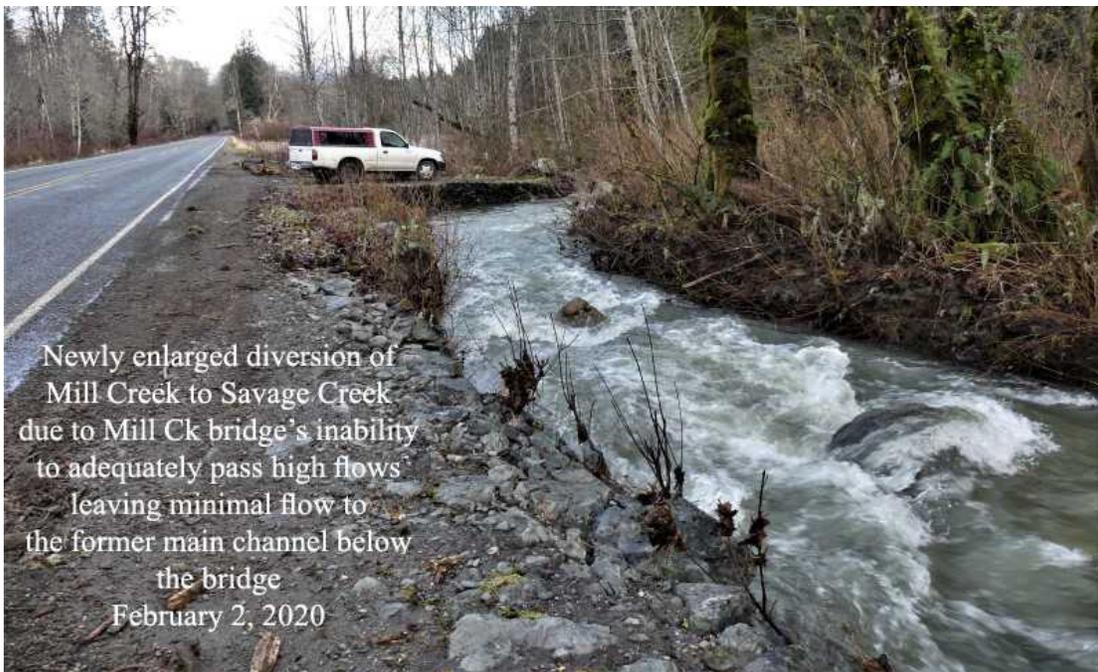
Photo 6. The text with the photo explains the situation and was sent out to Skagit interest parties (Feb. 2, 2020)

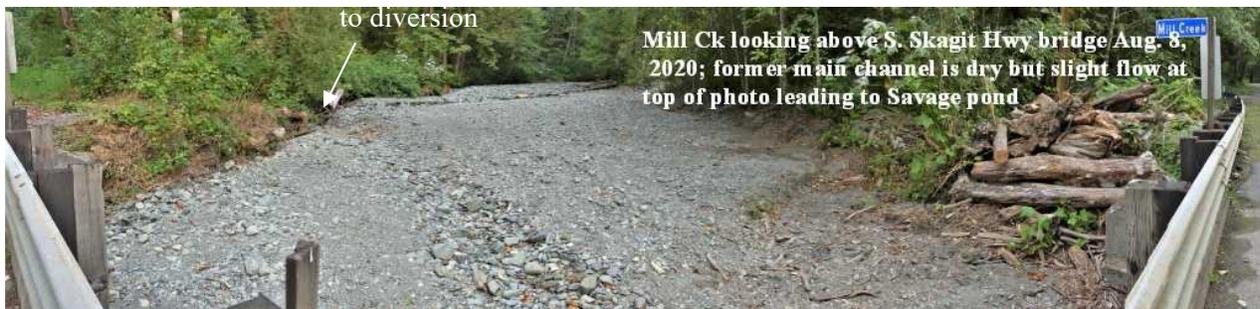
Photo 7. This shows the well intended fix that occurred in August of 2020 to try to prevent diversion of Mill Creek to Savage Creek and pond above the bridge; the raised bed was lowered, blocking wood removed, and trees with rootwads were again place at the entry to the diversion channel in hopes of minimizing flow to it; however, what little flow occurred at the time, as indicated in the text, led directly to that diversion channel.

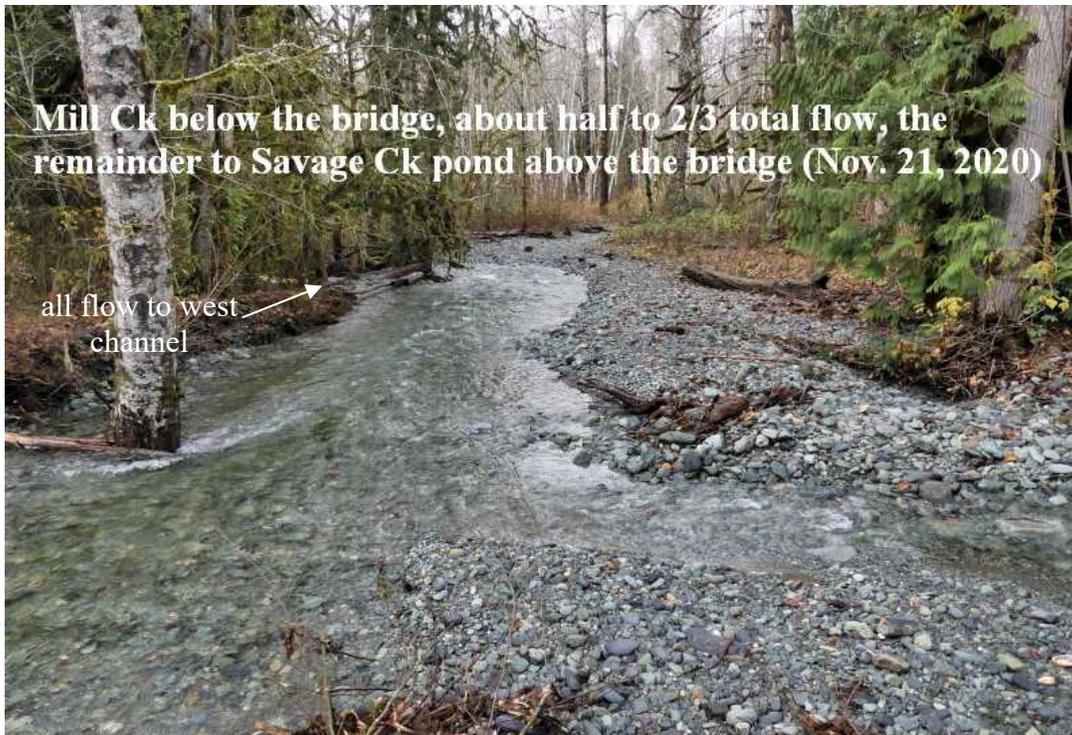
Photo 8. November 2020 freshets resulted in flow again below the bridge leading west to the Skagit (Nov. 21, 2020)

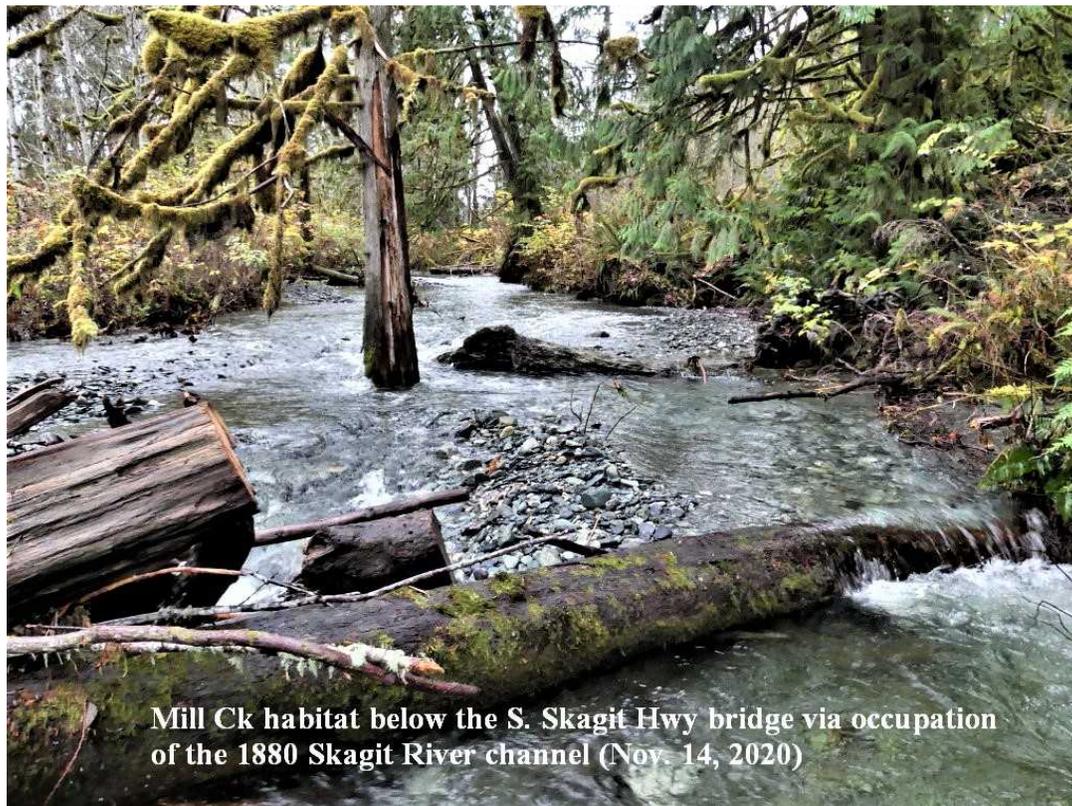
Photo 9. Mill Creek flow as reestablished to the extended length of the old 1880 Skagit channel (Nov. 14, 2020)

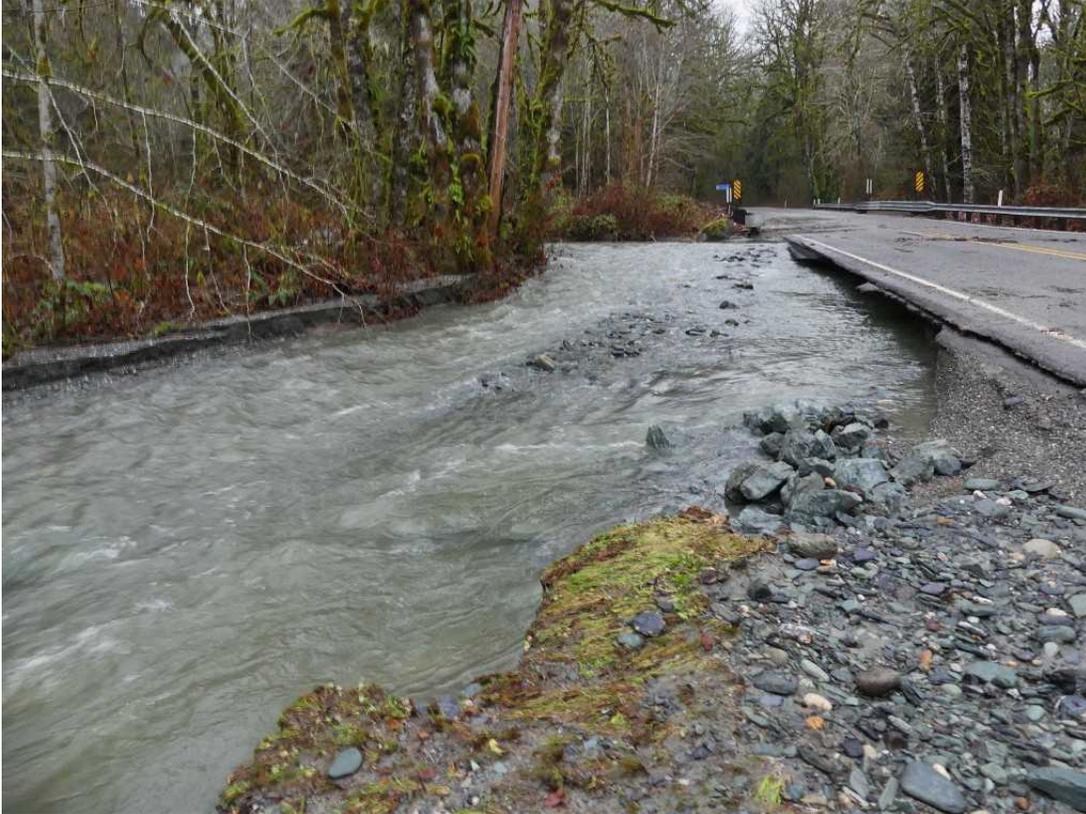
Photo 10. Results of high flow event at Mill Creek bridge with all flow to the diversion channel (Dec. 6, 2023)

and the flow beneath the bridge to the west channel to the Skagit. Then a large event occurred on December 5<sup>th</sup> of 2023 with particularly catastrophic results (as shown in Photo 10 taken December 6<sup>th</sup>). The Savage Creek culvert plugged with transport of woody debris backing up the pond of Savage Slough for a quarter mile upstream and eroding the road fill. Reconstructive repair took about a week. Although significant flow was resumed below the bridge, the large amounts of wood placed below the bridge to clear it resulted in wood blocking the west channel to the Skagit (Photo 11), and all the flow except in higher flow events went northward to the old former channel and then angled east to Savage Creek about 150 yards below the highway. This remained the case until sometime between January 8<sup>th</sup> and January 13<sup>th</sup> of 2025. A high flow event then occurred that diverted all flow to the diversion channel as found at normal flows on January 17<sup>th</sup> (Photo 12). The channel below the bridge was completely abandoned once again leaving a prior Chinook redd and seven coho redds dry (Photo 13).

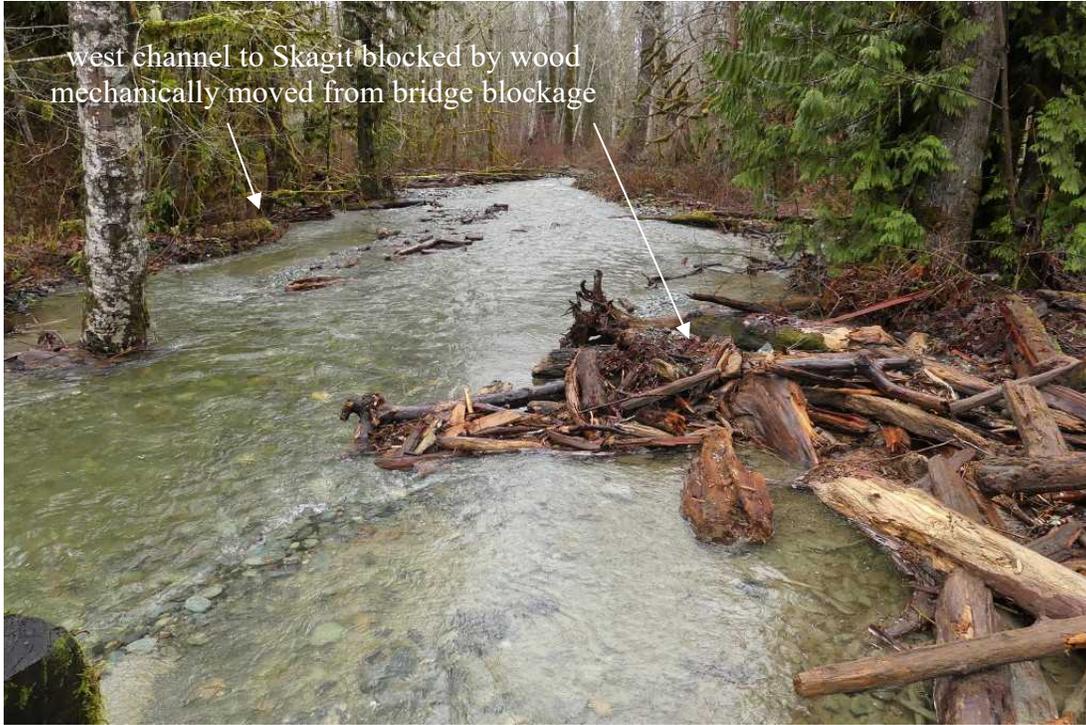
Photo 11. About half Mill Creek flow restored below the bridge but not the west channel to the Skagit (Jan. 25, 2024)

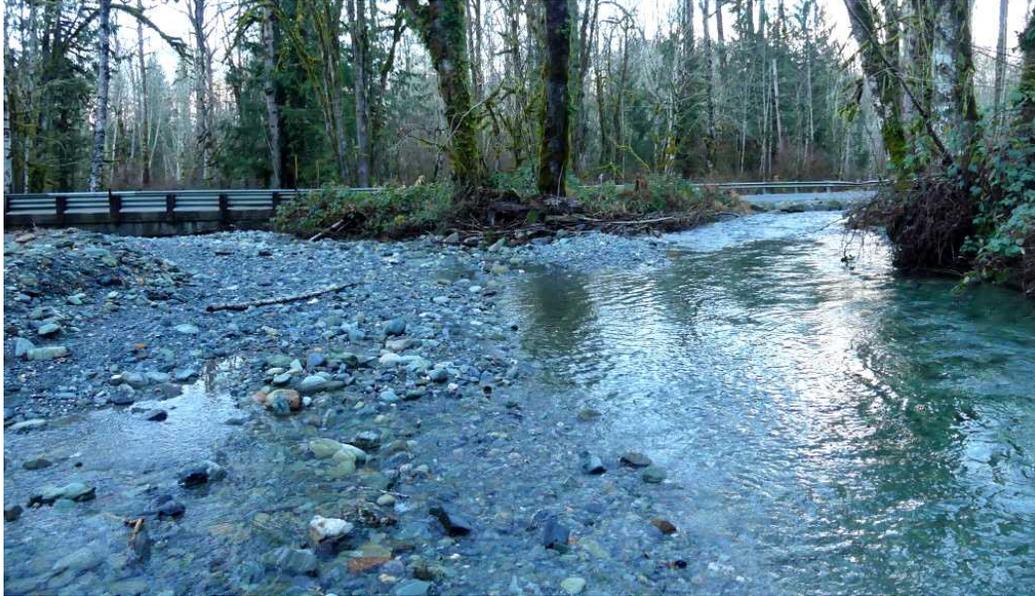
Photo 12. Downstream view to Mill Ck bridge with complete diversion to Savage Ck to right (Jan. 17, 2025)

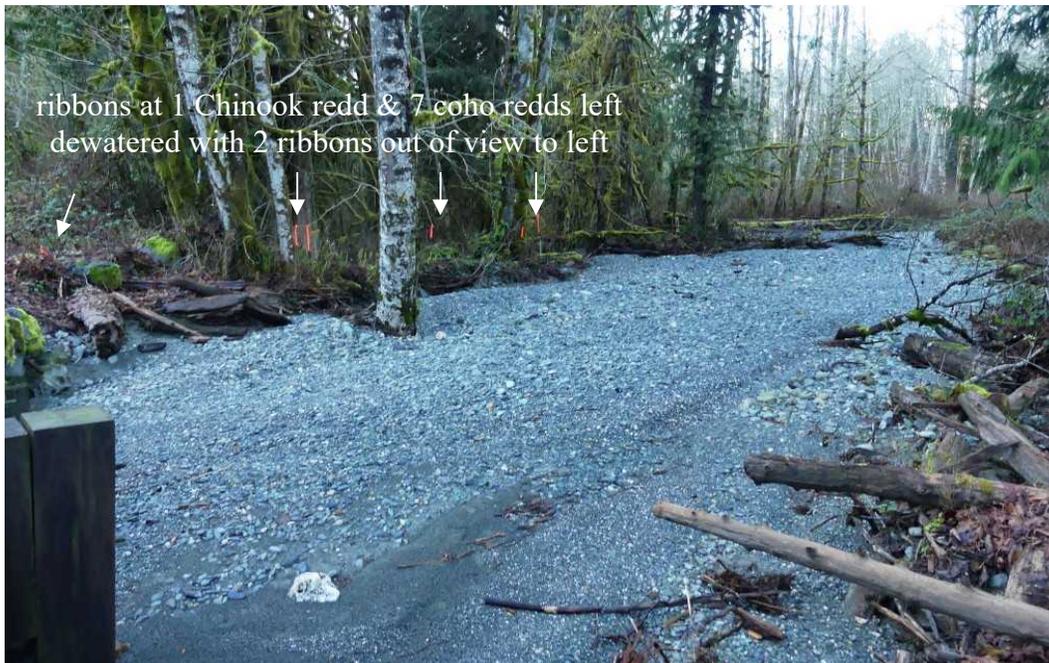
Photo 13. Downstream view from Mill Ck bridge, ribbons of dewatered salmon redds center left (Jan. 17, 2025)

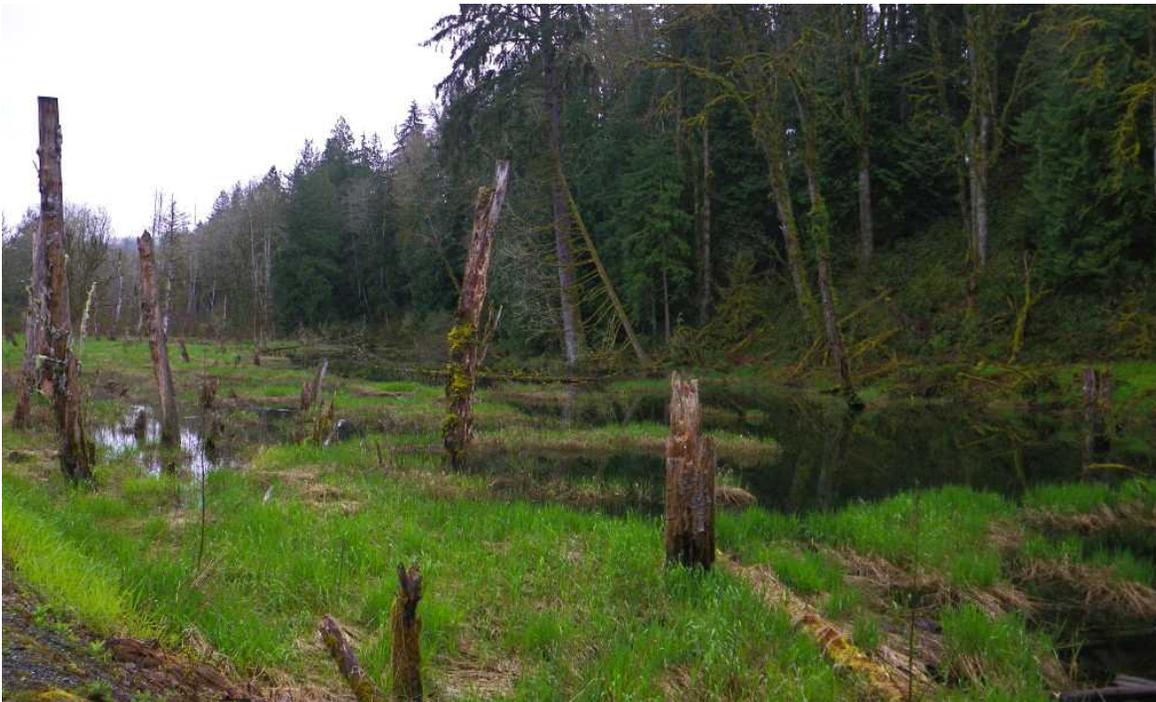
Photo 1. Lower Savage Pond that Savage Creek formerly entered and exited via the highway culvert (Apr. 21, 2011)

Both above and below the highway, Savage Creek historically ran through ponds that were once part of differing old Skagit River channels, now called Savage Slough. The one that was about a quarter mile long beginning just above the Savage Creek culvert is shown as it was from at least 1998 (of my first knowledge) to about 2019 as shown in 2011 (Photo 1 of this section). These ponds are particularly important as an integral part of Savage Creek's own salmonid ecosystem with considerable differences from Mill Creek's. What the actual historical configuration of Savage Creek was prior to the logging railroad, and subsequent South Skagit Highway, is unknown. However, John Thompson's memory was that Savage Creek prior to the culvert crossed further upstream with a bridge. There are multiple ponds on both sides of the highway that once may have been related to Savage Creek at differing points in time before the railroad and highway roadbeds blocked natural connectivity. However, as shown in Photo 2 of this section, the pond directly above what is now the Savage/Mill Creek culvert has greatly filled in with the deposition of the Mill Creek diversion channel diversion. This is similarly the case with the former long pond that in the early 2000s was about 150 yd below the South Skagit Highway. A long length of its upper end has now filled in with a resulting creek channel rather than a pond due to Mill Creek's diversion with transport of gravel and sediment downstream.
