# Mill and Savage Creeks History, and Salmon and Steelhead Use

Bill McMillan, February 2, 2024

## Part I. Earliest Available History Found for Mill and Savage Creeks & to the Present Time

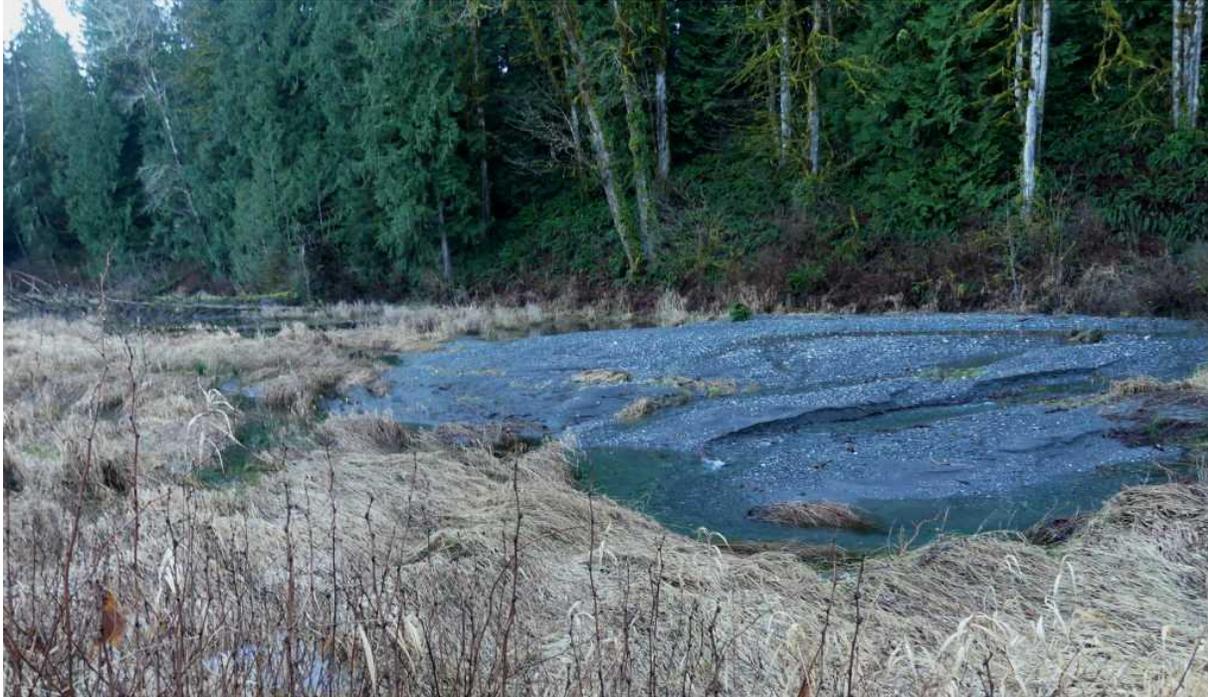
Photo 8. Great loss of lower Savage Pond above the highway as a result of Mill Ck diversion (Jan. 17, 2025)

Both above and below the highway, Savage Creek historically ran through ponds that were once part of differing old Skagit River channels, now called Savage Slough. The one that was about a quarter mile long beginning just above the Savage Creek culvert is shown as it was from at least 1998 (of my first knowledge) to about 2019 as shown in 2011 (Photo 1 of this section). These ponds are particularly important as an integral part of Savage Creek's own salmonid ecosystem with considerable differences from Mill Creek's. What the actual historical configuration of Savage Creek was prior to the logging railroad, and subsequent South Skagit Highway, is unknown. However, John Thompson's memory was that Savage Creek prior to the culvert crossed further upstream with a bridge. There are multiple ponds on both sides of the highway that once may have been related to Savage Creek at differing points in time before the railroad and highway roadbeds blocked natural connectivity. However, as shown in Photo 2 of this section, the pond directly above what is now the Savage/Mill Creek culvert has greatly filled in with the deposition of the Mill Creek diversion channel diversion. This is similarly the case with the former long pond that in the early 2000s was about 150 yd below the South Skagit Highway. A long length of its upper end has now filled in with a resulting creek channel rather than a pond due to Mill Creek's diversion with transport of gravel and sediment downstream.
