Illabot Creek Habitat Restoration Feasibility Study

By Devin Smith and Kate Ramsden

Skagit River System Cooperative

January 17, 2006

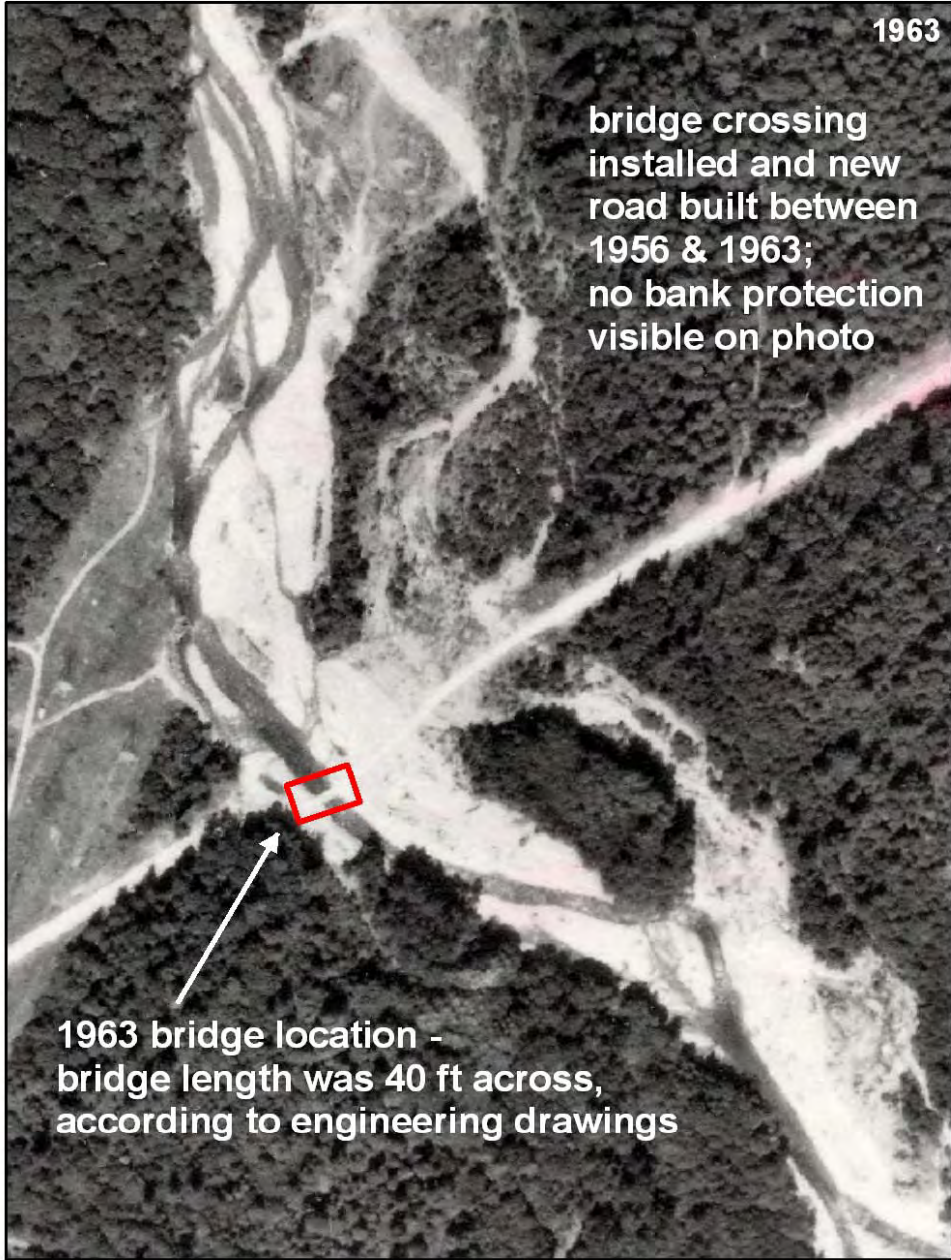
1963

bridge crossing installed and new road built between 1956 & 1963; no bank protection visible on photo
