# Illabot Creek Bridge Design Project -Alternative Study Report

Prepared for:
Skagit River System Cooperative
June 2, 2011

**TranTech Engineering, LLC** 12011 NE 1<sup>st</sup> St, Suite 305 Bellevue, WA 98005 (425) 453-5545

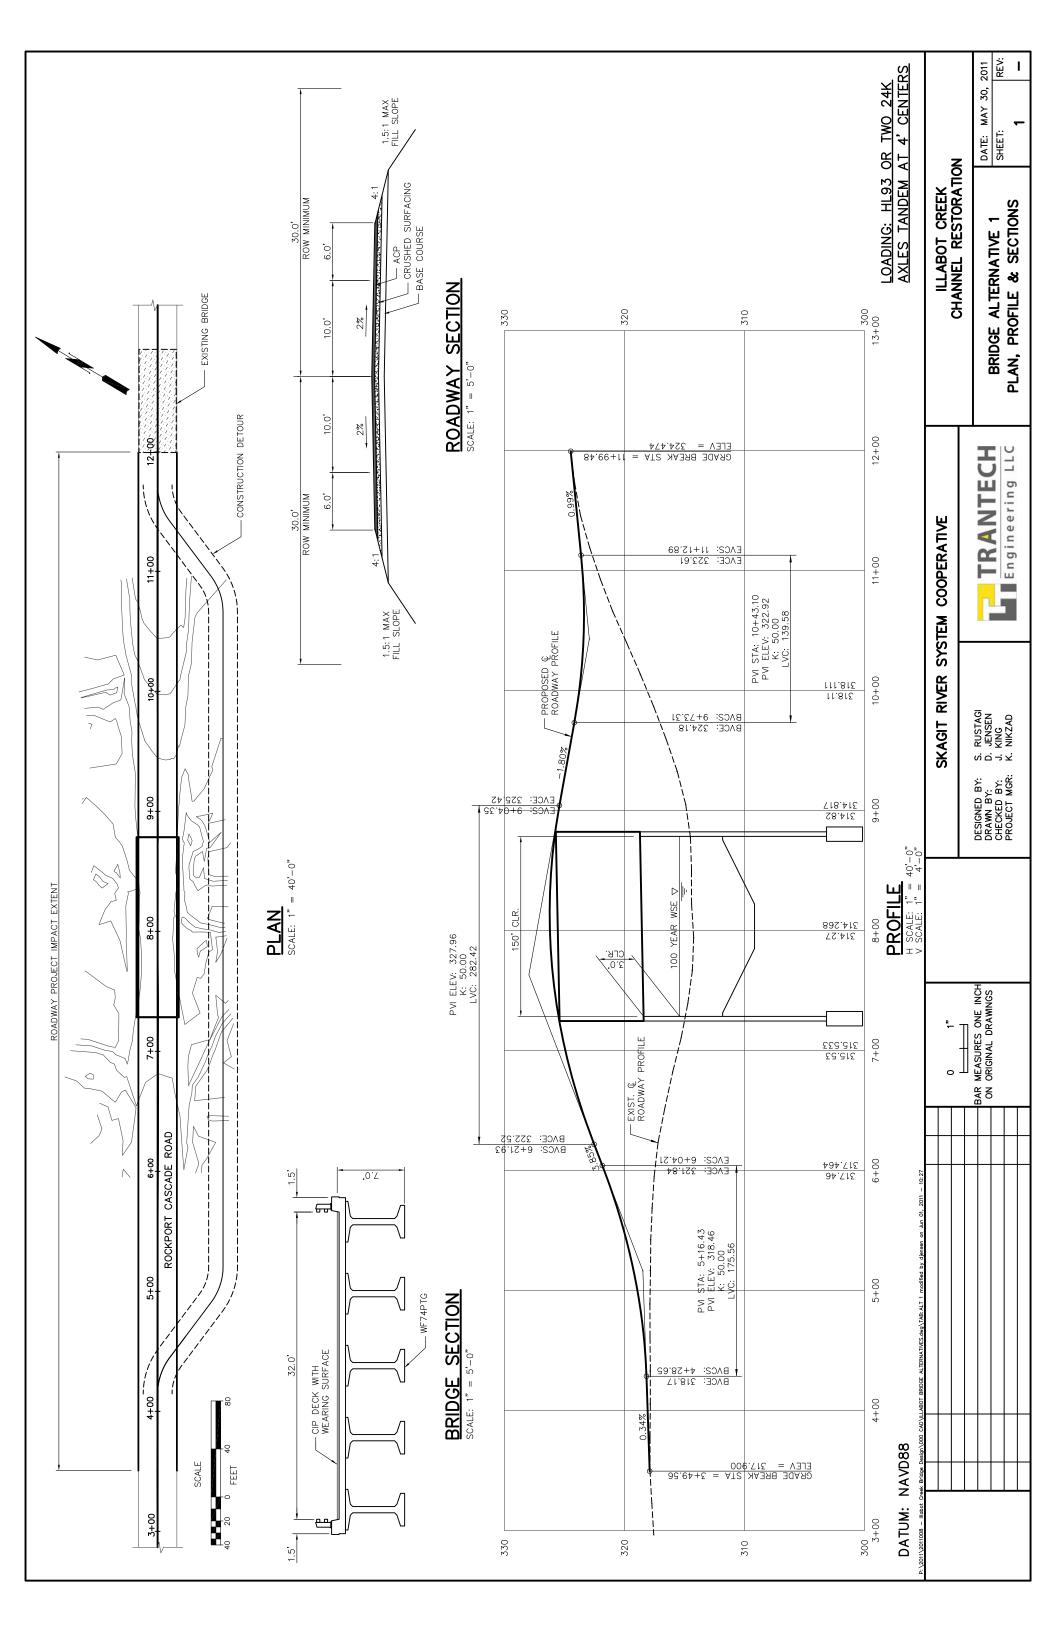
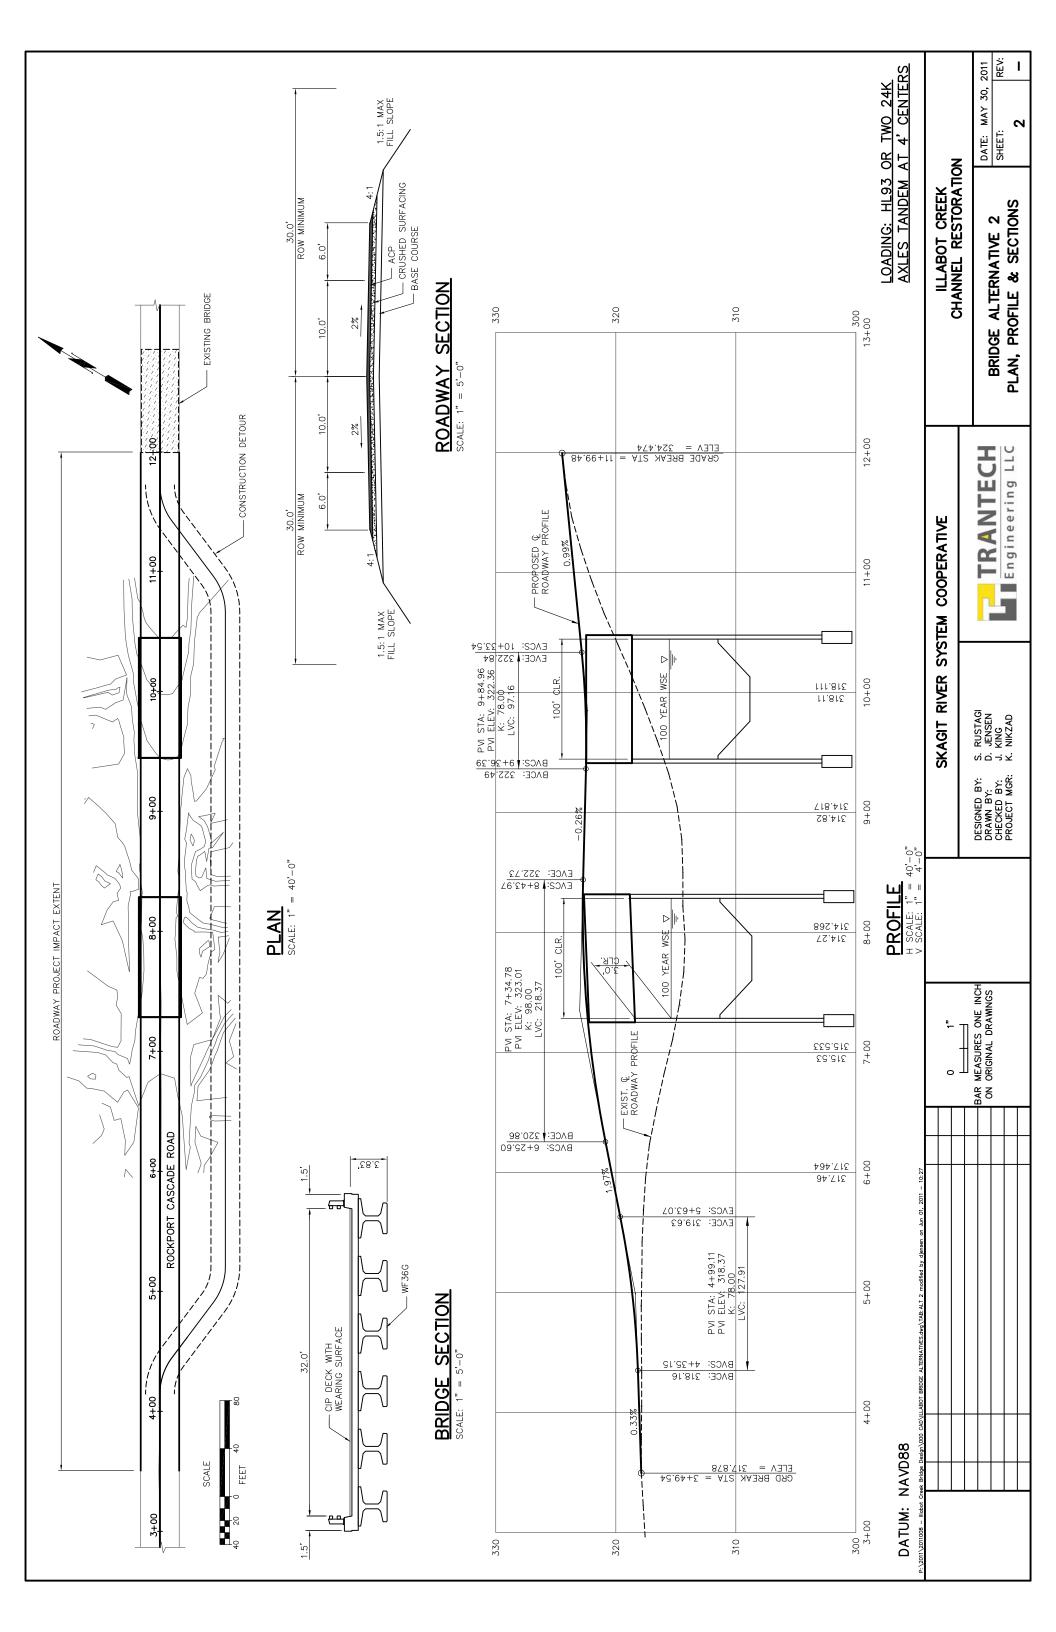
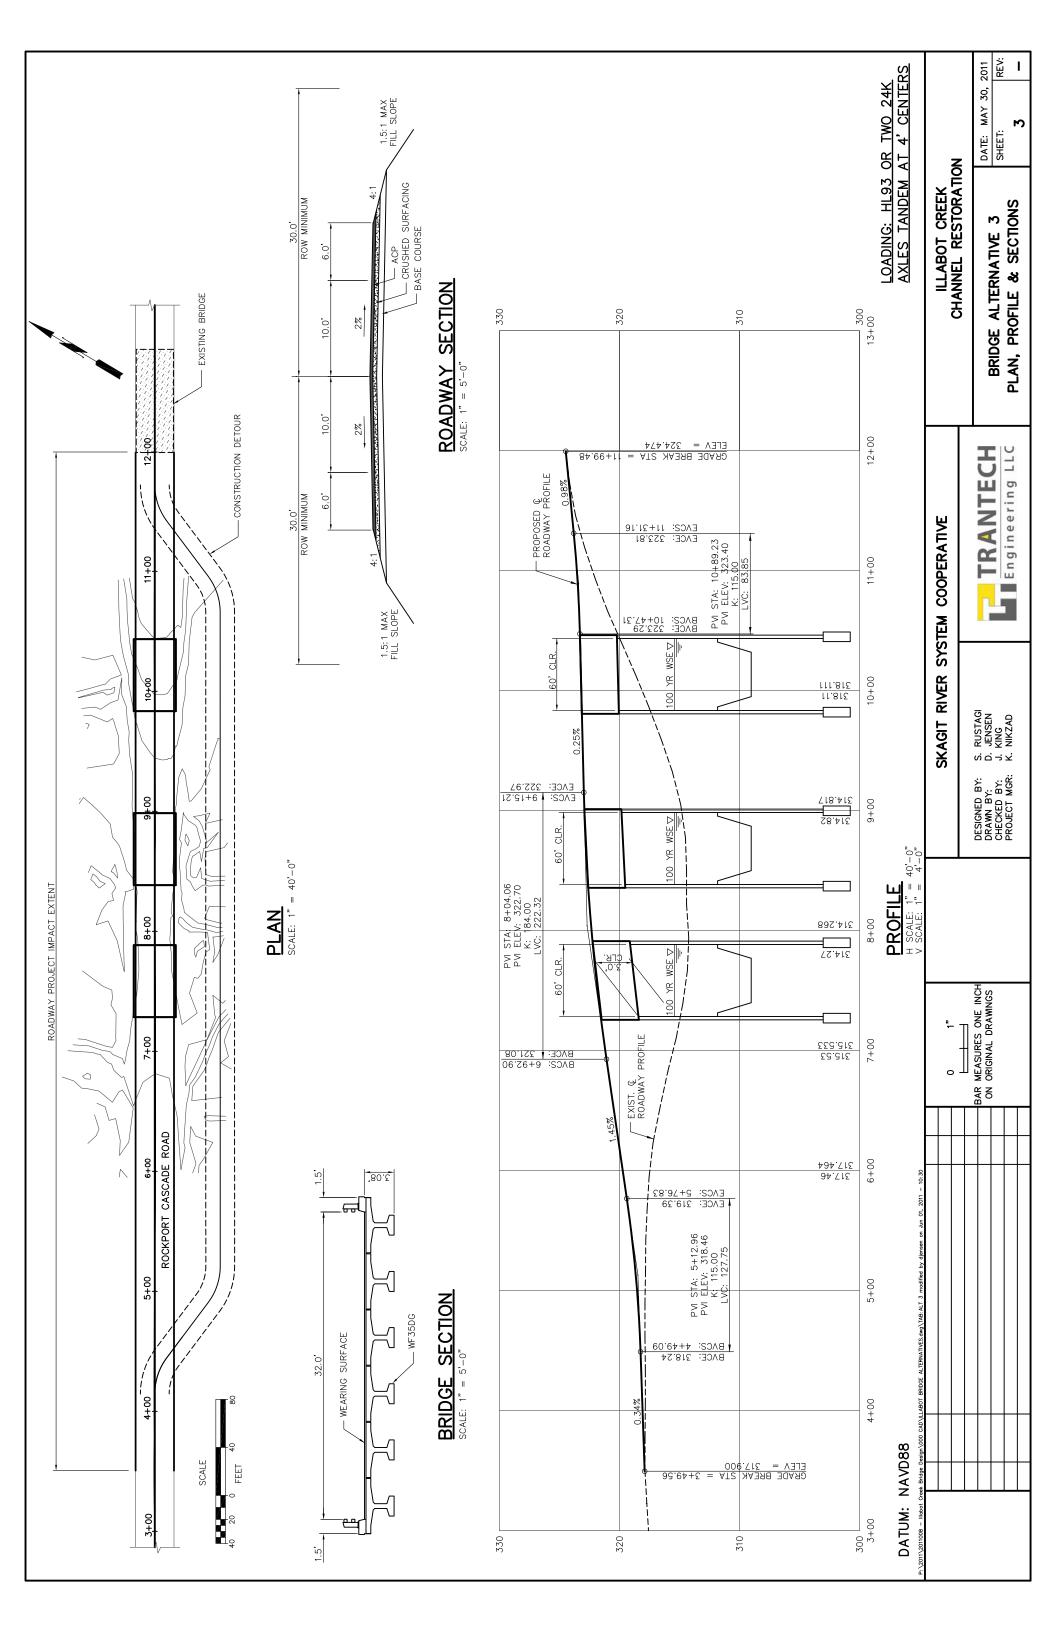
# **Appendix A1 – Alternative Concept Drawings**

- Alternative 1 Single-span bridge with a clear span of 150 feet
- Alternative 2 Two single-span bridges with clear spans of 100 feet
- Alternative 3 Three single-span bridges with clear spans of 60 feet

The superstructure on Alternative 3 is composed of 2½" of wearing surface on top of side-by-side placed W35DG precast pre-stressed girders spaced at 6 feet on center. This Alternative provides an overall superstructure depth of 37".

The substructure on all of the alternatives, per geotechnical recommendations, is composed of wall abutments founded on spread footings.

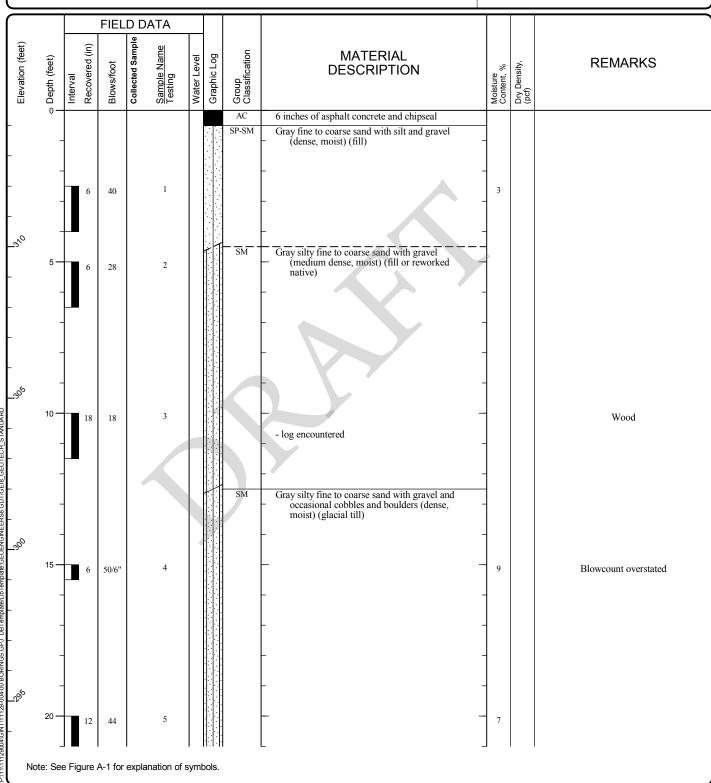
Figure A-2 Sheet 1 of 2

Start	Logged By AJH Checked By AJH Driller Boretec, Inc.	Drilling Method Hollow-stem Auger
Surface Elevation (ft) Vertical Datum 314.5	Hammer 140 lb hammer Data Two wraps on cathead	Drilling M55 Track-mounted Drill Rig
Latitude Longitude	System Geographic Datum	Groundwater Depth to Date Measured Water (ft) Elevation (ft)
Notes:		Undetermined

# Log of Boring B-1

The borings were continuously monitored by a geotechnical engineer from our firm who examined and classified the soils encountered, obtained representative soil samples, observed groundwater conditions and prepared a detailed log of each exploration. Soils encountered were classified visually in general accordance with ASTM D-2488-90, which is described in Figure A-1. An explanation of our boring log symbols is also shown on Figure A-1.

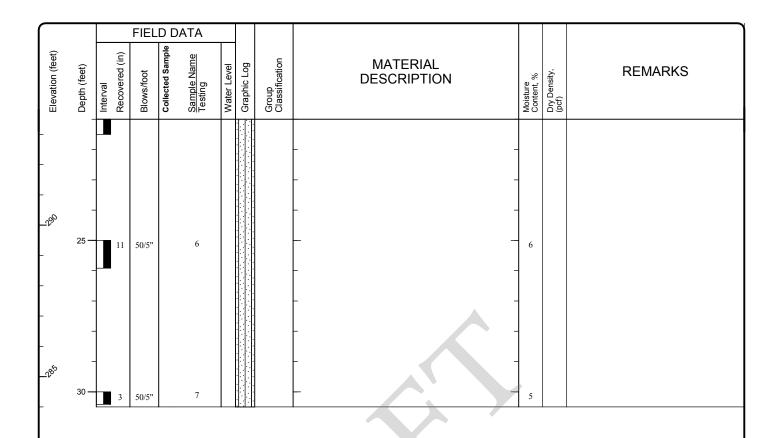
Figure A-2 Sheet 2 of 2

# Log of Boring B-1 (continued)

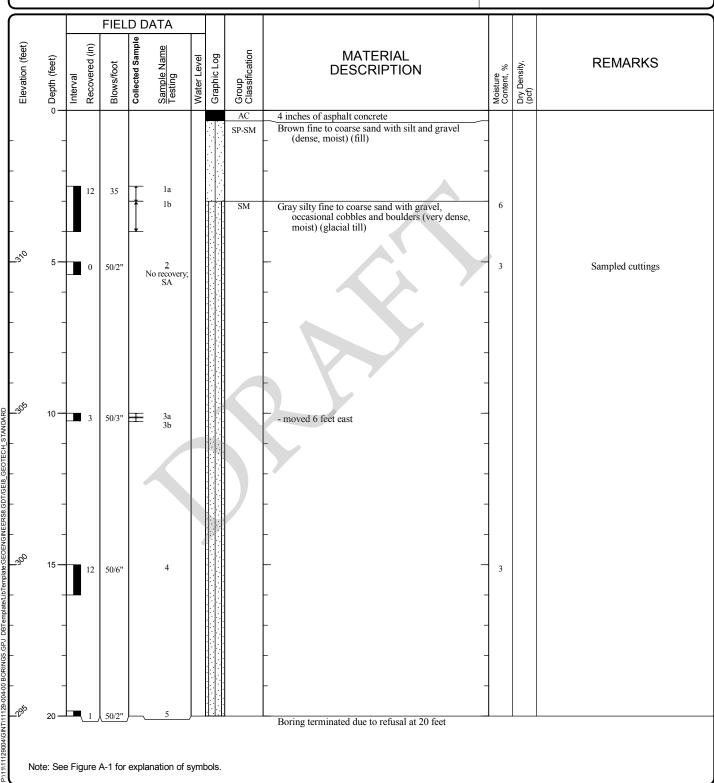
Figure A-3 Sheet 1 of 1

Start         End         Total         20           Drilled         4/26/2011         4/26/2011         Depth (ft)	Logged By AJH Checked By AJH Driller Boretec, Inc.	Drilling Method Hollow-stem Auger
Surface Elevation (ft) Vertical Datum 315.0	Hammer 140 lb hammer Data Two wraps on cathead	Drilling M55 Track-mounted Drill Rig Equipment
Latitude Longitude	System Geographic Datum	Groundwater Depth to Date Measured Water (ft) Elevation (ft)
Notes:		Undetermined

# Log of Boring B-2

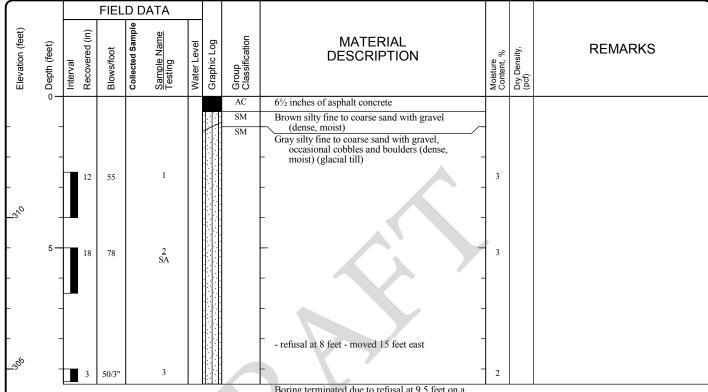
Figure A-4 Sheet 1 of 1

Start         End         Total           Drilled         4/26/2011         4/26/2011         Depth (ft	9.5	Logged By AJ Checked By AJ	Drillor Boretec Inc.		Drilling Method Hollow-stem Auger
Surface Elevation (ft) Vertical Datum 314.0		Hammer Data	140 lb hammer Two wraps on cathead	Drilling Equipment	M55 Track-mounted Drill Rig
Latitude Longitude		System Datum	Geographic	Groundwate  Date Measur	Depth to
Notes:					Undetermine

Boring terminated due to refusal at 9.5 feet on a rock

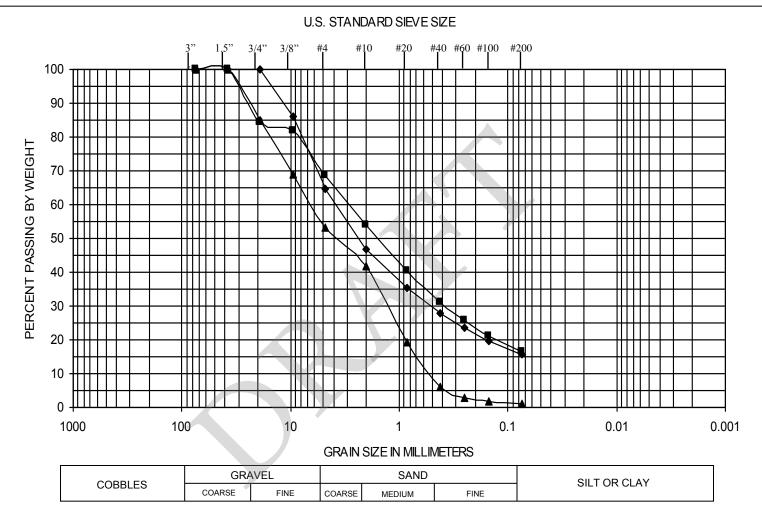
Figure A-5

Symbol	Exploration Number	Sample Depth (feet)	Soil Classification
<b>*</b>	B-2	5- 10	Gray silty fine to coarse sand with gravel
	B-3	5	Gray silty fine to coarse sand with gravel
<b>A</b>	Riverbed	Surface	Gray medium to coarse sand with gravel

Sieve analyses were performed on selected samples in general accordance with ASTM D 422 to determine the sample grain size distribution. The wet sieve analysis method was used to determine the percentage of soil greater than the U.S. No. 200 mesh sieve. The results of the sieve analyses were plotted, classified in general accordance with the Unified Soil Classification System (USCS), and are presented in Figure A-5.
