2010 FACILITY CONSERVATION ACTION PLAN

FACILITY Skagit County Road Department Administration Building 201 Avon Ave., Burlington		SITE ID SC-02	DATE 7-29-10
CURRENT ENERGY USE INDEX (EUI) 23 kBtu/Sq Ft		TARGET EUI 20 kBtu/Sq Ft	AVERAGE EUI (BENCHMARK) FOR THE FACILITY TYPE: <u>TBD</u>
NEXT REVIEW OF PLAN Review and update annually.	FACILITY RCM TEAM MEMBERS (NAME AND POSITION) 1. Ric Boge, SCOG RCM, 2. Mike Elde, ER&R Coordinator 3. Margo Frydenlund, Administrative Supervisor, 4. Ross Bailey, Facilities Ops Supervisor; 5. Katie Hampton, Sustainability Coord.		
WALK THROUGH SUMMARY AND PHOTOS	DATE AND TIME OF WALK THROUGH: <u>6-21-10</u>		METER ON EIS? <u>No</u>

Skagit County Road Department Administration Building

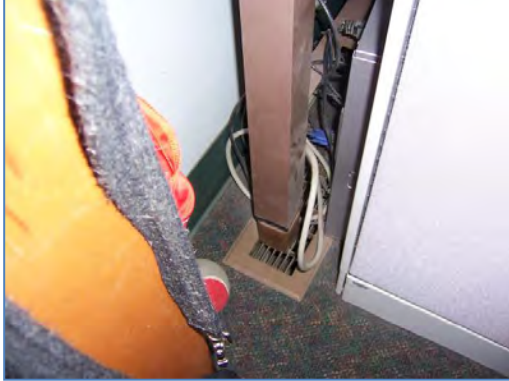
Partially blocked supply-air register in office area.

Staff mentioned that upstairs spaces are often not comfortable, even though thermostats are set properly and the HVAC equipment is serviced regularly. Part of this problem is due to restricted pathways for supply and return air from/to the heating and cooling equipment. Restricted pathways from the registers reduce the ability of the HVAC equipment to adequately meet the heating and cooling demands placed upon it.

1. Keep pathways clear from second floor registers

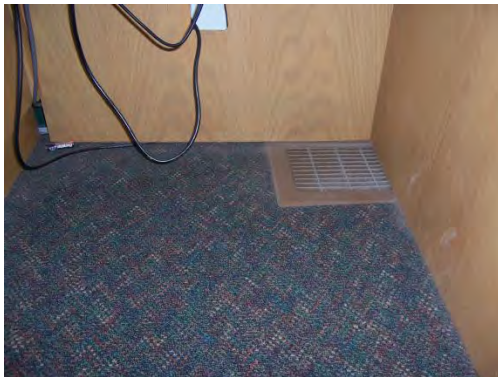
Partially blocked return-air register in meeting room.

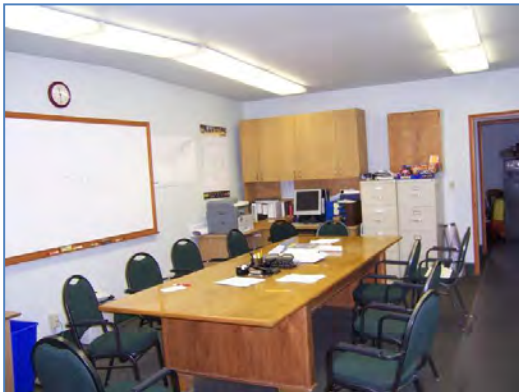
Significant heat gain is coming from ten 4-lamp overhead fluorescent fixtures – all on one switch. (When these lights are on, it's like having a 1500W personal space heater running in the room!)

Unwanted heat gain is a major problem in this room, especially when the doors are closed. Staff said the receptionist, located just outside the west door to the room sometimes has conditioned 'cool' air blowing on her, making her uncomfortable, especially during the colder months..... This is because the reception space is controlled by the same thermostat that's in the meeting room space. With a meeting going on, especially with closed doors and several people, the room heats up and the thermostat calls for cooling – no matter what the temperatures are outside that room.

Actions to alleviate the heat-gain problem include:

- Replace the 4 lamp T-12 fixtures with 2-lamp T-8 fixtures.
- Add a switch so not all the overhead lighting needs to be turned on at the same time, as it currently does
- Add vents above the meeting room doors to facilitate upstairs air circulation when the doors are closed (consider a fan for one or both vents as well).
- Move some of the office equipment outside this room, especially the copy machine. When replacement is due, replace office equipment with Energy Star certified models that will not contribute as much heat gain to this space.

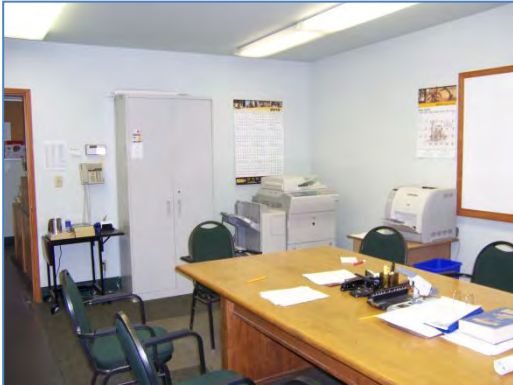
Heat gain in the meeting room is also significant from office equipment – see temperatures recorded the day of the audit shown to the right.

Temperatures recorded the day of the audit on surface areas of the office equipment in the room were:

- 107 degrees on the copy machine
- 85 degrees on the printer
- 85 degrees on the fax machine
- 87 degrees on the shredder.

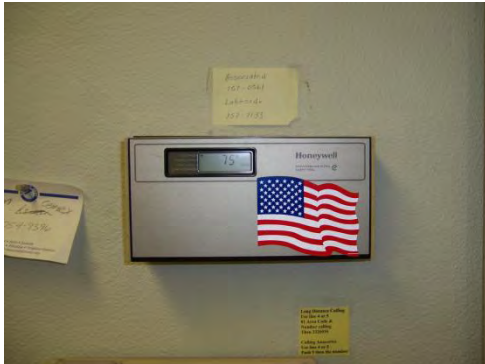
Thermostat in upstairs meeting room was set for cooling at 75 degrees. Temperature on the wall above thermostat and the walls surrounding the room was about 80! (Registers were delivering 75 degree air; outside air temperature was about 60 degrees!)

Despite the HVAC system being serviced regularly, according to staff, the system was not providing adequately cooled air to the meeting room space at the time of the audit.

3. Calibrate thermostats with the HVAC system and replace the thermostat in the upstairs conference room if necessary.

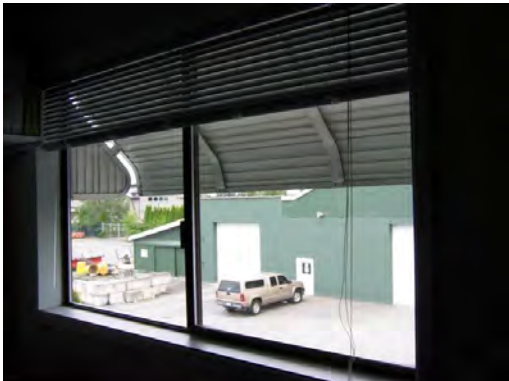
4. **Kudos** for installing awnings over the windows to help reduce unwanted solar heat gain!

This is a good conservation measure for less use of artificial cooling – saves money!

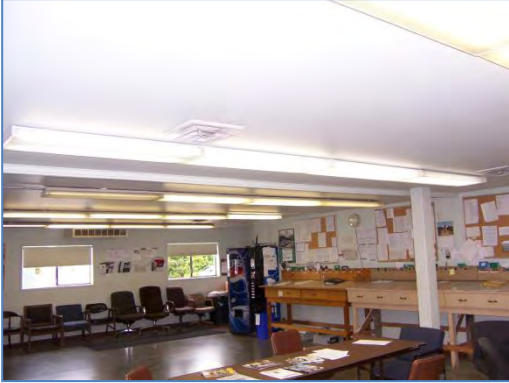
T-12 fluorescents in downstairs crew quarters

1. Replace the linear T-12 fluorescent lighting throughout the building with more efficient T-8.

Note: replace with fewer T-8 lamps, if possible.

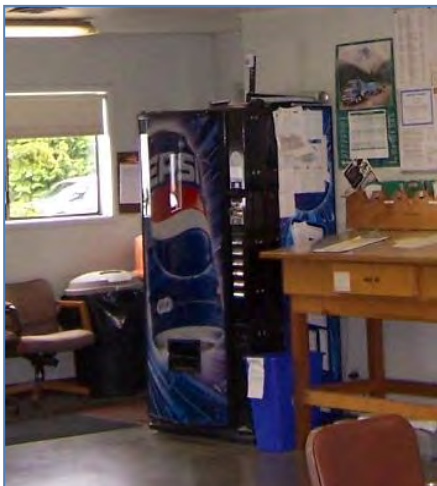
3. **Kudos** for installing a 'vending miser' to the top of the cold drink vending machine in the crew quarters!

Vending misers are occupancy sensors that power-down cold drink vending machines during periods of unoccupancy. Each cold drink vending machine with a miser installed can save up to \$150/year on electricity!

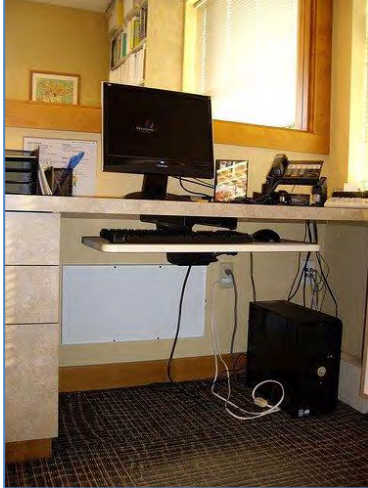
Photo shows 100W white infrared radiant heat panel that can be mounted under desk to help keep desk user comfortable.

Infrared radiant heating is much more efficient than personal space heaters. It heats surfaces in line with the radiant heat rather than the air.

4. In conformance with County policy, restrict use of personal space heaters to those that use 250W or less. (example below)

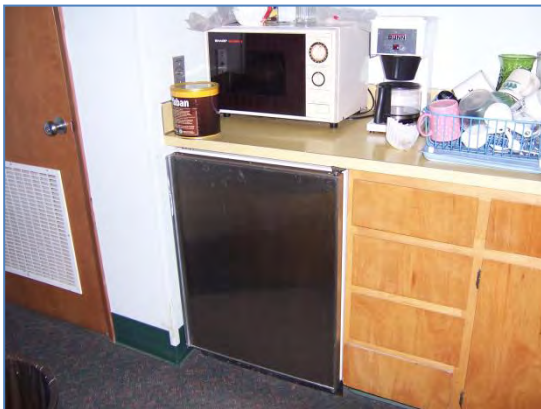
Small, non-Energy Star older fridge under counter

5. Use only *Energy Star* rated appliances.

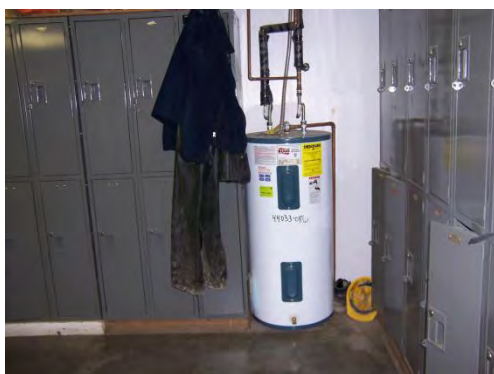
55g electric hot water tank in men's locker room

1. Keep the water heater servicing washrooms set not to exceed 120°F.

Consider replacing the electric hot water tank with a natural gas-fired tank when replacement is due to save money.

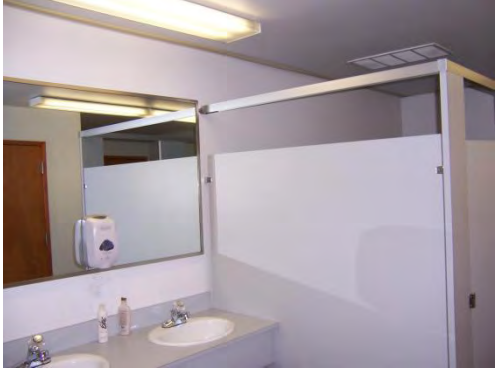
<p><i>Faucets in men's restroom</i></p>	<p>Funding: Operating budget.</p> <p>Staff: Outside contractor / vendor.</p> <p>Schedule: When replacement is due</p>
<p>3. Report building plumbing and irrigation equipment leaks immediately. Investigate and repair as soon as possible.</p>	<p>Note:</p> <hr/> <p>Funding: Budget neutral</p> <p>Staff: All staff report leaks.</p> <p>Schedule: Ongoing</p> <hr/> <p>Note: Ongoing water leaks can add up to a big waste of money!</p>

<p>2. Convert plumbing fixtures to efficient but effective low flow models to conserve water usage.</p>
