## SKAGIT COUNTY DEPARTMENT OF PUBLIC WORKS

### 2013 ANNUAL BRIDGE REPORT

**SUBMITTED FEBRUARY 2014**

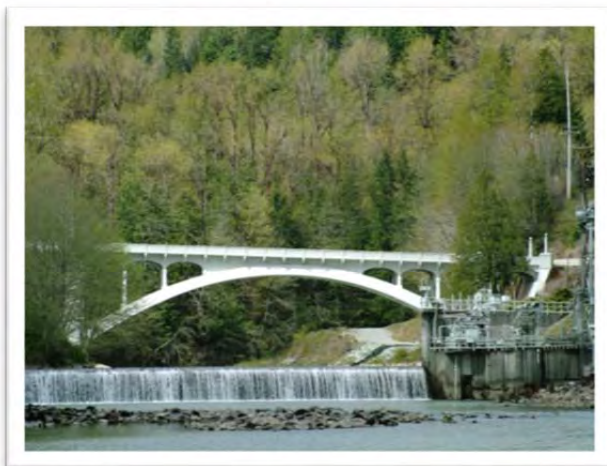
**Baker River Bridge, Town of Concrete**

- The other local agency bridges inspected are all in good condition. The Town of Concrete's bridge, Baker River Bridge is listed as functional obsolete with a sufficiency rating of 20.67, and is load restricted at 10 Tons to 28Tons depending on axle layout.

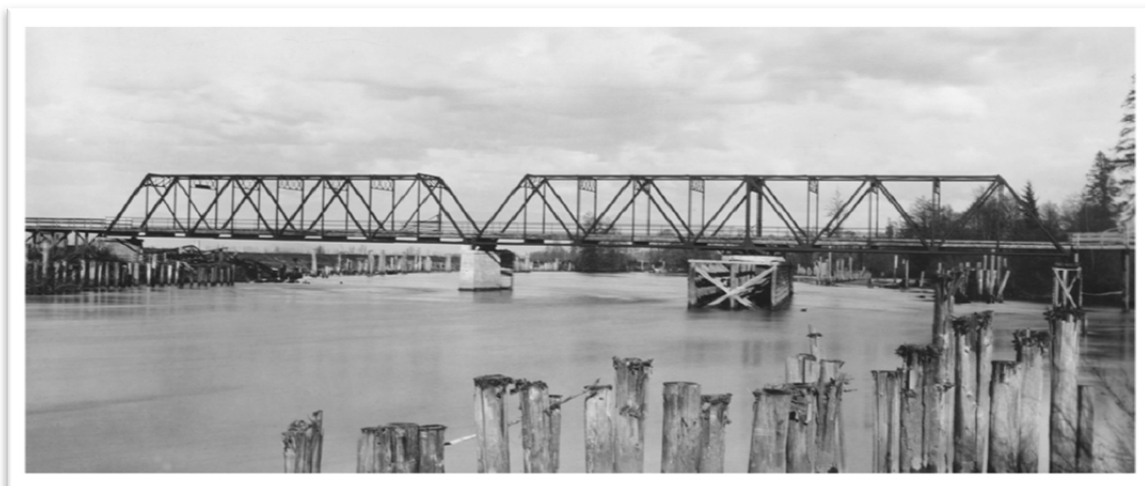
*North Fork Bridge - 1912*

- Burlington Northern Overpass #40111
  - Structurally deficient, timber structure is deteriorating
  - Functionally obsolete, does not meet the geometry standard of the road system.
- North Fork Bridge #40037
  - Structurally deficient, pier has twisted and settled.
  - Functionally obsolete, does not meet the geometry standard of the road system.
