ANACORTES SCHOOL DISTRICT NO. 103

2014 State Study and Survey

*Anacortes School District No. 103
Skagit County, Washington*

December 2014

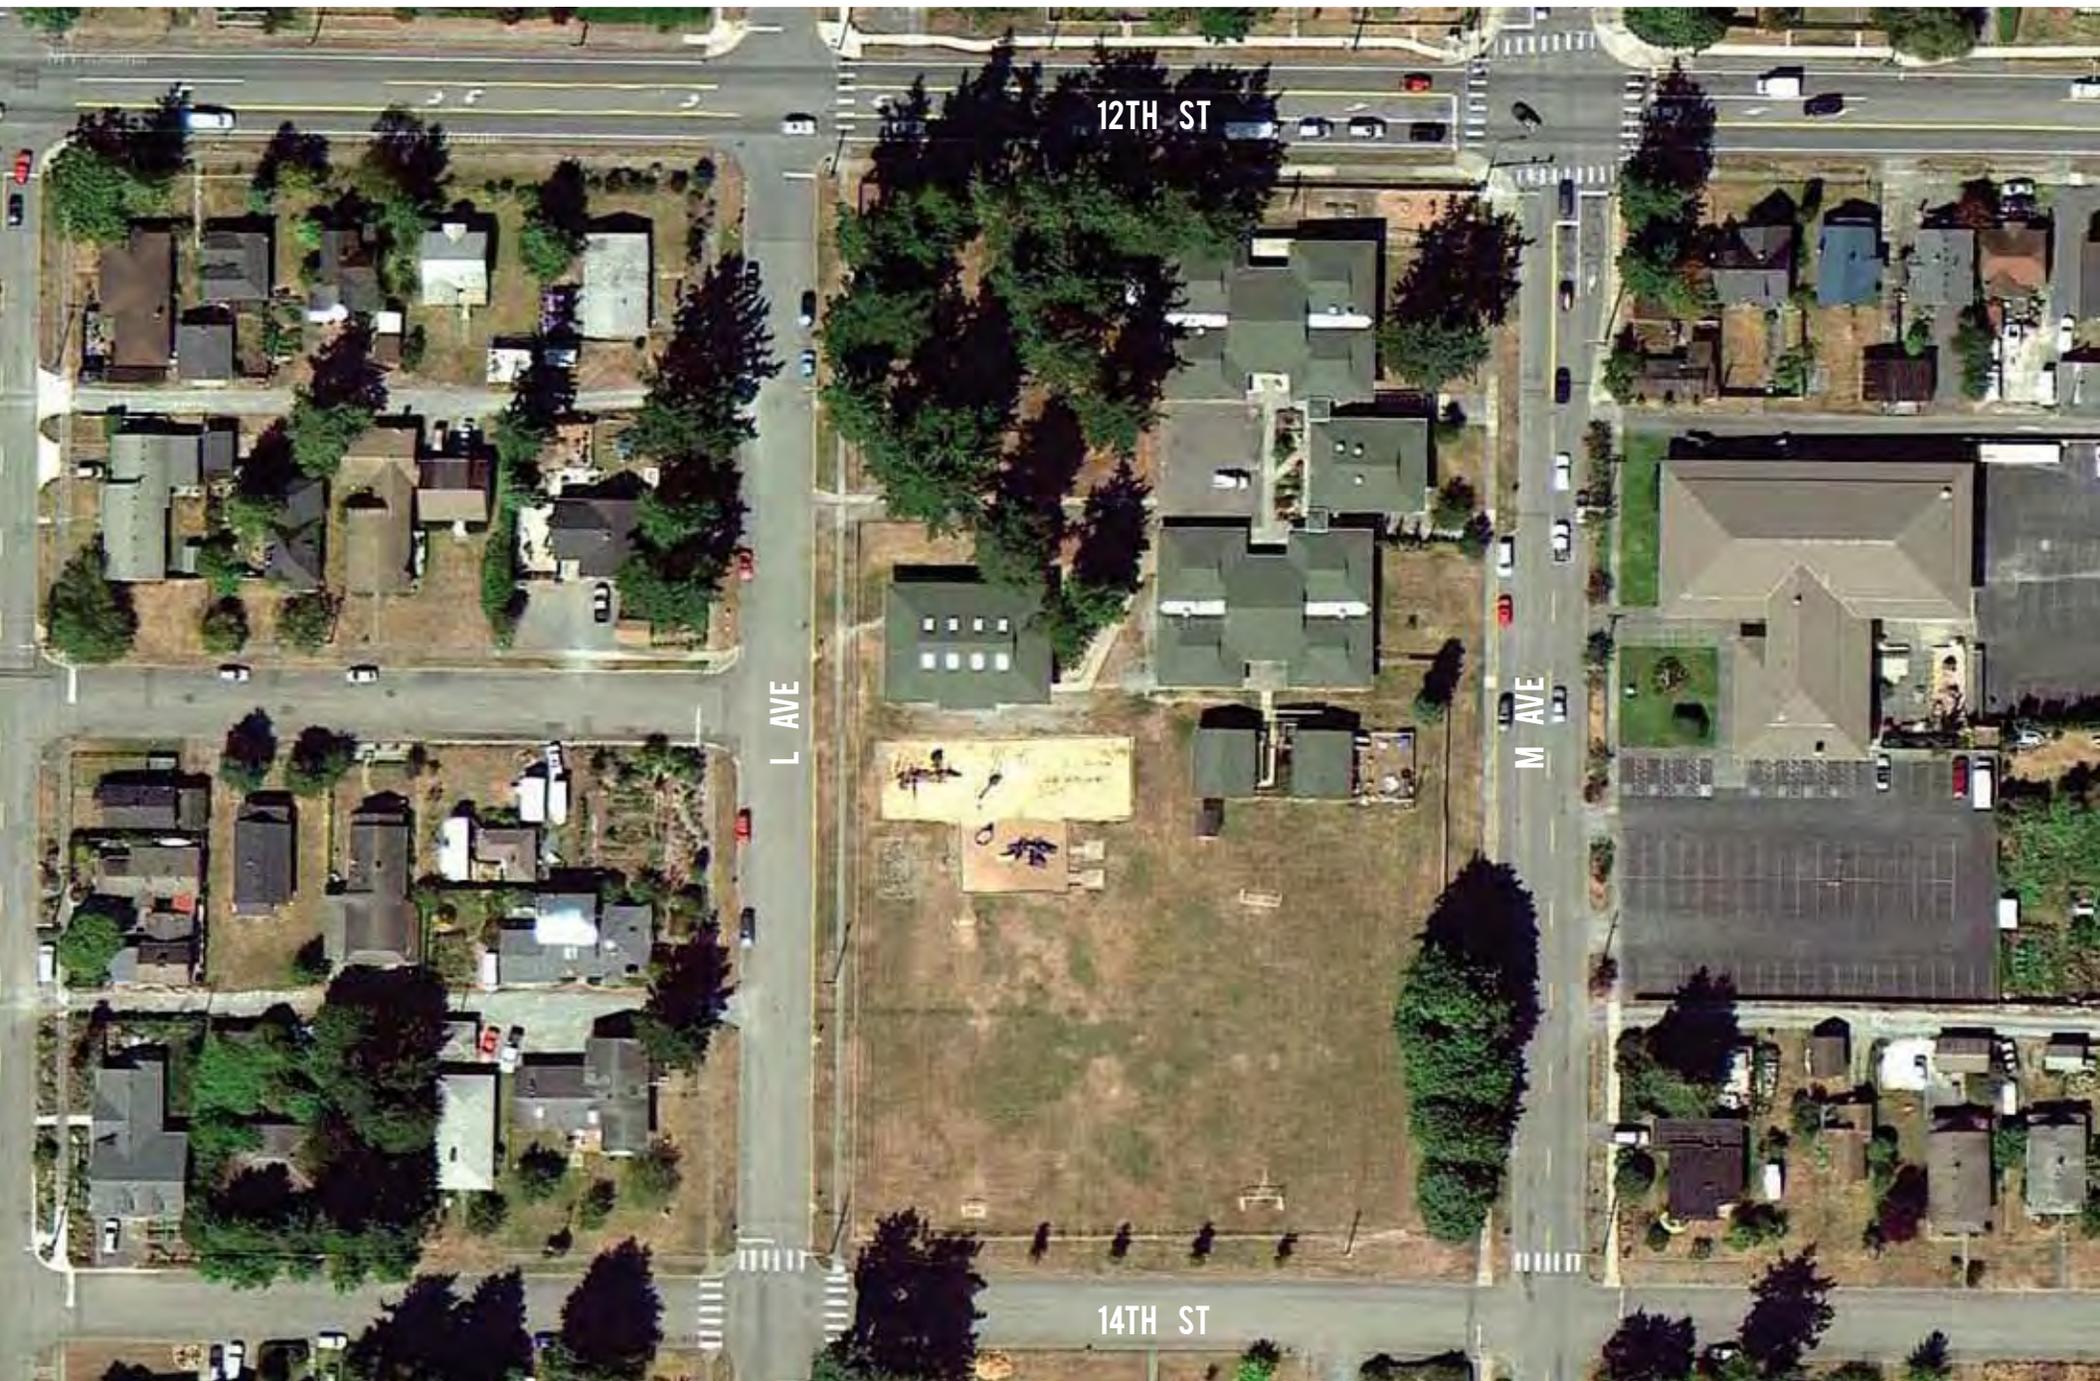
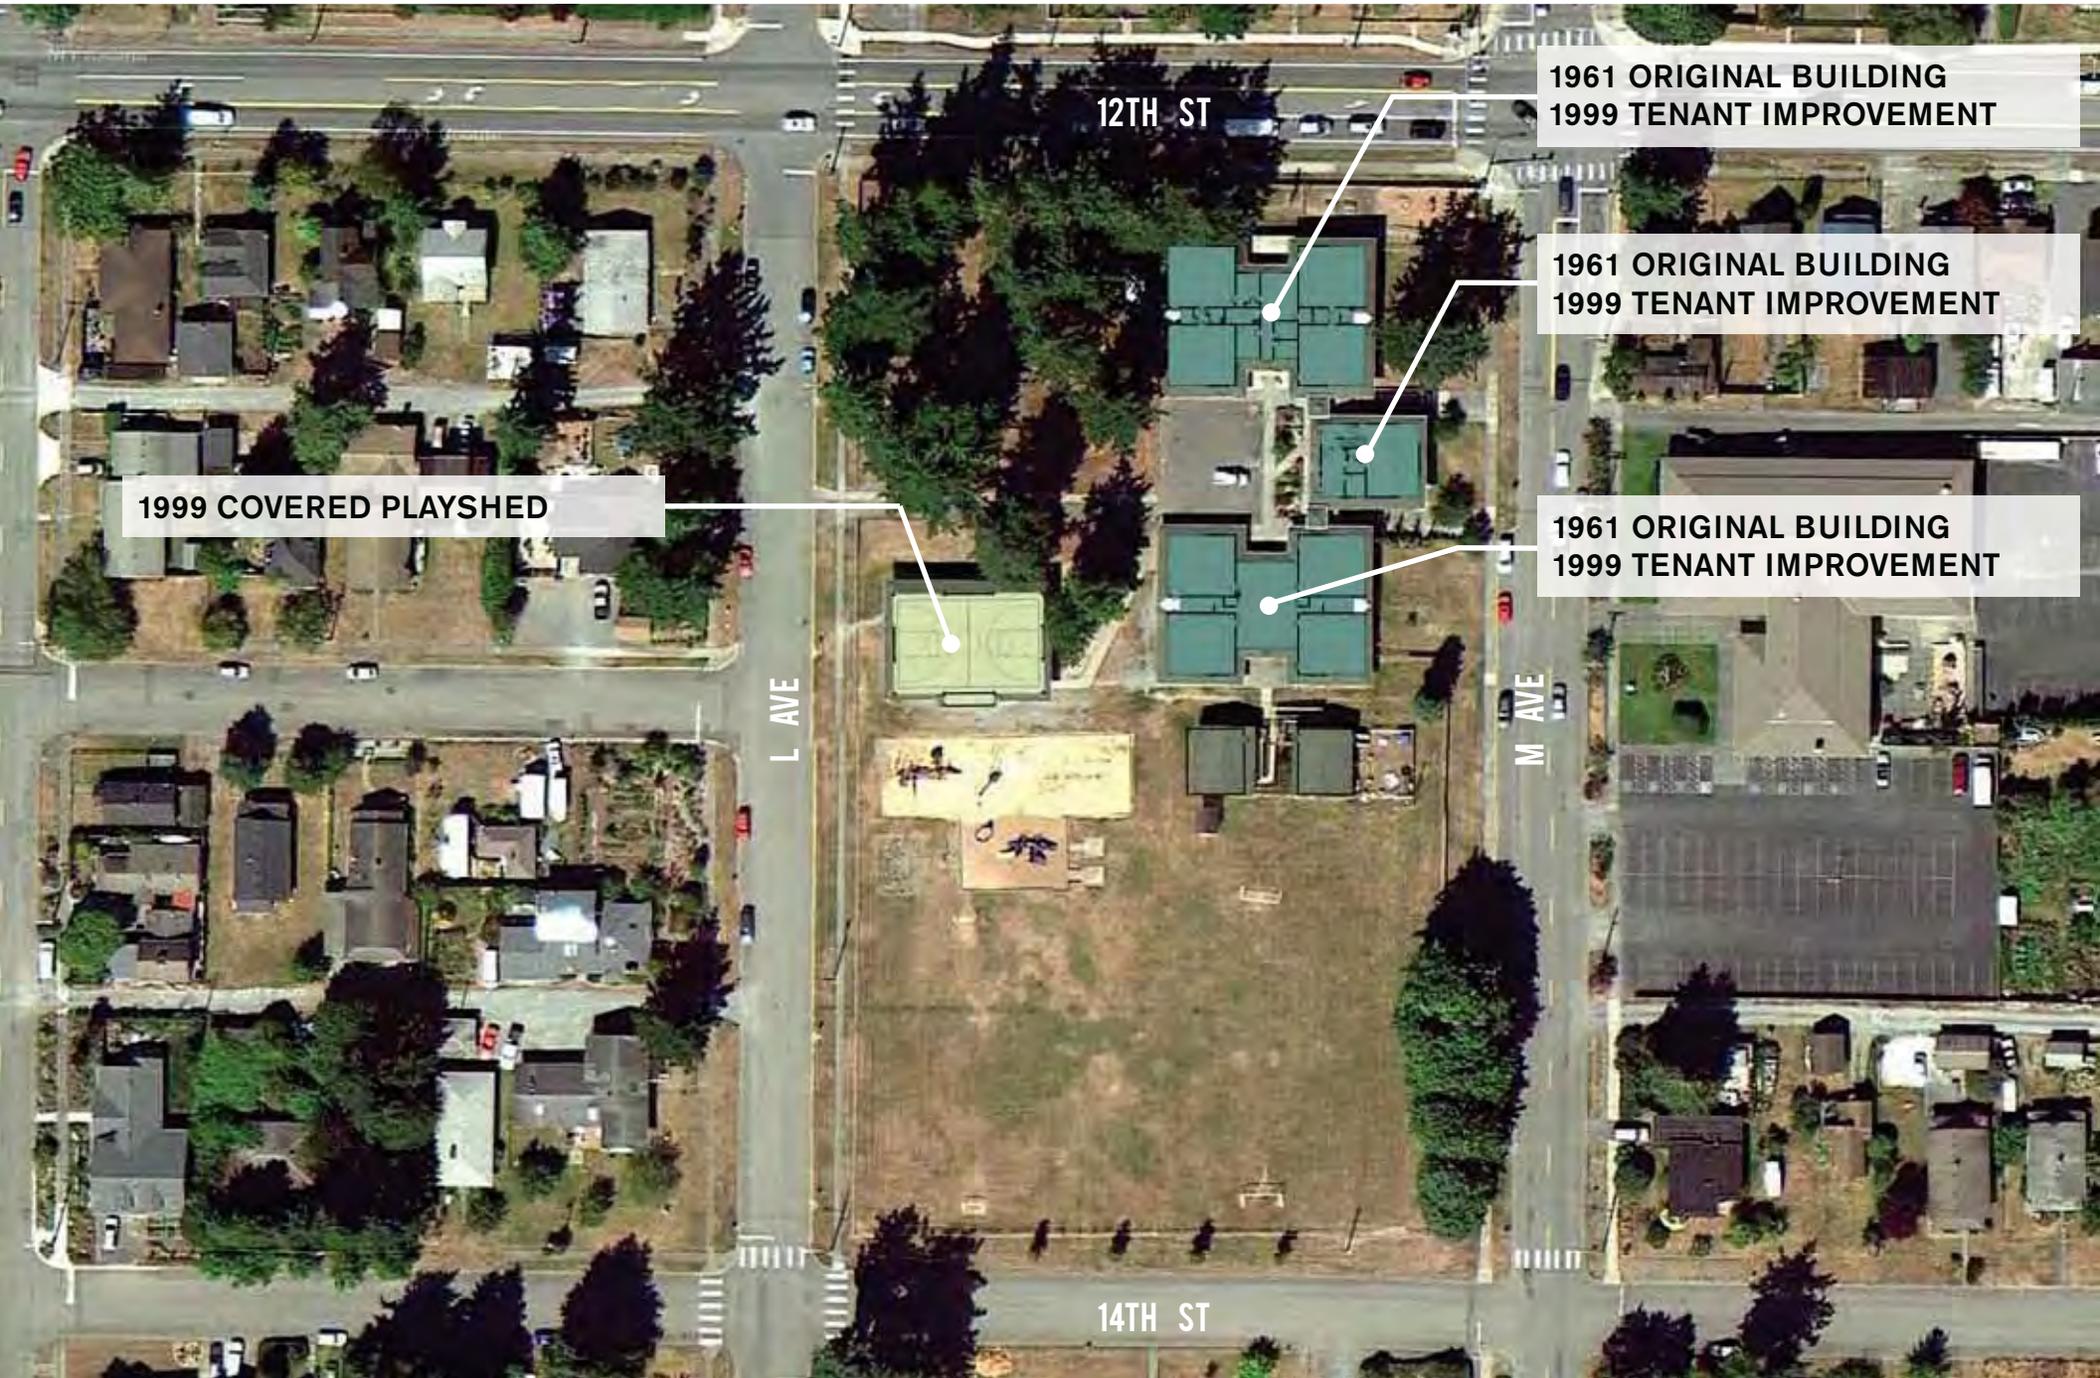
WHITNEY EARLY CHILDHOOD EDUCATION CENTER

- 9. School is constructed of “residential quality”. Maintenance efforts should be planned to continue at an increasing rate.
- 10. Exterior wood siding shows obvious signs of rot.
- 11. Elevator access is not provided to lower floor of general office building.
- 12. The school is not fire-sprinklered.

1. Interior emergency exit lights and signs are currently powered by standard battery powered units which have no indication of dead batteries.
2. Classroom casework is worn and past its serviceable life.
3. Restroom finishes are old and exhibit obvious signs of patching required by maintenance issues.
4. No room for expansion of lunch program.
5. Many windows are original single-pane construction.
6. Upgrade to the DDC head end, panels, devices, actuators, and sensors is needed.
7. Intercom system should be upgraded with a new IP head end.
8. Fire alarm panel and devices should be upgraded.
9. Power panels have limited space for future expansion.

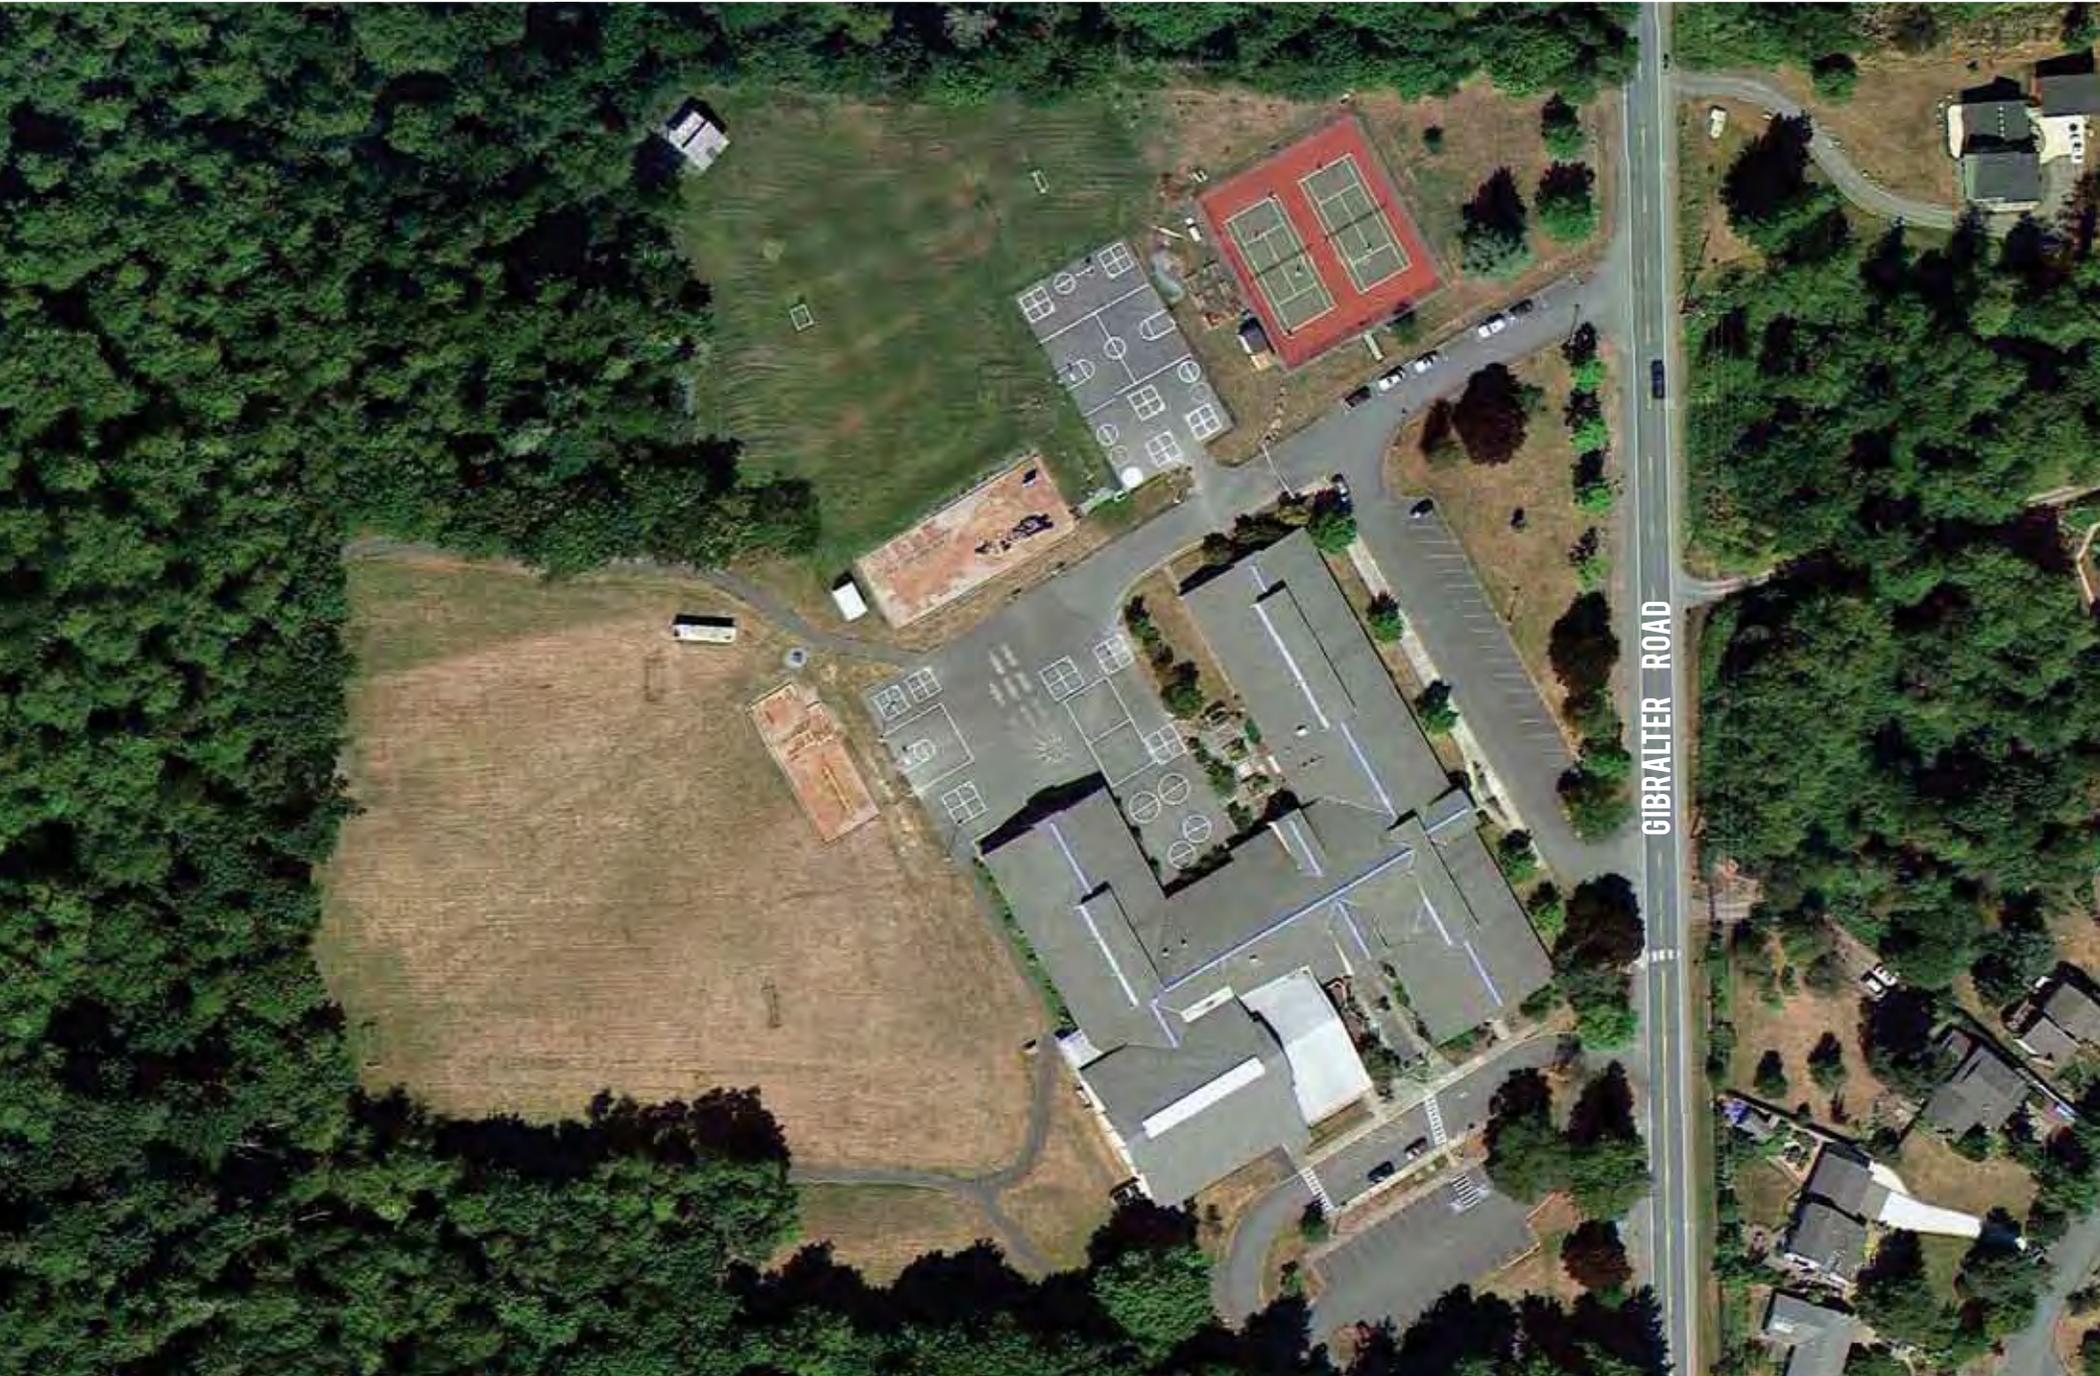
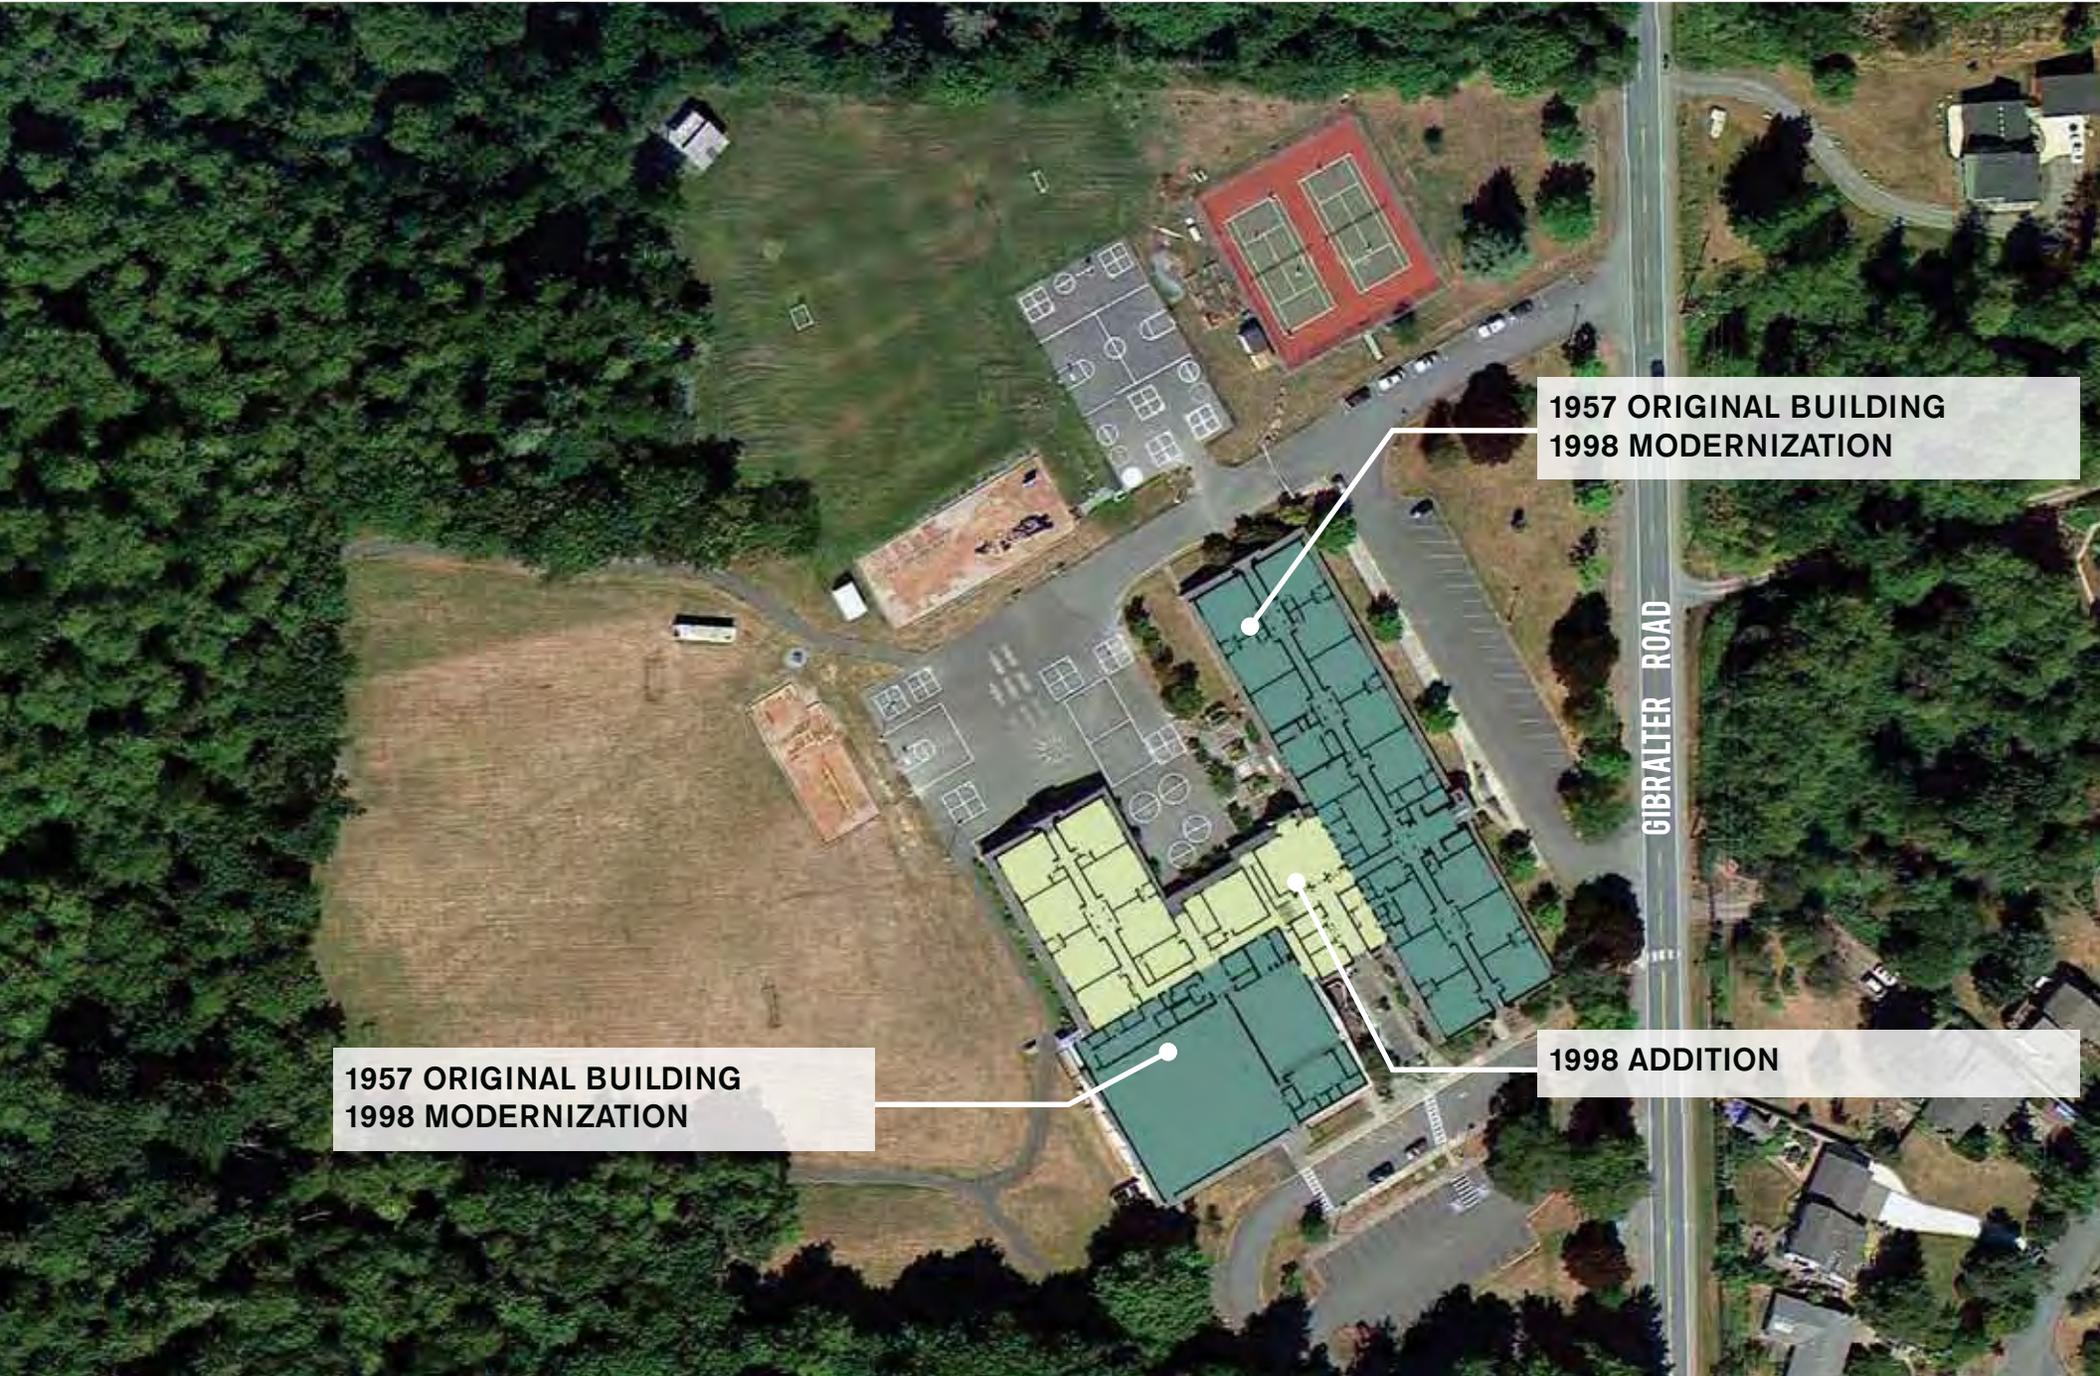
**1957 ORIGINAL BUILDING
1998 MODERNIZATION**

1. The volume of vehicular pick-up traffic causes backups and congestion along Gibraltar Road causing traffic delays and conflicts for busses exiting the site.

1. Water heater is 20 years old; the burner has been rebuilt, the tank has not yet leaked, but is beyond anticipated service life.
2. Upgrade to the DDC head end, panels, devices, actuators, and sensors is needed.
3. Intercom system should be upgraded with a new IP head end.
4. Fire alarm panel and devices should be upgraded.

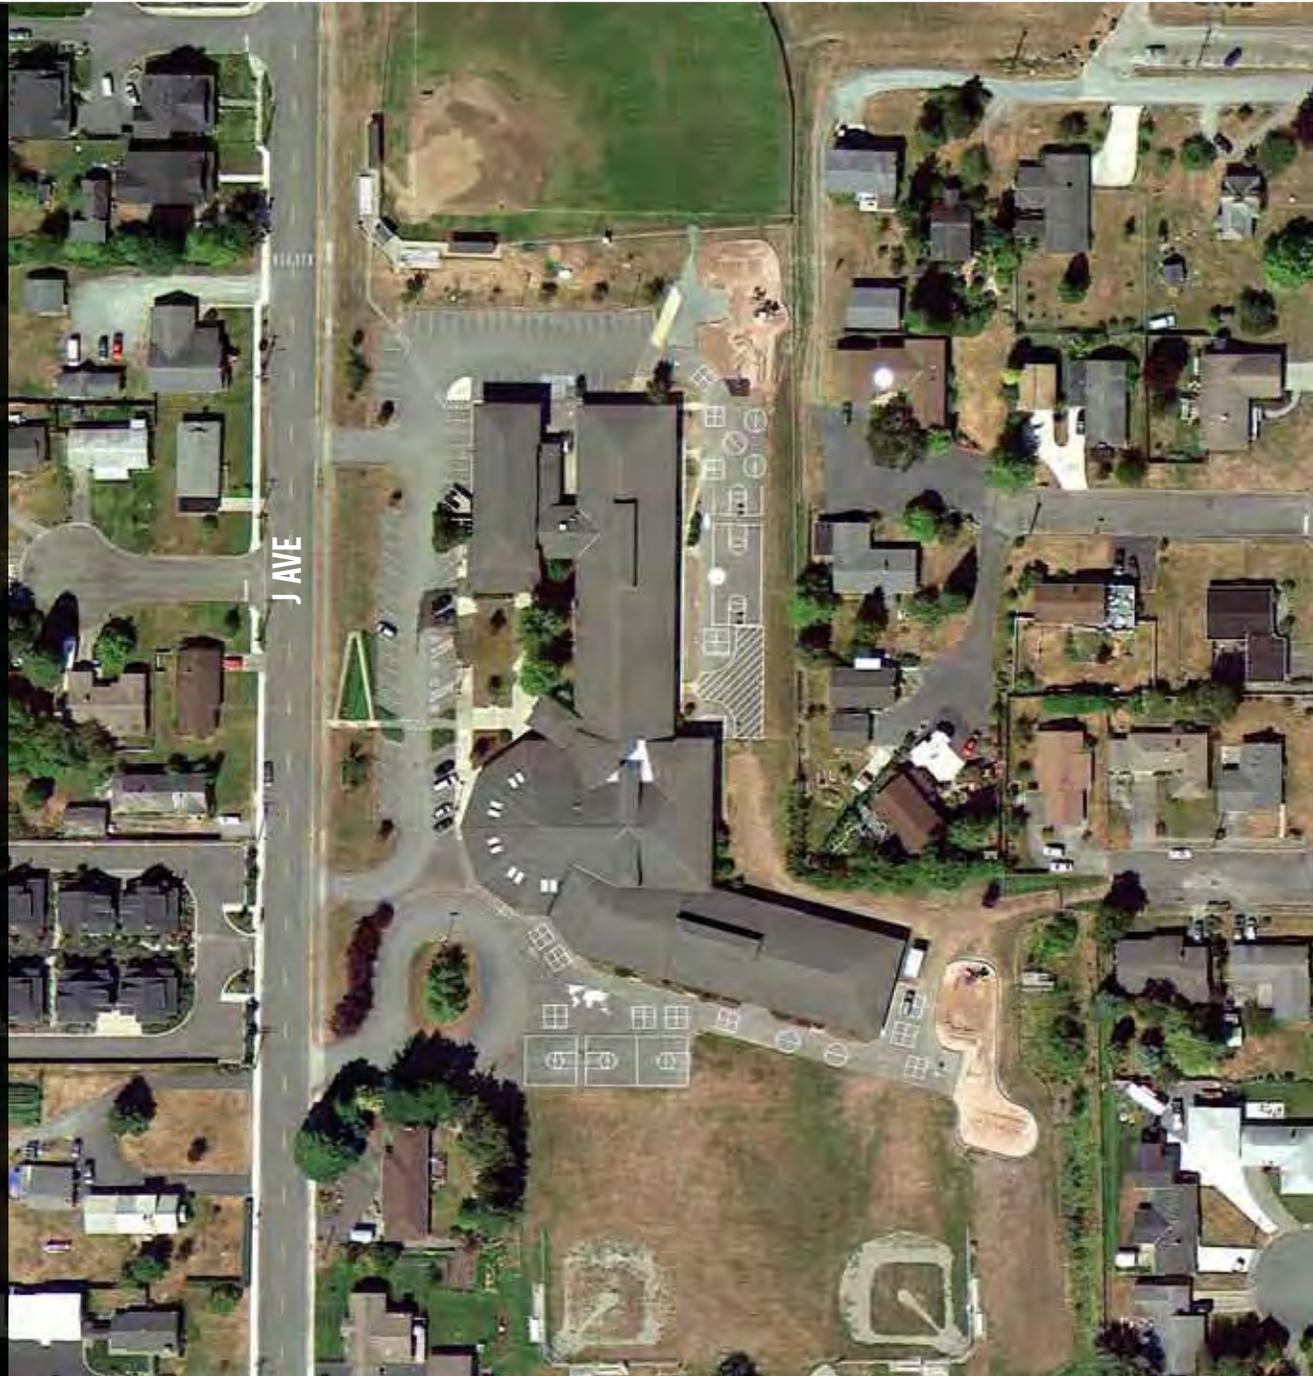
1. Student drop-off and pick-up occurs down the center parking isle causing congestion and is a safety issue.
2. Vehicular back-up onto J Avenue sometimes blocks the busses from being able to exit the site.
3. Primary walking route passes across the main parking lot creating a safety issue.
4. Waste line from restrooms on east side of gym is old and frequently plugs when restrooms are in use.

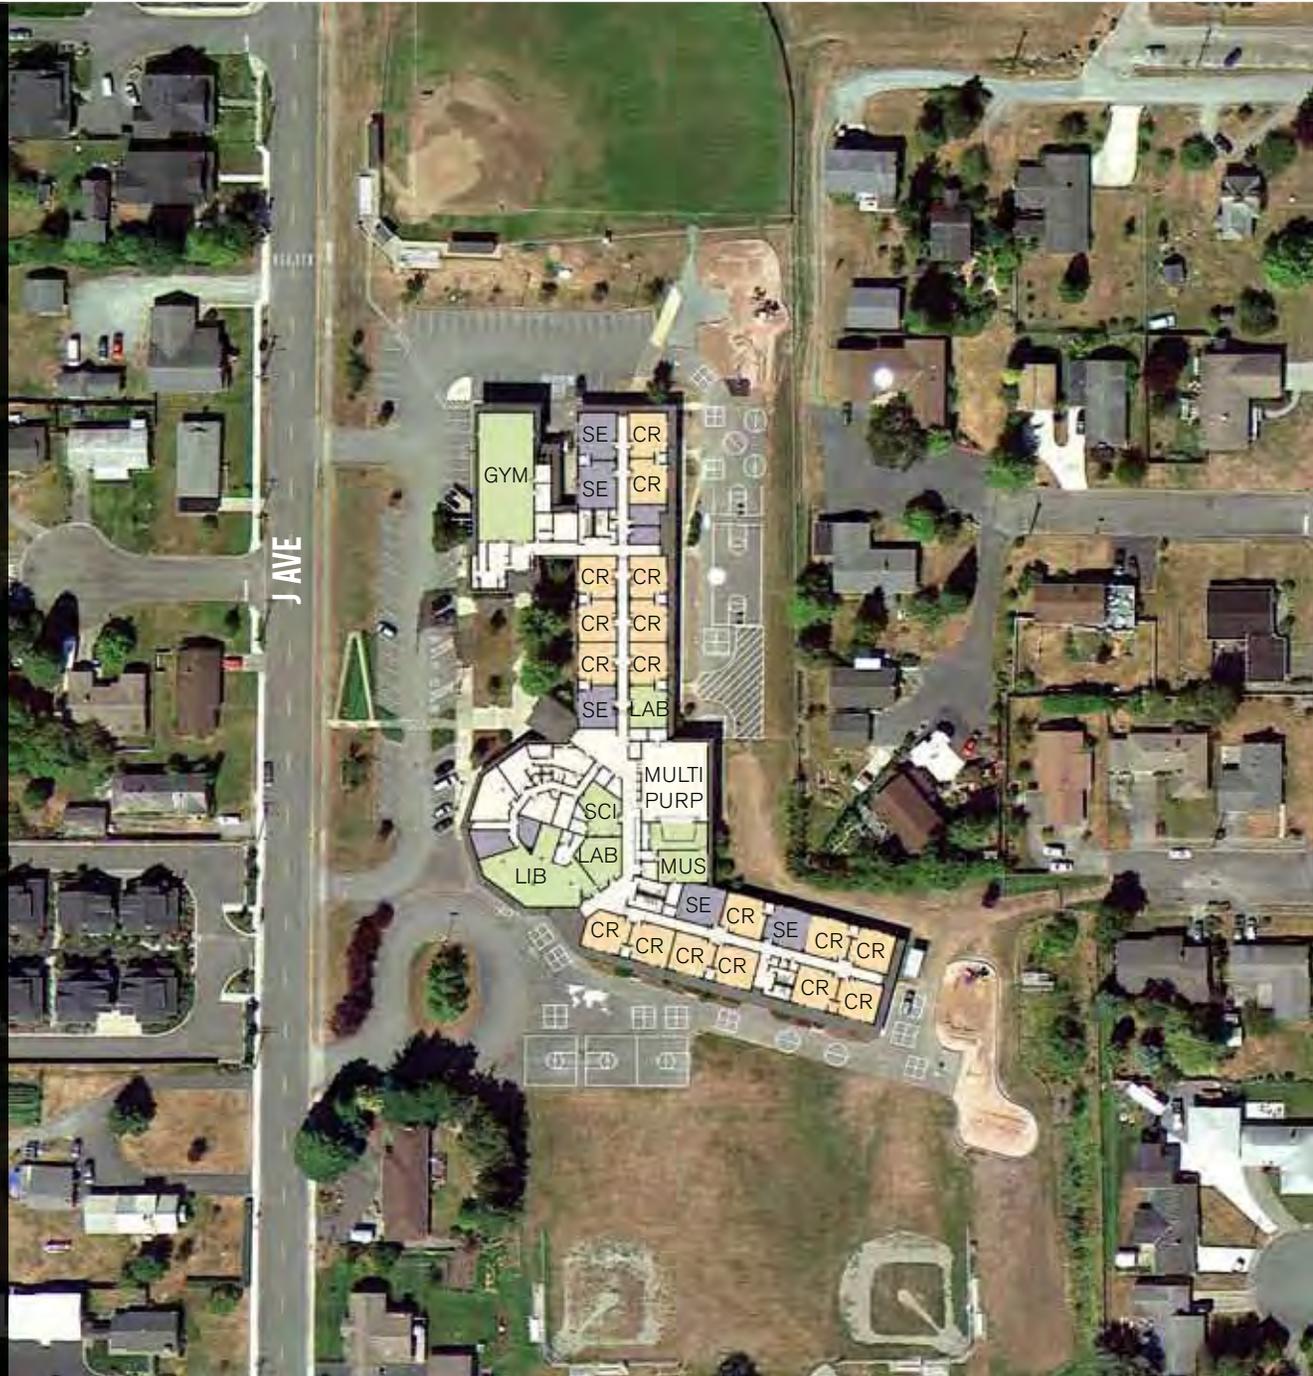
1. Upgrade to the DDC head end, panels, devices, actuators, and sensors is needed.
2. Intercom system should be upgraded with a new IP head end.
3. Fire alarm panel and devices should be upgraded.
