ANACORTES SCHOOL DISTRICT NO. 103

2014 State Study and Survey

*Anacortes School District No. 103
Skagit County, Washington*

December 2014

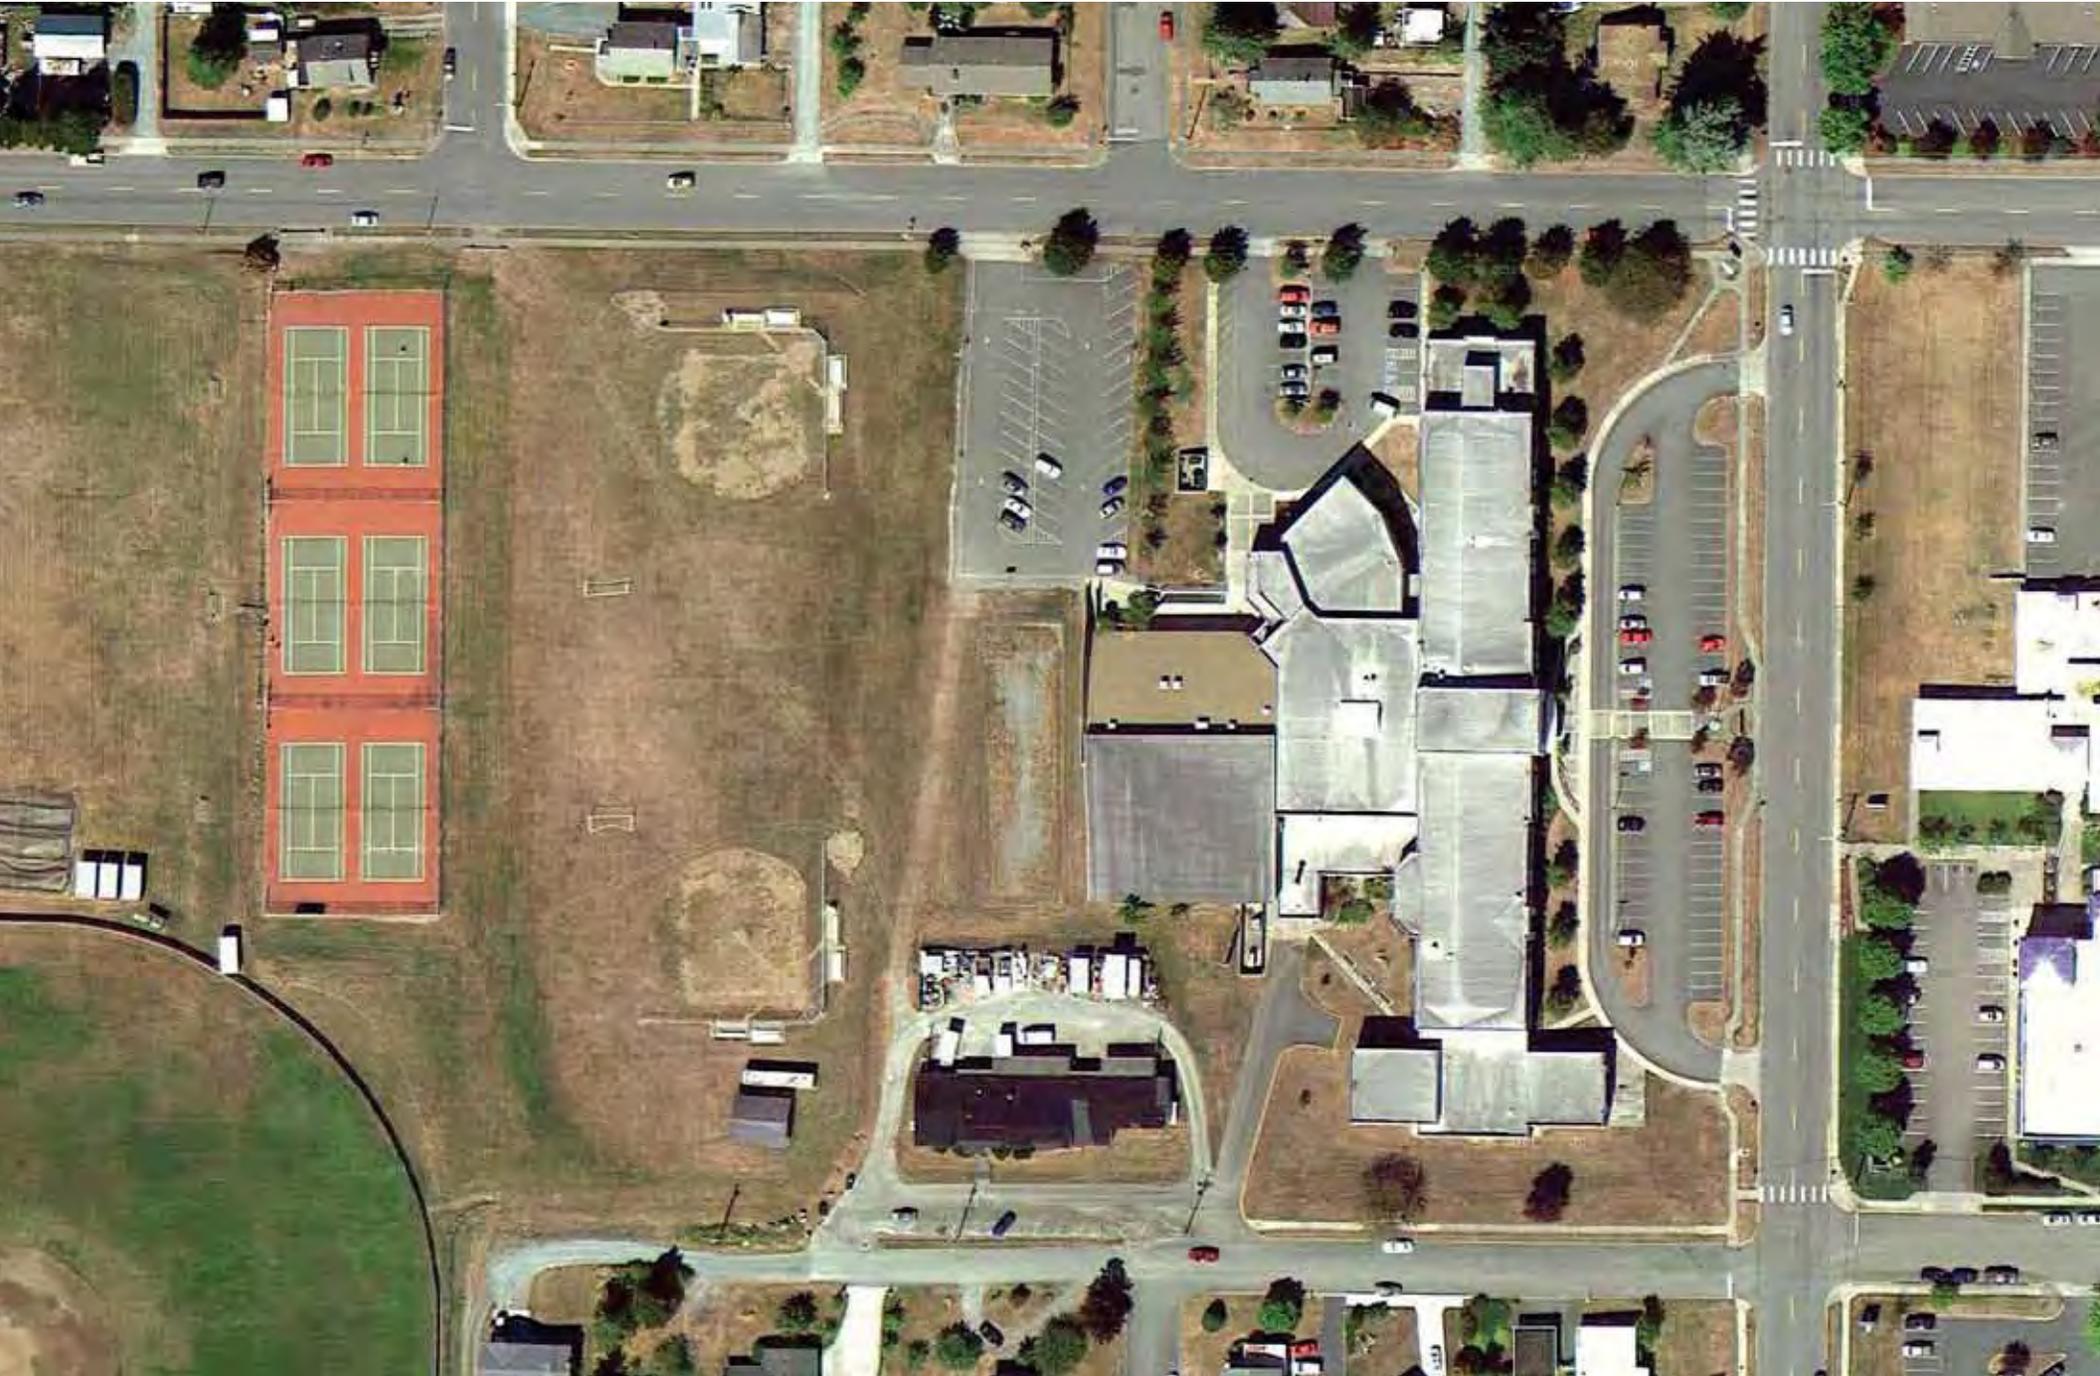
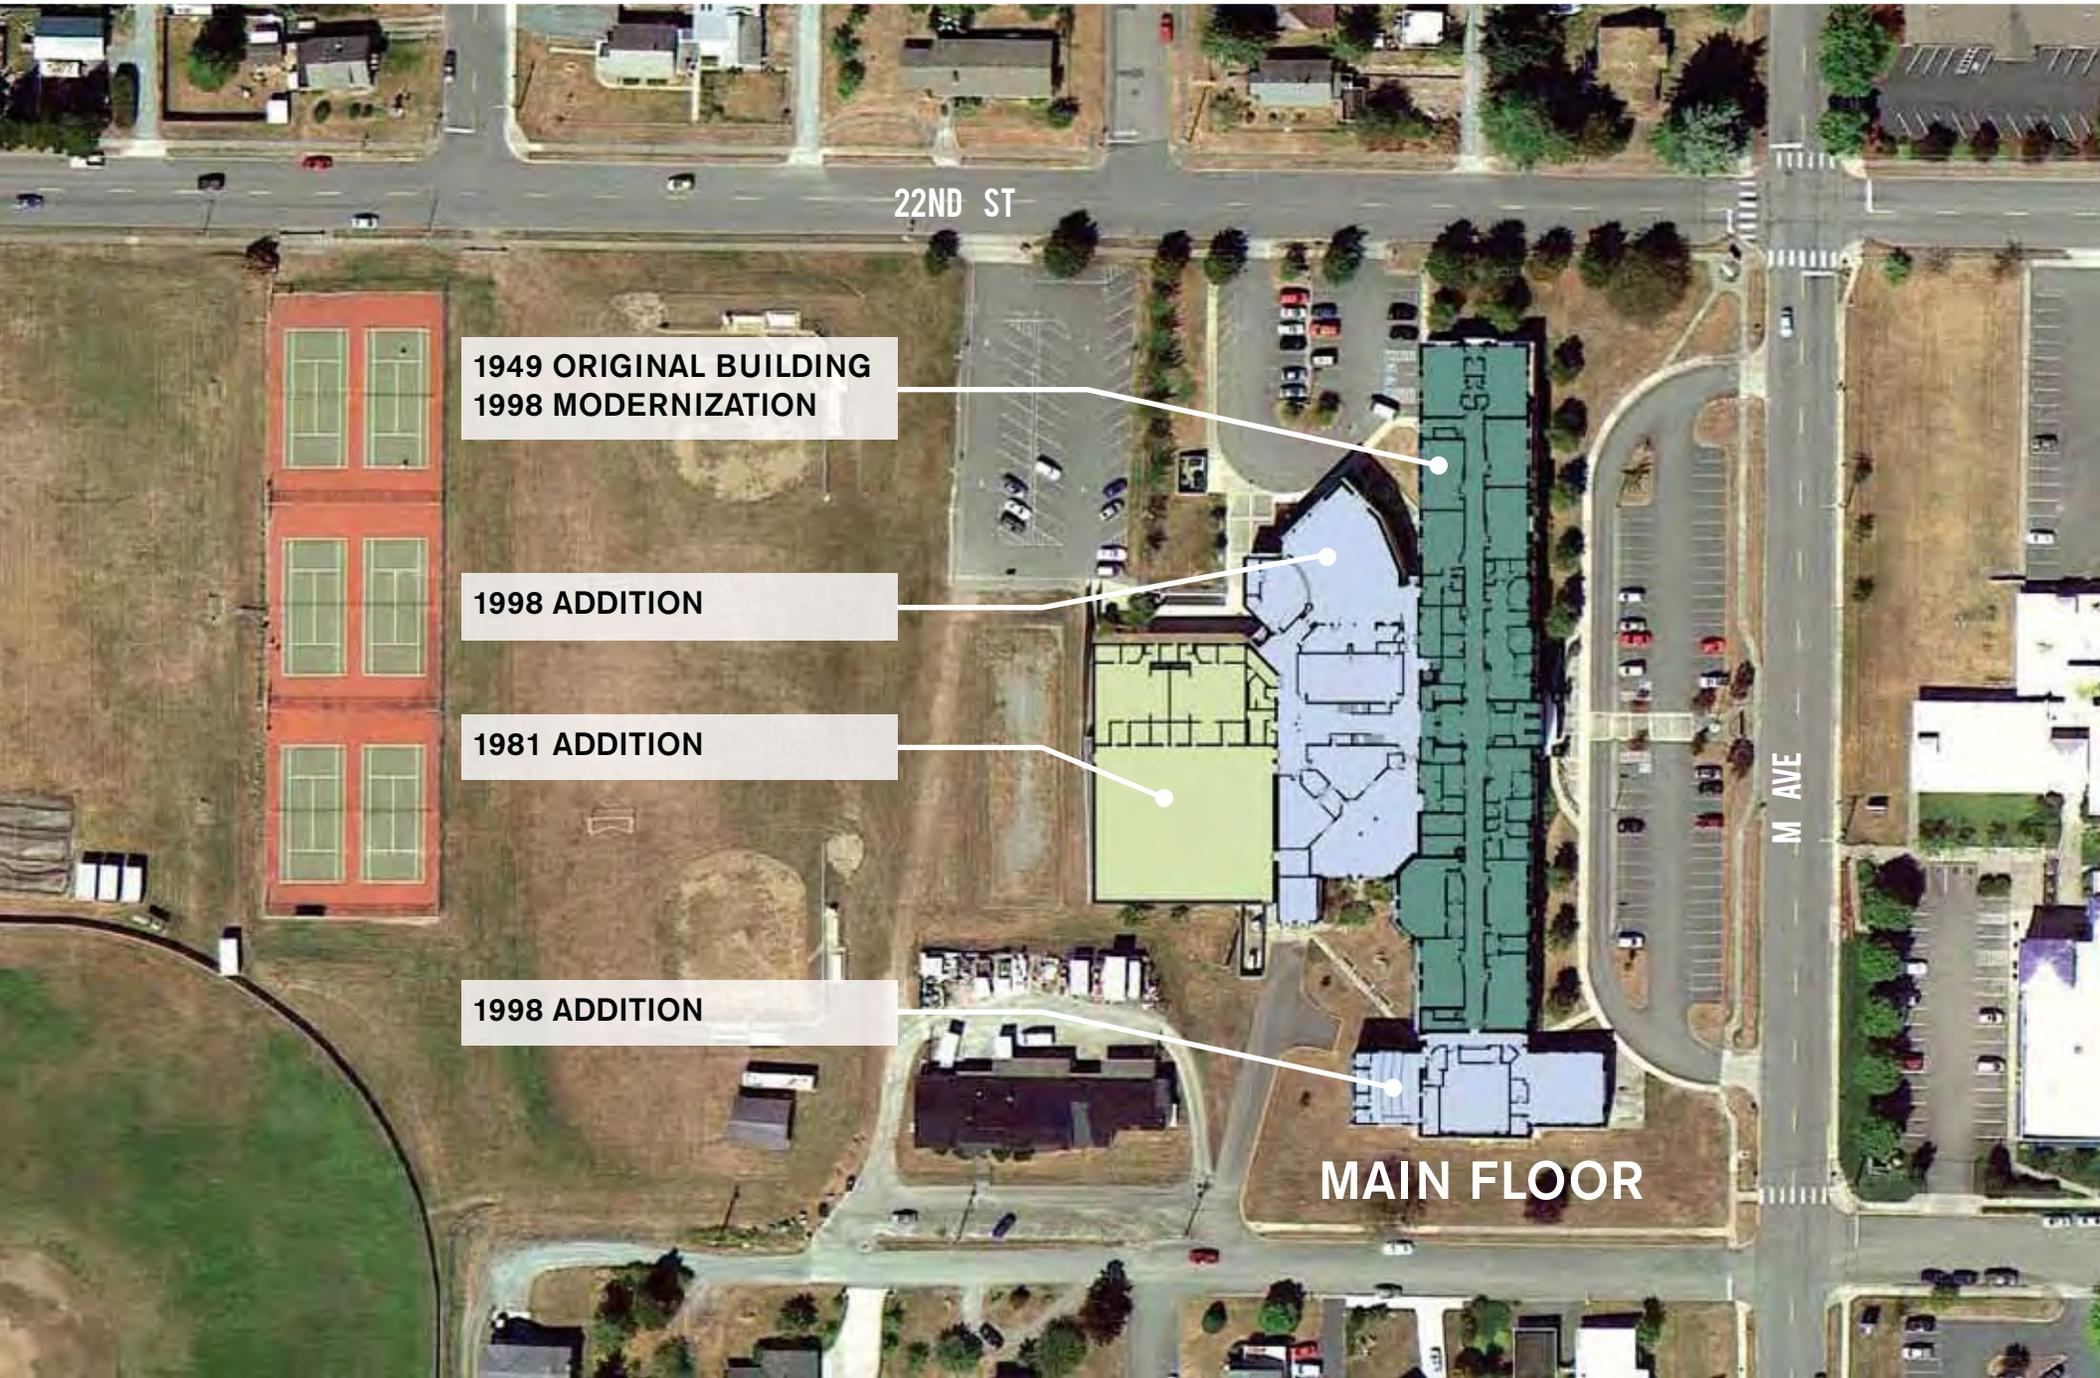
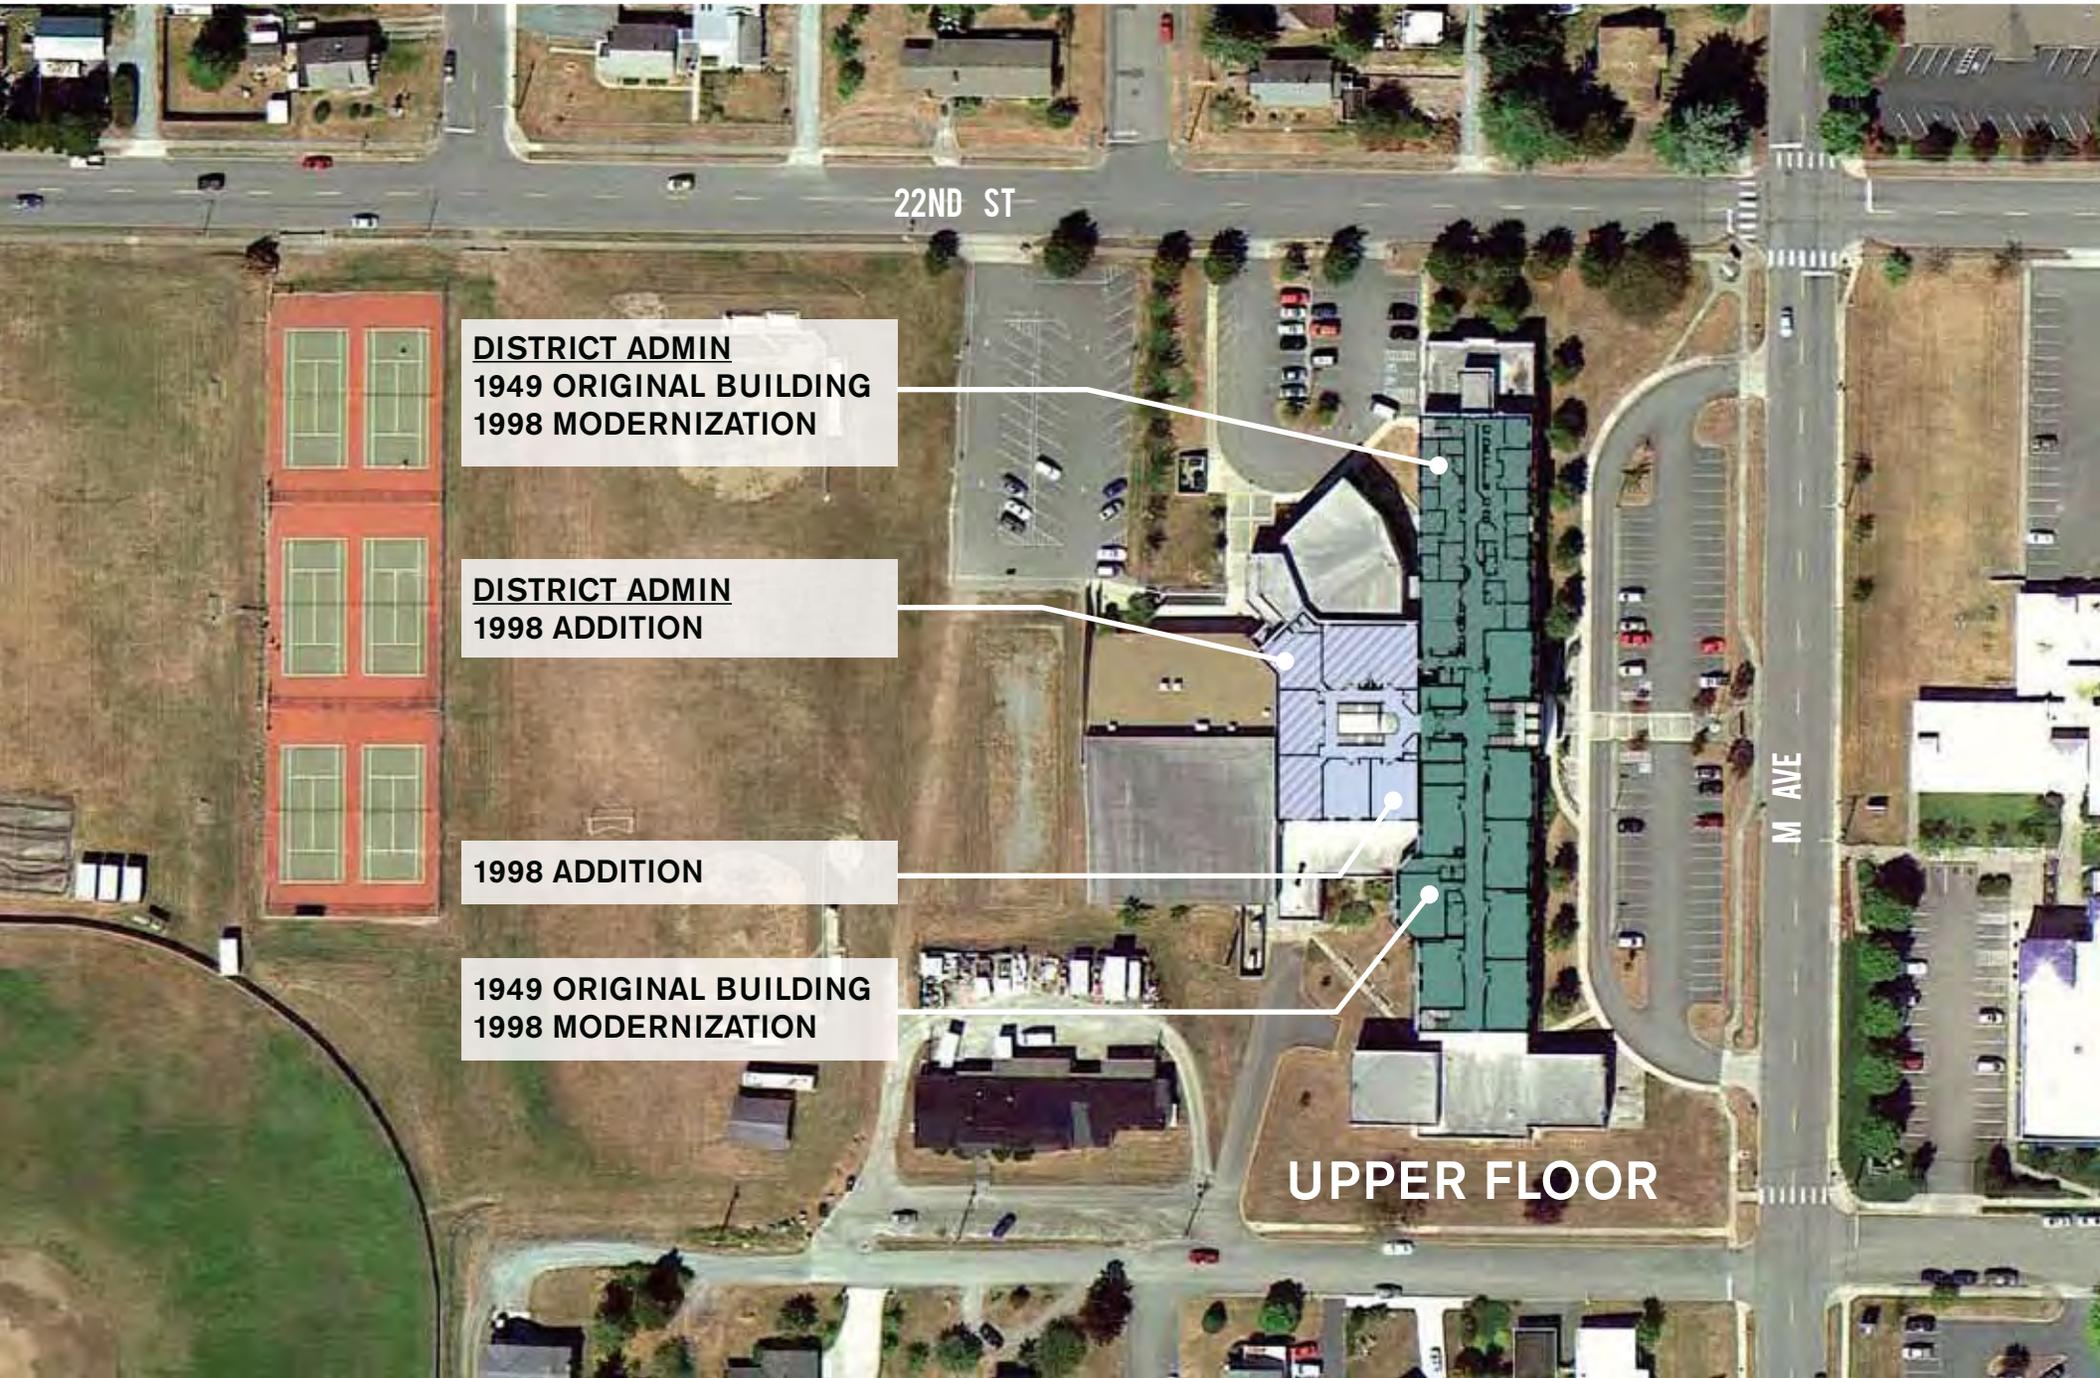
ANACORTES MIDDLE SCHOOL & DISTRICT ADMINISTRATION

1. Exterior sill flashing does not have proper slope to allow drainage away from the window. This is causing water to leak into the building at a number of locations.
2. Roofing should be carefully monitored over the next 5 - 8 years as it will reach the end of its expected serviceable life in 8-10 years.
