May 21, 2020

Re: **Geologic Hazard Assessment**
Proposed surface mine expansion
Skagit County Parcel P44865

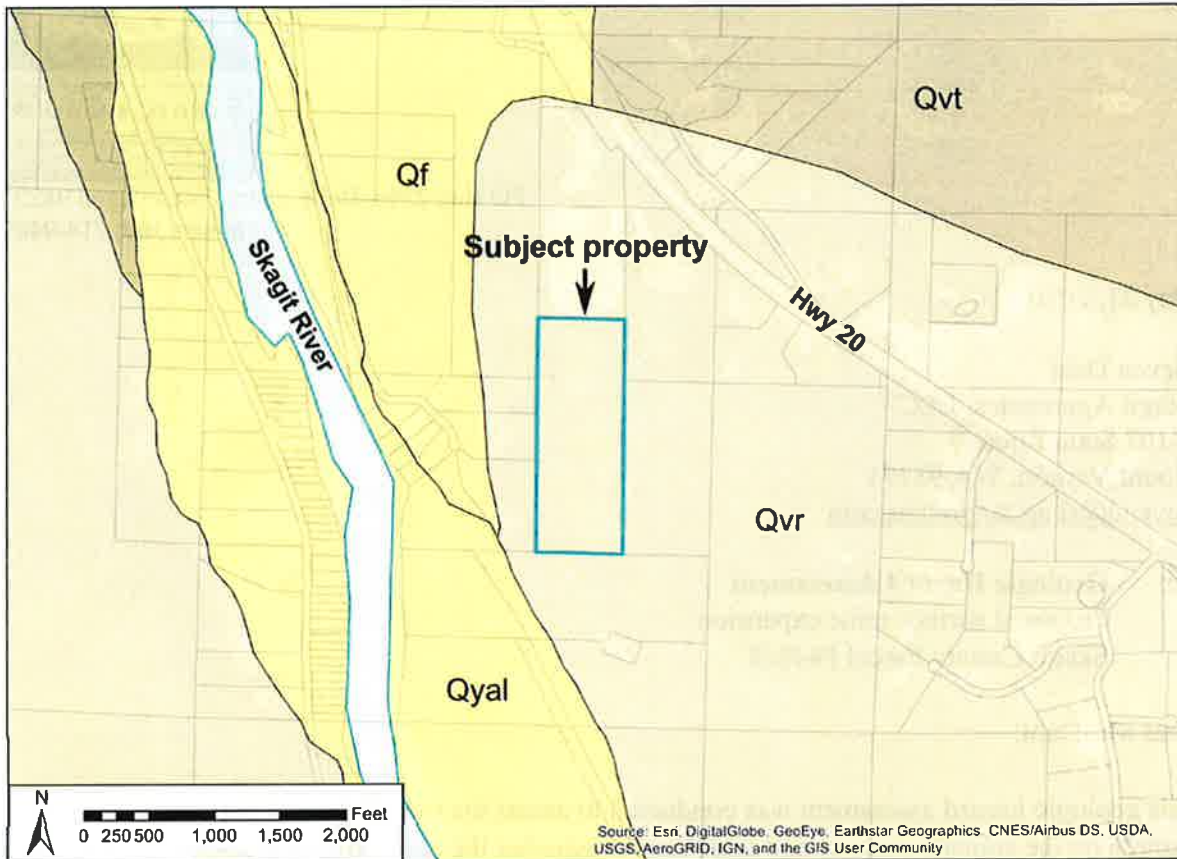
The Geologic Map of the Sauk River 30- by 60-minute Quadrangle, Washington (Tabor and others, 2002) indicates that the subject property is underlain by Vashon recessional outwash (Figure 1).

Figure 1. Geologic map of the subject property and vicinity based on geologic mapping by Tabor and others (2002). Qvr = Vashon recessional outwash, Qvt = Vashon till, Qf = Quaternary alluvial fan, Qyal = Quaternary younger alluvium.
