SKAGIT COUNTY DEPARTMENT OF PUBLIC WORKS

2020 ANNUAL BRIDGE REPORT

2020 BRIDGE REPORT

Submitted: March 2021

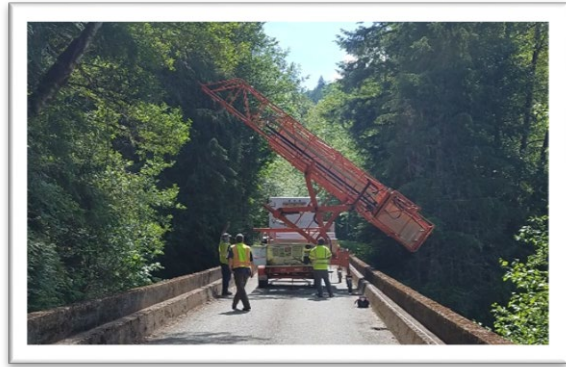
Whatcom Co Hydro-Platform on Finney Cr Bridge

- 66 bridge inspections were performed in Skagit County.
 - 53 routine inspections performed on Skagit County bridges
 - 3 routine inspections performed for local agencies including 2 new bridges in Sedro Woolley that were inventoried this year.
 - 10 routine and fracture critical inspections performed by the Washington State Bridge Preservation Office.
 - A Special Inspection was performed on the Upper Finney Creek Bridge using Whatcom County's Hydro-Platform to get a closer look at possible girder damage.

- Design phase commenced on Upper Finney Creek Seismic Retrofit and Strengthening Project. The proposed work includes a seismic retrofit, making the bridge more resistant to earthquake damage, while also increasing its overall strength and load capacity. Skagit County was awarded \$3,000,000 in Federal Local Bridge Program funds for this project.

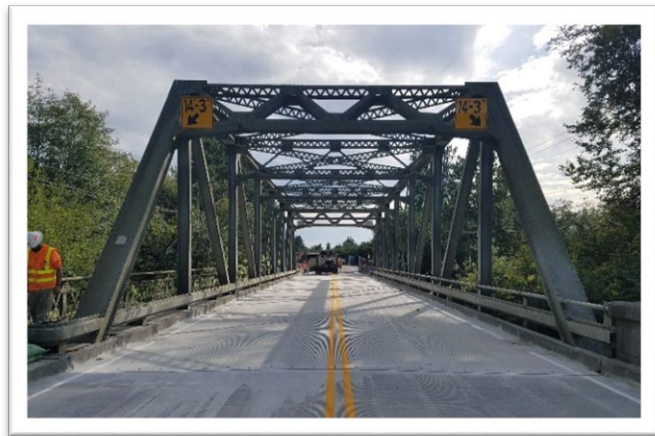
Samish River Bridge - Vertical Clearance Signage

Steel Truss Bridges all have sway bracing across the top which creates a vertical limitation to vehicles traveling over the bridge. Below is a list of bridges that have this limitation with a vertical measurement which helps when reviewing the route of an oversized load application. Skagit County crews have also posted the height restriction on two of the bridges that are near or below legal height (See Table 3).

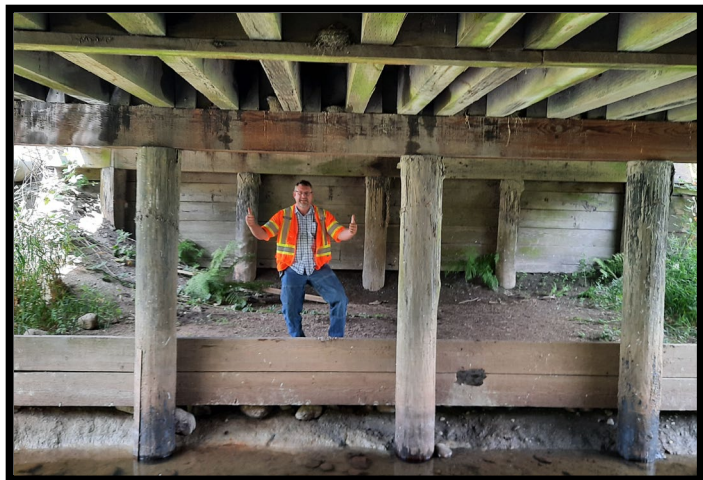
Thomas Creek Bridge – Old Hwy 99 N.

This bridge is considered structurally deficient and has a sufficiency rating of 37.16, making it eligible for replacement funding. The inspection frequency has been increased to every 12 months to better monitor the deterioration and maintain motorist safety along this heavily traveled corridor. We will be applying for replacement funds in the **2021 Local Bridge Program Call for Projects**.
