## SKAGIT COUNTY DEPARTMENT OF PUBLIC WORKS

# 2025 ANNUAL BRIDGE REPORT

**SUBMITTED MARCH 2026**

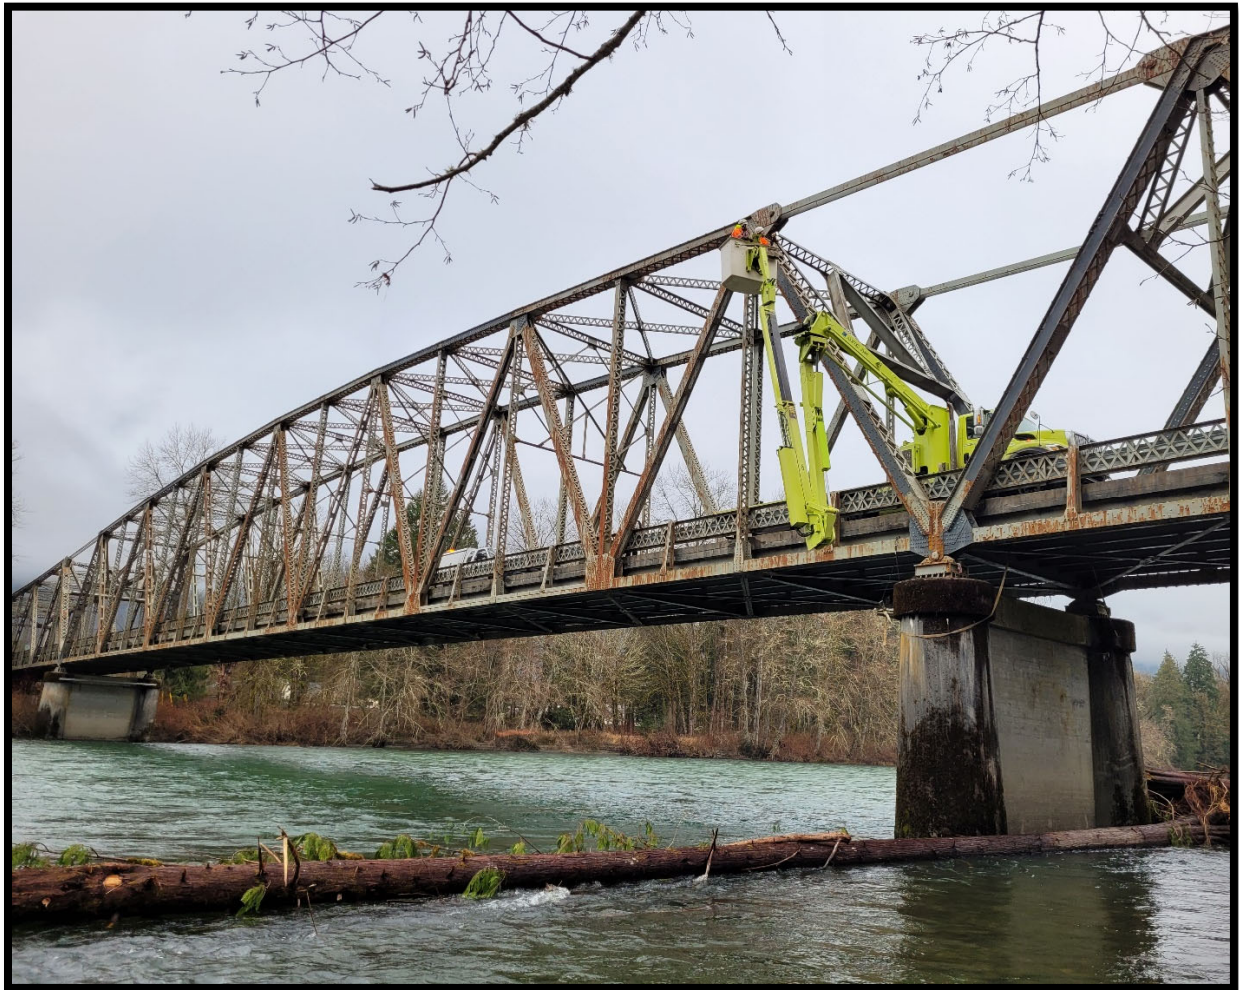
*Inspection of the 96-year-old Skagit River Marblemount Bridge (#40070) amid an ongoing rehabilitation project that includes strengthening, painting, and repairs.*

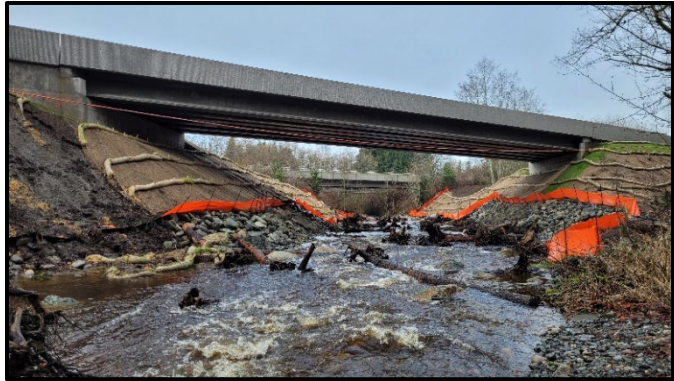
- Due to a massive debris blockage during the December 2025 extreme weather event, Jordan Creek migrated to the west and destroyed a portion of Rockport Cascade Road.

The bridge is structurally sound, but it did suffer an extensive amount of scouring around its pile foundation. The road will remain closed for an indeterminate amount of time until a new crossing is constructed over the current Jordan Creek location.

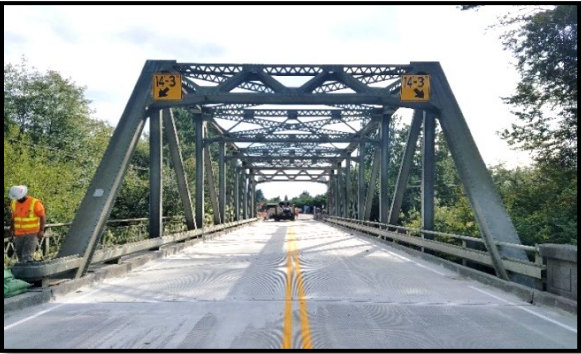
Samish River Bridge - Vertical Clearance Signage

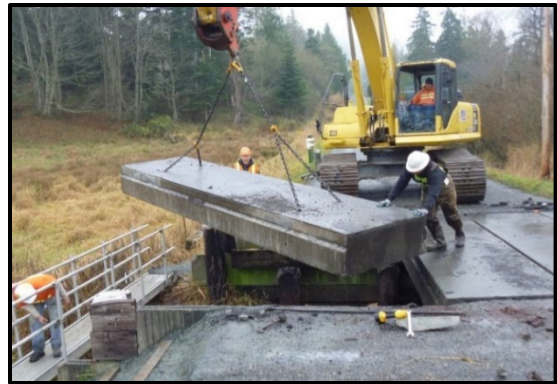
Campbell Lake Outlet slab girders put back in place after receiving new timber cap in 2013.

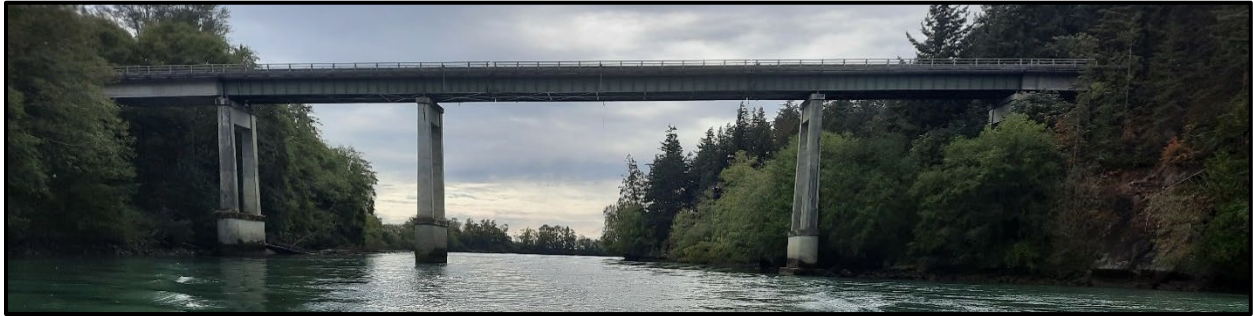
North Fork Bridge looking downstream.

The North Fork Bridge has served the County well for 67 years, but its narrow configuration and limited load capacity have rendered it obsolete. Currently, the bridge is in Fair condition and not eligible for Federal Local Bridge Program replacement funds. However, given the importance of the route it serves (connecting Interstate-5 with State Route 20 and serving as an alternative trucking route to the Port of Skagit, the refineries, and Port of Anacortes) we are looking for infrastructure grants, coupled with non-motorized grants and salmon restoration / flood water conveyance grant opportunities.
