M/V Guemes CY2019 Lifecycle Valuation and Propulsion Study

Produced By:

Match 31, 2020

M/V Guemes 2019 Valuation Survey and UT Inspection Plan

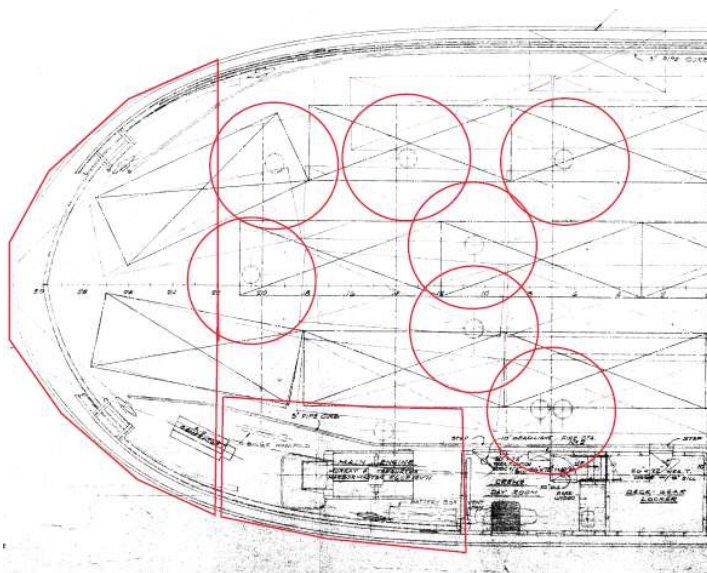
Figure 1: Number 2 End Deck UT Inspection Plan

The last main deck UT inspection was completed in 2014. It showed areas of high wear near the Number 2 bow and Number 1 engine. Both bows receive heavy abuse due to the repeated cycles of the vehicle loading ramps impacting the deck and the vehicles themselves on-loading and off-loading. Both of these regions will receive an inspection with a two-foot grid. The areas around both engines, thrusters, and the generator are prone to greater wear due to vibrations and are prone to pooling water and other mechanical fluids. These will be inspected with a two-foot grid. This area includes the deck within the machinery compartments. There are many access hatches across the deck allowing entrance into the vessel's voids. These areas can also be prone to excessive corrosion due to moisture access and will be inspected with a two-foot grid within an approximately five-foot radius. All other areas on the main deck will be inspected using a four-foot grid. See red outlines in Figure 1 and Figure 2 for two-foot grid areas.

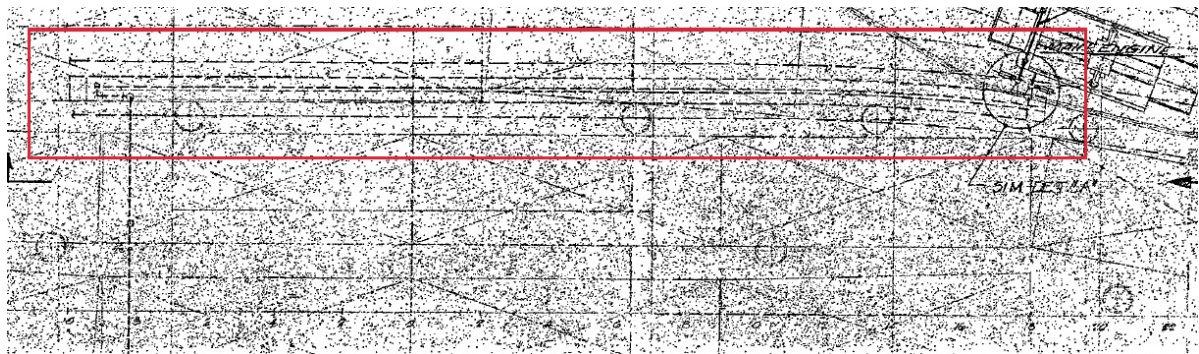
Figure 3: Keel Cooler Inspection Area

The side shell, bottom plating, and skegs were last inspected in 2014. All areas looked good with the exception of the bottom plating in way of the keel coolers between Frame 7 on the No. 1 end and Frame 7 on the No. 2 end. A two-foot grid shall be completed between Frames 10 and 20 (opposite ends from each other) and from four-feet in board to four-feet outboard of the keel coolers, see Figure 3. The keel coolers are channels protruding from the hull as seen in Figure 4. The two-foot grid shall also include the internal plating on top of the keel coolers within the voids. These areas can be identified by measuring from the outboard most chine inboard and by referencing the cooling piping penetrations.

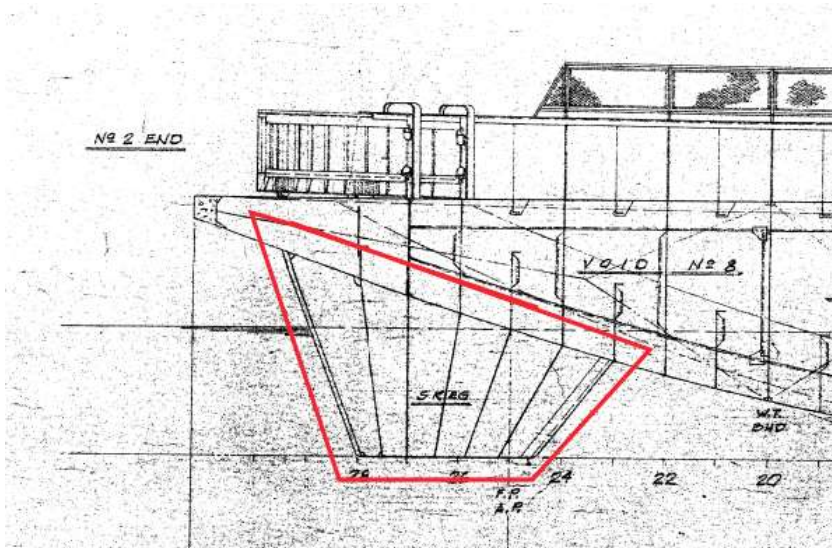
Figure 5: Skeg Two-Foot Grid Inspection Area (No. 1 End Similar)

A two-foot grid shall also be completed within approximately four feet of all structural connections to the hull such as the skeg to hull and thruster bracket to hull joints. Note that the thruster brackets themselves are not part of this scope. Additionally, a few parts of the skegs themselves showed the beginning of deterioration. A two-foot grid shall be completed on the skegs themselves, see Figure 5.

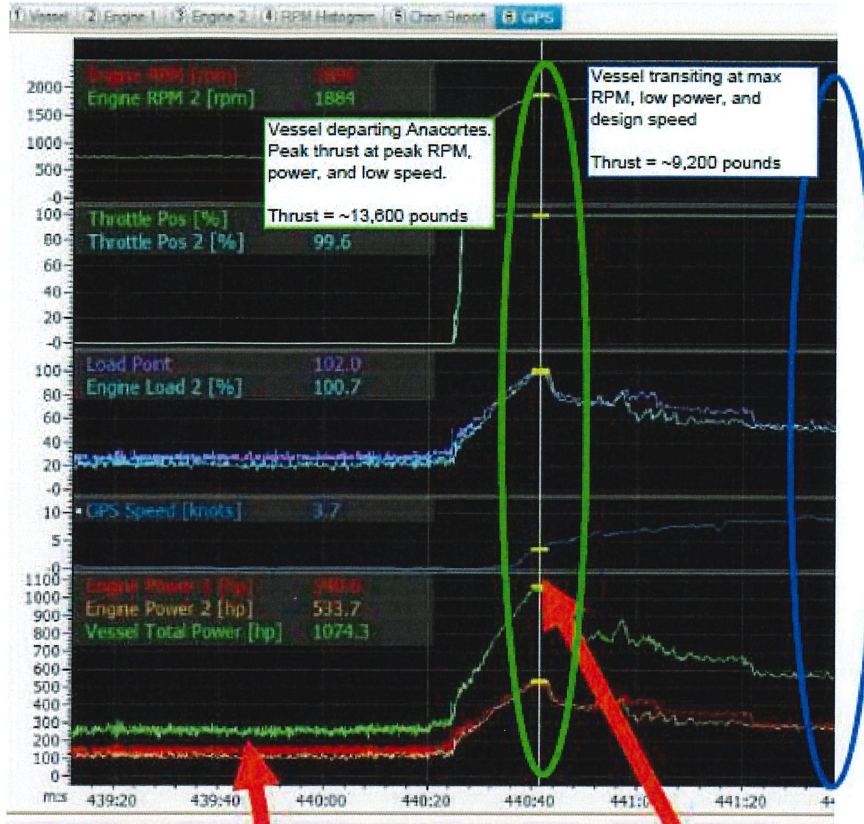
Figure 2: Engine Performance Leaving Anacortes

1. The thrust value of 9,400 pounds that was used in Reference [A] was confirmed as being associated with the vessel operating at a design speed of nine knots.
2. Peak thrust during the departure from Anacortes was determined to be approximately 13,600 pounds.
3. Maximum potential thrust which the propeller can deliver at 1800 engine RPMs is approximately 15,000 pounds.
4. While the vessel is arriving Guemes Island there are several instances of fluctuations between low RPM/power and high RPM/power as the vessel slows down. These fluctuations can cause large swings in thrust delivered by the propeller.

Figure 2 and Figure 3 show the operational conditions analyzed and the corresponding thrust values. Figure 4 shows these conditions plotted on the propeller curve. It is important to note that the exact thrust values and number of cycles produced as the vessel approaches Guemes Island are difficult to predict due to the rapid fluctuation in engine speed, vessel speed, and propeller orientation. However, it is known that the propeller sees many fluctuating instances of low to high advance coefficients during this transition and thus high cycles of thrust loading. Based on the analysis conducted in Appendix 1, the thrust imparted on the bracket, the principle stresses, and the number of cycles are higher than determined in Reference [A]. This will reduce the fatigue life from those calculations.

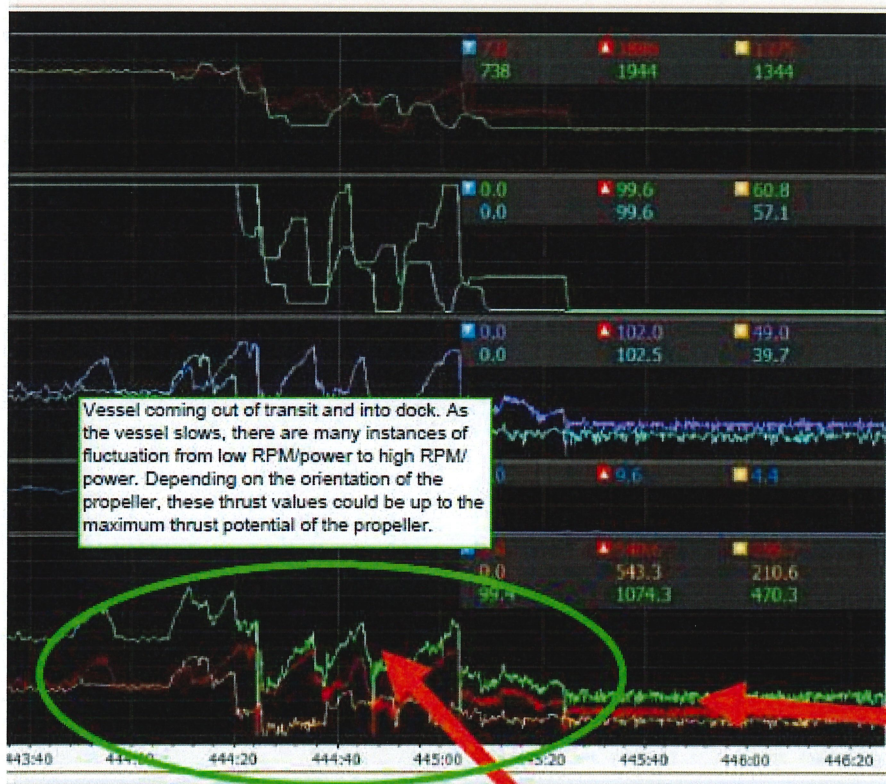
Figure 3: Engine Performance Arriving Guemes Island

While the vessel is arriving Guemes Island there are several instances of fluctuations between low RPM/power and high RPM/power as the vessel slows down. These fluctuations can cause large swings in thrust delivered by the propeller. It is difficult to determine the exact values of these thrust fluctuations since the advance velocity entering the propeller can not be determined accurately. It can be assumed to be the vessel speed at the greatest but is likely lower depending on the angle of the thruster to the vessel direction of movement. This indicates that the thruster bracket may be seeing more cycles of higher thrust (and thus higher stresses) than originally determined.

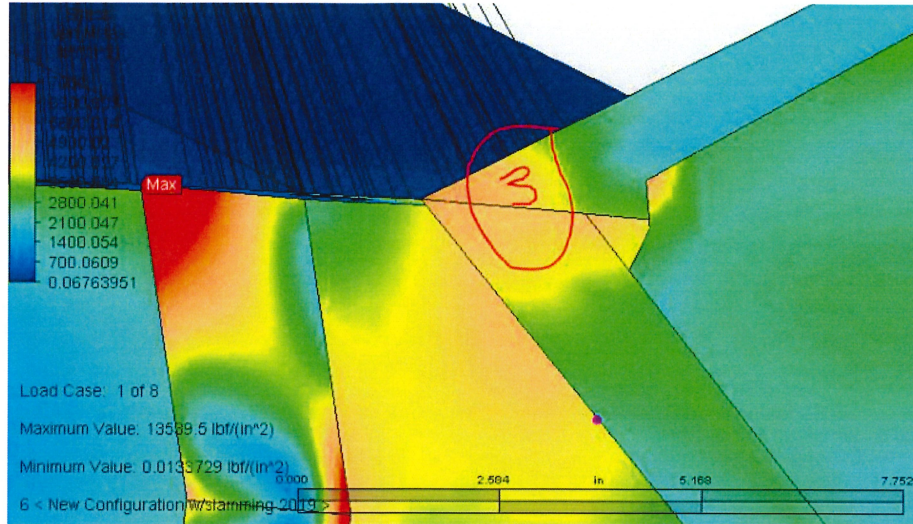
Figure 6: End No. 1 with 13,500 pound Thrust

Another goal of determining the actual thrust being produced by the propeller was to input it into the FEA model [A] and determine the affect of the higher static thrust loading on the principle stresses of the brackets. The thrust input into the FEA model (13,600 pounds) is an increase of about 43% from the previously used value of 9,400 pounds. The increase did not cause any of the structure to fail due to yielding. However, the magnitudes of stress ranges increased significantly, indicating a decrease in fatigue life. The stress range at the location of the highest measured stress (End No. 1, location 3) from NCE's testing was also investigated. The stress range output by the FEA model aligns closely with their measured values. This information will serve to validate the thrust to be used if the thruster brackets are re-designed in the future. Figure 5 and Figure 6 show results of the higher thrust value input into the FEA model. Location 3 is labeled.

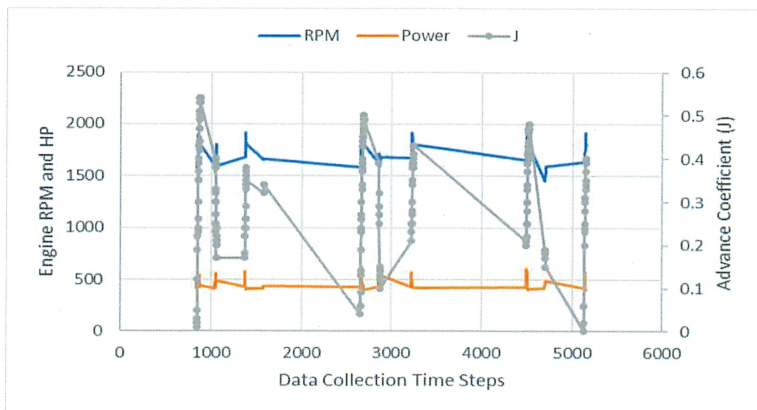
Graph from [7]

The engine log data that produced the above figure was filtered and analyzed [7] to determine the potential thrust magnitudes and cycles. The data in this range was filtered for instances when the Engine 1 is producing more than 400 hp and the RPM is greater than 1500. Since the vessel is slowing, these parameters will produce the greatest thrust potential. The graph below is from [7] showing these peaks. The advance coefficients were calculated based on vessel speed and are thus estimated to be conservative. As discussed above, it is challenging to determine the exact thrust. However, the data shows 29 instances of $J < 0.2$ which corresponds to a thrust of at least 13,000 pounds. Of these 29 instances, they are divided into five groups, indicating that there are potentially five low to high thrust cycles. This indicates the potential for more high thrust/stress cycles being imparted into the thruster brackets than originally anticipated.

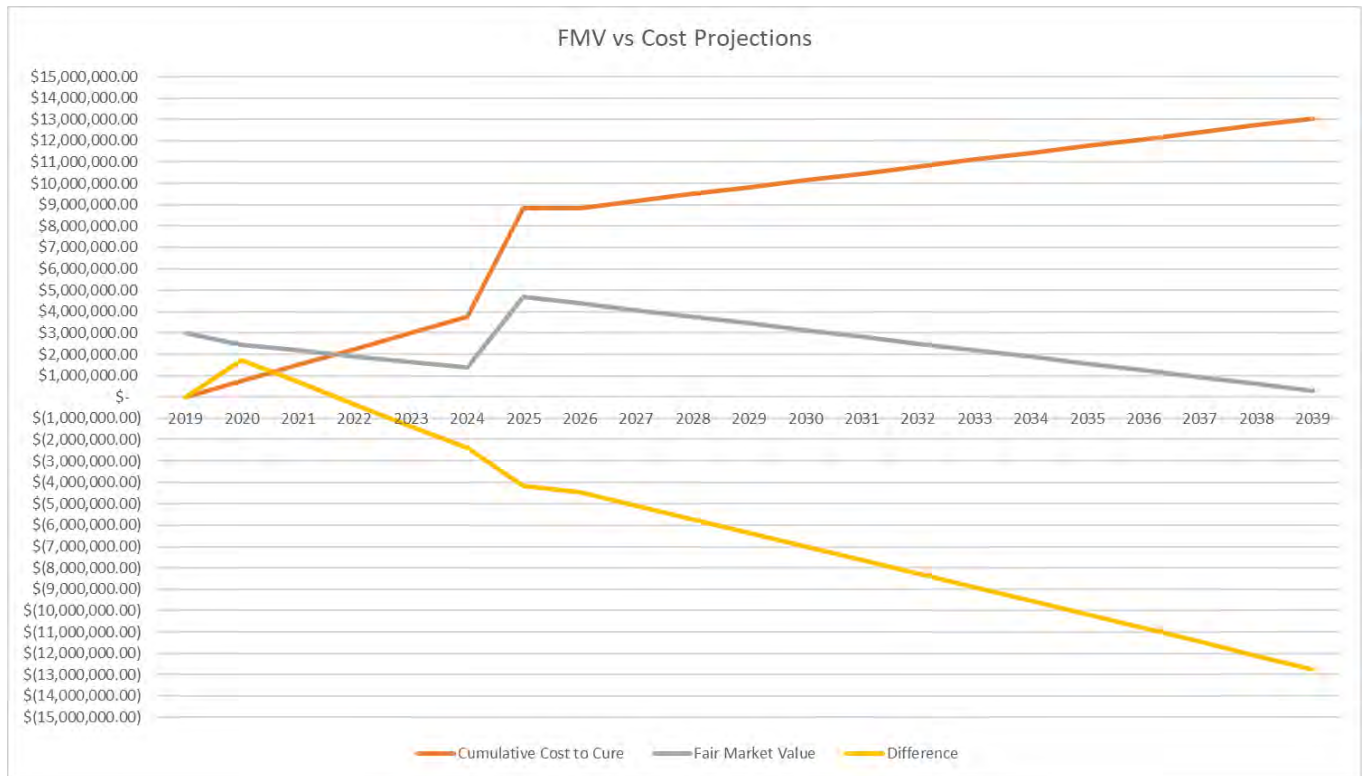
It should be noted the above graph captures the total projected costs and associated FMV with maintaining and extending the Guemes life to 2039 including the 2024 upgrade. In other words it is estimated that by the end of 2039 the owner would have spent a cumulative \$13,043,322 for maintenance and upgrades and own a vessel valued at \$304,000.

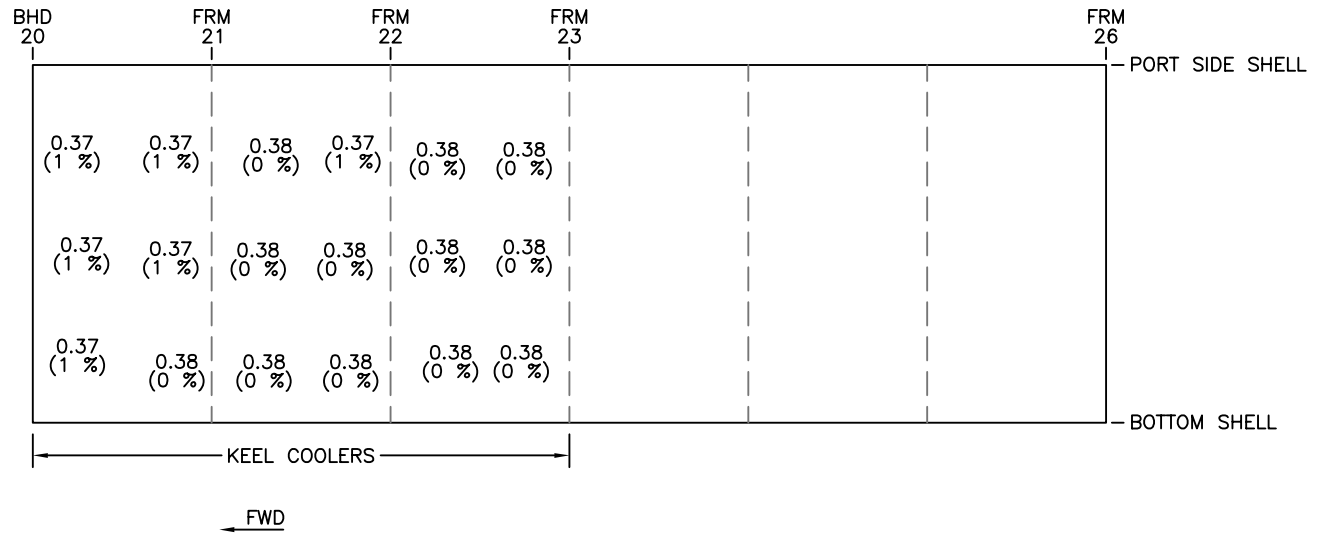
VESSEL: M/V GUEMES DRAWN BY: G. GRAHAM JOB # S3603	DESCRIPTION: No.8 VOID - PLATING IWO KEEL COOLERS PORT SIDE - PLAN VIEW DWG # No8 VOID BTM PLT DATE: MARCH 2019
---	---

NOTE:
 NO ORIGINAL SCANTLINGS AVAILABLE AT TIME OF SURVEY.
 NOMINAL THICKNESS MEASUREMENTS OBTAINED TO
 DETERMINE PERCENT WASTAGE.

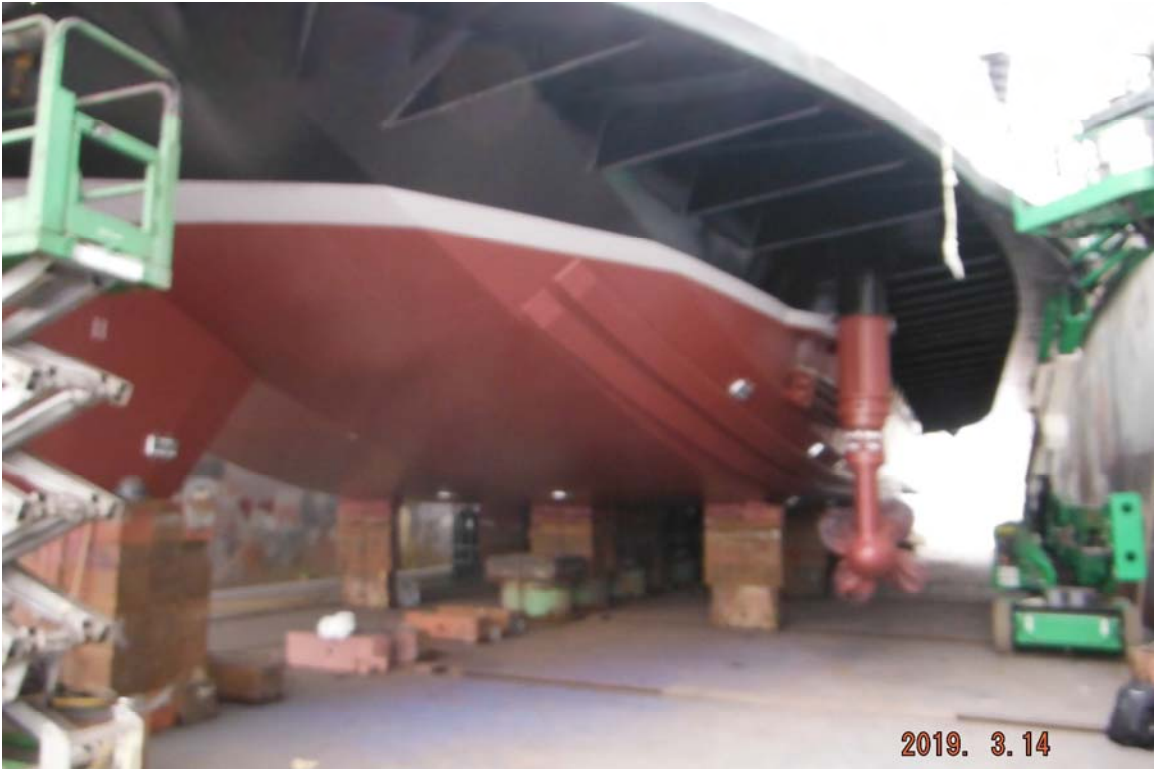
Photo No. 1
No. 1 end looking aft port side

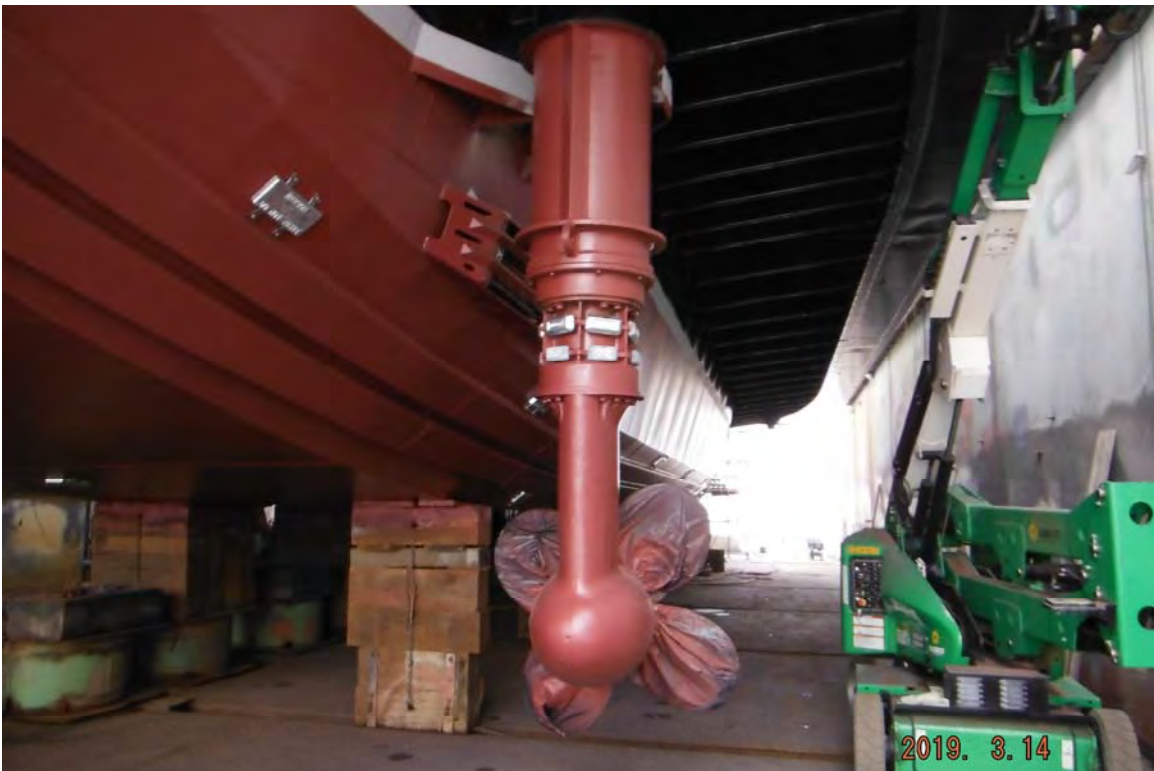
Photo No. 2
No. 1 end Z-drive Unit

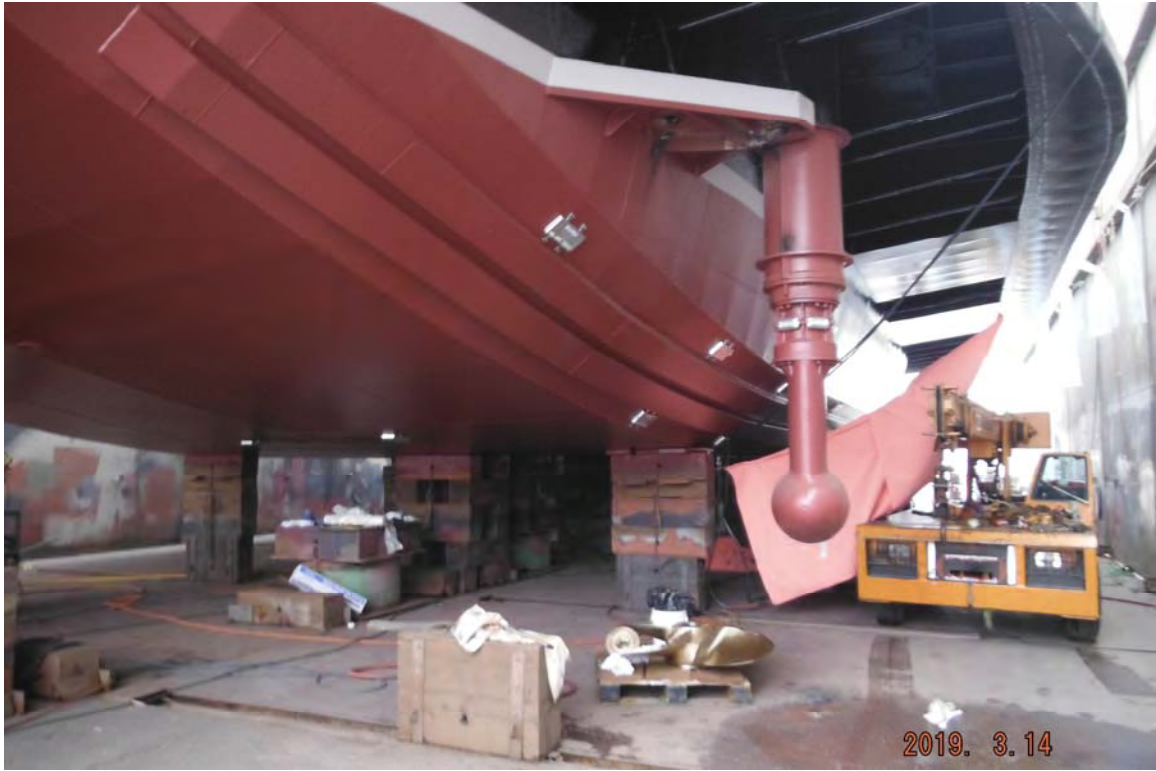
Photo No. 5
No. 2 end looking forward starboard side

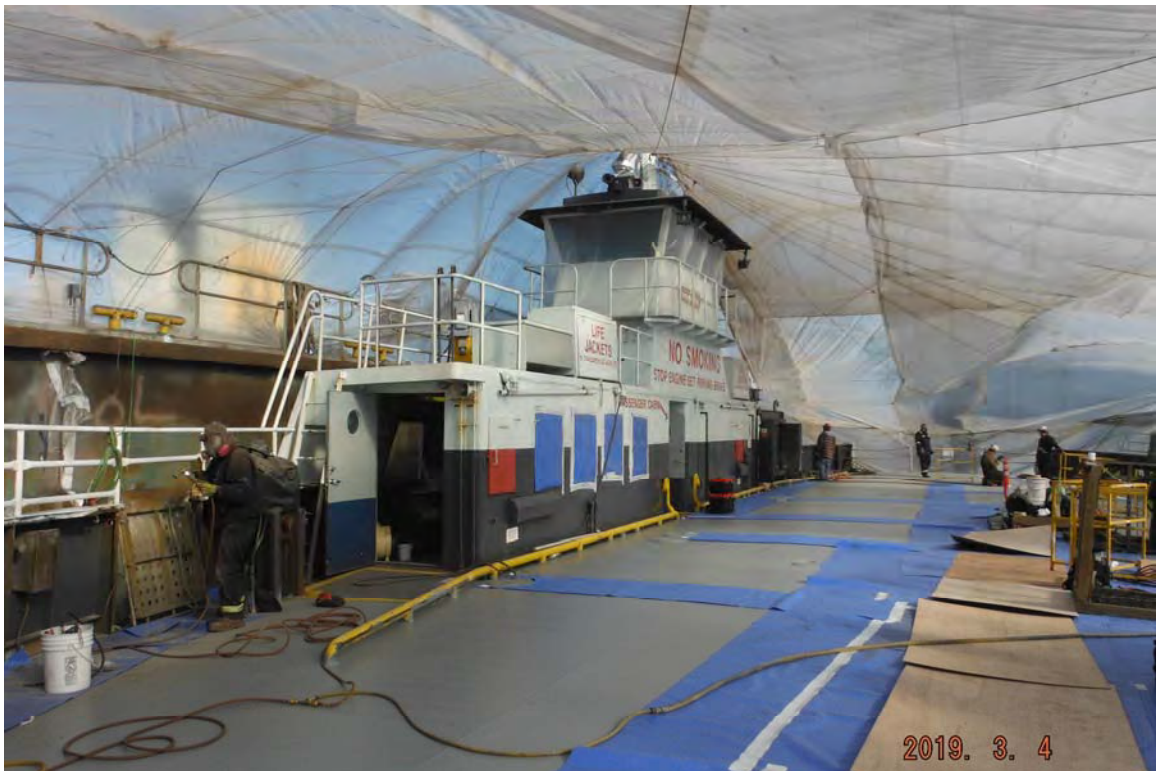
Photo No. 8
Main deck looking aft from No. 1 end

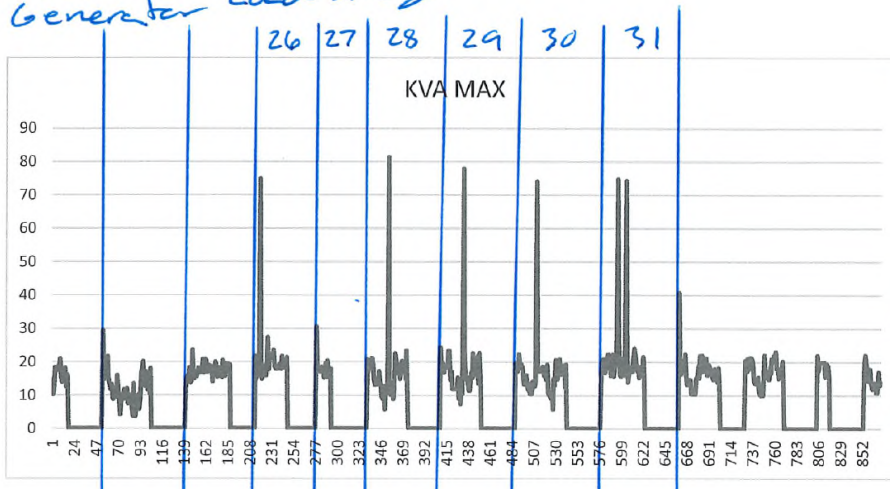
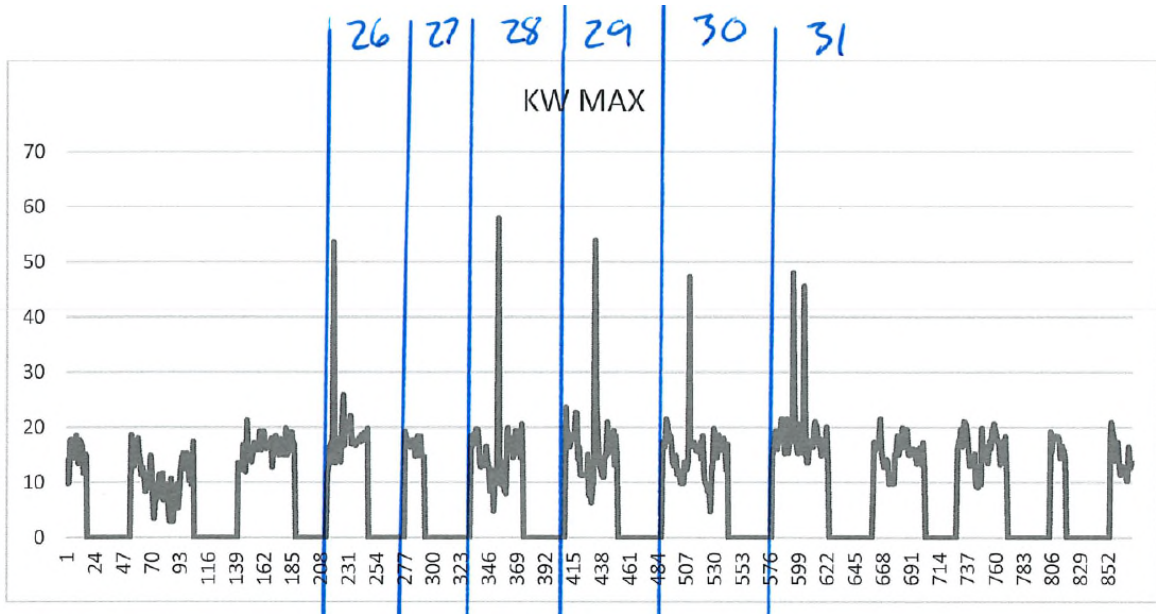
The below maximum power (kVA-Max) graph shows the high spikes when starting the electric motors. This paired with the second graph below, shows a severe voltage drop, amperage spike, and low power factor during these conditions. Because these spikes are short lived, and the existing generator doesn't show an issue with starting the motors, it is believed that a similarly sized generator will be able to support these loads. **However, a big question of this study is how low of a rating can we go and continue to support starting these motors?**

26: Fire pump start up /
Run w/ Heaters on

31: Both Fire pump running
2 X 10 min interval
