Glosten

**INNOVATIVE
MARINE
SOLUTIONS**

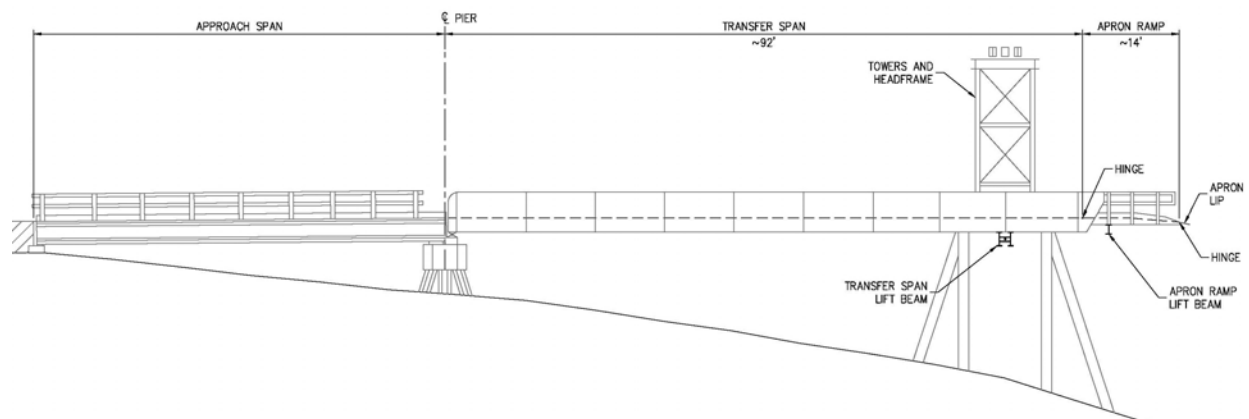
Figure 1: Terminal Ramp Anatomy

The vertical lift limits of the transfer span were checked at the Anacortes terminal by raising the ramp to its highest extent, at the highest pin hole in the live load hanger bars. It was determined that the end of the transfer span could be raised to an elevation of about +21-ft, MLLW at deck surface. See **Figure 1**, below for a graphical illustration of the ramp components. The lowest ramp elevation was not physically measured due to tidal levels at the time of evaluation. However, the shop drawings for the transfer spans and overhead hoist mechanisms indicate a lower stop on the live load hanger bar that restricts the ramp lowering to elevation +3-ft, MLLW at deck surface. A review of the lifting procedure with the crew was used to confirm that similar limits control maximum vertical lift for the Guemes terminal ramp. Both ramps are routinely raised and stowed at their full height overnight.

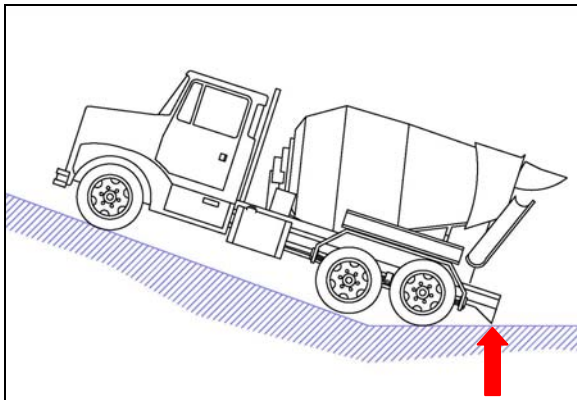
Figure 3: Negative Grade Break

Based on the above tidal data and the anticipated higher freeboard characteristics of a new vessel, the existing ramp vertical range will be suitable for all tides. This same analysis indicates that the existing ferry is probably also fully operational through all tides. It must be noted however, that this analysis is limited to the ability of the apron ramp to rest on the deck of the ferry, but neglects to consider the limits of vehicles travelling across the ramp. A discussion of permissible grade break, or abrupt change in vertical slope, is needed. Excessive grade breaks can cause damage to vehicles and/or the ramp from a vehicle’s bumper or hitch scraping on a negative grade break, illustrated in **Figure 3**, and/or high centering on a positive grade break, as shown in **Figure 4**.

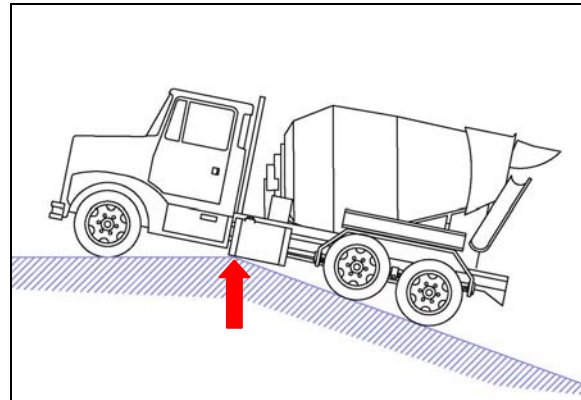
Figure 4: Positive Grade Break

Permissible grade breaks vary by vehicle type and size but as a general rule should be limited to no greater than 8%. Limiting grade breaks to 8% at all three interfaces yields an allowable low ramp elevation of +8.0-ft. Applying this metric to our allowable operational water level calculation yields an operational low water elevation of +3.5-ft for the existing boat and +1.0-ft for a proposed new vessel with assumed freeboard of 6-ft. The high tide condition does not result in large grade breaks, so is not analyzed further. **Appendix E** illustrates the grade break controlled minimum ramp elevation.

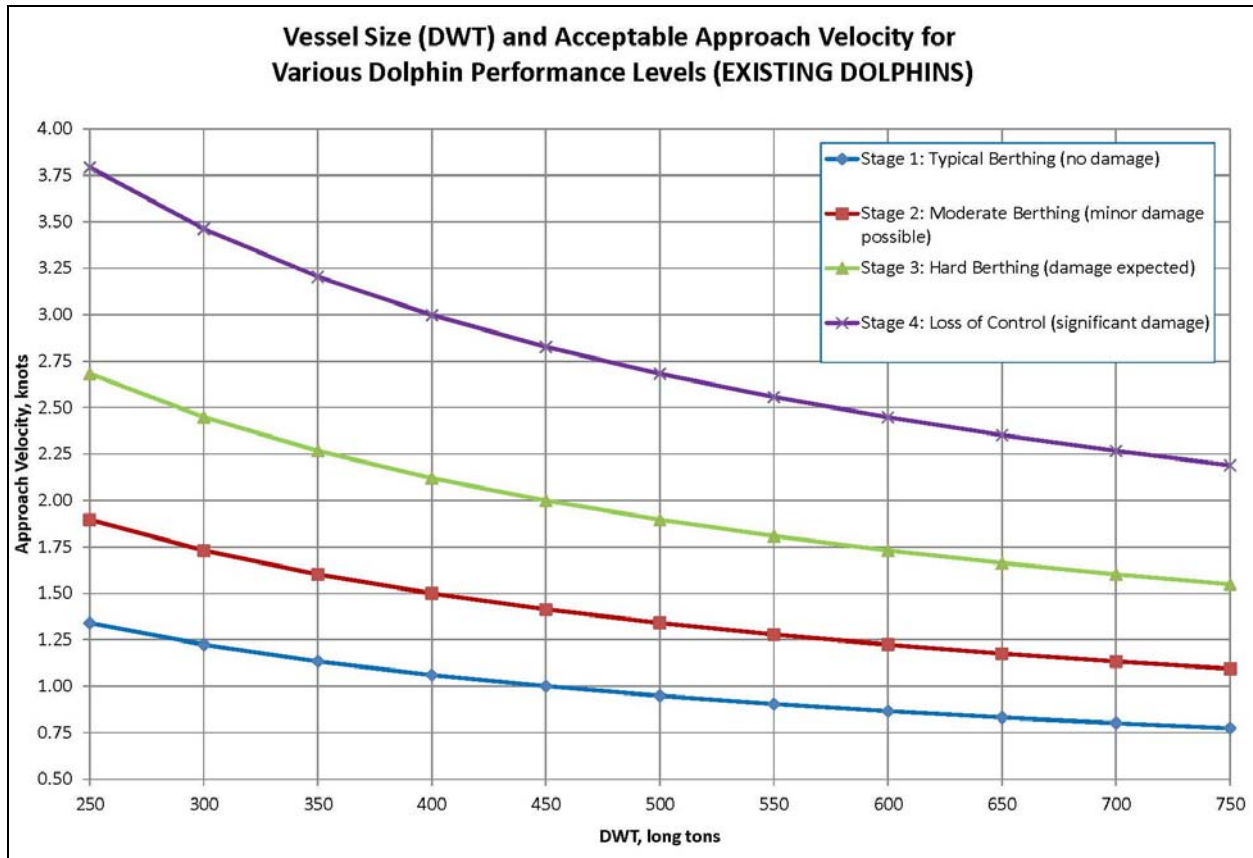
Figure 7: Existing Dolphin Performance Chart

By applying this equation and solving for v , the velocity at which various size vessels (m) reach the energy absorption (E) at each stage was calculated and plotted. Our task for this exercise was to help define how the existing dolphins would perform for larger vessels. The chart in **Figure 7**, below, shows the anticipated acceptable approach velocities for each stage, for a range of vessel sizes. The existing ferry has a dead weight tonnage (DWT) of approximately 300 long tons. We understand that a new vessel could be as large as 550 to 700 long tons. From the chart, it is clear that improved vessel speed and steering control, or other operational limits, would need to be established to maintain safe berthing for larger vessels at the existing dolphin structures.

It may not be possible or realistic to place operational (speed) limits on the ferry and captain(s) in order to maintain an operationally safe berthing facility. We were asked to supplement our analysis to consider what modifications to the existing dolphins might be possible in order to accommodate larger vessels (550 to 700 long tons) without significantly reducing acceptable approach velocity. Following is a brief description of this evaluation.

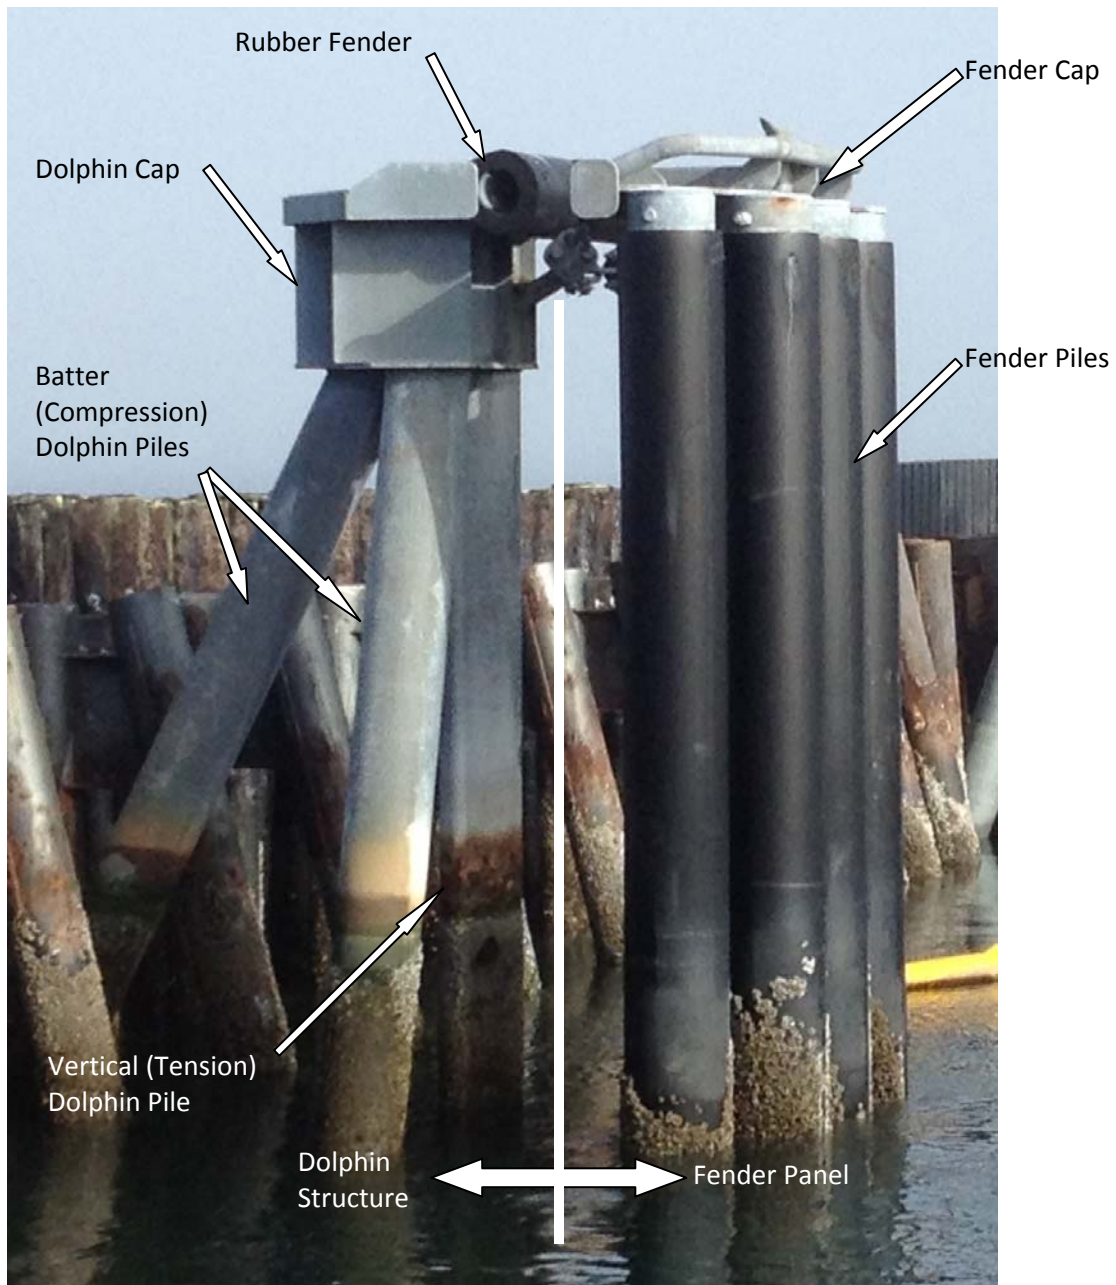
Figure 8: Dolphin Anatomy

It is unlikely that the existing dolphins can be ‘modified’ to achieve these same criteria through all four stages, but we will explore some options that could meet some of the criteria without requiring full replacement. For purposes of describing our analysis and options, refer to the dolphin anatomy photo in **Figure 8**, below.

The dolphins are constructed of two principal components: dolphin structure and fender panel. The dolphin structure is made of one vertical tension pile and two batter compression piles, topped with a dolphin cap. The dolphin cap has two rubber energy absorbers (fenders) bolted to it. The fender panel is made of five vertical steel pipe piles with plastic sleeves, capped with a fender cap.

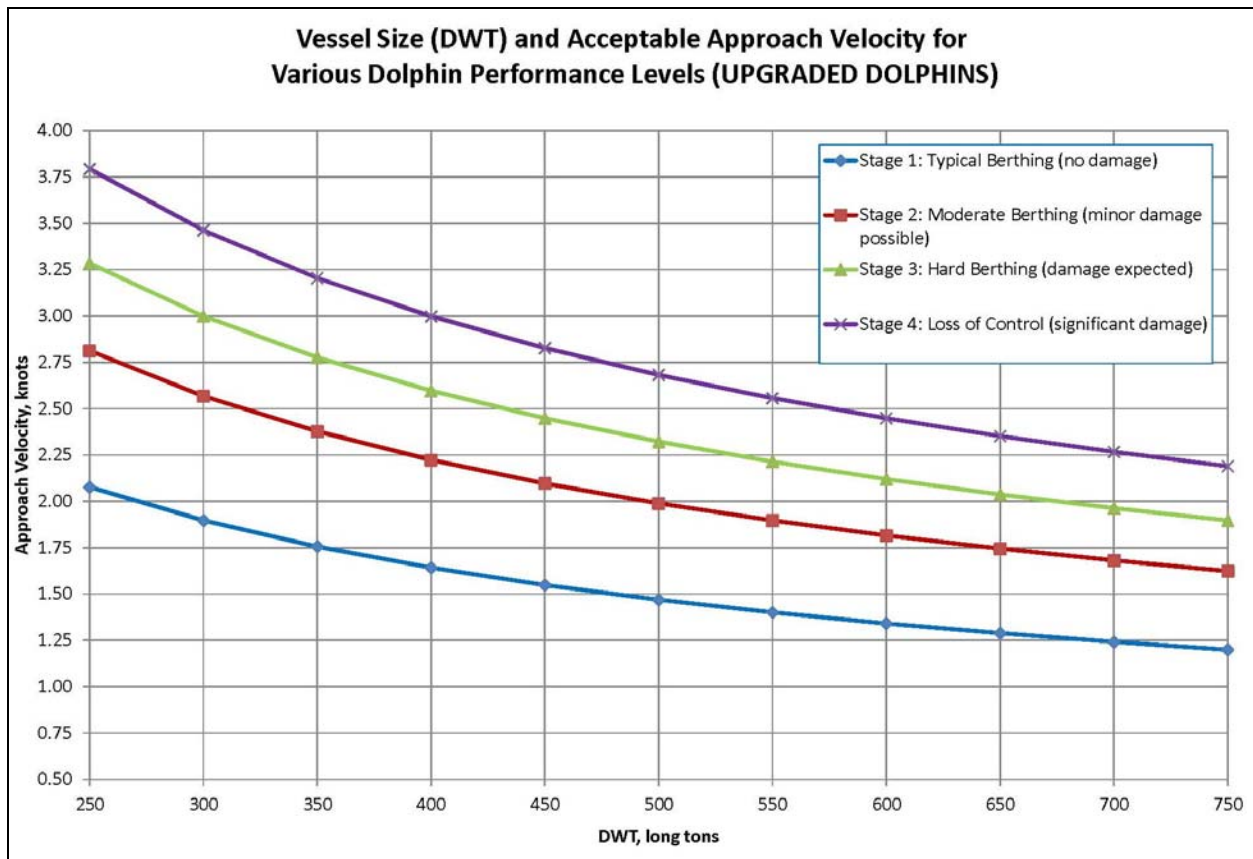
Figure 9: Modified Dolphin Performance Chart

The chart in **Figure 9**, below, shows the potential improved performance of the dolphins with modified fender panels as described.

It should be noted that the stage 4 energy absorption does not improve with the described upgrades. Only stages 1, 2 and 3 show performance improvements. The table below highlights the potential improved capacity of the dolphins after modification.

The fender panel could be upgraded to increase efficiency for larger vessels by adding fender piles, replacing the fender cap (to accommodate the added fender piles), and replacing the rubber fenders with larger units. It is conceivable that energy absorption levels up to 60 kip-ft and 110 kip-ft within the level 1 and 2 performance criteria (no/minor damage) could be achieved. Additionally, energy absorption of about 150 kip-ft, corresponding to level 3 (sustaining repairable damage) could be reached. The maximum energy absorption, as stated earlier, would top out at about 200 kip-ft (causing significant dolphin damage, but sparing the vessel and passengers).

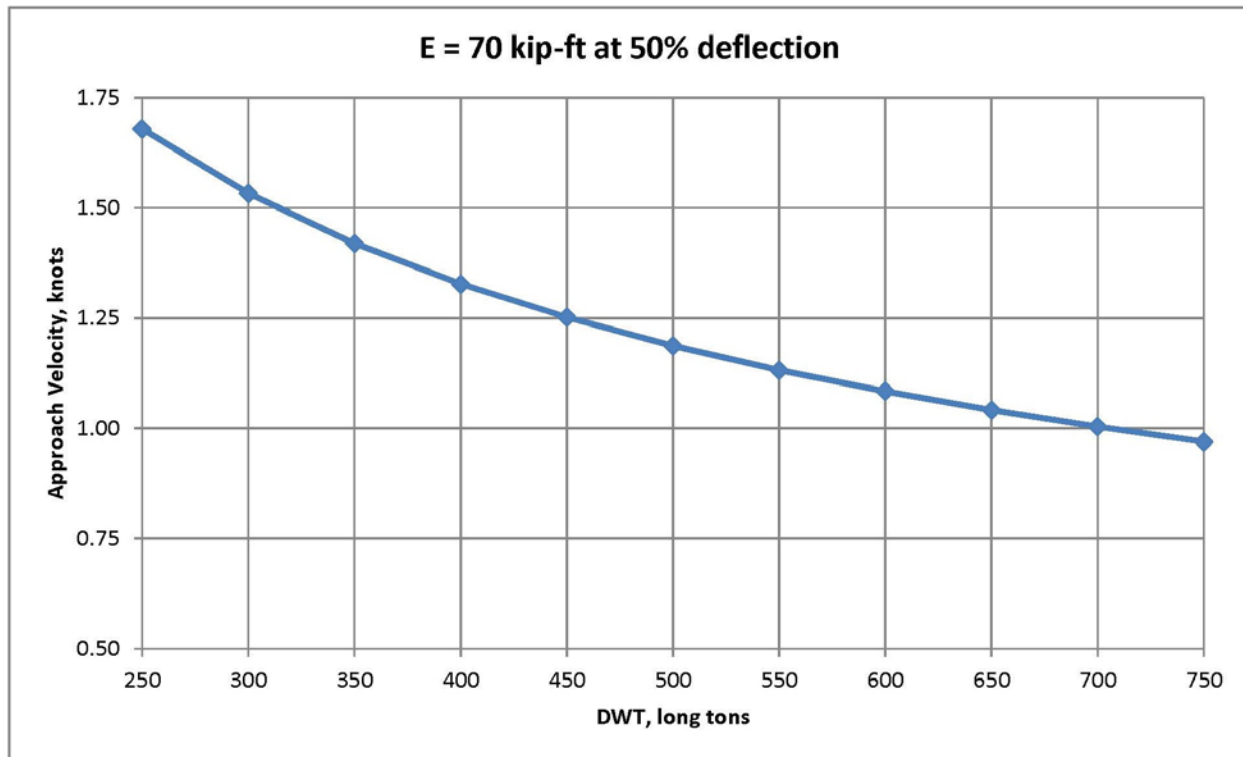
Figure 10: Wingwall Performance Chart

Another consideration regarding the wingwalls is the berthing velocity of the approaching ferry. For this, the design energy absorption of the wingwalls is estimated and, using similar calculations and methods as employed in the dolphin analysis, approach velocity and vessel mass are compared. The design energy absorption of each wingwall of approximately 50 kip-ft, translates to a ferry kinetic energy of about 70 kip-ft. The chart in **Figure 10**, below, shows the anticipated acceptable approach velocities for full compression of the wingwall fenders, for a range of vessel sizes.

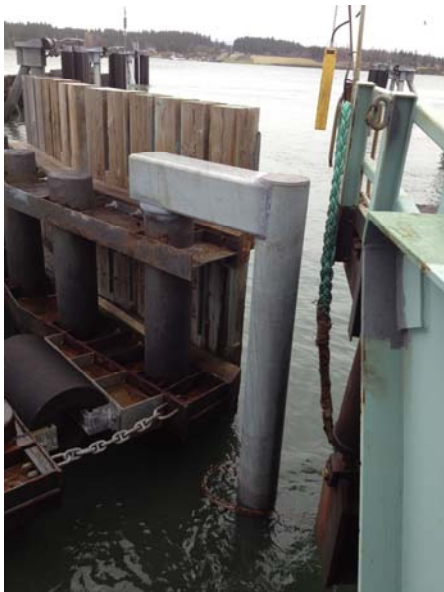
Figure 12: Photo of Mooring System

The configuration of the wingwalls however is a concern. Currently the gap between the wingwalls at the Anacortes terminal is too tight to allow replacement with a wider apron. These wingwalls were recently modified to add a mooring line system for overnight moorage of the ferry while the ramp is hoisted to its upper limit. The existing gap between mooring pipes is about 20'-9", excluding the mooring lines that are permanently attached to the pipes. **Figure 11** is a photo of the apron ramp, wingwalls and referenced mooring pipes.

The wingwalls at the Guemes side are slightly wider apart, which would provide adequate space for a wider apron without modification to the wingwalls. Modifications to the Anacortes wingwalls to accommodate a wider apron would require development of a new overnight moorage system. **Figure 12** is a photo of one of the existing pipes in the mooring system.

Design, fabrication and installation of new apron ramps could be done by matching the existing hinges and making some modifications for the hydraulic lifts. Rough order of magnitude costs for fabrication and installation of new apron ramps and lip plates, including necessary modifications to the wingwalls at
