# COAL CREEK ALTERNATIVES FEASIBILITY STUDY

December 21, 2010

Prepared for Skagit County Public Works

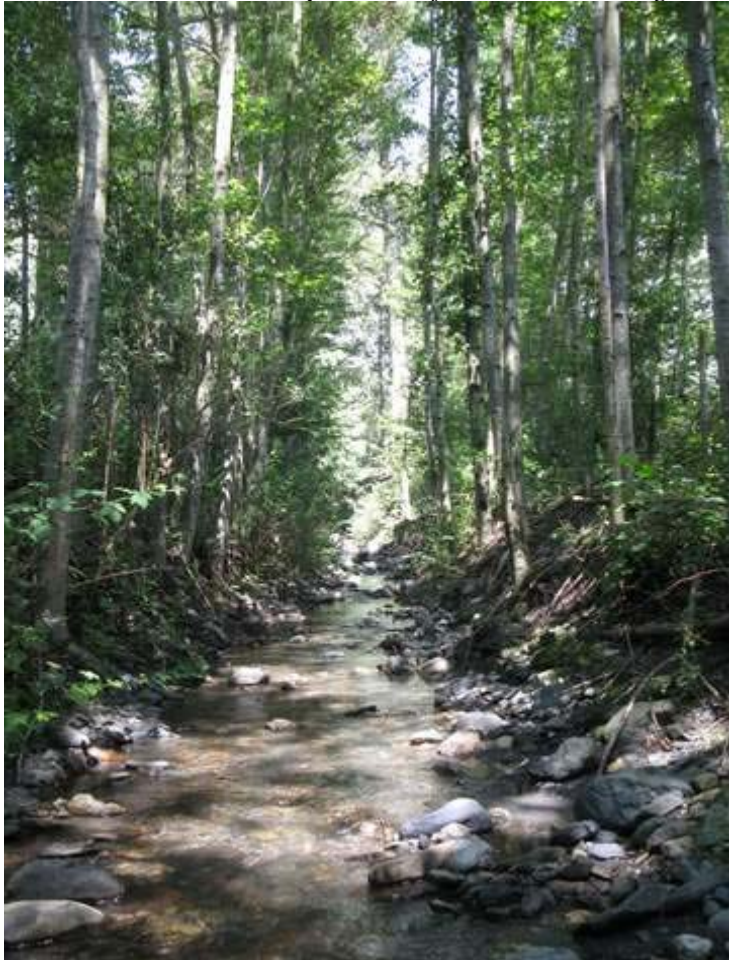
*Picture 4. Descent to Coal Creek via Sierra Pacific road access. Steep, densely vegetated bank with erosion, small landslides, and evidence of past logging on steep banks.*

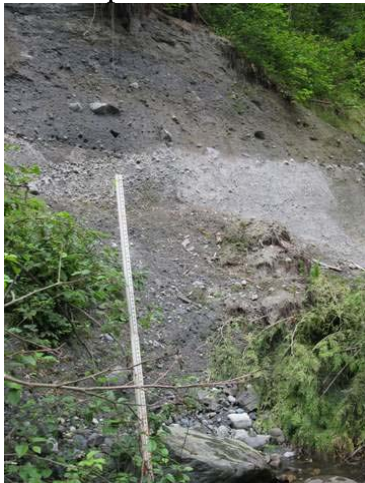
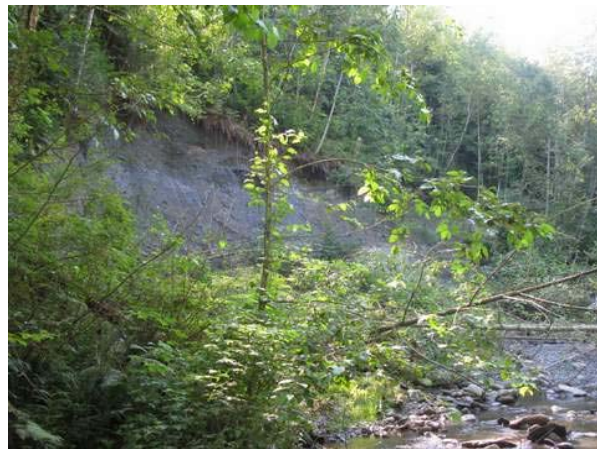
*Picture 6. Eroded bank looking upstream.*

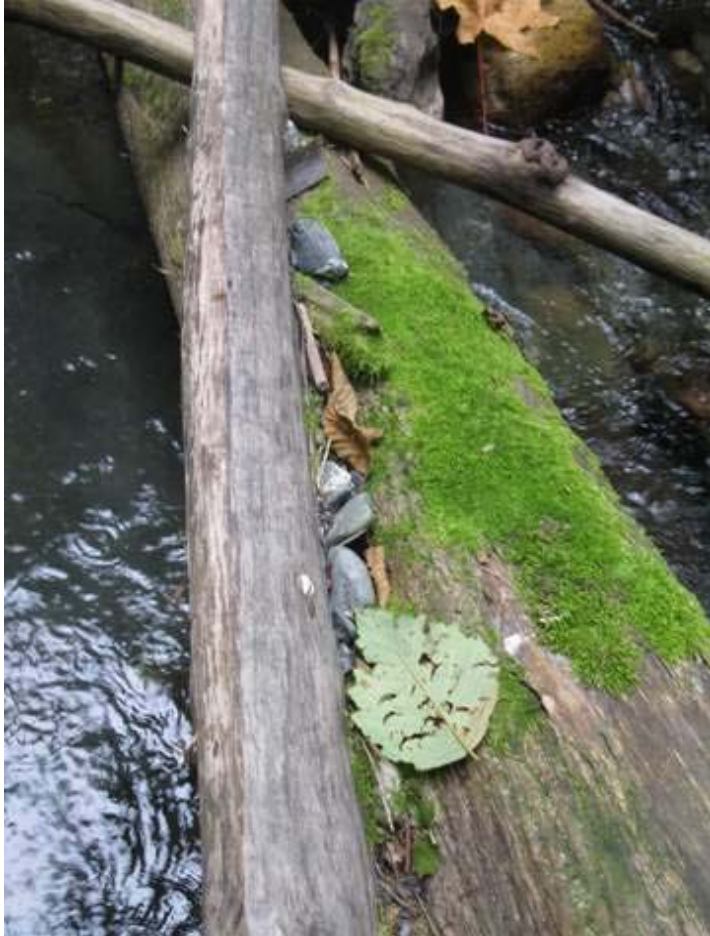
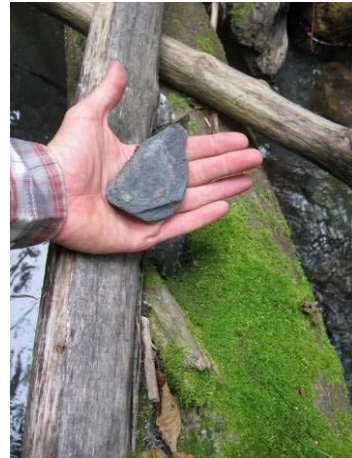
*Picture 17. Large-woody-debris in stream and complex cascade habitat.*

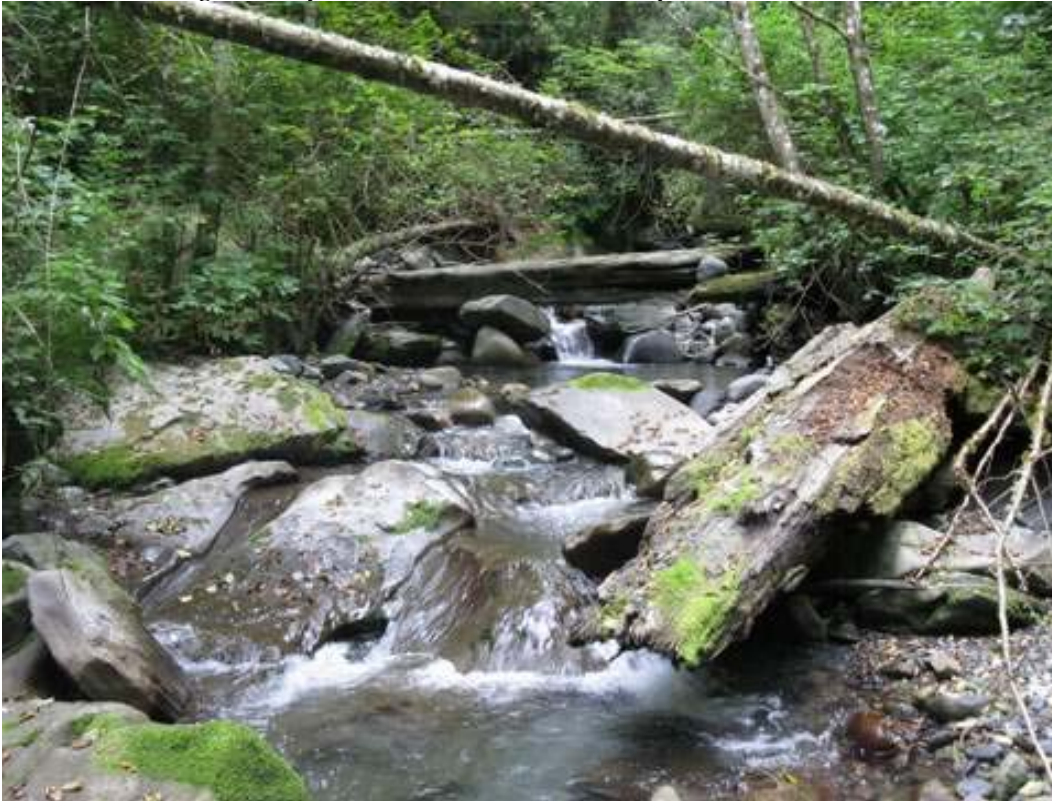
*Picture 18. Narrow channel with Chuckanut Sandstone sides approximately 2 m wide with ~0.5 m falls/cascade into 1 m deep pool.*

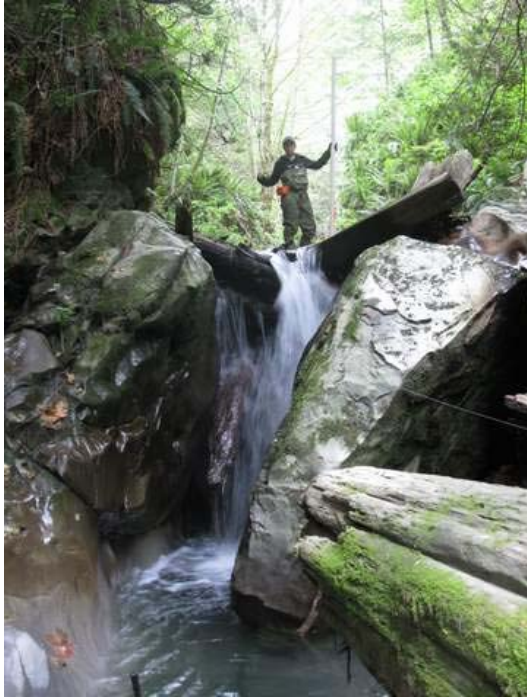
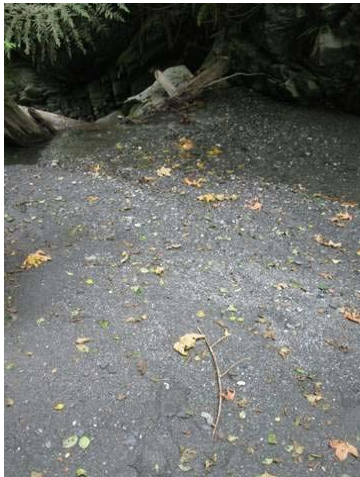
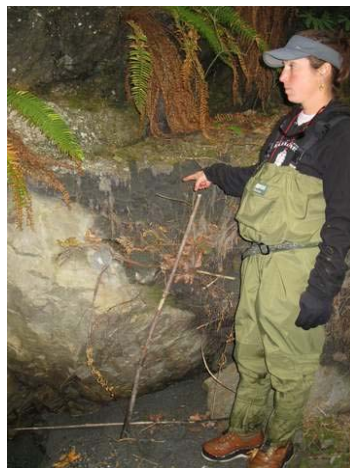
*Picture 20. Instream sediment pile (cobbles, gravels, sands) in center across to left-bank approximately 0.5 meters high at deepest point. Sediment pile is immediately upstream of Mr. Lindzy's home (visible from stream).*

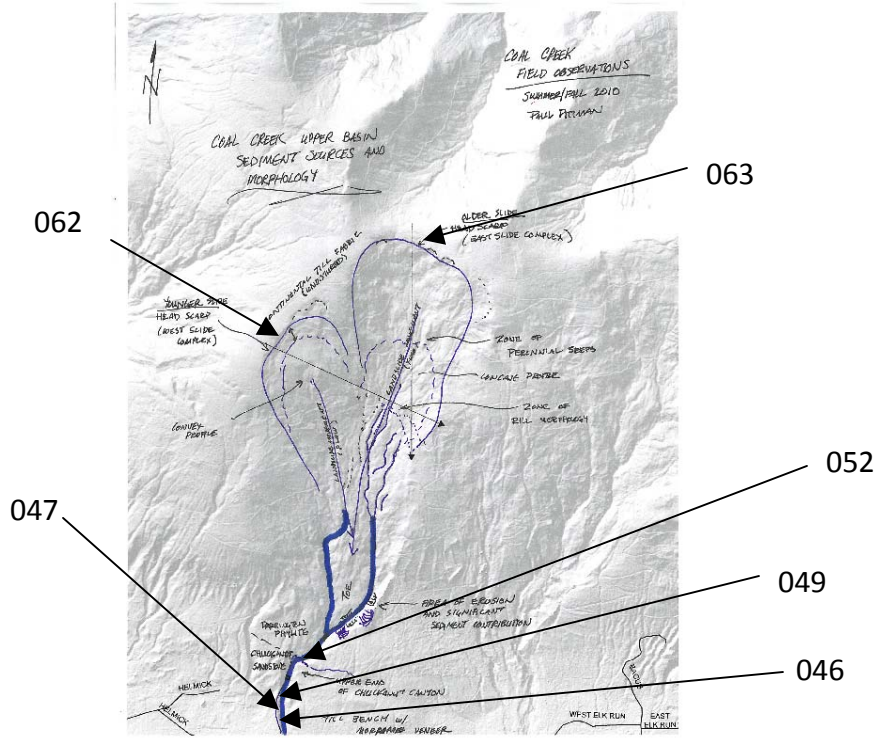
LiDAR Hillshade landslide morphology

062 Photo D6	West Slide Complex (younger slide) – Head scarp and offset of continental glacial sediment and glacial morphology texture. Some bedrock exposed in scarp. A convex slope profile.
063 Photo D8	East Slide Complex (older slide) – Head scarp. Less defined offset of slide mass. Significant bedrock exposed in scarp. A zone of numerous perennial initiation points located at slope break below scarp. A concave slope profile.

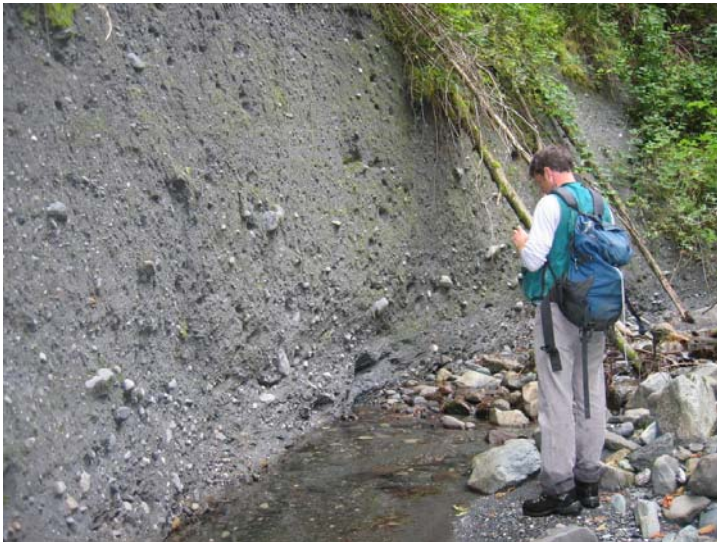
**Photo D1: Glacial sediment (lodgment or basal till) exposed near the apex of the alluvial fan immediately downstream of the Chuckanut Formation canyon.**

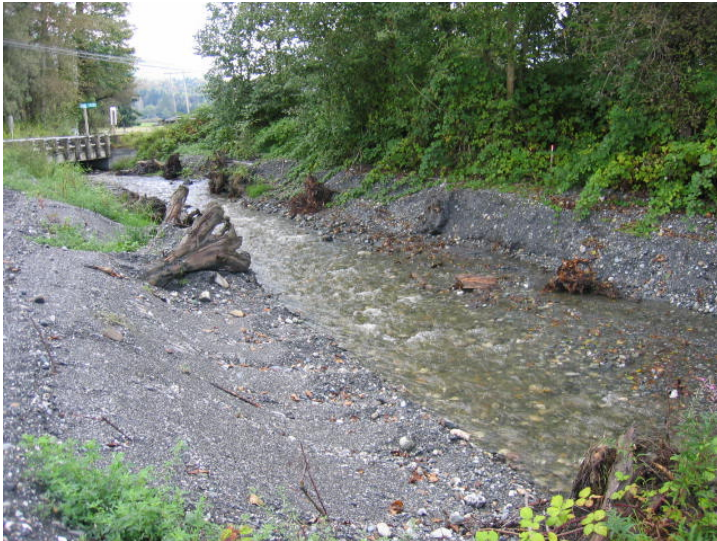
**Photo D4: Minkler Road sediment trap (looking upstream) with the recent installation of LWD designed to maintain sediment transport through this reach and into the depositional area (following image)**

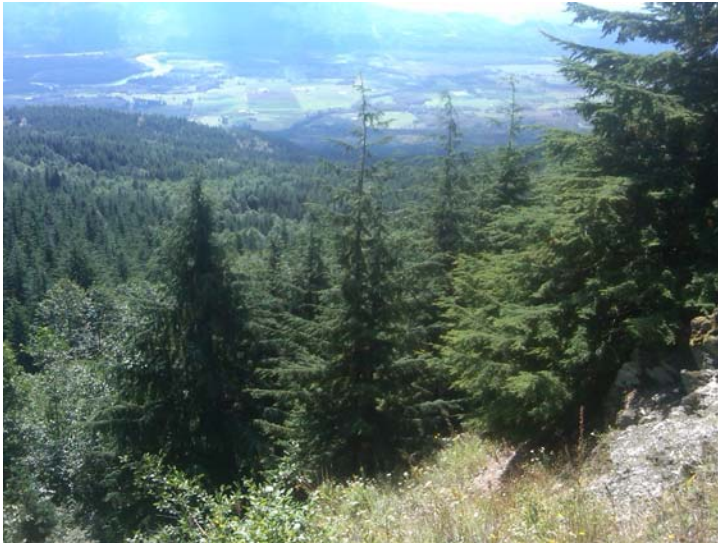
**Photo D9:** Looking down the East Slide complex.
