# Memorandum

Date: December 9, 2019

Re: Flow Obstruction Assessment on Edens Road

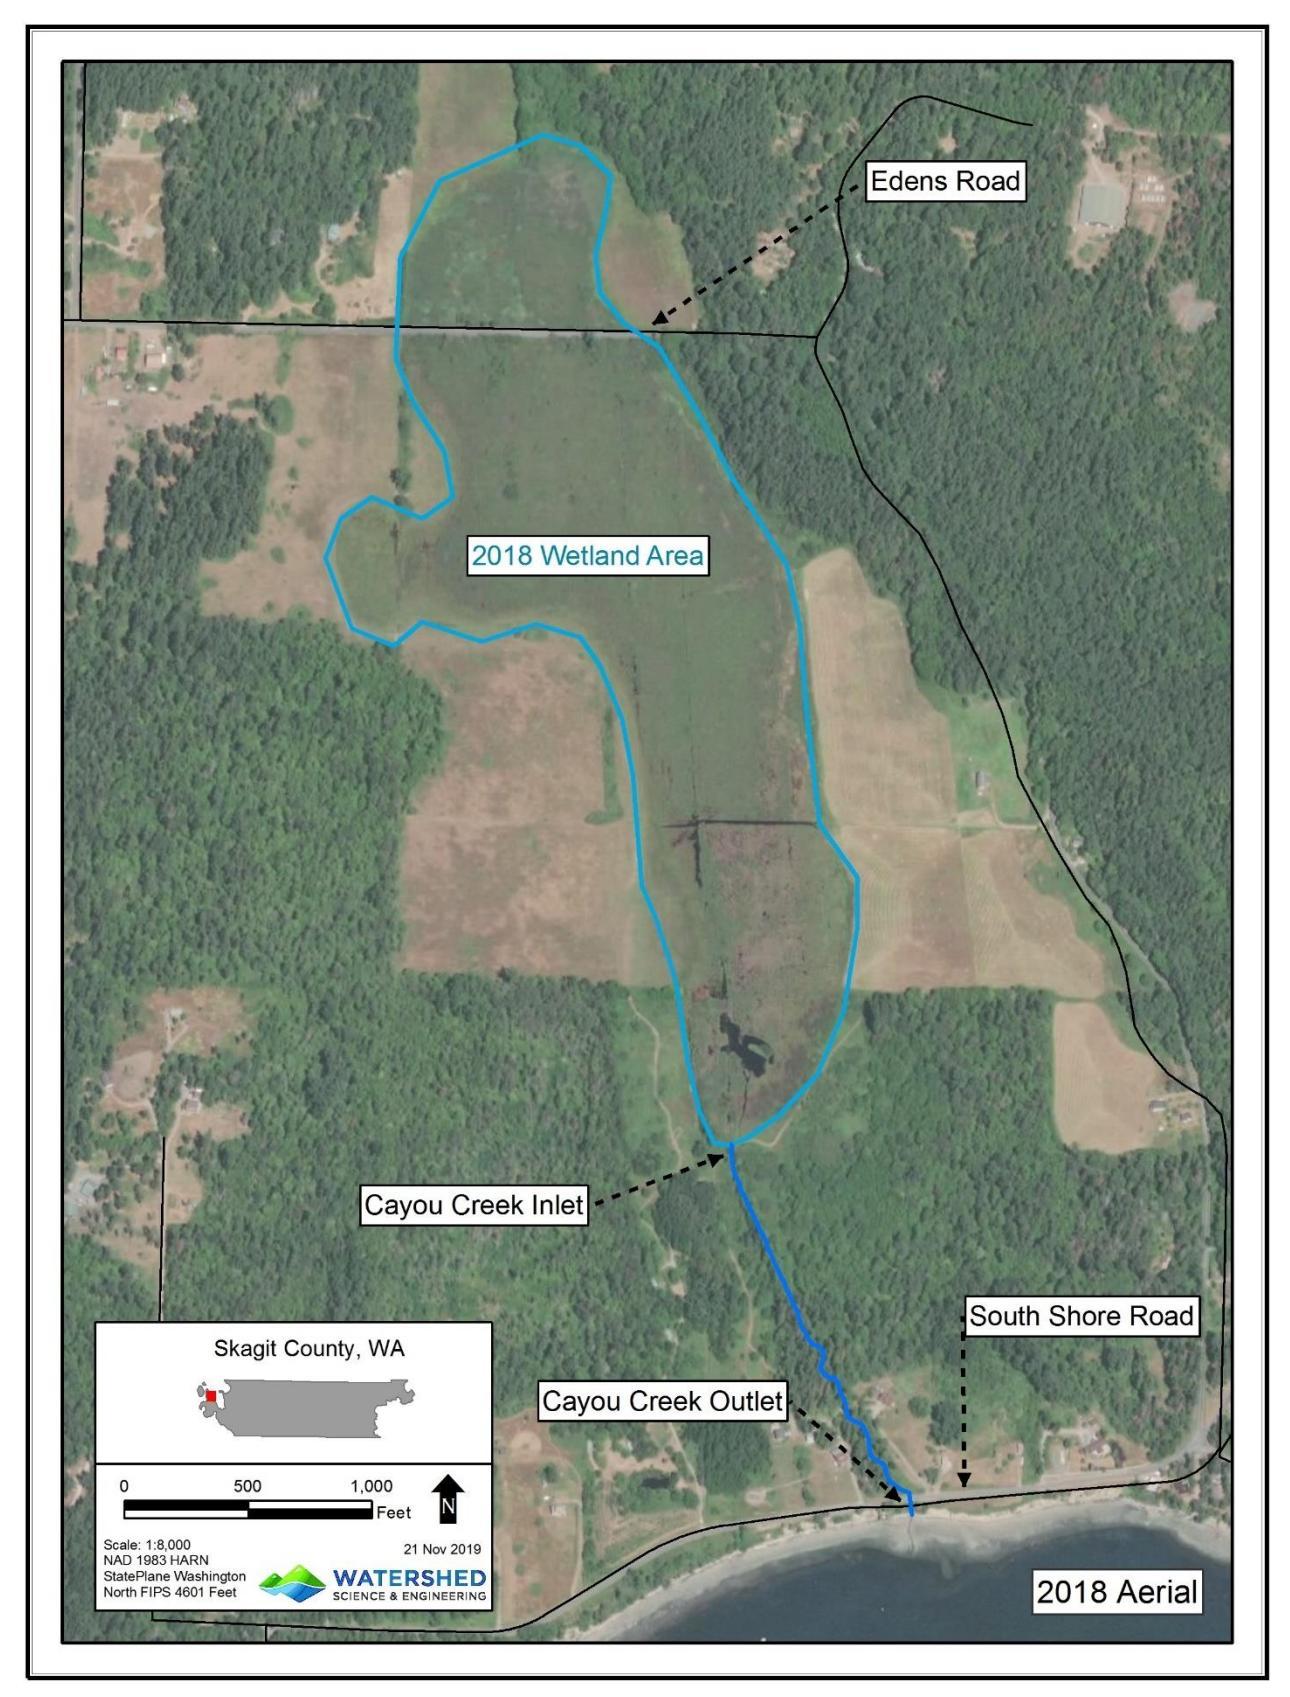
The current wetland that Edens Road passes through is approximately 4100 feet long and 1000 feet wide, occupying an area of almost 90 acres based on 2018 aerial imagery (Figure 2). It has a small outlet at its south end where it connects to Cayou Creek, which flows 1600 feet to the Guemes Channel. The wetland surface maintains a relatively constant elevation of approximately 27 feet between Edens Road and the outlet at Cayou Creek. Cayou Creek descends quickly through an incised channel before flowing through a culvert under South Shore Road to empty into Guemes Channel (Figure 3).

Figure 2 – Location map of Edens Road and the wetland basin on Guemes Island (2018 aerial)
