**Carpenter Creek, Hill Ditch and Fisher Slough Watersheds
Initial Flood and Sediment Study**

Skagit County, WA

Final Report

March 2007

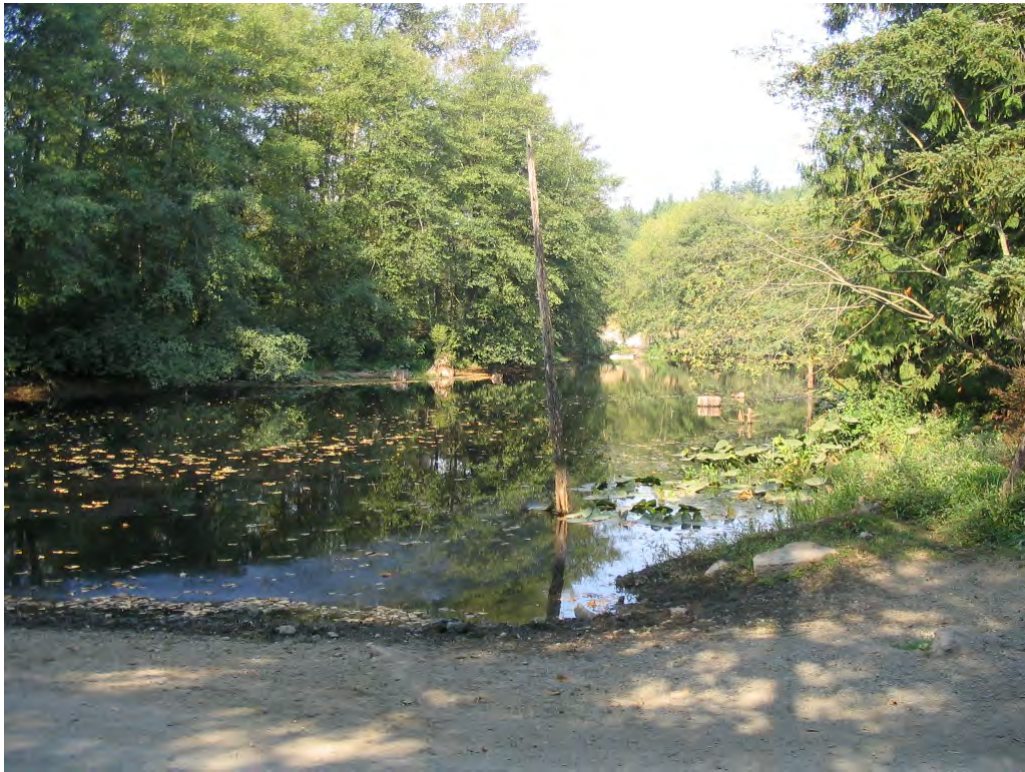
Figure 5. Lang Pony Farm Middle Pond

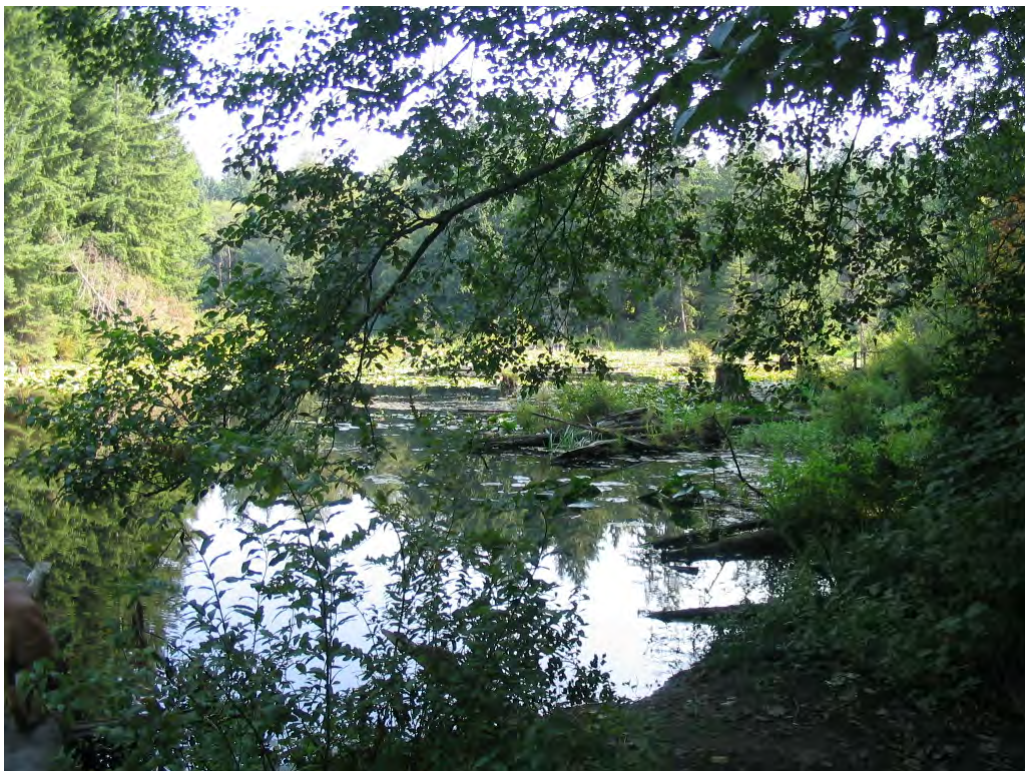
Figure 6. Lang Pony Farm Upper Pond

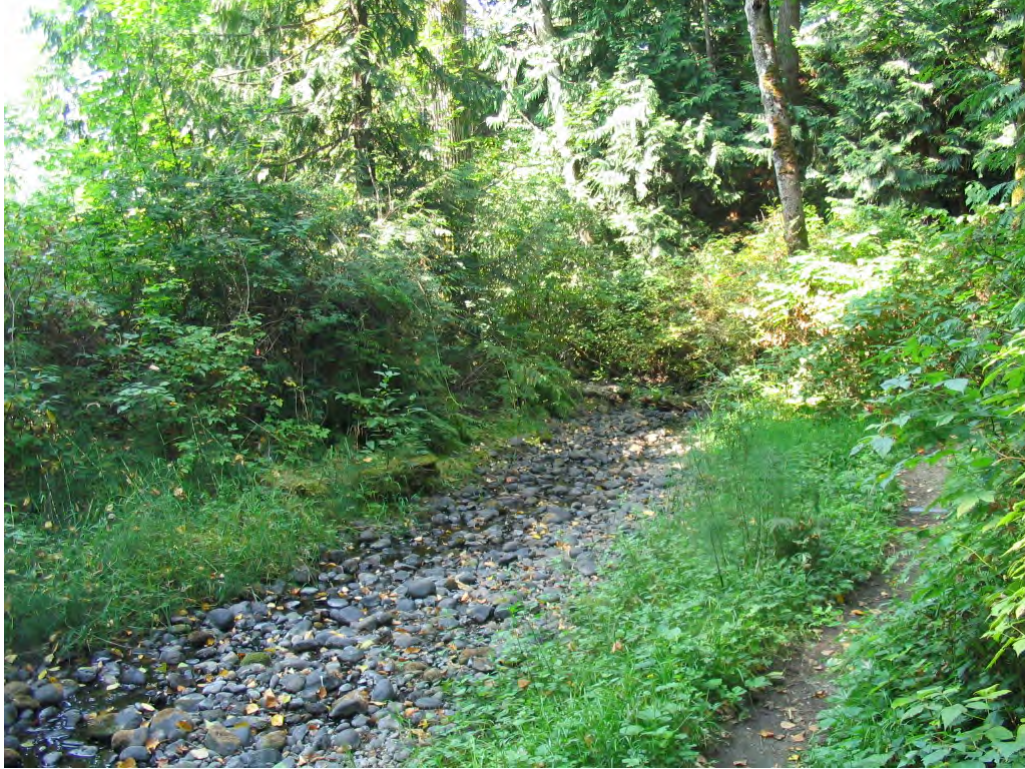
Downstream from the horse pasture area, Carpenter Creek flows through a steeper ravine (**Figure 9**). The bed and banks of the ravine are the primary source of coarse sediment to Carpenter Creek. The ravine has an average gradient of five percent and maximum gradient of 11 percent. The ravine walls are 100 feet high and landslides probably occur in infrequent, high-intensity storm events. The creek is currently stable except for one large cut bank in the southeast quarter of Section 33 (SCD, 2006b). At its downstream end, the ravine reach has abundant large cobbles and scattered small boulders, with moderate to slight bank erosion and no instream channel structure. Most of the ravine is within Little Mountain Park and has mature riparian forest and a stable, pool-riffle channel (SCD 2006), and presumably some channel structure from LWD.

Figure 9. Carpenter Creek in ravine near quarry

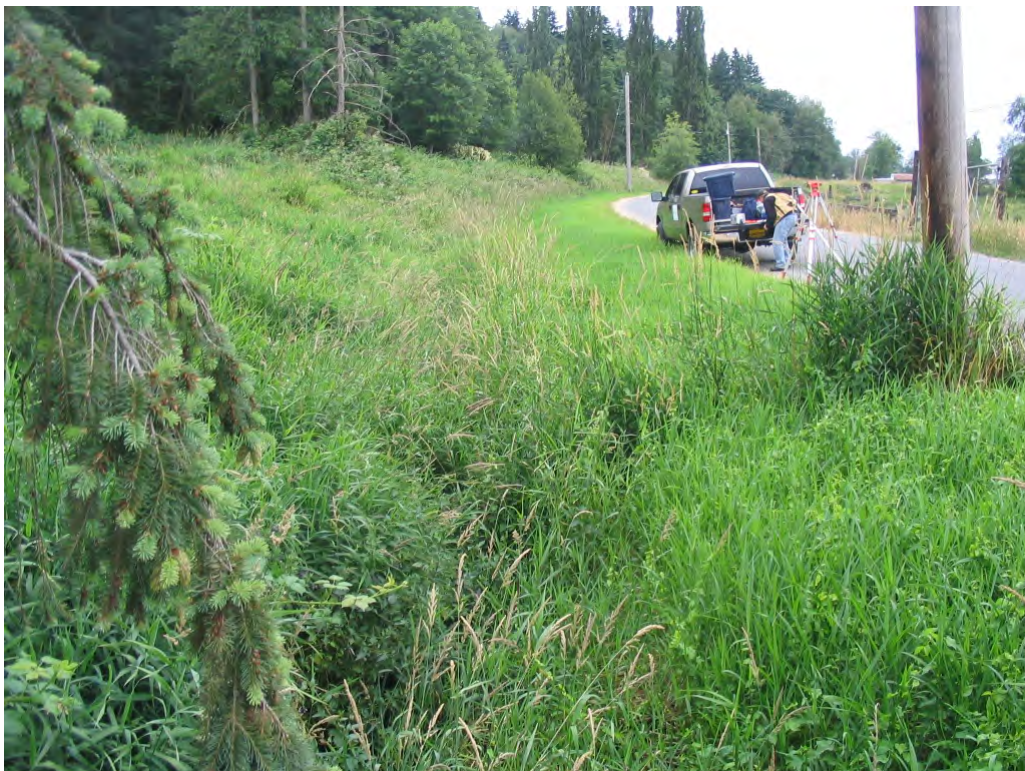
After exiting the ravine, Carpenter Creek flows down a gentle, unconfined, alluvial reach with an average gradient of four percent. This reach of Carpenter Creek had severe, localized bank erosion following the sudden failure of a three-foot diameter culvert at the quarry in 1990 (SCD 2006a). The undersized culvert was replaced with a 10 foot diameter culvert and banks have reportedly stabilized with no known current erosion sources except localized bank erosion associated with bank armoring between Hickox Road and Cascade Ridge Road. Carpenter Creek is joined on the east by 10 Lake Creek, a steep but stable bedrock channel, and on the west by Stackpole Creek, a low gradient rock-lined roadside ditch (SCD 2006a). The final reach of Carpenter Creek is a very low gradient ditch, starting a short distance below Cascade Ridge Road and paralleling Stackpole Road (**Figure 10**). This area was identified during interviews as being a flood overflow area, where Carpenter floods and overtops Stackpole Road and flows into the farm fields on the adjacent properties to the west.

Figure 10. End of Carpenter Creek and start of Hill Ditch along Stackpole Road

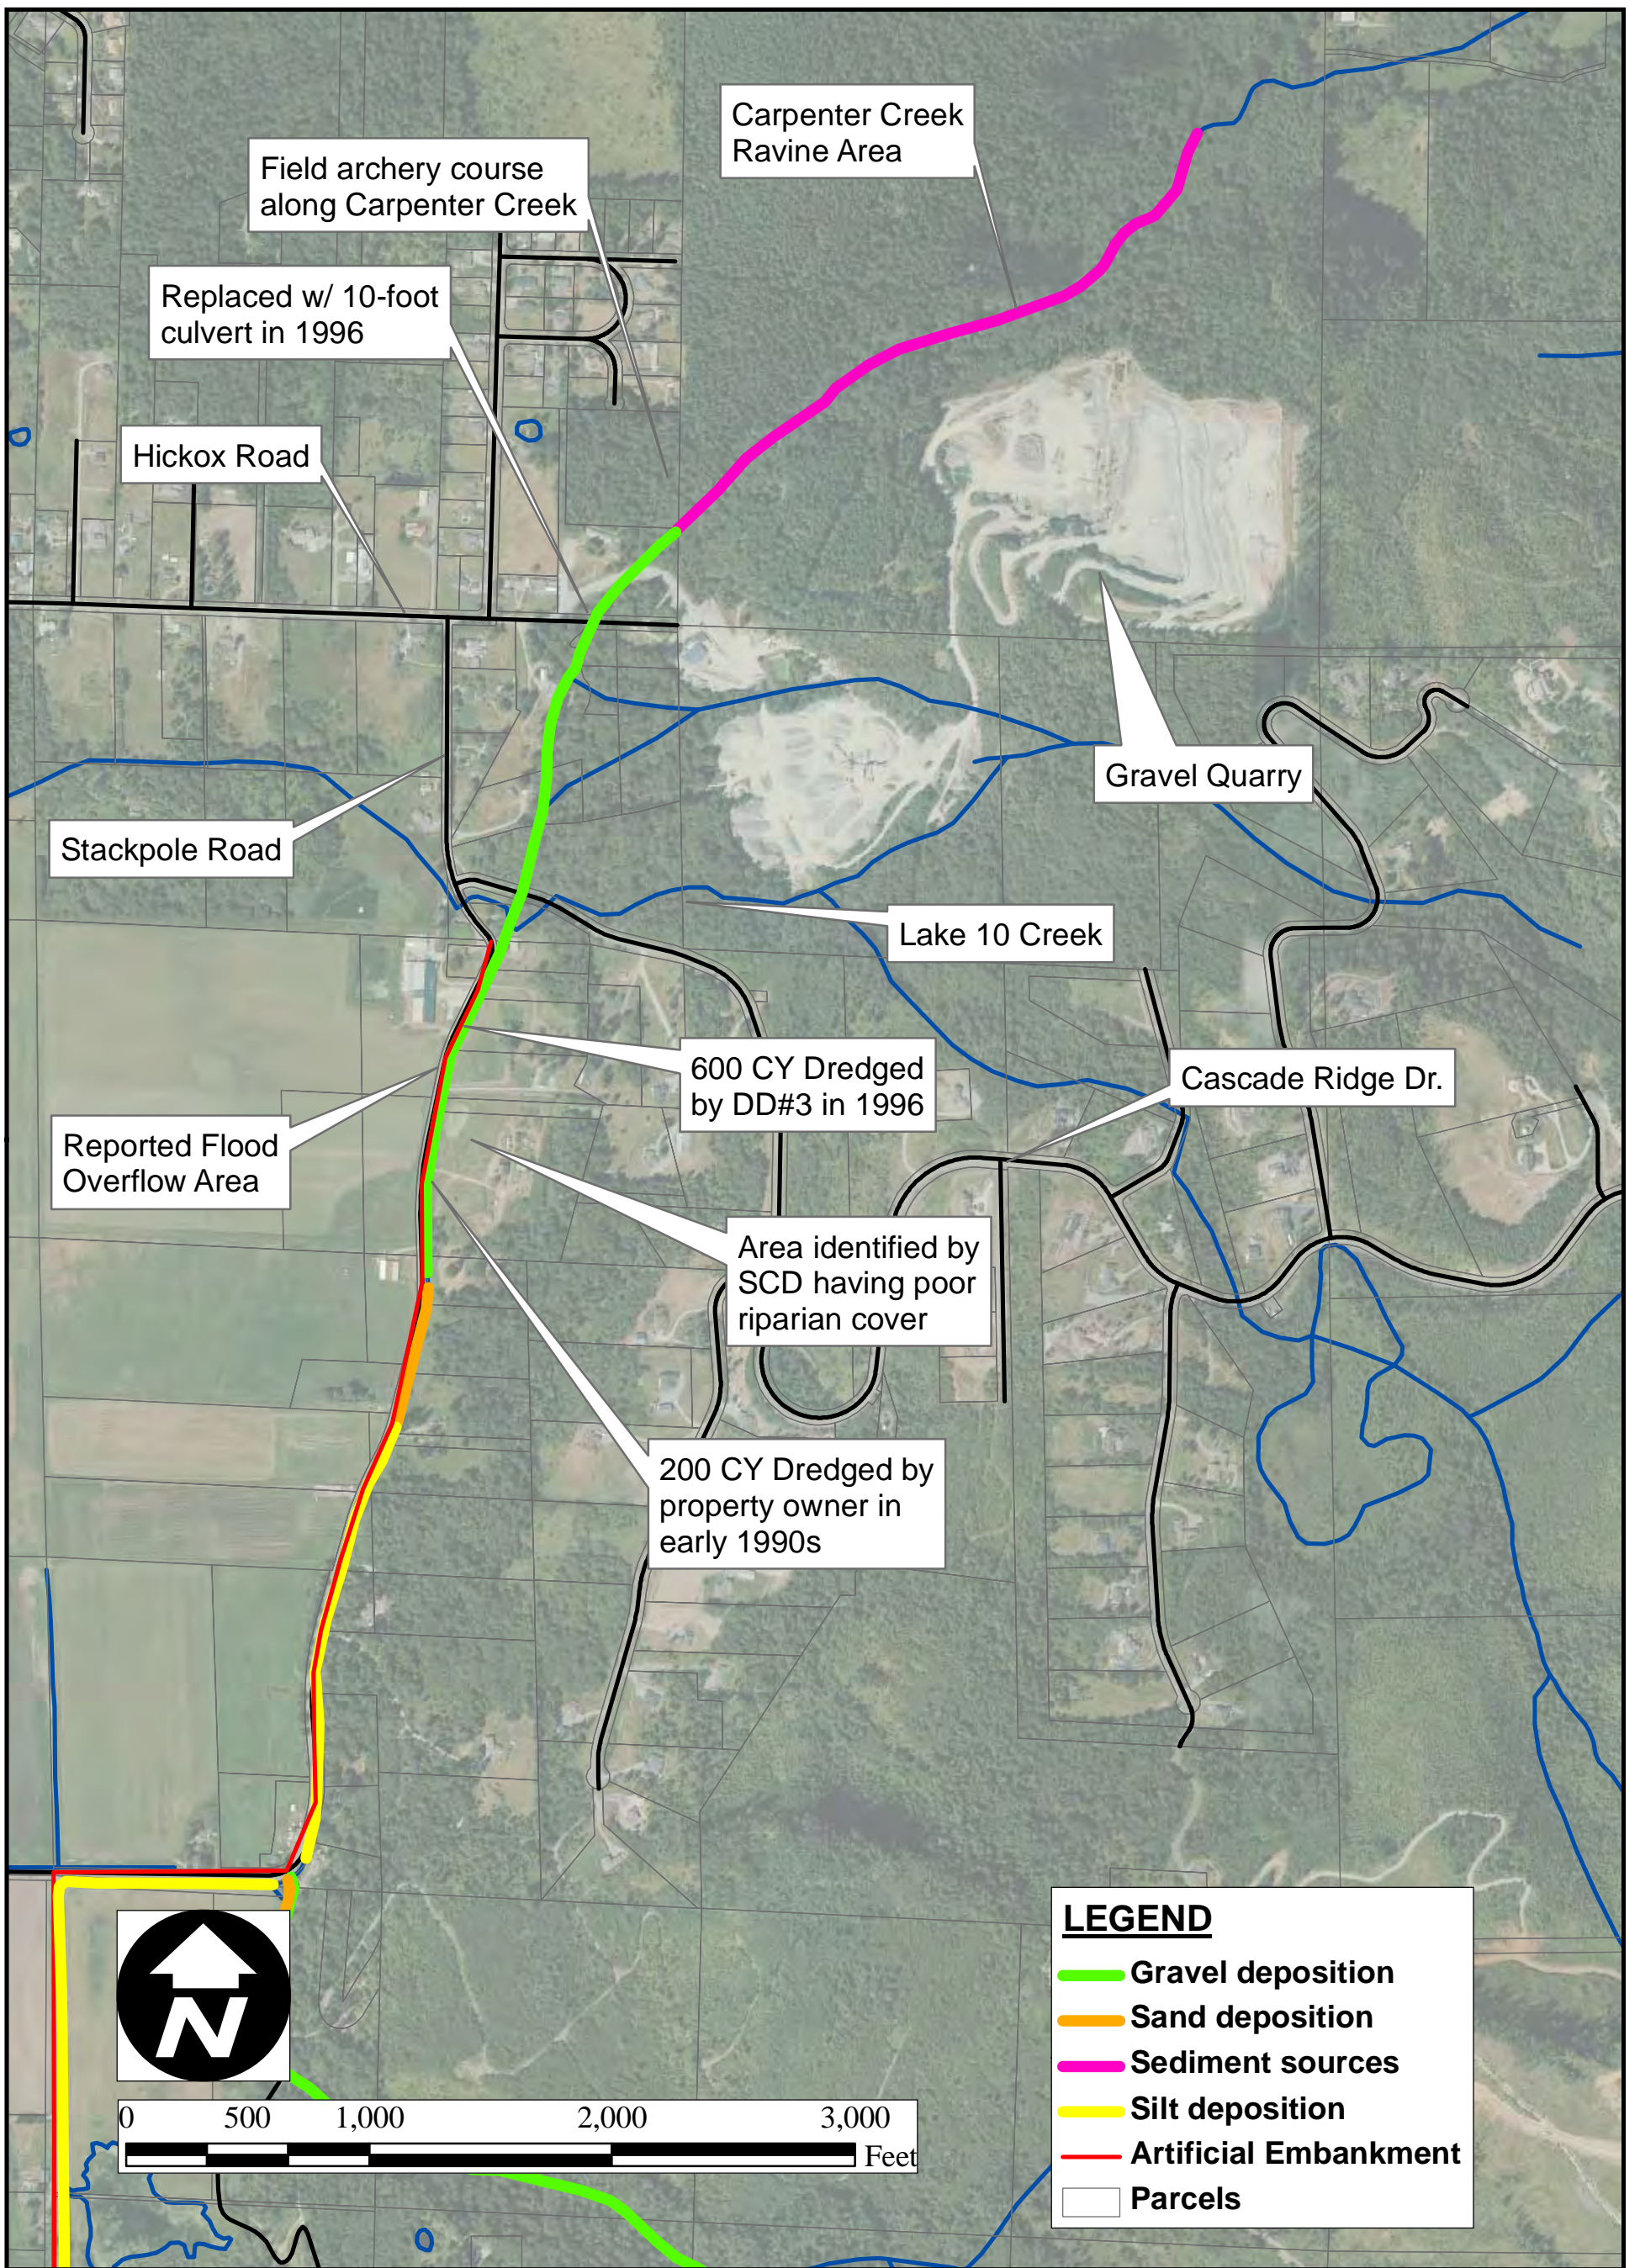
The declining gradient and lack of valley confinement reduce Carpenter Creek's sediment transport capacity downstream from the ravine. The maximum size of sediment declines from 15-inch boulders just above the gravel pit to gravel, sand, and finally silt in Hill Ditch (**Figure 11**). Although this is clearly the depositional zone for the creek's coarse sediment load, the amount of sediment appears low. 800 cubic yards of gravel were reportedly dredged from this section of Hill Ditch in the 1990s. The ditch has apparently not needed recent dredging. Much of the dredged sediment may have resulted from the 1990 culvert blowout. The low sediment load is attributed to the low level of hydrologic changes from development, the broad valley and wetlands that trap sediments and attenuate flood flows in the upper half of the watershed, the relatively gentle relief and undisturbed riparian corridor (with the exception of the Stackpole Road area just downstream from the 10 Lake and Stackpole Creek confluence). However, future land use plans show significant potential development in the upper watershed within the City of Mount Vernon and Skagit County urban growth areas, which could increase flooding and sedimentation problems.

**FIGURE 11. CARPENTER CREEK
SEDIMENT SOURCES AND
DEPOSITION ZONES**

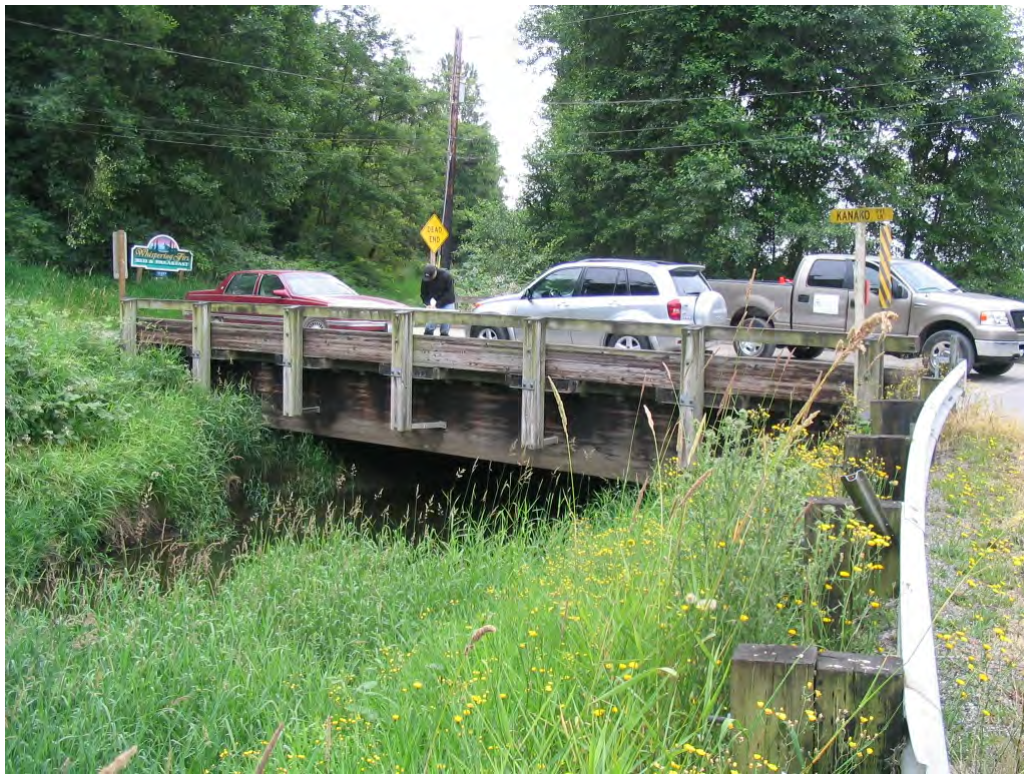
By 1937, the date of the earliest aerial photographs, Hill Ditch was already present and Sandy Creek was channelized to the north flowing (up valley) towards Kanako Lane and the valley wall (**Figure 17**). The Sandy Creek, Hill Ditch confluence is directly beneath the Kanako Lane bridge (**Figure 18**). Sediment deposits have accumulated in the 10 years or so since the last dredging and now nearly block the bridge opening. The current bridge was constructed in 1983. Dredging the bridge and Hill Ditch has typically been done every 5 or 6 years. According to interviews with Skagit County Public Works and Dike District #3, the dredging frequency has decreased due to difficulties in obtaining permits. Sediment deposits are located underneath the bridge and force flow towards the west abutment, which is experiencing scour and exposing the bridge abutment foundation. Hill Ditch has two 90 degree bends in its alignment that increase backwater resistance. The first bend is at Kanako Lane Bridge and the second is at the Dike District #3 levee and access road.

Figure 18. Looking at Sandy Creek/Hill Ditch confluence at Kanako Road Bridge

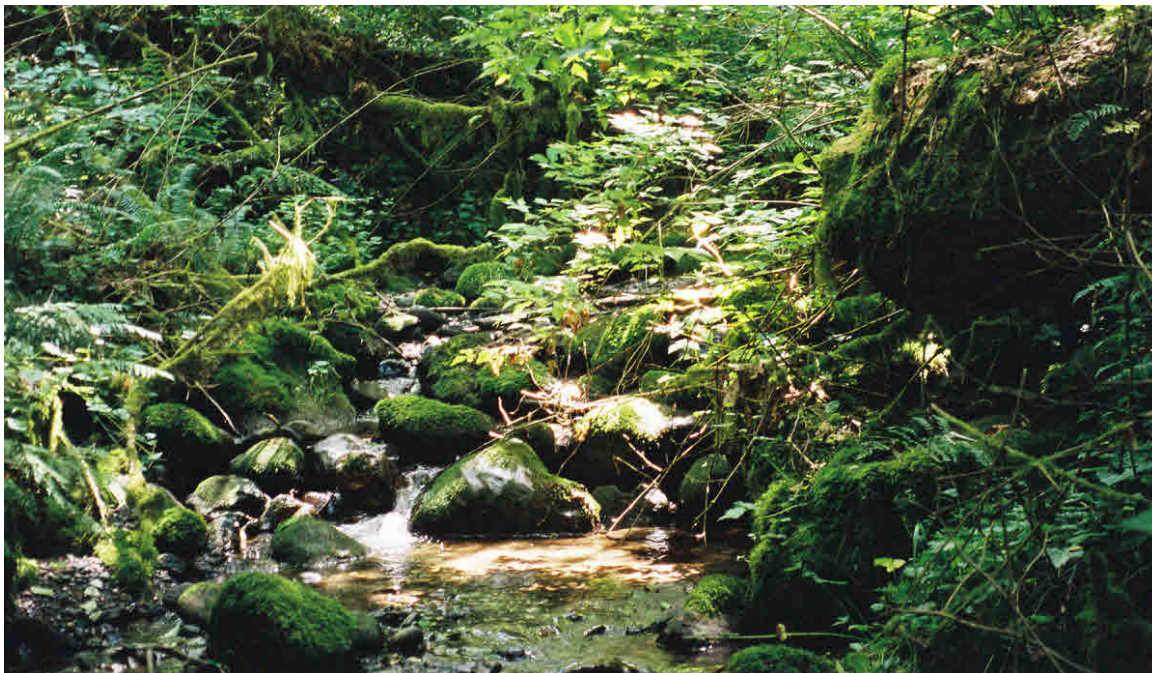
The first half mile of the Sandy Creek ravine was walked to observe erosion sources and sediment transport processes. The first 500 feet upstream from the fan is a slightly entrenched, plane bed channel without gravel bars. The next 500 feet upstream the channel steepens and has a step-pool channel that is incised 3-5 feet deep. The channel then further steepens to a cascade with some bedrock falls. Revegetated landslide scars were observed at 1600 and 2300 feet upstream from the alluvial fan. The only active erosion sources were local areas of eroding streambanks, mostly composed of very dense glacial till that appears to erode slowly but some alluvium as well further downstream. The bed and banks were generally erosion-resistant materials. Overall, the creek appeared to be transporting very little sediment. The inner gorge was densely forested, and many boulders and cobbles were covered with moss, indicating minimal sediment transport (**Figure 19**), and abundant sandstone boulders form stable steps within the channel.

Figure 19. Photo of moss-covered boulders in ravine

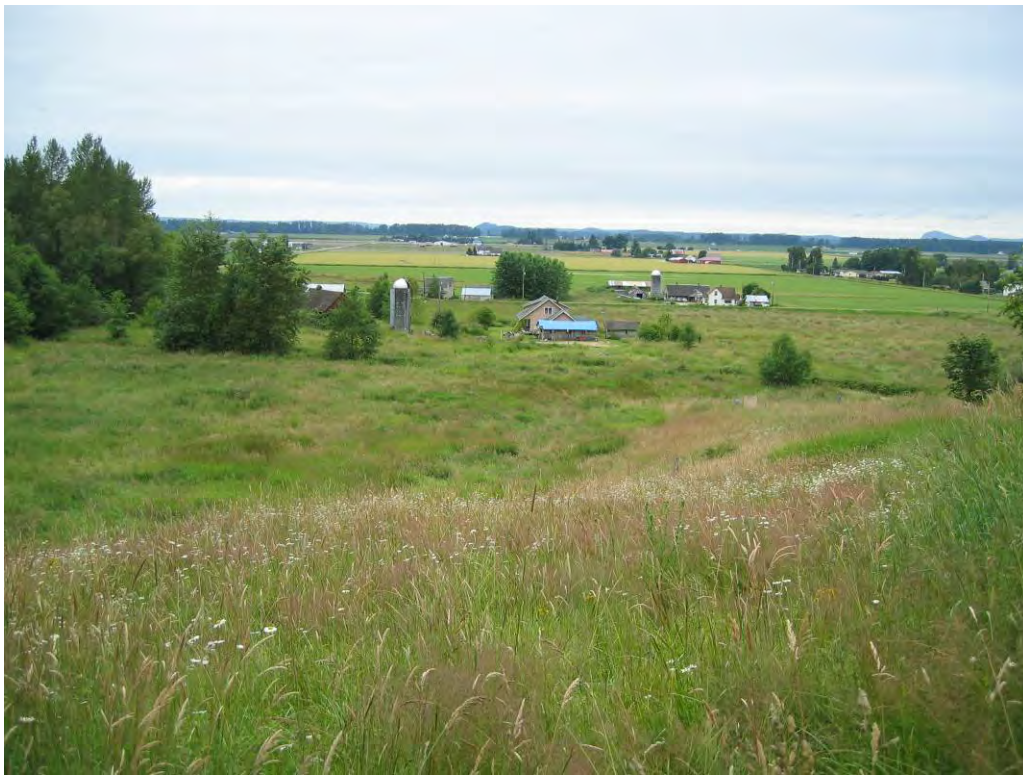
The historic alluvial fan is about 1800 feet long and 900 feet wide (**Figure 24**). The west tip of the fan has been separated from Johnson Creek by the Hill Ditch. The farm buildings were probably located on the fan to get above Skagit River flooding. By 1937, the date of the earliest aerial photographs, Hill Ditch was already present and Johnson Creek had been moved to the along the southern edge of the fan, next to the bedrock valley wall.

Figure 24. Looking west from north side of Johnson Creek alluvial fan.

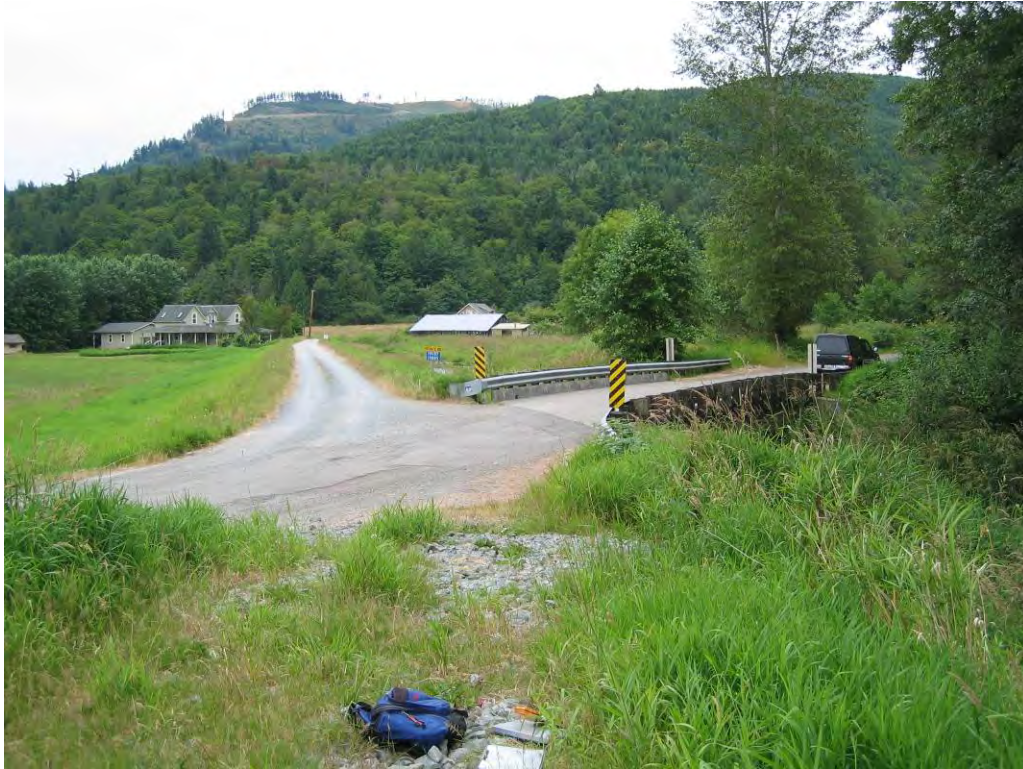
At the downstream end of the fan, the creek drops down and flows for a short distance in a ditch along the private driveway, crosses the driveway in a culvert and enters Hill Ditch (**Figure 28**). Since it was last dredged in 2003 or 2004, the creek has deposited a large sandbar in Hill Ditch that extends 100 feet upstream of the bridge and 280 feet downstream, which was recently removed in September 2006 (**Figure 29**). This sediment deposit, in combination with a low beaver dam, has ponded the flow and backed water up into a large open-water wetland that extends upstream nearly to the Sandy Creek fan. The sediment accumulation has been dredged about every five years since 1990 (Dave Olsen, Diking District #3). Dredging activities and removal of the beaver dam will likely lower backwater pond elevations upstream in the degraded wetland area.

Figure 28. Looking north along levee towards Johnson Road bridge

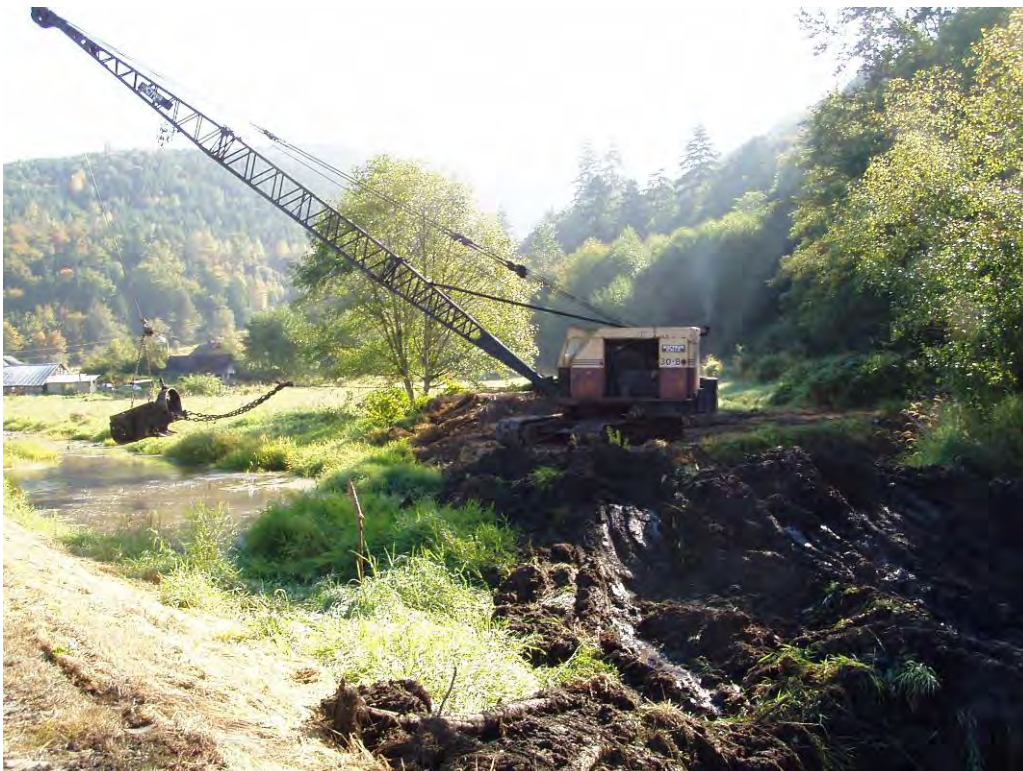
Figure 29. September 2006 dredge operations at mouth of Johnson Creek

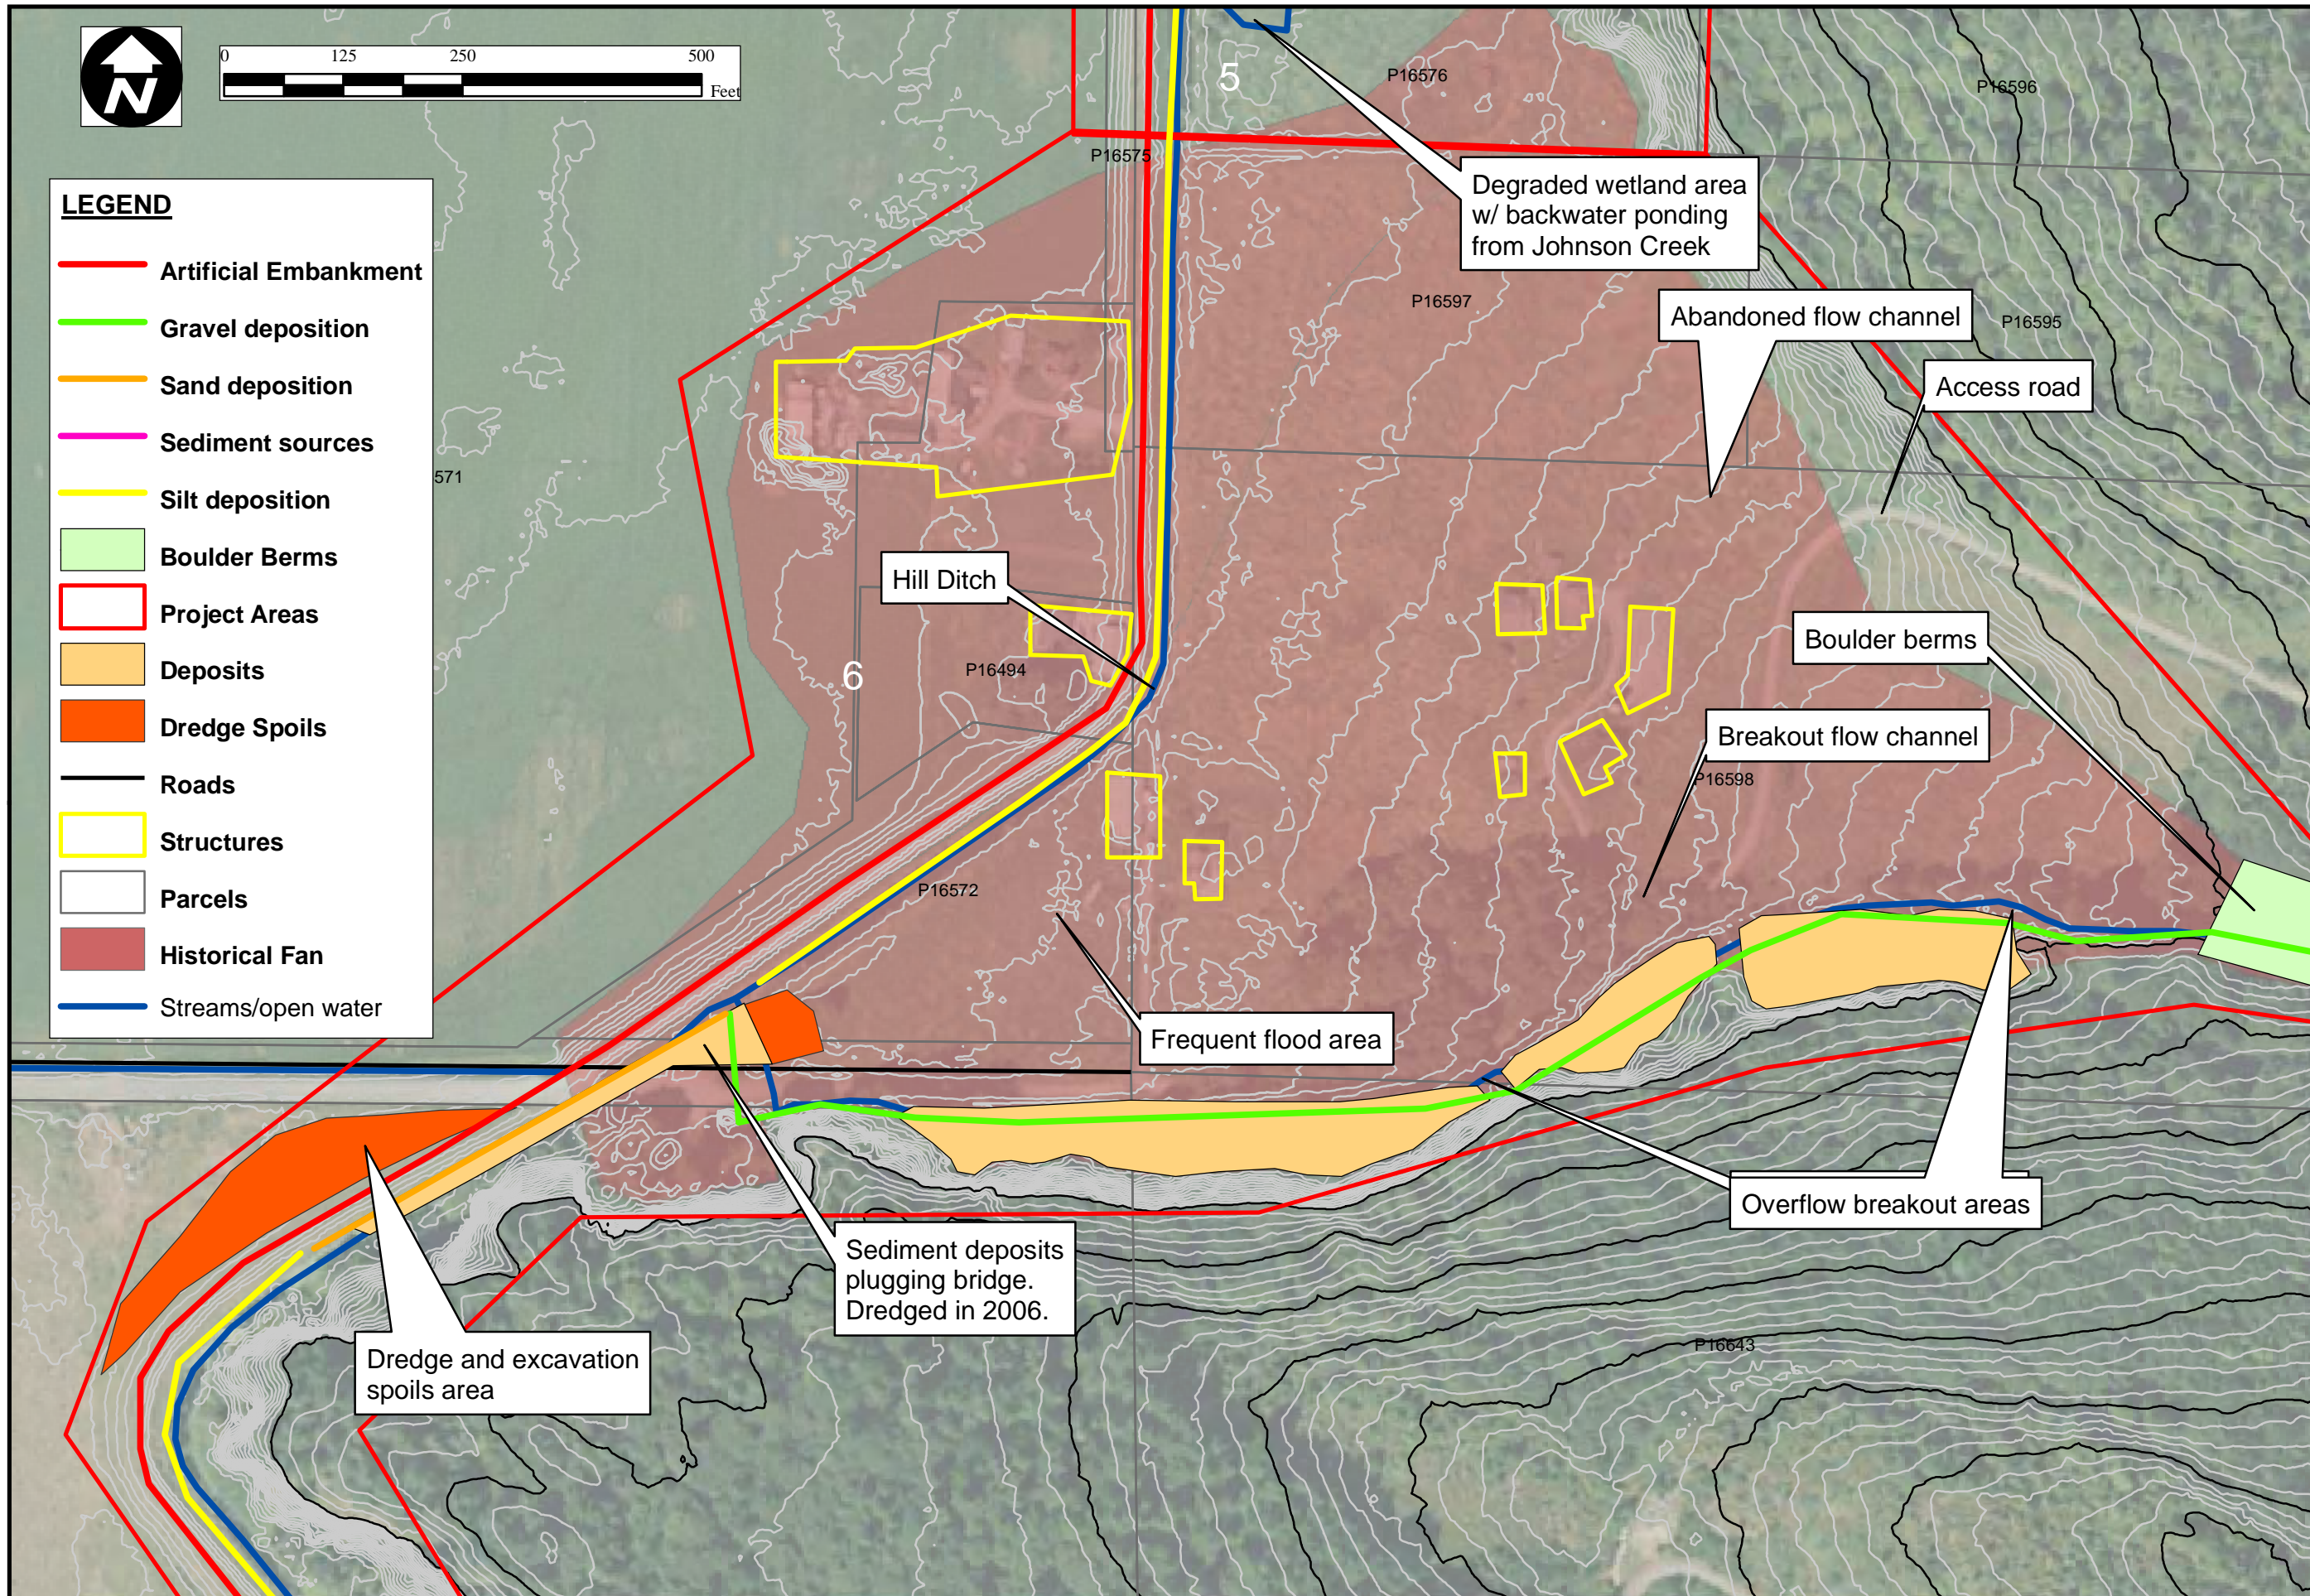
Sediment supply rates to Johnson Creek were estimated based on calculated volumes of dredge spoils and perched sediment and information on dredging rates provided by Diking District and Skagit County staff. The volume estimate based on deposition and dredge spoils was combined with watershed sediment supply to estimate supply rates of coarse and fine sediment (**Figure 30**).

FIGURE 30.
JOHNSON CREEK
EXISTING CONDITIONS SITE MAP
 SKAGIT COUNTY, WASHINGTON

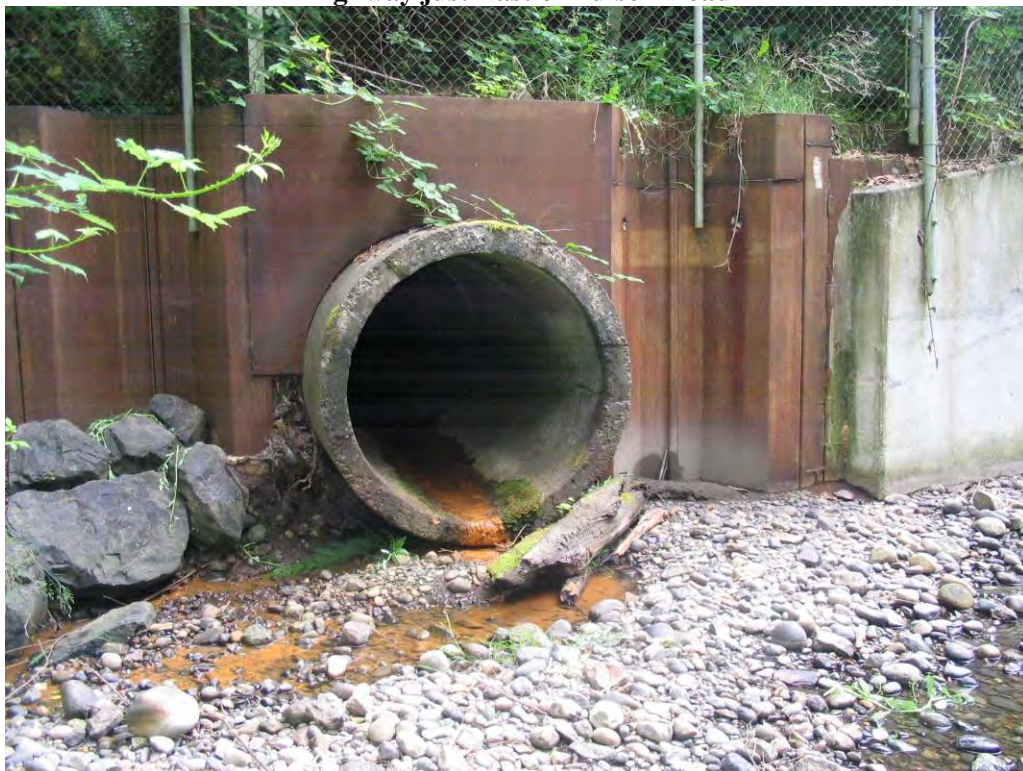
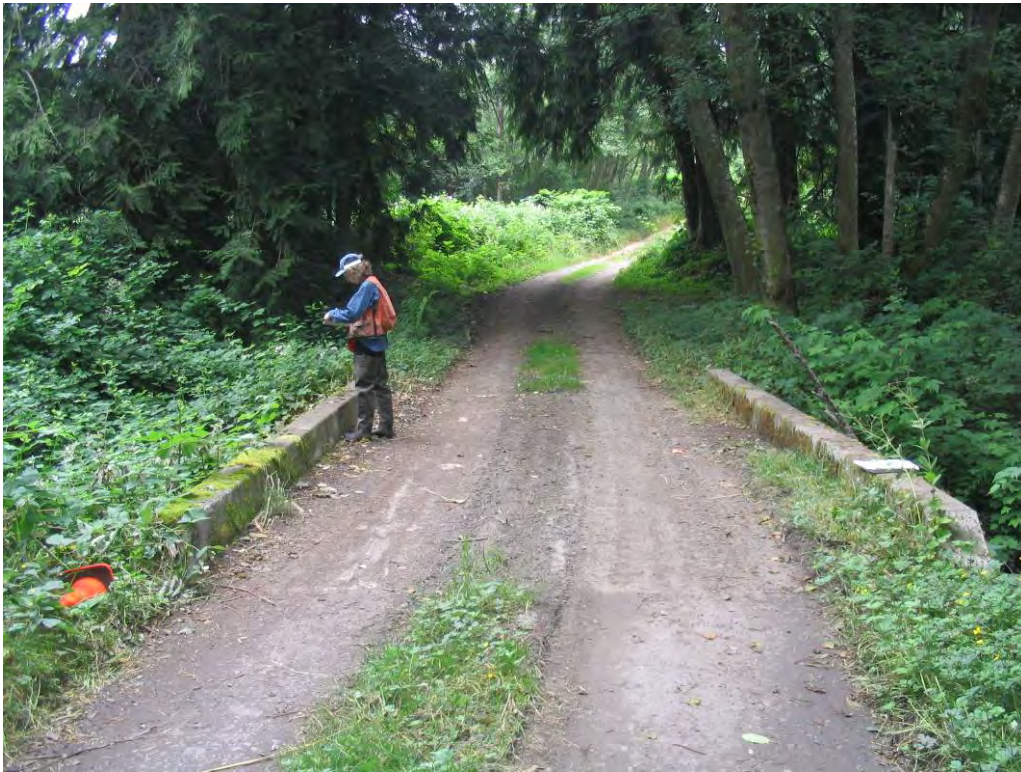
The concrete bridge en route to the Sixteen Lake camp has scoured the channel leaving the sewer pipe exposed. The exposed sewer line could be a potential risk and actions should be taken to protect the structure (**Figures 39 and 40**).

Figure 39. Looking upstream at old culvert (now overflow culvert) on Bulson Creek on Lake McMurray Highway just East of Bulson Road

Figure 40. Bridge crossing N. Fork Bulson Creek on Sixteen Lake Camp Road

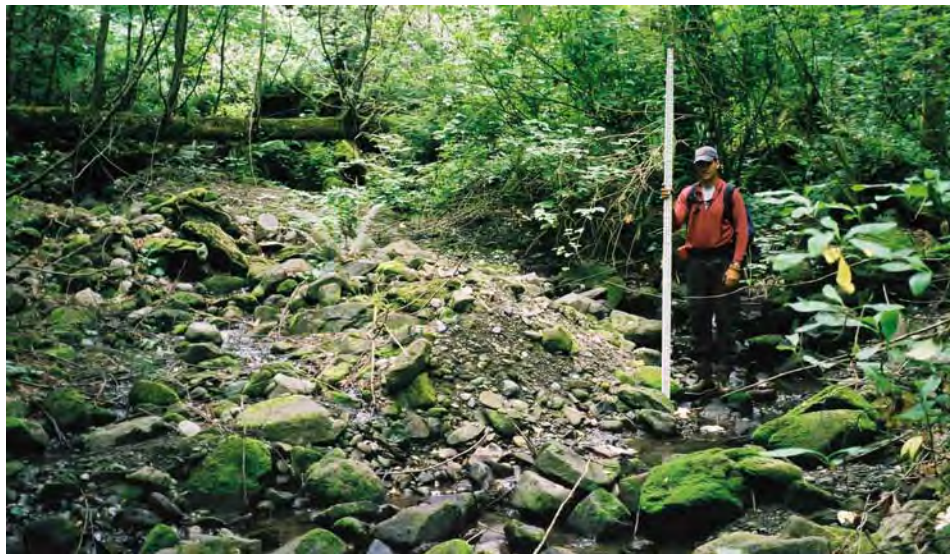
The first half mile of the ravine was walked to observe erosion areas and evidence of sediment transport processes. In the first 900 feet of the ravine, the channel was commonly incised 4-6 feet and had eroding banks. Small boulders had been recently transported and deposited on top of sediment deposits (Figure 3). Valley wall erosion started about 900 feet upstream of the fence near the fan apex. Landslides and landslide deposits of various ages occurred from 1000 to about 2300 feet upstream from the fan apex. The creek is pinched between the valley wall and landslide deposits (Figure 4), leading to rapid incision that further destabilizes the valley walls, which in turn causes more landslides. The north valley wall has

Figure 3. Photo showing boulders in transport positions a short distance upstream from the fan apex.

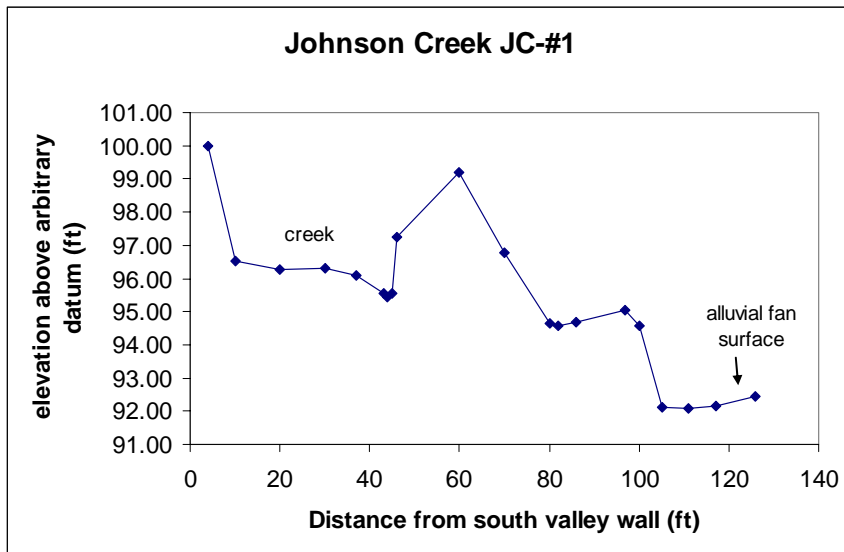
Over the decades since Johnson Creek was diverted there, the creek has deposited well over 10,000 cubic yards of sediment. The creek is now perched about four feet above the rest of the alluvial fan (Figures 5 and 6). This causes flow to go subsurface and the creek dries up at times during the summer. In most locations, an irregular combination of old, constructed and natural levees keeps the creek in its present location. The blue arrows on show areas with gaps in the levee where the creek breaks out whenever the flow comes up. Muddy water crosses the fan and floods the two clusters of buildings on the fan on its way to Hill Ditch. The County has dredged and placed sandbags in the downstream 500 feet of the private road next to the creek during emergency flood operations (Tom Sheehan, Skagit County Emergency Management).

Figure 5. Cross-section JC-1 of Johnson Creek showing stream channel perched on sediment deposits

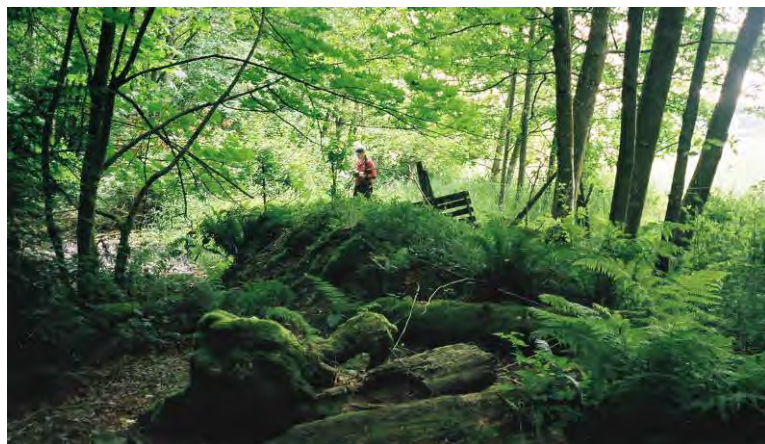
At the fan apex near the mouth of the canyon, the channel is no longer perched but there are other depositional landforms. There are several boulder berms, which are long, narrow, steep-sided landforms about 3.5 to 5.5 feet high and 25 to 50 feet long (Figure 7). The berms are formed of coarse sediment and contain small boulders all the way to the top. They appear to be deposited in single flood events, probably dam-break floods. They date to at least two different events, as one berm has 1-4 inch diameter alders growing on it and another 6-9 inch alders. There is a former log jam which has failed and the creek has now incised through the sediment that filled in behind the jam. There are also concrete blocks the may be

Figure 7. Boulder berm in the fan apex area

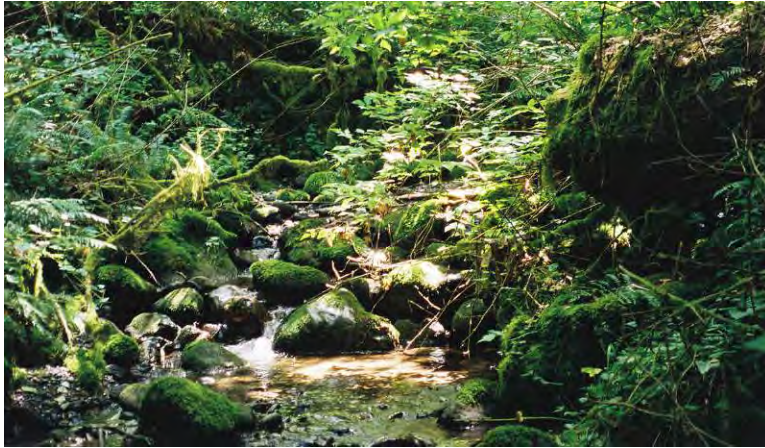
The first half mile of the ravine was walked to observe erosion sources and sediment transport processes. The first 500 feet upstream from the fan have a slightly entrenched, plane bed channel without gravel bars. The channel steepens and the next 500 feet have a step-pool channel that is incised 3-5 feet deep. The channel then steepens to a cascade with some bedrock falls. Revegetated landslide scars were observed at 1600 and 2300 feet upstream from the alluvial fan. The only active erosion sources were local areas of eroding streambanks -- mostly very dense glacial till that appears to erode slowly (Figure 8), but some alluvium as well further downstream. The bed and banks were generally erosion-resistant materials. Overall, the creek appeared to be transporting very little sediment. The inner gorge was densely forested, and many boulders and cobbles were covered with moss (Figure 9). Abundant sandstone boulders formed stable steps in the channel.

Figure 9. Photo of moss-covered boulders in ravine

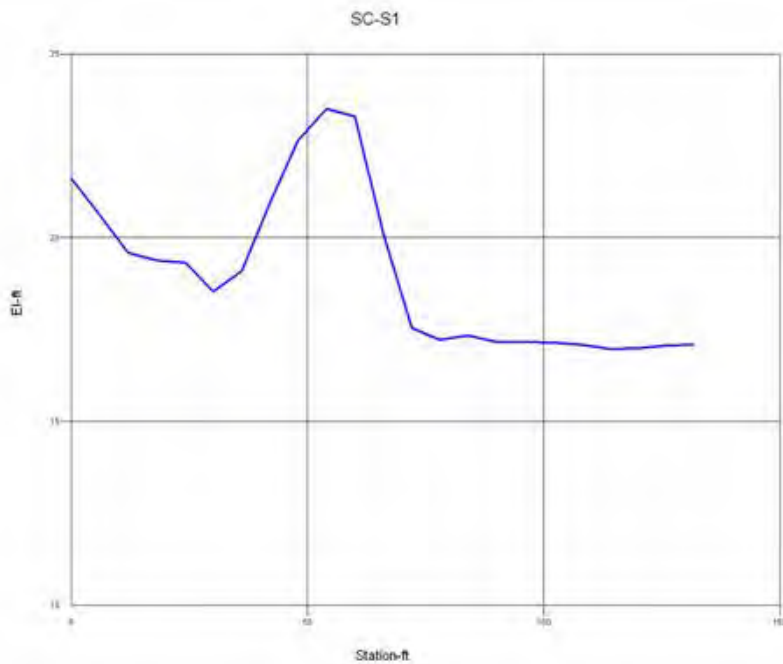
Over the decades since Sandy Creek was diverted there, thousands of cubic yards of sediment have been dredged from the creek. Most of the dredge spoils have been placed west of the creek. The creek has been repeatedly dredged deeply enough that it has not become perched above the alluvial fan. The dredge spoils form a barrier preventing the creek from flowing onto the fan (Figure 10). Since Kanako Lane is a private road, there are no records kept about dredging or flooding problems on the fan. No emergency operations have been done there (Tom Sheehan, Skagit County Emergency Management). There is a depositional zone above the upstream culvert and the spoils levee is fairly low, so that is likely where problems tend to occur. The gradient in the culvert zone is 0.46%.

Figure 10. Cross-section looking upstream, showing Sandy Creek to the left of the dredge spoils at the edge of the valley wall.
